**Special Crash Investigations
On-Site Alleged Air Bag
Malfunction Investigation
Vehicle: 2005 Mercury
Mountaineer
Location: Arkansas
Crash Date: August 2016**

| 16. Abstract This report documents the driver's frontal air bag system in a 2005 Mercury Mountaineer and the sources of the driver's facial injuries. This crash occurred in an urban area on the north roadside of a straight, two-lane State highway. The Mercury was a 4-door sport utility vehicle (SUV) equipped with second-generation frontal air bags. An unbelted 32-year-old male drove the vehicle. The Mercury was traveling northeast in the northeast-bound lane when the vehicle departed the lane and crossed the southwest-bound travel lane. The vehicle then departed the left (north) side of the road near a residential driveway and the front plane struck and displaced a mailbox (Event 1). The vehicle continued across the driveway of the residence and the front plane struck a 39 cm (15.4 in) diameter tree (Event 2) resulting in the deployment of both frontal air bags. The vehicle then came to final rest against the tree heading east. The driver sustained police-reported "A" (incapacitating) injuries and was transported by ambul

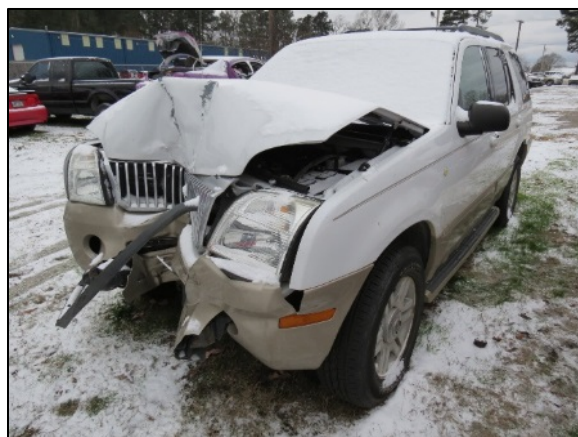
Figure 1. The damaged 2005 Mercury Mountaineer.

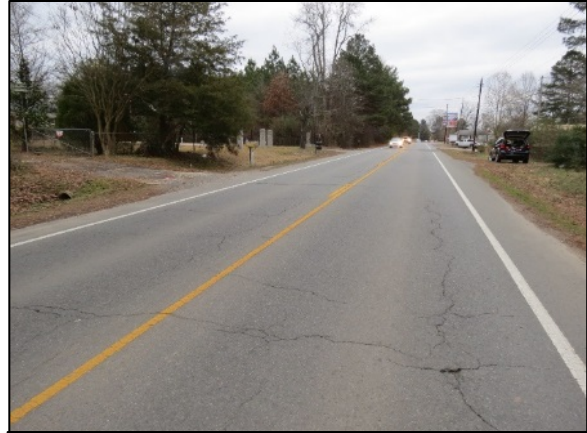
Figure 2. Northeast-bound approach of the Mercury.

The driver of the Mercury was on his way to work and was traveling northeast in the northeast-bound lane (**Figure 2**). The vehicle departed the northeast-bound lane for unknown reasons and crossed the southwest-bound lane. The vehicle then departed the north side of the road and traveled toward a mailbox, residential driveway, and 39 cm (15.4 in) tree (**Figure 3**). The unbelted driver was out of position with his head in close proximity to the steering wheel as a result of the vehicle's impact with the mailbox and off-road travel prior to the impact with the tree. The police crash report indicated that drug use was a factor in the crash.

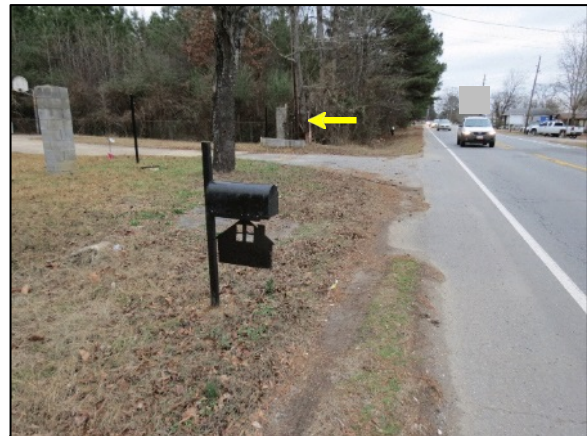
Figure 3. Approach to impact with the mailbox and tree (arrow), view northeast.

The front plane of the Mercury struck the mailbox (Event 1) and displaced it from the ground. The vehicle then traveled 16.2 m (53.1 ft) through the yard and driveway of the residence and the front plane of the vehicle (**Figure 4**) struck a 39 cm (15.4 in) diameter tree (**Figure 5**, Event 2). The impact resulted in deployment of both frontal air bags. The vehicle came to final rest against the tree heading northeast. The force direction was in in the 12 o'clock sector and the damage and trajectory algorithm of the WinSMASH program calculated the impact speed as 44 km/h (27 mph). The total calculated

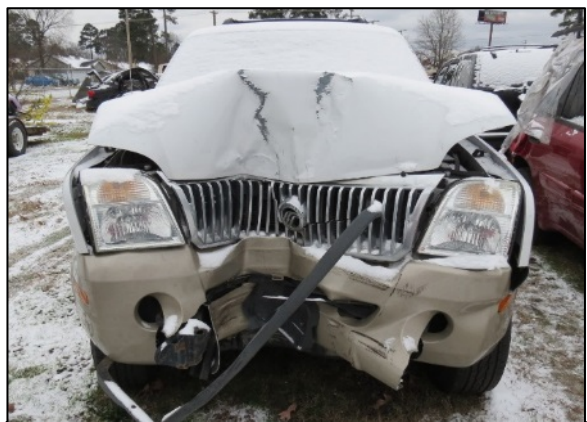
Figure 4. Damage to the front plane of the Mercury from the tree impact.

The front plane also sustained direct damage from the impact with a 39 cm (15.4 in) diameter tree. The damage involved the bumper, grille, and hood. The direct damage began 28 cm (11.0 in) right of the left bumper corner and extended 97 cm (38 in) to the right across the front plane. The Field L was 172 cm (67.7 in). Crush measurements were taken on the bumper bar and the maximum residual crush was 44 cm (17.3 in) occurring 93 cm (36.6 in) right of the left-front bumper corner. (**Figure 6**). The crush values were: $C_1 = 0$ cm, $C_2 = 12$ cm (4.7 in), $C_3 = 30$ cm (11.8 in), $C_4 = 44$ cm (17.3 in), $C_5 = 43$ cm (16.9 in), and $C_6 = 3$ cm (1.2 in).

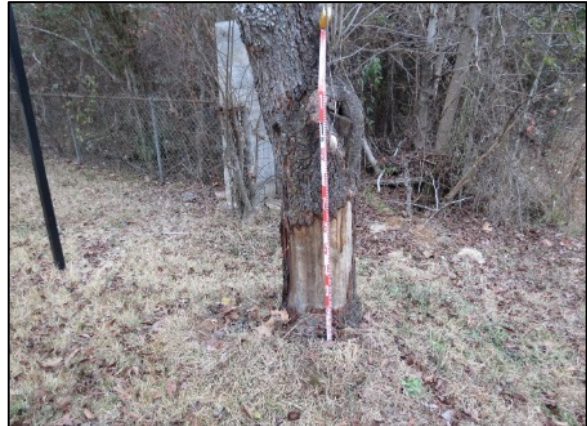
Figure 5. Tree struck by the Mercury.

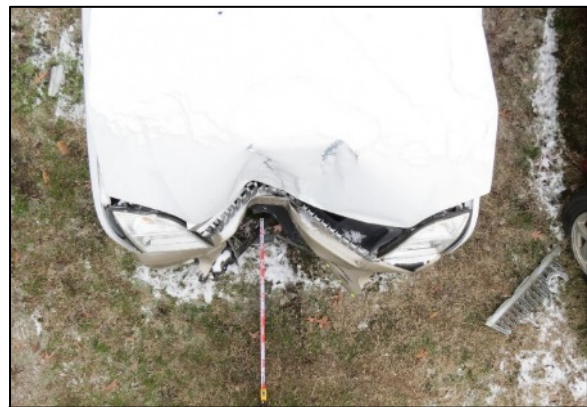
Figure 6. Crush to the front plane of the Mercury from the tree impact.

The CDC was 12FDEW2. The severity of the damage was moderate.

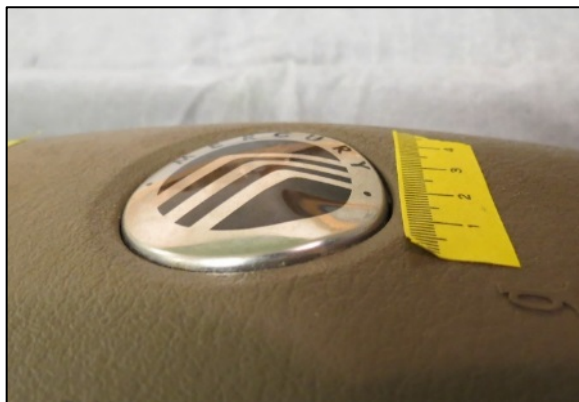
The interior of the Mercury sustained no occupant compartment intrusions as a result of the crash events. Evidence of occupant contact consisted of a fractured transmission lever, probably from contact by the driver's right hand. The Mercury emblem located at the center of the top cover flap of the air bag module was dented (**Figure 7**), probably by contact with the driver's face. There also was a scuff on the cover flap to the left of the Mercury emblem, also probably from contact by the driver's face. Blood spatter and transfers were present on the bottom and left portions of the deflated driver's frontal air bag. There was no deformation to the steering wheel. All the doors and the back hatch remained closed and operational. The windshield was cracked from impact forces. The remaining glazing was undamaged.

Figure 7. Dent in Mercury emblem located on top cover flap of driver's frontal air bag module.

The driver's frontal air bag module was located in the steering wheel hub and the module cover was a two-flap configuration constructed of pliable vinyl with a horizontal tear seam. The top module cover was 25 cm (9.8 in) wide and 13 cm (5.1 in) high. There was a 45 mm (1.8 in) diameter metal Mercury emblem located in the center of the module cover flap. The bottom flap was 18 cm (7.1 in) wide and 5 cm (2.0 in) high. The flaps opened at the designated tear seams. Evidence of damage to the top cover flap consisted of a dent to the right portion of the Mercury emblem from contact by the driver's face. There also was a 4 cm (1.6 in) long, vertical oriented scuff in the vinyl located 9 cm (3.5 in) left of the Mercury emblem, also from contact with the driver's face during the air bag deployment. The driver's deflated frontal air bag was 58 cm (22.8 in) in diameter. There was a large area of blood spatter and transfer on the left half of the air bag as well as some blood spatter and transfer on the bottom, center, and right portions of the air bag.

The SCI investigation revealed no evidence of an air bag malfunction in the 2005 Mercury Mountaineer. It was determined that the driver’s frontal air bag deployed when the front plane of the vehicle struck the 39 cm (15.4 in) diameter tree. The damage to the front plane of the vehicle indicated that the impact was severe enough to require deployment of that air bag. It was also determined that the driver’s facial injuries and loss of sight in his right eye were the result of contact with the top cover flap of the driver’s frontal air bag module indicating the unbelted driver was out of position and in close proximity to the air bag module at the time of deployment. The evidence supporting the contact between the driver’s face and the air bag module cover flap is the dent in the Mercury emblem located at the center of the cover flap and the 4 cm (1.6 in) long, vertical oriented scuff in the cover flap vinyl located 9 cm (3.5 in) left of the emblem. In addition, the diagonal laceration extending from the driver’s left forehead onto his right eye is consistent with contact to the bottom edge of the top cover flap. Two probable scenarios as to why the driver was out of position are as follows: The unbelted driver was under the influence of inhaling “Air Duster,” losing consciousness or suffering muscle weakness resulting in his body slumping forward toward the steering wheel prior to the tree impact. Alternatively, the driver was out of position, with his head in close proximity to the steering wheel as a result of the vehicle’s impact with the mail box and its off-road trajectory prior to the tree impact.
