DOT HS 812 906

# **Special Crash Investigations: On-Site Small Overlap/ Oblique Impact Investigation; Vehicle: 2010 Ford Fusion; Location: Michigan; Crash Date: September 2017**

**Special Crash Investigations**  
**On-Site Small Overlap/Oblique Impact Investigation**  
**Case Number: IN17029**  
**Vehicle: 2010 Ford Fusion**  
**Location: Michigan**  
**Crash Date: September 2017**

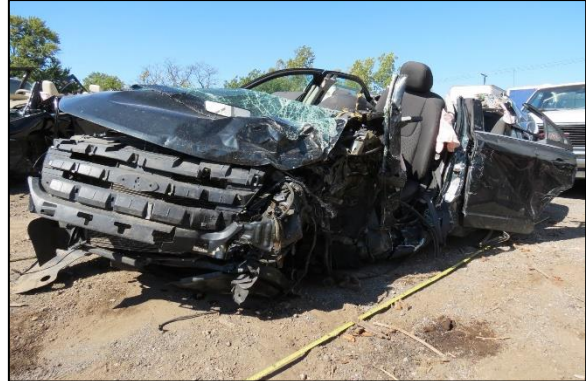
**Figure 1.** The damaged 2010 Ford Fusion.

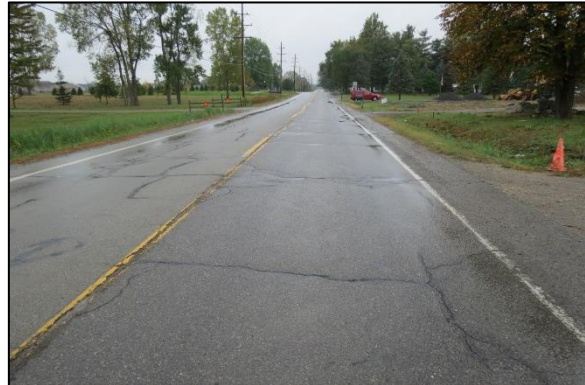
**Figure 2.** Southbound approach of the Ford.

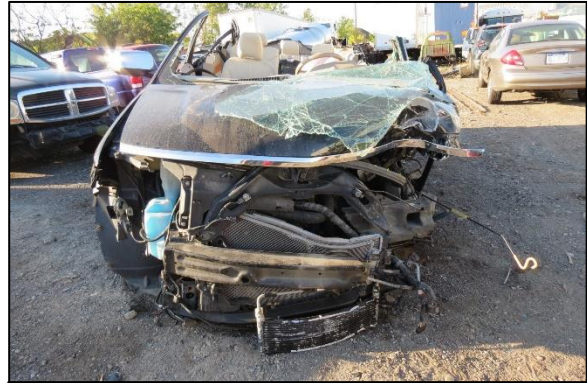
**Figure 5.** Damage to the front plane of the Lincoln.

The Lincoln sustained direct and induced damage to the front and left planes from the impact with the front plane of the Ford. The front bumper, hood, left head lamp/turn signal assembly, left fender, left front wheel, and left front door were directly damaged. The direct damage began at the left corner of the front bumper and extended 46 cm (18.1 in) across the front plane. The Field L was 127 cm (50.0 in). Crush measurements were taken at the bumper level and the maximum residual crush was 43 cm (16.9 in) occurring at the left corner of the front plane. The crush values were:  $C_1 = 43$  cm (16.9 in),  $C_2 = 41$  cm (16.1 in),  $C_3 = 11$  cm (4.3 in),  $C_4 = 0$  cm,  $C_5 = 0$  cm, and  $C_6 = 0$  cm.

The CDC was 12FLEW3 (0 degrees). The severity of the damage was severe.
