**Special Crash Investigations:  
Remote Vehicle Fire/Child  
Restraint System Investigation;  
Vehicle: 1998 Nissan Altima;  
Location: California;  
Crash Date: July 2016**

**Special Crash Investigations**  
**Remote Vehicle Fire/Child Restraint System Investigation**  
**Case Number: DS19016**  
**Vehicle: 1998 Nissan Altima**  
**Location: California**  
**Crash Date: July 2016**

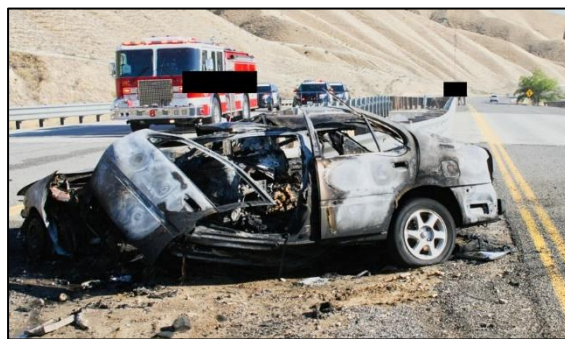
**Figure 1.** The 1998 Nissan Altima (police photo).

This report documents the remote vehicle fire/child restraint system (CRS) investigation of a post-crash fire in a 1998 Nissan Altima (**Figure 1**) involved in a single-vehicle crash and the child occupant of the Nissan who was seated in a CRS. The investigation was intended to determine the events leading to the fire, how quickly the fire spread to the occupant compartment, the magnitude of the fire, how quickly EMS and other responders arrived on scene, occupant restraint usage, demographics, injury data, and CRS data. The crash was identified during a review of Fatality Analysis Reporting System (FARS) crash reports. The criteria for the crash type include an impact not involving the rear plane, fire which spreads to the occupant compartment, and at least one occupant seated in a CRS. The Special Crash Investigations (SCI) team obtained the on-scene images.<sup>1</sup> The case was initiated by the SCI group of the National Highway Traffic Safety Administration in July 2019.

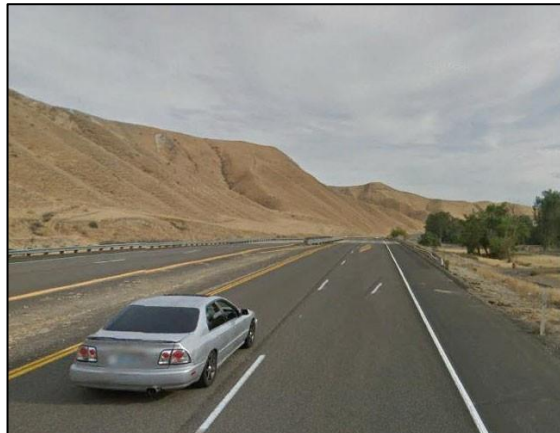
This single-vehicle crash occurred in July 2016 in an unincorporated area of California. The crash site was a two-lane, divided, east/west State highway (**Figure 2**). The roadway was oriented north/south at the crash location. The curved asphalt roadway consisted of two lanes in both directions that were initially separated by a paved asphalt median. As the roadway approached the overpass, the concrete overpass structure was protected by a bullnose style metal guardrail end terminal. All the travel lanes were approximately 3.8 m (12.5 ft) wide. The southbound lanes were bordered to the left by solid double yellow lines and to the right by a solid white fog line and a paved 2.4 m (7.9 ft) asphalt shoulder. At the crash location, the roadway was straight and mostly level. There were no rumble strips present. The roadway transitioned from a right curve to the straight section 143.5 m (470.8 ft) north of the impact area. The speed limit was 89 km/h (55 mph).

**Figure 2.** Southbound approach (Google Earth image).

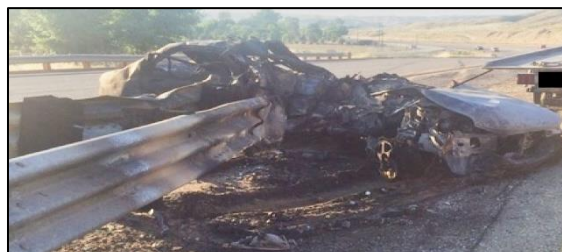
**Figure 3.** The 1998 Nissan Altima, right plane damage (news photo).

The Nissan sustained severe right plane damage from the impact with the end terminal (**Figure 3**). The direct damage included the entire right passenger compartment area. The estimated Collision Deformation Classification was 03RPEW7. The exterior and interior were extensively damaged by fire. The police attempted to conduct a mechanical evaluation but determined that the tire, braking system, electrical system, and steering wheel were either destroyed or compromised beyond inspection/test requirements.
