**Special Crash Investigations:
Remote Vehicle Fire/Child
Restraint System Investigation;
Vehicle: 2012 Ram 1500;
Location: Missouri;
Crash Date: December 2017**

Special Crash Investigations
Case Number: DS19020
Remote Vehicle Fire/Child Restraint System Investigation
Vehicle: 2012 Ram 1500
Location: Missouri
Crash Date: December 2017

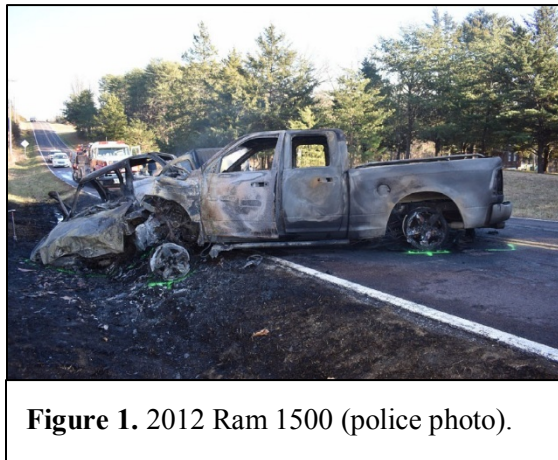
This report documents the remote vehicle fire/child restraint system (CRS) investigation of a post-crash fire in a 2012 Ram 1500 pickup (**Figure 1**) involved in a two-vehicle crash and the child occupant of the Ram who was seated in a CRS. The investigation intended to determine events leading to the fire, how quickly the fire spread to the occupant compartment, the magnitude of the fire, how quickly EMS and other responders arrived on-scene, occupant restraint usage, demographics, injury data, and CRS data. The crash was identified during a review of Fatality Analysis Reporting System (FARS) crash reports. The criteria for the crash type includes an impact not involving the rear plane, fire that spreads to the occupant compartment and at least one occupant seated in a CRS. The Special Crash Investigations (SCI) team obtained the on-scene images and the case was initiated by the SCI group of the National Highway Traffic Safety Administration in August 2019. Both vehicles were supported by the Bosch Crash Data Retrieval system. The police were unable to image either air bag control module due to fire damage.

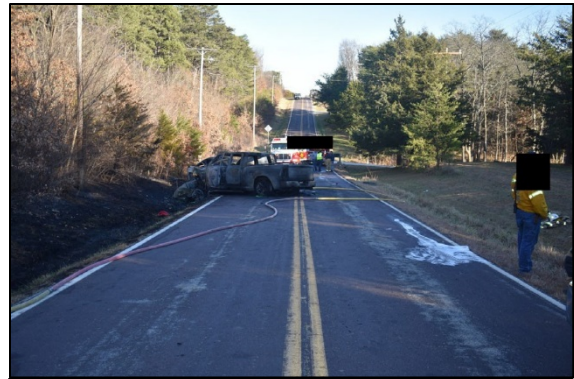
Figure 2. Eastbound view (police image).

The Ram was being driven eastbound at an unknown speed (**Figure 2**) by a belted 28-year-old male. The second row left seat was occupied by a 7-year-old male seated in an unknown model booster CRS. The Chevrolet was traveling westbound at an unknown speed (**Figure 3**). For unknown reasons, the Ram crossed the centerline and entered the westbound travel lane.

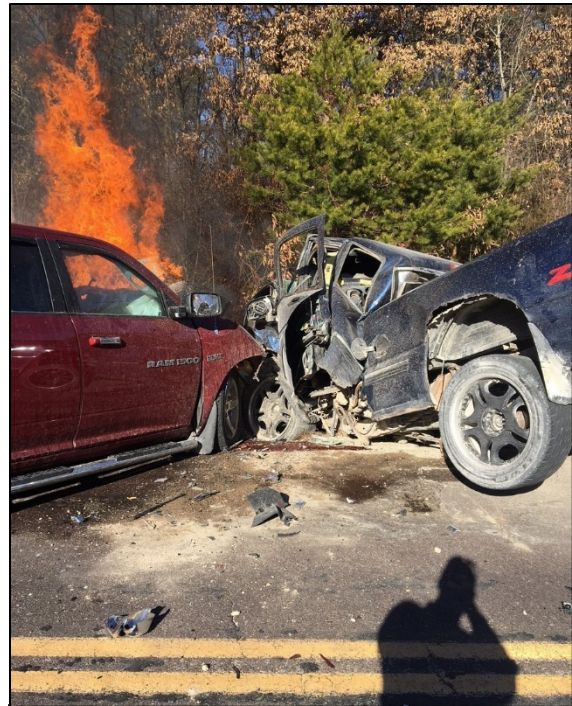
Figure 4. Vehicle fire, Ram on left, Chevrolet on right (police image).

The Ram rotated counterclockwise and came to rest partially in a ditch facing northeast. The Chevrolet rotated clockwise and came to rest partially in a ditch on the north side of the roadway facing northwest. After coming to rest, both vehicles caught fire (Events 2 and 3). It appears that

the fire began in the Ram and spread to the Chevrolet (**Figure 4**). The driver and second row left occupant of the Ram were removed from the vehicle by passersby. EMS was dispatched 7 minutes after the crash and arrived on-scene 24 minutes after the crash. They provided care and assessment to both of the Ram occupants but due to a road closure from this crash both patients were transferred to a second EMS service. The driver was transferred 65 minutes after the crash and the passenger was transferred 90 minutes after the crash. Both were then transported by ambulance to a local trauma center. The driver of the Ram was admitted and hospitalized for 6 days. The second row left occupant was admitted and hospitalized for 2 days. The driver of the Chevrolet was transported by ambulance to an area trauma center where he was declared deceased.

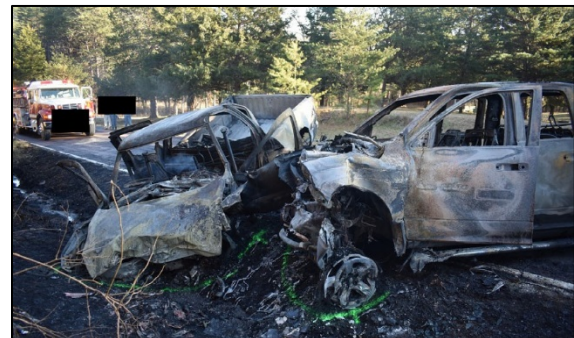
Figure 5. Exterior damage, 2012 Ram 1500 on right, 1999 Chevrolet Silverado on left (police photo).

The Ram sustained severe frontal damage from the head-on impact with the Chevrolet (**Figure 5**).

Two crush measurements were estimated from post-crash baseline dimension measurements taken by police investigators at the bumper corners as follows: C1 = 88 cm (34.6 in) and C2 = 78 cm (30.7 in). The Collision Deformation Classification (CDC) was 12FDEW3. Shortly after the vehicle came to rest, a fire began in the engine compartment. The fire eventually consumed the entire vehicle.

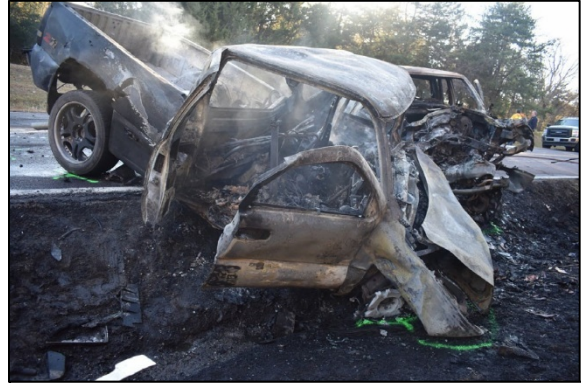
Figure 6. 1999 Chevrolet Silverado 1500 Z71 pickup (police photo).

The Chevrolet sustained severe frontal damage from the head-on impact with the Ram (**Figure 6**). The CDC was 12FDEW2. Shortly after the vehicle came to rest, a fire began in the engine compartment. The fire eventually consumed the entire vehicle.
