U.S. Department  
of Transportation

**National Highway  
Traffic Safety  
Administration**

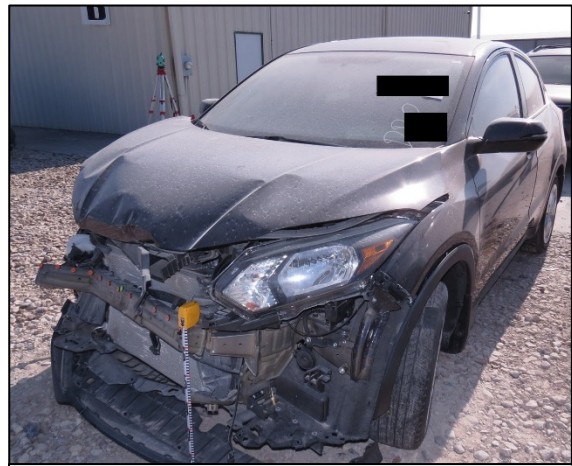
**Figure 1.** The 2016 Honda HR-V.

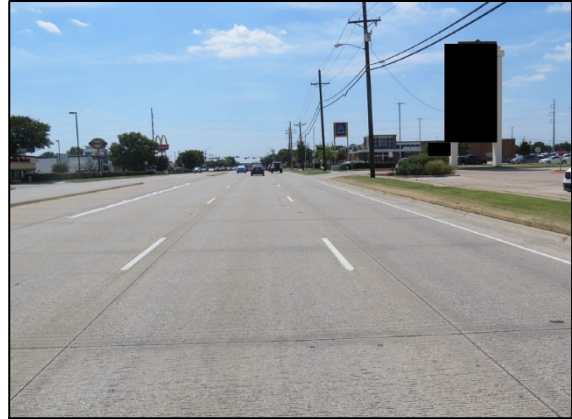
**Figure 2.** Westbound approach, the 2016 Honda HR-V.

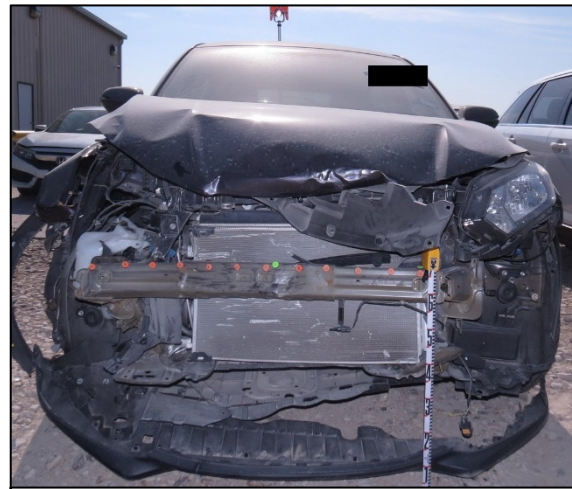
**Figure 4.** Frontal damage, the 2016 Honda HR- V.

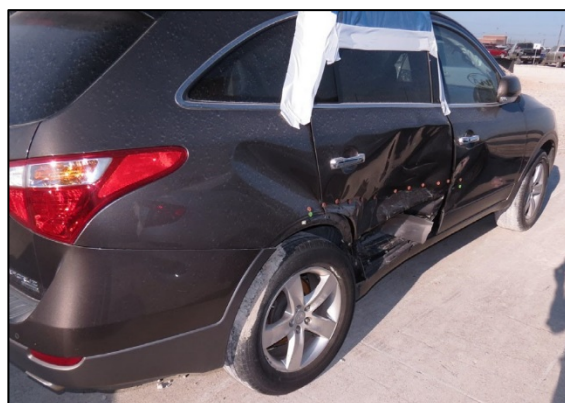
**Figure 5.** Right plane damage, the 2008 Hyundai Veracruz.
