DOT HS 813 015

# **Special Crash Investigations: On-Site Air Bag Inflator Rupture Crash Investigation; Vehicle: 2012 Honda Fit; Location: California; Crash Date: December 2016**

**Special Crash Investigations  
On-Site Air Bag Inflator Rupture Crash Investigation  
Office of Defects Investigation  
Case Number: DS17006  
Vehicle: 2012 Honda Fit  
Location: California  
Crash Date: December 2016**

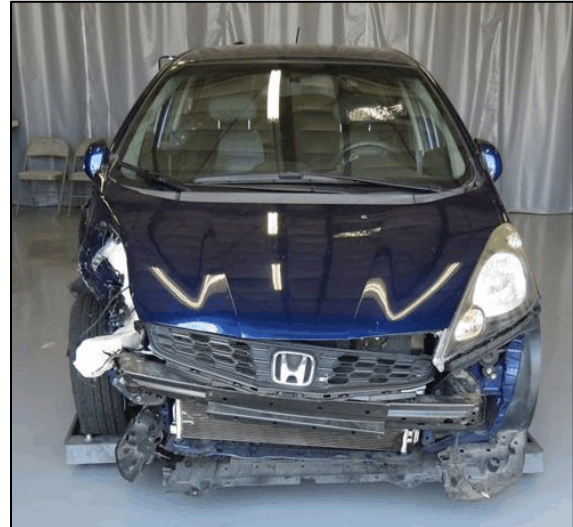
**Figure 1.** 2012 Honda Fit.

This report documents the on-site investigation of the front air bag module inflator rupture in a 2012 Honda Fit (**Figure 1**). The purpose of this inspection is to document the ruptured driver air bag inflator, the air bag, and the steering wheel/column assembly. This investigation was initiated by the Office of Defects Investigation in response to a manufacturer notification. The Special Crash Investigations (SCI) group of the National Highway Traffic Safety Administration assigned the case to Dynamic Science, Inc., in April 2017. The vehicle was being held by the driver's attorney at a private storage facility. Arrangements were made with the attorney and the vehicle inspection occurred in May 2017. Multiple parties associated with Honda, Takata, and the driver's attorney were present during the SCI inspection and conducted their own inspections. The vehicle was supported by the Bosch Crash Data Retrieval (CDR) system and the vehicle's event data recorder (EDR) was imaged during the inspection.

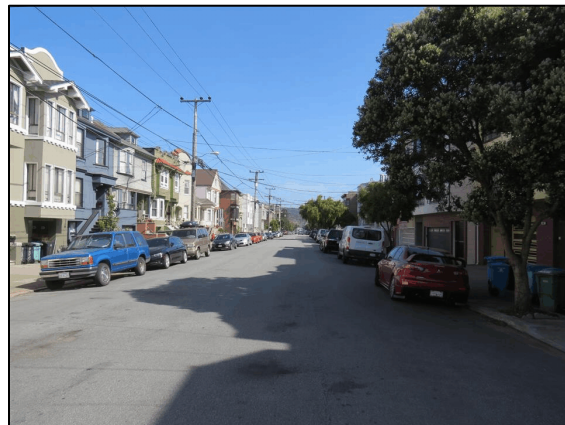
**Figure 2.** Crash site, northbound approach.

This crash occurred on a two-lane undivided urban roadway at 2011 hours (**Figure 2**). The asphalt roadway was straight and wet at the time of the crash. It was dark and the streetlights were lit. Parked vehicles were present on both sides of the roadway. The posted speed limit was 40 km/h (25 mph). The weather at the nearest reporting station was 9 degrees C (48 degrees F), 71 percent humidity, clear visibility, and the winds were out of the west northwest at 11.1 km/h (6.9 mph). A crash diagram is attached at the end of this report.

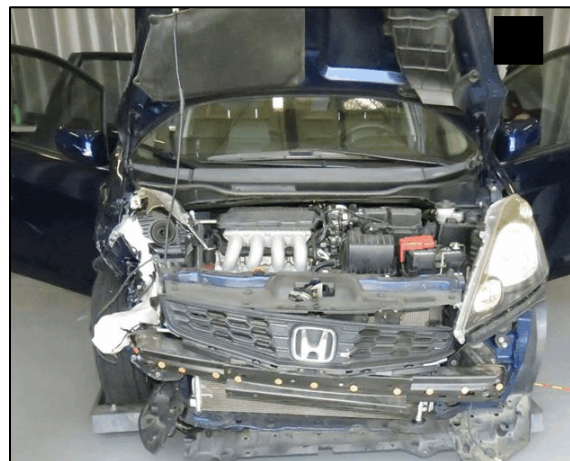
**Figure 3.** 2012 Honda Fit.

The Honda sustained moderate severity frontal damage from the impact to the rear of the parked Toyota Prius (**Figure 3**). The direct damage began at the right front bumper corner and extended 33 cm (12.0 in) to the left. The damaged extended along the right side to just aft of the right front tire. The Field L extended from bumper corner to bumper corner. Twelve measurements were taken at bumper level by the Nikon Total Station

and the Faro Blitz program computed crush measurement in six increments as follows:  $C_1 = 0$  cm,  $C_2 = 0$  cm,  $C_3 = 0$  cm,  $C_4 = 0$  cm,  $C_5 = 2$  cm (0.8 in),  $C_6 = 9$  cm (3.5 in). The Collision Deformation Classification (CDC) was 12FREE3.

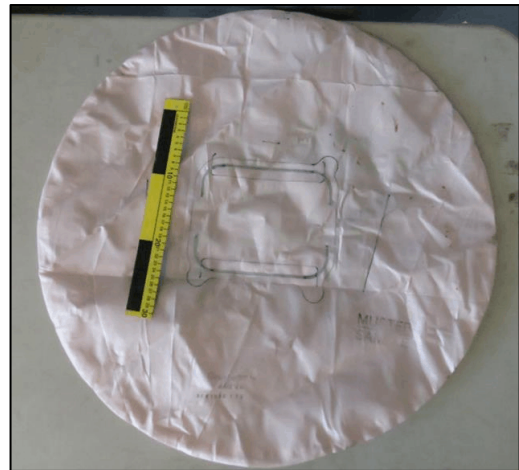
**Figure 4.** Driver's air bag (front), 2012 Honda Fit.

The driver's air bag deployed from an H- configuration module cover located in the hub of the steering wheel rim. The air bag was circular and measured 60 cm (23.6 in) in diameter in its deflated state (**Figure 4**). The air bag was configured with rear panel vent ports and was tethered. The air bag inflator ruptured during the air bag deployment. It was reported that the air bag and module cover were displaced from the steering wheel during the deployment rupture (**Figure 5**).

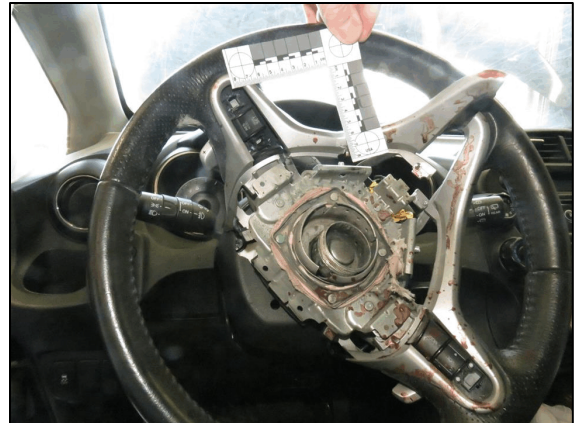
**Figure 7.** Air bag module (in place in vehicle), 2012 Honda Fit.

The driver's dual-stage air bag inflator was manufactured by an unknown party and was not original to this vehicle. It is presumed that the original inflator had been replaced during the repair to this vehicle in 2012. At the time of the inspection, the bottom portion of the module was still attached to the vehicle (**Figure 7**). The top of the module was missing and not recovered. The wire mesh filter was located in the front right seat. The module was unbolted from the steering wheel and further torn down for inspection (**Figure 8**). The sidewalls of the inflator body were deformed outward (**Figure 9**). The rear bracket the module was deformed and there were two indentations on the lower bracket from screws where it was seated in the steering wheel (**Figure 10**).
