DOT HS 813 030

**Special Crash Investigations:
Possible Advanced Air Bag
Fatality Crash Investigation;
Vehicle: 2010 Kia Soul;
Location: California;
Crash Date: April 2019**

Special Crash Investigations
Possible Advanced Air Bag Fatality Crash Investigation
Case Number: DS19013
Vehicle: 2010 Kia Soul
Location: California
Crash Date: April 2019

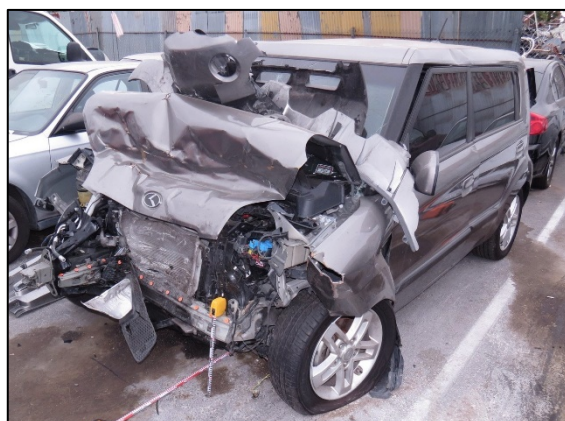
Figure 1. The 2010 Kia Soul.

This report documents the on-site investigation of a possible advanced air-bag-related fatality in a 2010 Kia Soul (**Figure 1**). The vehicle was involved in a head-on crash with a 2013 Kia Sorrento. The investigation was intended to determine the crash events, occupant restraint usage, demographics, and possible injury mechanisms. The crash was identified during a review of Fatality Analysis Reporting System (FARS) crash reports. The Special Crash Investigations (SCI) group of the National Highway Traffic Safety Administration assigned the case to Dynamic Science, Inc., in June 2019. The vehicle inspection was completed in June 2019. The vehicle was not supported by the Bosch Crash Data Retrieval (CDR) system, and the vehicle's Event Data Recorder (EDR) was not imaged during the inspection. Based on the vehicle inspection and medical data obtained, it was determined that the air bag was not the source of the fatal injuries to the 10-year-old Kia Soul passenger.

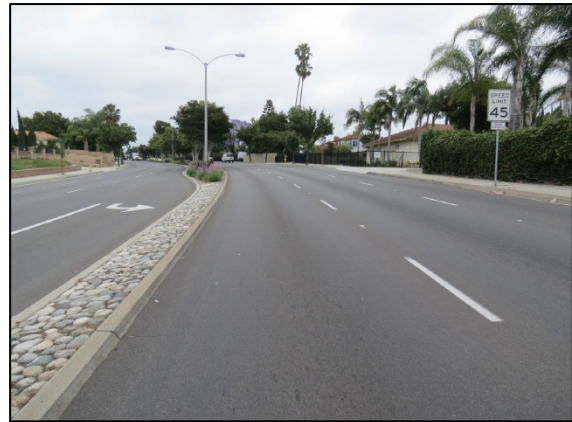
Figure 2. Eastbound approach for the 2010 Kia Soul.

The Kia Soul was traveling eastbound in the third lane from the right (**Figure 2**), driven by an unbelted 33-year-old female. The front row right seat was occupied by a belted 10-year-old male. The Kia Sorrento was traveling westbound in the third lane from the right (**Figure 3**), driven by a 34-year-old male who was operating as a transportation network company driver. The driver of the Kia Sorrento reported that he was traveling at approximately 64 km/h (40 mph). The driver of the Kia Soul reported that she was on her way home and had fallen asleep.

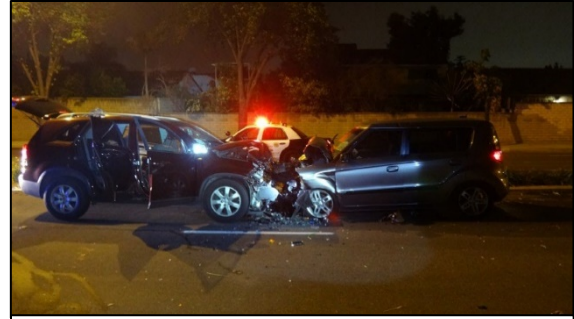
Figure 4. Final rest, looking south, the Kia Sorrento on left, Kia Soul on right (police image).

(BES) was 73 km/h (45 mph). The results fit the model and appear reasonable. The WinSMASH program calculated a total delta V of 56 km/h (35 mph) for the Kia Sorrento. The longitudinal and lateral components were -56 km/h (-35 mph) and 0 km/h, respectively. The BES was 55 km/h (34 mph). Both vehicles came to rest in the westbound travel lane (**Figure 4**).

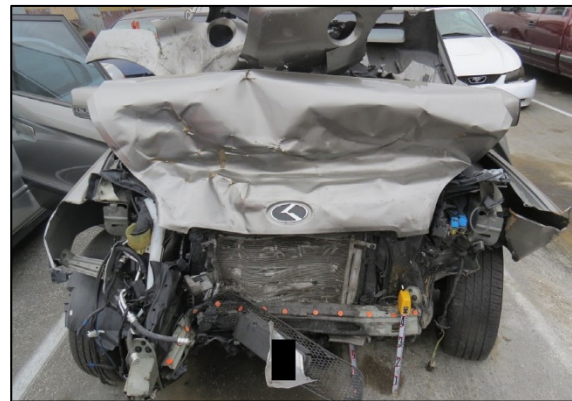
Figure 5. The 2010 Kia Soul.

The Kia sustained minor damage to the left front wheel from the impact with the median. The Collision Deformation Classification (CDC) was 12FLWN3. The vehicle sustained severe front plane damage from the impact to the front plane of the Kia Sorento (**Figure 5**). The direct damage began at the left front bumper corner and extended 104 cm (40.9 in) to the right. The Field L extended from bumper corner to bumper corner. Thirteen measurements were taken at bumper backing bar level by the Nikon Total Station and the Faro Blitz program computed crush measurement in six increments as follows: $C_1 = 47$ cm (18.5 in), $C_2 = 48$ cm (18.8 in), $C_3 = 51$ cm (20.0 in), $C_4 = 51$ cm (20.0 in), $C_5 = 48$ cm (18.5 in), and $C_6 = 17$ cm (6.6 in). The maximum crush was located 83 cm (32.6 in) from the left front bumper corner and measured 51 cm (20.0 in). The CDC was 12FDEW3.

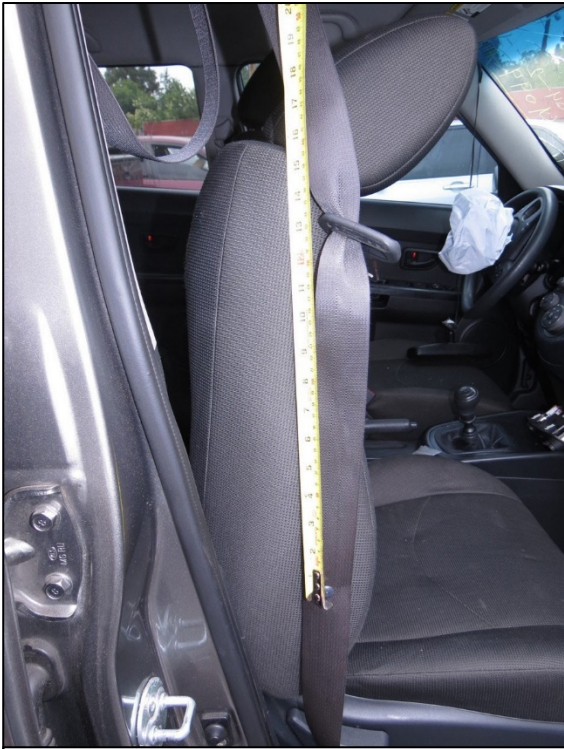
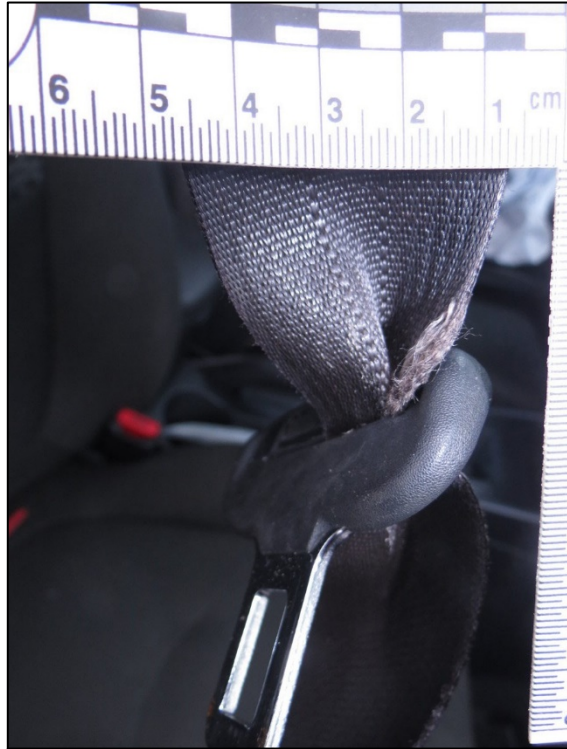
The front row was equipped with driver and front right passenger lap and shoulder seat belts. The driver's belt was equipped with continuous loop belt webbing, a sliding latch plate, an emergency locking retractor (ELR), and an adjustable upper anchor that was adjusted to the full-up position. The front right passenger's seat belt was equipped the same as the driver's, but had a switchable ELR/automatic locking retractor. The adjustable upper anchor was adjusted to the full-up position. The driver's seat belt did not exhibit any indications of use in this crash. The pretensioner did not actuate. The front right passenger's seat belt was used in this crash and the pretensioner actuated. The belt webbing was trapped in the sliding latch plate 33 cm (12.9 in) above the stop button and showed signs of loading (**Figures 6–7**).

Figure 6. Front right seat belt, the 2010 Kia Soul.

Figure 7. Front right seat belt, the 2010 Kia Soul.

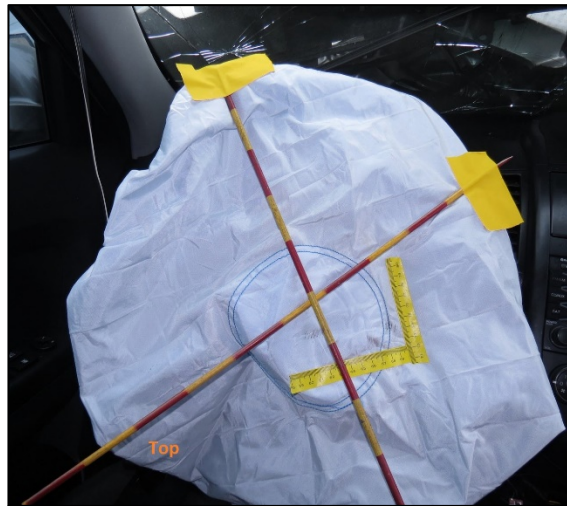
Figure 8. Driver's frontal air bag, the 2010 Kia Soul.

The driver's frontal air bag deployed from an H-configuration module cover located in the hub of the steering wheel rim. The air bag was circular and measured 46 cm (18.1 in) in diameter in its deflated state (**Figure 8**). The air bag was configured with rear panel vent ports and was tethered. There were make-up contacts identified on the air bag face. The right passenger's frontal air bag deployed from the top of the instrument panel. The air bag was rectangular in shape and measured 41 cm (16.1 in) seam to seam and 51 cm (20.0 in) top to

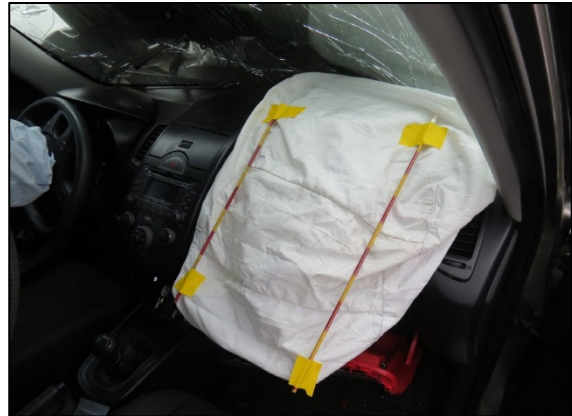
Figure 9. Passenger’s frontal air bag, the 2010 Kia Soul.

bottom (**Figure 9**). There were no indications of occupant contact.

During the vehicle inspection, it was determined that the seat was at the rear most track position, there was no evidence of occupant contact to the air bag, there was evidence of knee contact to the glove compartment, there was interaction between the occupant and the rear seat back due to possible cargo movement, and the seat belt showed evidence of loading and was trapped in the sliding latch plate. This suggested that the occupant engaged and loaded the lap and shoulder seat belt with his torso and abdomen.

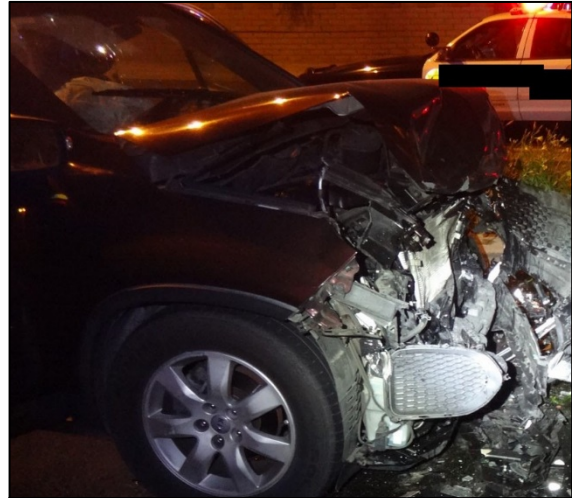
Figure 12. The 2013 Kia Sorrento (police image).

The Kia Sorrento sustained major front plane damage from the impact with the Kia Soul (Figure 12). There was damage to the front bumper, hood, and both front fenders. The estimated CDC based on police images of the damaged vehicle was 12FDEW2. The vehicle was towed due to damage.
