DOT HS 813 044

# **Special Crash Investigations: Front Axle Shaft/U-Joint Malfunction Crash Investigation; Vehicle: 2006 Dodge Ram 3500; Location: Nebraska; Crash Date: March 2019**

**Special Crash Investigations**  
**Front Axle Shaft/U-Joint Malfunction Crash Investigation**  
**On-Site Office of Defects Investigation**  
**Case Number: DS19009**  
**Vehicle: 2006 Dodge Ram 3500**  
**Location: Nebraska**  
**Crash Date: March 2019**

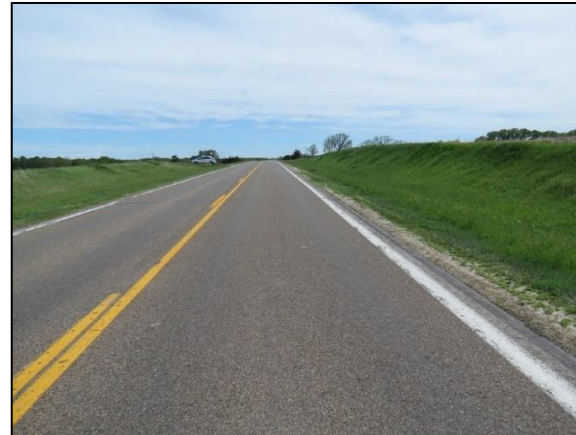
**Figure 2.** Southbound approach.

The crash site was a two-lane, undivided, State highway in rural Nebraska (**Figure 2**). The asphalt roadway was straight with a less than 2 percent negative grade in the northbound direction. The travel lanes measured between 3-3.3 m (10-11 ft) wide and were separated by solid/dashed yellow painted lines and bordered by solid white painted fog lines. The east shoulder and region immediately east was slightly sloped to the east, with an open field to the east. The area to the west descended into a ditch that rose to a raised earth berm. West of the raised berm was an open field. The speed limit, according to the Nebraska speed limit map, was 96 km/h (60 mph) in both directions. The weather at the nearest reporting station was 0.5 °C (33 °F), clear visibility, and calm winds. A crash diagram is attached at the end of this technical report.

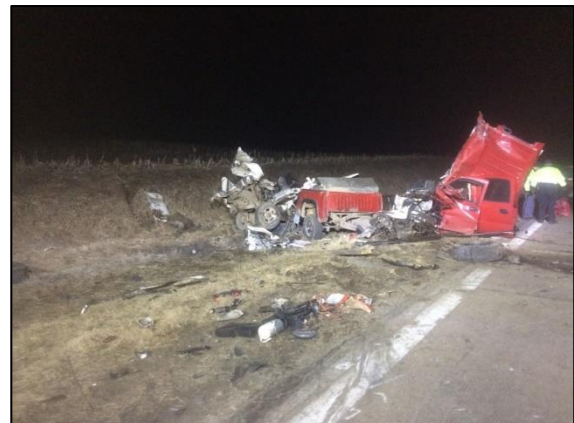
**Figure 4.** Final rest, the 2005 Chevrolet Silverado, looking northwest (police photo).

For the Chevrolet, the EDR reported a maximum recorded delta V of -64.3 km (-39.96 mph) at 107.5 milliseconds (ms). The Chevrolet was pushed rearward, and the cab was displaced (**Figure 4**).

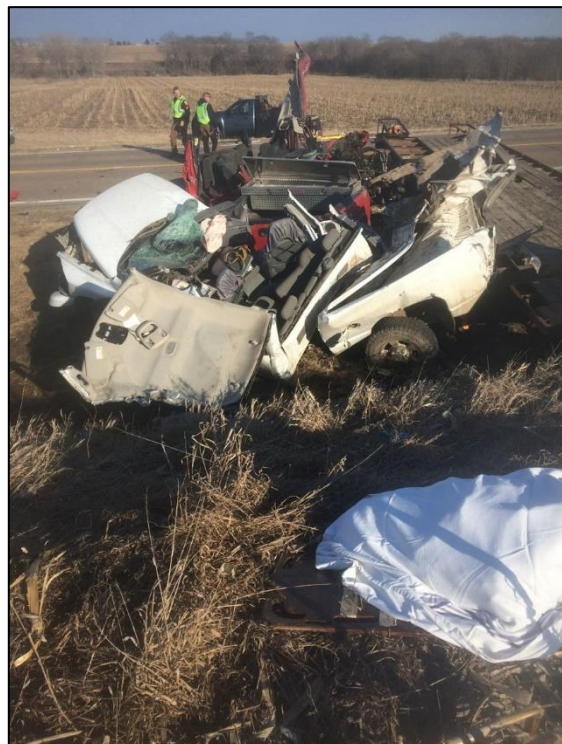
**Figure 5.** Final rest, the 2006 Dodge Ram, looking southeast (police photo).

The Dodge was displaced to the east in a clockwise rotation. The vehicle came to rest in the ditch on the west side of roadway facing northeast (**Figure 5**).

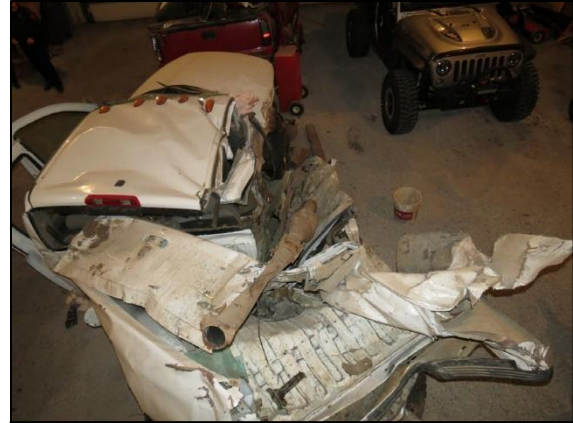
**Figure 6.** Right plane damage, the 2006 Dodge Ram 3500 pickup.

The Dodge sustained catastrophic right plane damage as a result of the frontal impact of the Chevrolet (**Figure 6**). The damage could not be measured. There was extensive crush to the passenger compartment. The right doors were removed during extrication. The vehicle's bed was shifted to the right and deformed upward both from the impact with the Chevrolet and intra-unit movement with the trailer (**Figure 7**). The estimated Collision Deformation Classification (CDC) was 01RDAW9.

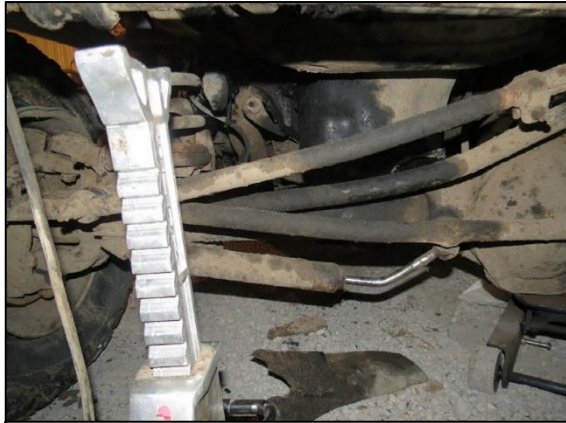
**Figure 8.** Damaged steering damper, the 2006 Dodge Ram 3500.

The steering damper was deformed, as was the tie rod (**Figure 8**). This is likely crash-related damage. The left axle shaft U-joint was fractured in multiple locations (**Figures 9–11**). The left wheel was locked in place and could not be rotated. The wheel could be turned slightly from side to side when turning the steering wheel, indicating the steering linkages were still connected. Based on available evidence, it is likely that the U-joint failed pre-crash, causing a steering malfunction that caused the vehicle to yaw and cross the centerline.

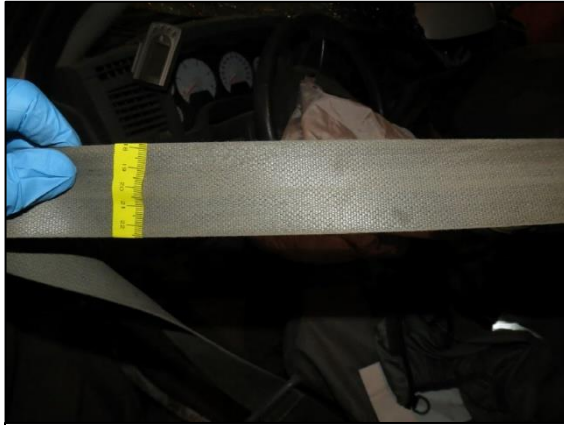
**Figure 12.** Driver's seat belt, the 2006 Dodge Ram 3500.

The driver's seat belt was found in the spooled-out position. The retractor was locked in position, resultant from actuation of the retractor pretensioner. There was loading evidence measuring 44 cm (17.3 in) long that was located 55 cm (21.6 in) above the stop button (**Figure 12**). The front right passenger's seat belt had been cut during the passenger's extrication suggesting that the belt was used in the crash.

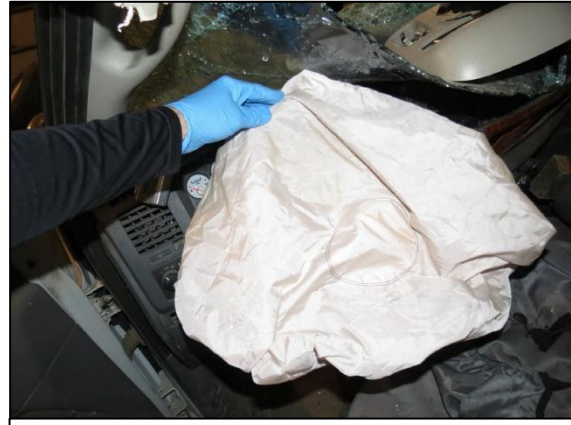
**Figure 13.** Driver's frontal air bag, the 2006 Dodge Ram 3500.

The driver's frontal air bag was located in the steering wheel hub. The air bag had a deflated diameter of 48 cm (18.8 in) and was configured with a tether and two vent ports. The cover flaps opened at the designated tear seams and were undamaged. There was no discernible evidence of occupant contact to the air bag (**Figure 13**).

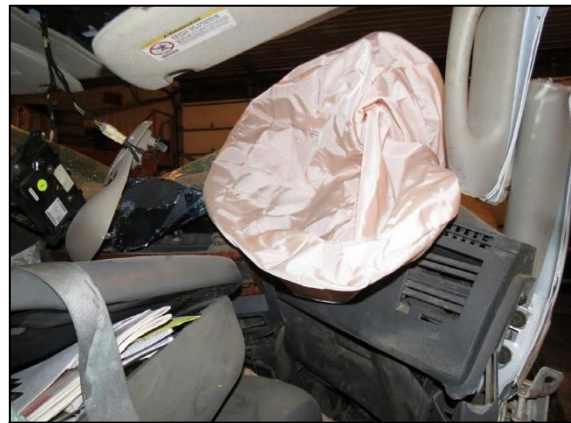
**Figure 14.** Passenger's frontal air bag, the 2006 Dodge Ram 3500.

The passenger's frontal air bag was located on top of the instrument panel above the glove box. The cover flaps opened at the designated tear seams and were undamaged. There was no discernible evidence of occupant contact to the air bag (**Figure 14**).

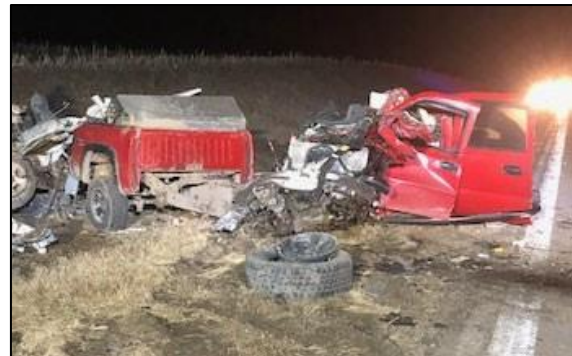
**Figure 15.** The 2005 Chevrolet Silverado pickup (police photo).

The Chevrolet sustained severe frontal damage from the impact to the right side of the Dodge. The impact caused the cab portion of the vehicle to be displaced from the chassis (**Figure 15**). The estimated CDC was 12FDAW6.
