U.S. Department  
of Transportation  
**National Highway  
Traffic Safety  
Administration**

DOT HS 813 046

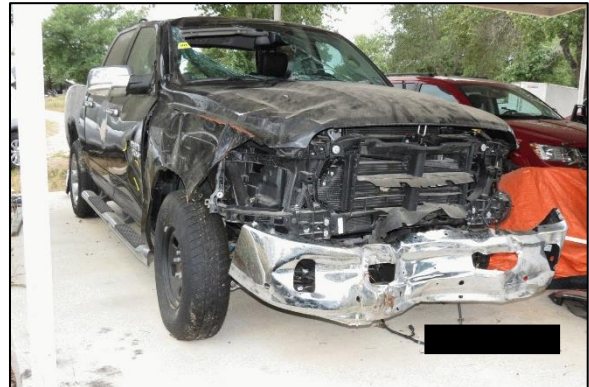
**Figure 1.** The damaged 2016 Ram 1500.

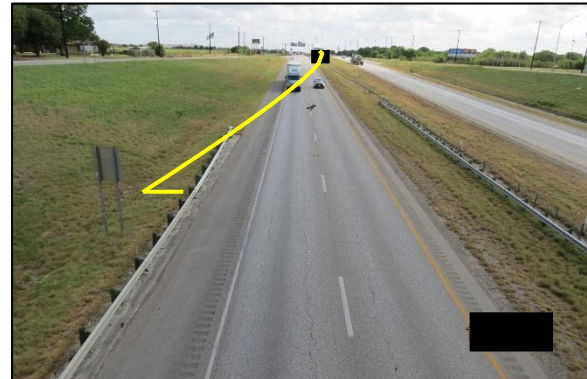
**Figure 3.** Northeast view, V1 approximate travel.

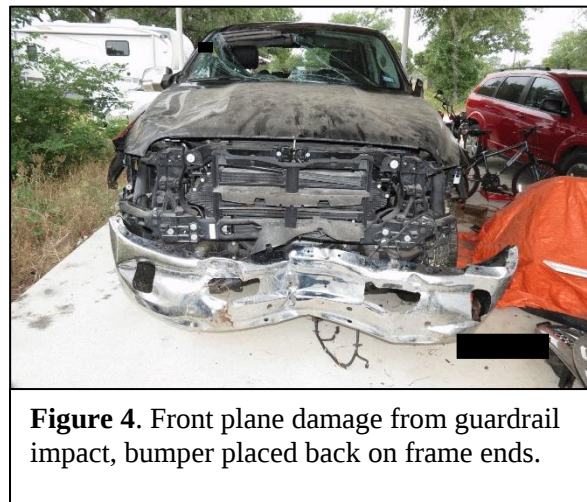
**Figure 4.** Front plane damage from guardrail impact, bumper placed back on frame ends.

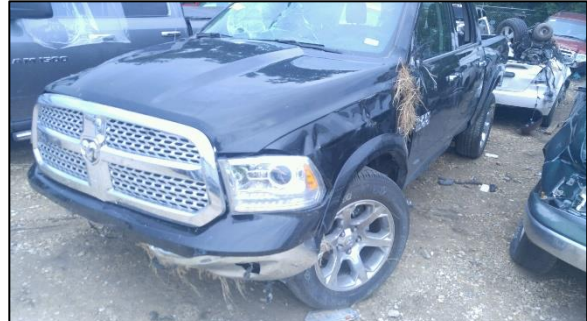
**Figure 5.** Ram 1500 rollover damage to left plane, photo by the driver's father.

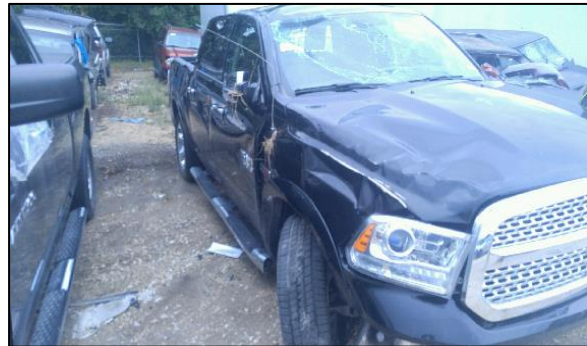
**Figure 6.** Ram 1500 rollover damage to right and top planes, photo by the driver's father.
