DOT HS 813 084

# **Special Crash Investigations: Ambulance Crash Investigation; Vehicle: 2017 Ford E-450 Type III Ambulance; Location: Michigan; Crash Date: January 2019**

**Special Crash Investigations  
Ambulance Crash Investigation  
Case Number: DS19007  
Vehicle: 2017 Ford E-450 Type III Ambulance  
Location: Michigan  
Crash Date: January 2019**

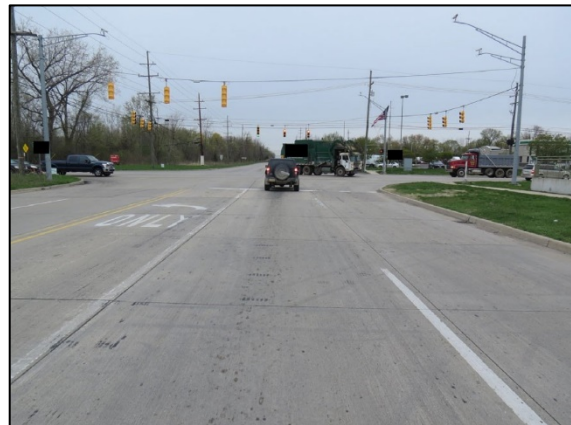
**Figure 2.** Northbound approach, the ambulance.

lanes, a left turn lane, and two southbound travel lanes (**Figure 2**). The concrete roadway was straight and level. The westbound roadway was composed of two westbound travel lanes, a left turn lane, and a wide eastbound lane (**Figure 3**). The concrete roadway was straight and level. There were tall willow bushes in the southeast corner of the intersection obscuring the view looking south. The intersection was controlled by 3-phase overhead traffic signals. The speed limit was 80 km/h (50 mph) for both roadways.

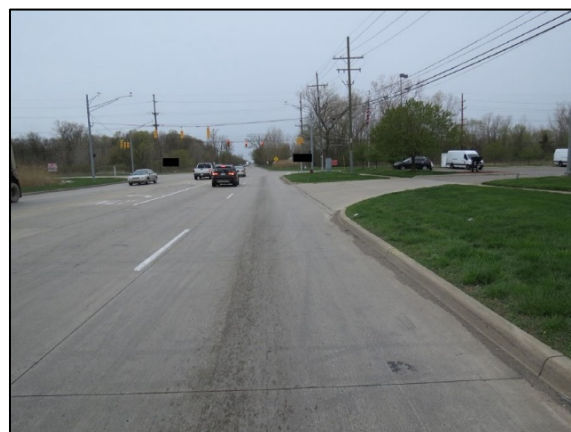
**Figure 3.** Westbound approach, the 2014 Dodge Caravan.

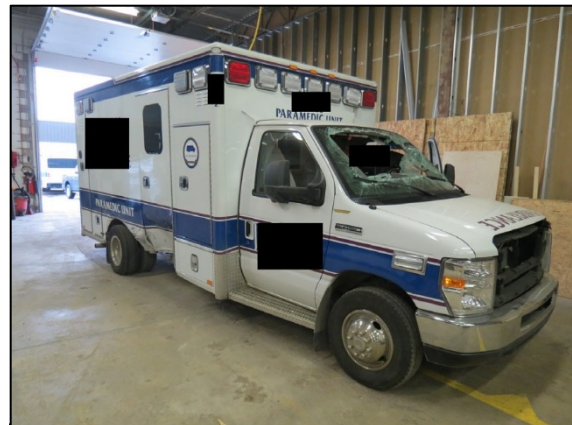
The direct damage for the right plane impact began 30 cm (11.8 in) aft of the right rear axle and extended 198 cm (77.9 in) forward (**Figure 5**). Twenty-three measurements were taken at the sill level by the Nikon Total Station and the Faro Blitz program computed crush measurement in six increments as follows:  $C_1 = 1$  cm (0.4 in),  $C_2 = 1$  cm (0.4 in),  $C_3 = 10$  cm (3.9 in),  $C_4 = 13$  cm (5.1 in),  $C_5 = 35$  cm (13.7 in), and  $C_6 = 25$  cm (9.8 in). The calculated Principal Direction of Force (PDOF) was approximately 20 degrees. The maximum crush was located 150 cm (59.0 in) forward of the right rear axle. The Truck Deformation Classification (TDC) was 01RBEWA.

**Figure 5.** Right plane damage, the ambulance.

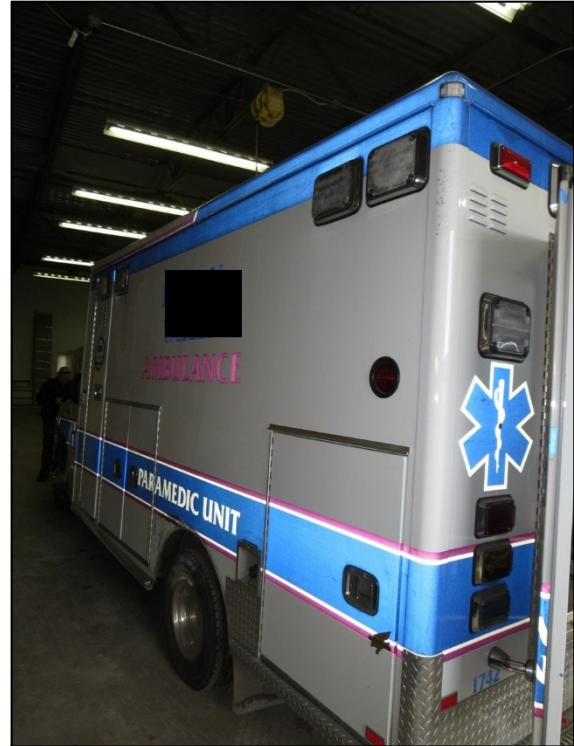
The direct damage to the left plane from the rollover began at the rear aspect of the patient compartment and extended 410 cm (161.4 in) forward (**Figure 6**). The damage height was 229 cm (90.1 in), which include components from the sill to the roof. There was no damage to the vehicle chassis. The TDC was 00LBAOA.

**Figure 6.** Left plane damage, the ambulance.

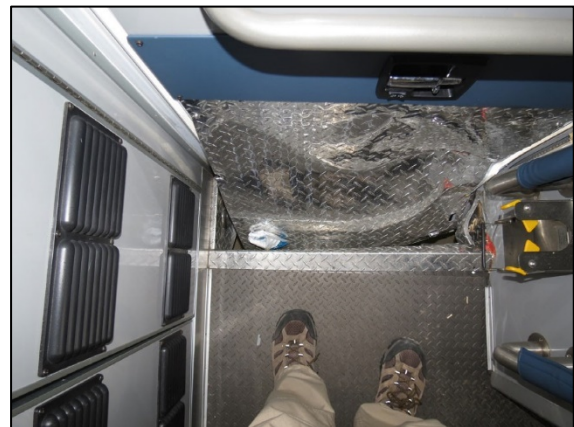
The patient compartment sustained right plane intrusion from the impact with the Dodge. The lateral intrusion measured 18 cm (7.0 in) and was located at the base of the right compartment

**Figure 7.** Right patient compartment intrusion, the ambulance.

door (**Figure 7**). The right bench seat cushions were displaced laterally. The right door was jammed. The rear compartment doors remained closed and operational. There were blood deposits and hair located along the left wall and cabinetry.

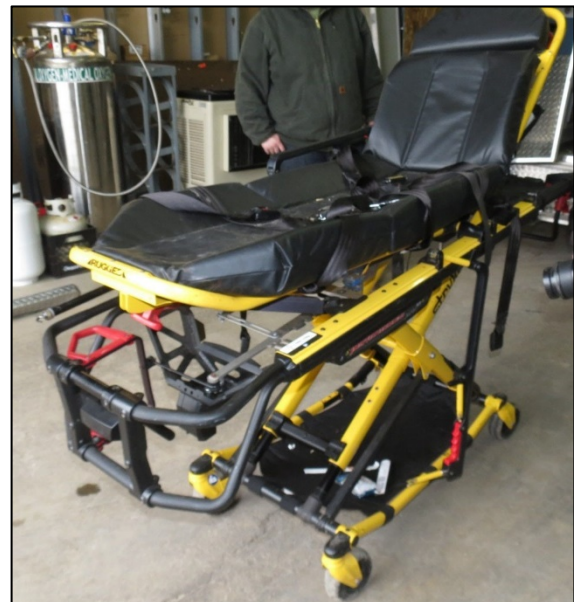
The patient cot was a Power-Pro XT ambulance cot manufactured by Stryker (**Figure 9**). The X-frame supporting the mattress platform featured power height adjustment capabilities and the mattress platform featured 0-73 degrees of

**Figure 9.** Rugged Power-Pro XT ambulance cot.

backrest articulation. Its length was 203 cm (79.9 in) and the width was 58 cm (22.8 in). The cot (minus mattress and restraints) weighed 40 kg (89 lbs) and had a maximum weight capacity of 318 kg (700 lbs). The serial number for the cot was 121xxxxxx. The cot was secured in place in the passenger compartment via a Stryker 6392 Performance-Load floor-mount cot fastener system (**Figure 10**). The cot was equipped with three lap and one torso cot restraints.

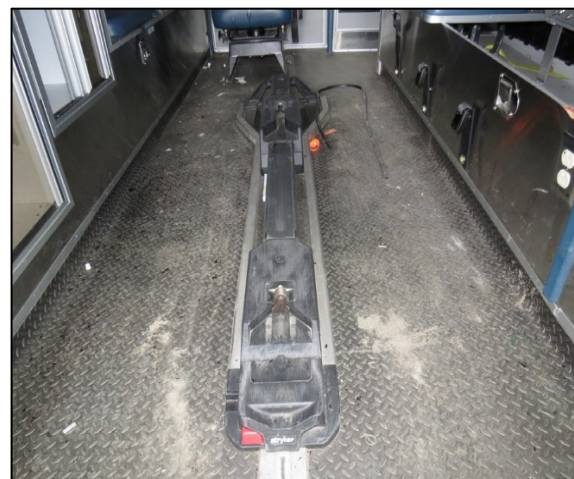
**Figure 10.** Stryker 6392 Performance-Load floor-mount cot fastener.

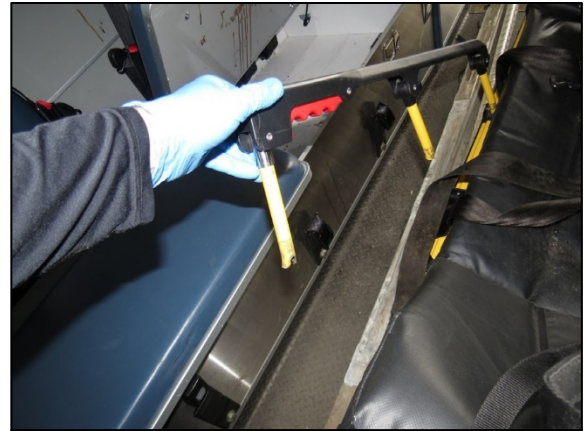
The cot sustained minor damage to the left arm during the rollover (**Figure 11**). It appears that the EMT contacted and fractured the arm as she pitched to the left side of the vehicle.

**Figure 11.** Ambulance cot damage.
