DOT HS 813 101

**Special Crash Investigations:
On-Site Child Restraint System
Crash Investigation;
Vehicle: 2012 Ford Explorer;
Location: Texas;
Crash Date: September 2019**

Special Crash Investigations
On-Site Child Restraint System Crash Investigation
Case Number: CR19002
Vehicle: 2012 Ford Explorer
Location: Texas
Crash Date: September 2019

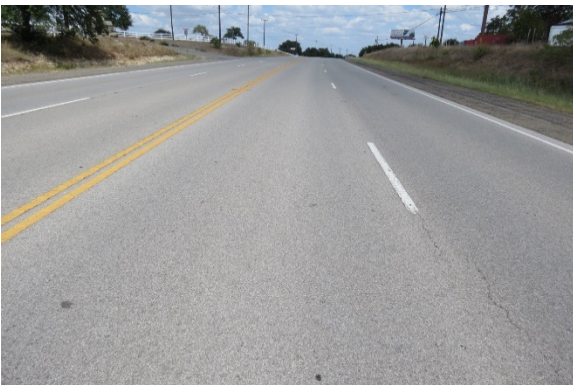
Figure 2. North view, the Ford's approach

The Ford was traveling north in the left lane of the northbound roadway (Figure 2) at an EDR-reported speed of 88 km/h (55 mph) at 5 seconds prior to algorithm enable (AE). The Honda was traveling south in the left lane of the southbound roadway (Figure 3) at an unknown speed. The Honda broke traction of the wet road surface and began to rotate counterclockwise, traversing the centerline and into the northbound lanes. A pre-impact tire mark attributed to the Honda began in the southbound left lane and continued for 65 m (213.2 ft) into the northbound right lane. Based on the EDR, the Ford driver started to steer significantly to the right at -2 sec prior to AE. He applied the service brakes at -1.5 second of AE. Crash scene evidence also indicated that the driver steered to the right to avoid the crash. The crash diagram is included at the end of this report.

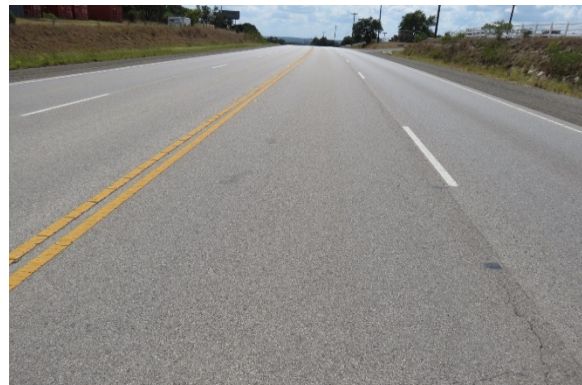
Figure 3. Southbound view of the Honda's approach

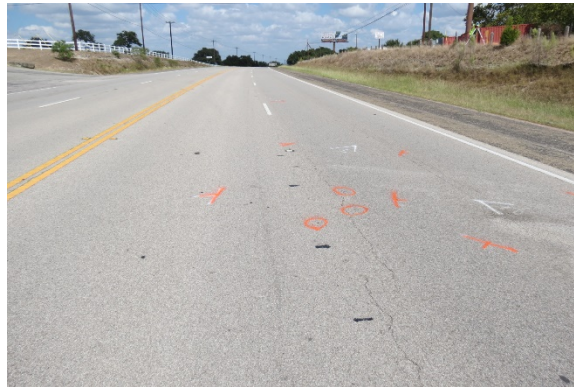
Figure 4. Impact/final rest area (northbound view)

The crash occurred in the center of the northbound lanes (Figure 4) when the front plane of the Ford struck the right plane of the Honda (Event 1). The EDR recorded speed of the Ford at impact was 66 km/h (41 mph). The resultant directions of force were in the 12 o'clock sector for the Ford and 3 o'clock for the Honda. As a result of the impact, both frontal and IC air bags, as well as the driver's seat-mounted air bag, deployed. The Ford rotated slightly counterclockwise and came to final rest facing north, mostly in the right lane, with the right rear wheel on the

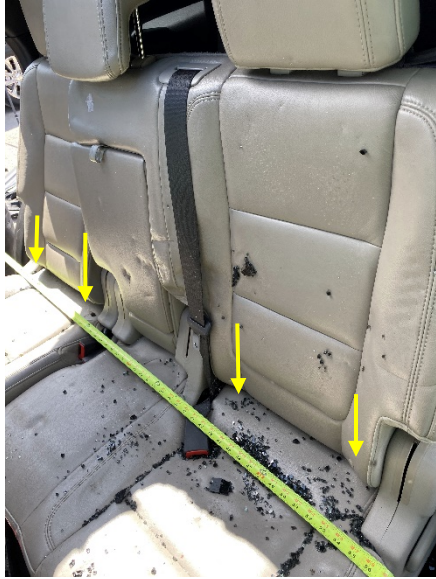
Figure 5. Second-row seat LATCH anchor points

The interior of the Ford was configured for seven occupants with front-row bucket seats with adjustable head restraints, a split-bench second-row seat with folding backs and adjustable head restraints, and a third-row split bench seat with folding backs and non-adjustable, folding head restraints. Manual safety systems included 3-point lap and shoulder seat belts for the seven seat positions. Supplemental restraints included frontal air bags for the driver and right front positions, front-row-seat-mounted side impact air bags, and dual sensing (side impact and rollover) inflatable curtain (IC) air bags. Both left and right frontal and IC air bags deployed during the crash, and so did the driver's seat-mounted side impact air bag. The second-row seat was configured with Lower Anchors and Tethers for Children (LATCH), with lower anchors present for the outboard seating positions and top tether anchors present for all three seat positions (Figures 5 and 6). The vehicle's owner's manual stated: "The standard spacing for LATCH lower anchors is 28 cm (11 in). Do not use LATCH lower anchors for the center seating positions unless the child seat manufacturer's instructions permit and specify using anchors spaced at least as far apart as those in this vehicle." The space between the outboard seat anchors was 28 cm (11 in), and the space between the two inboard anchors (at the center seat) was 52 cm (20.5 in). The second-row center position was not an approved LATCH position by the CRS manufacturer.

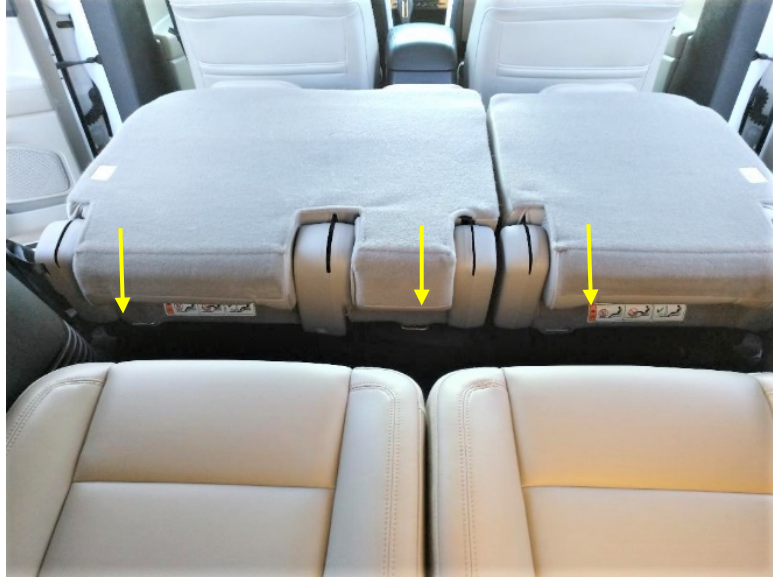
Figure 6. Second-row top tether anchor points

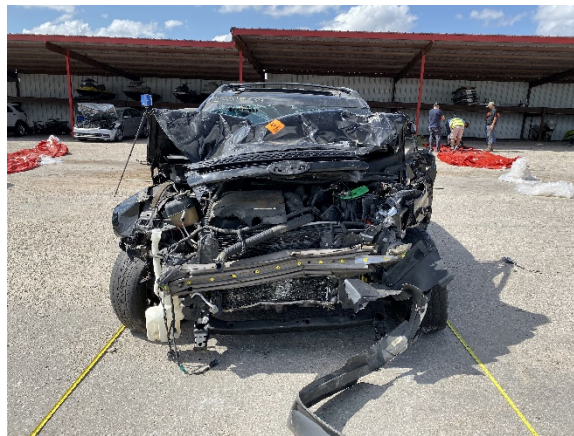
Exterior damage was present on the front and left planes of the Ford, consistent with the dynamics of the crash sequence. The front bumper beam, bumper fascia, grille, hood, fenders, and both headlamp/turn signal assemblies were all directly damaged (Figure 7). The direct and induced damage extended the entire length of the front plane, 160 cm (63.0 in), based on exemplar measurements. The Field L was 143 cm (56.3 in). Crush measurements were taken on the bumper beam. The residual maximum crush was 48 cm (18.9 in), occurring at the front left bumper corner. The crush profile measurements were C1 = 46 cm (18.1 in), C2 = 42 cm (16.5 in), C3 = 48 cm (18.9 in), C4 = 42 cm (16.5 in), C5 = 33 cm (13.0 in), and C6 = 21 cm (8.3 in).

Figure 7. The Ford's front plane damage

The collision deformation classification (CDC) assigned to the damage pattern was 12FDEW3 (350 degrees). As the Ford and the Honda were engaged and moving toward final rest, the Honda rotated around the left front corner of the Ford and contacted the Ford's left plane. The direct

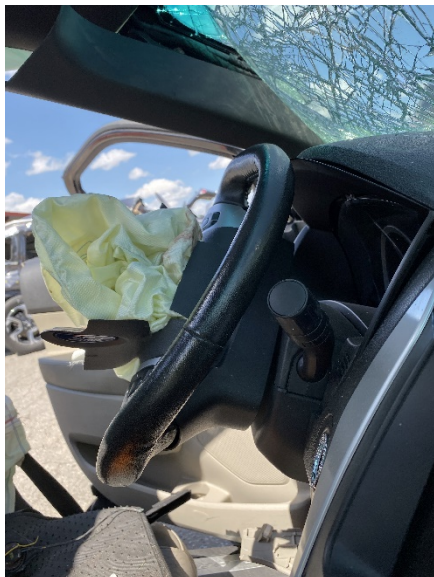
The occupant compartment of the Ford did not sustain intrusion damage from the frontal engagement with the Honda. The driver loaded through the deployed air bag and engaged and deformed the upper half of the steering wheel rim forward approximately 3 cm (1.2 in). His loading force also compressed the energy absorbing steering column (Figure 8). His knees contacted and deformed the knee bolster. There were no identified contacts attributed to the front right passenger.

Figure 8. The Ford's steering wheel/column deformation

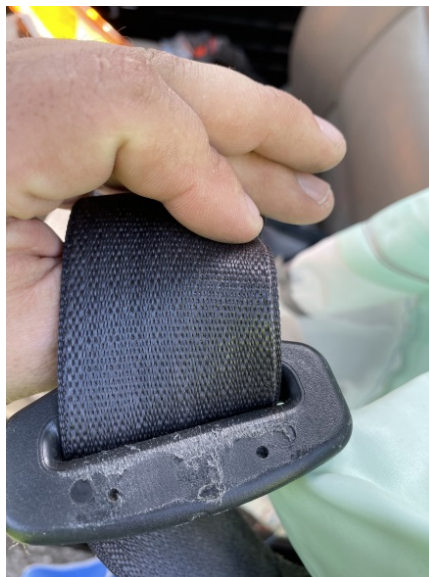
The driver was restrained by his seat belt. Both retractor and buckle pretensioners actuated during the crash. As the pretensioners actuated, the seat belt webbing was pulled taut across the driver as he was displaced forward as a result of frontal crash forces and loaded the seat belt system. Loading evidence consisted of frictional abrasions on the latch plate belt guide (Figure 9). There were also 7 cm (2.8 in) and 22 cm (8.7 in) long frictional abrasions on the webbing

from engagement against the buckle and D-ring, respectively, and an unretractable length of webbing was extended from the retractor, consistent with usage.

Figure 9. Frictional abrasions on the driver's latch plate

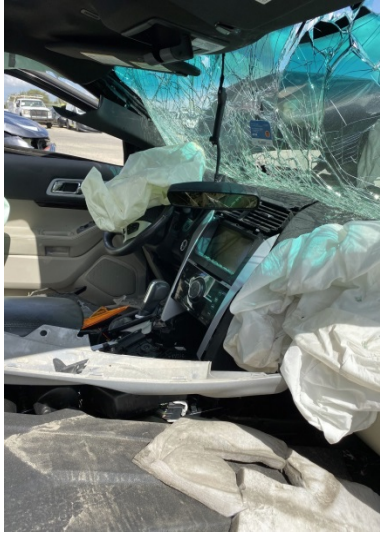
The driver's frontal air bag was mounted in the center hub of the steering wheel and was concealed by I-configuration cover flaps. The deflated air bag measured 53 cm (20.9 in) in diameter. The driver loaded through the air bag as evidenced by the deformation of the upper half of the steering wheel rim. The lower half of the back side of the air bag was stained with blood, though there was no discernable driver contact (i.e., tissue transfer) evidence to the air bag.

Figure 10. The Ford's deployed frontal air bags

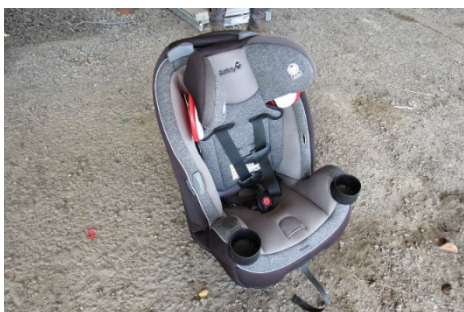
The second-row center passenger was positioned in a Dorel Juvenile Group, Safety First "Grow and Go" convertible CRS (Figure 11). The CRS was manufactured on February 17, 2017, and was identified by Model No. CC138EFL. The CRS was constructed of a molded plastic shell with a multi-piece padded cover, dual armrests with integrated cup holders, and a 5-position adjustable headrest with corresponding positions for the shoulder portion of the 5-point harness system. The CRS was designed for use as a rear-facing infant seat for children of up to 18.1 kg (40 lb), a forward-facing 5-point harness restraint for children of 10.1 to 29.4 kg (22 to 65 lb), and a high-back belt-positioning booster seat for children of 18.1 to 45.4 kg (40 to 100 lb). At the time of the crash, the shoulder straps and headrest were adjusted to one setting up from the bottom, and the adjustable crotch strap buckle was set in the position closest to the child. The base was adjustable to three positions and was color coded for use in forward-facing (position 1,

Figure 11. Dorel Safety First, "Grow and Go" CRS

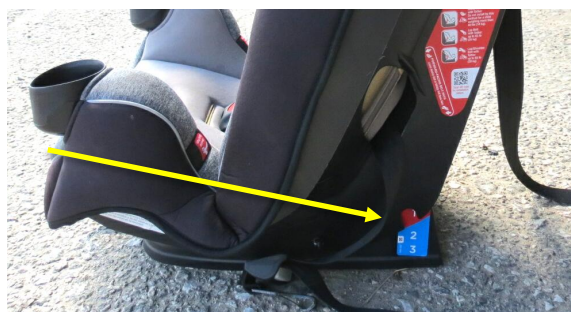
red) or rear-facing (positions 2 and 3, blue), and at the time of inspection, the base was tilted to position 1 (Figure 12). The CRS was equipped with Lower Anchors and Tethers for Children (LATCH) with color-coded belt paths for use as forward-facing (red) and rear-facing (blue).

Figure 12. Left side of CRS with incline adjustment at the "1" (most upright) position

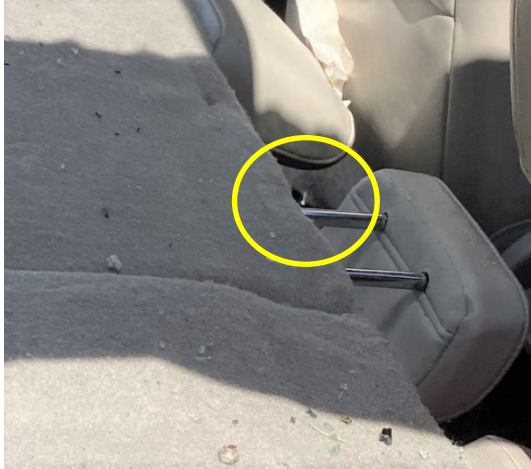
Based on the inspection and research, the CRS was secured to the second-row seat in an unapproved manner at the time of the crash. Inspection of the CRS revealed one small stress mark on the front of the seat, 14 cm (5.5 in) left of the center, but otherwise there was no observed structural damage or discernable stress marks to the shell. The levers for the headrest/shoulder strap adjustment did not function properly (Figure 14), and the left harness

Figure 13. Top tether load mark at top second-row, center seat back

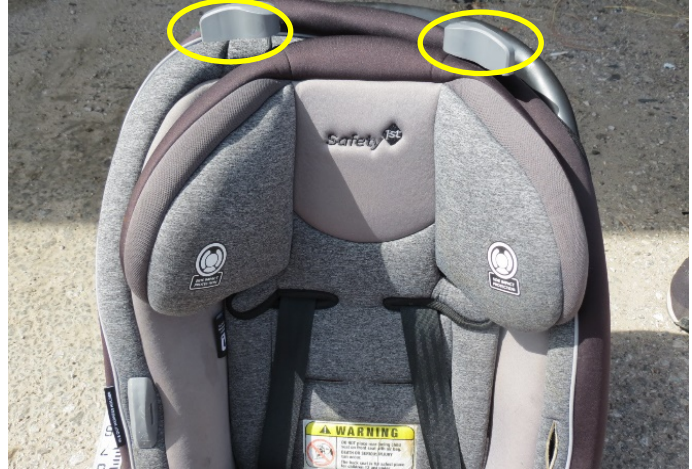
strap holder (used when moving child in and out of the CRS) was broken off, though it is unknown whether it was a result of this crash. Frictional abrasions at the belt routing area from the LATCH straps were minimal; all buckles, hardware, and the shoulder strap retainer clip were undamaged and in good working condition.

Figure 14. CRS headrest and shoulder strap adjustment levers

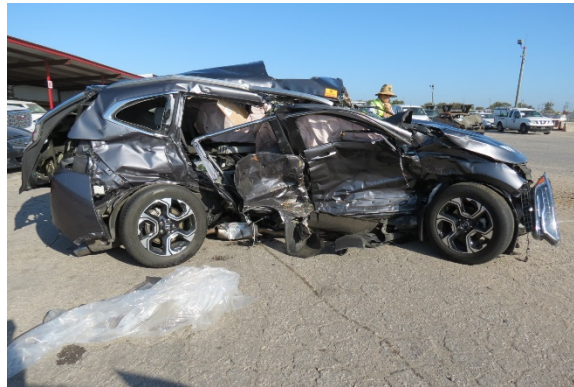
The Honda sustained damage to its entire right plane as a result of the impact with the Ford. The right fender, both doors, quarter panel, rear wheel, and B-pillar were directly damaged (Figure 15). The direct damage began 256 cm (100.8 in) forward of the right rear axle and extended rearward 298 cm (117.3 in). The Field L was 350 cm (137.8 in). Crush measurements were taken at the lower door level with maximum residual crush of 44 cm (17.3 in) occurring 128 cm (50.4 in) forward of the right front axle. The crush values were C1 = 22 cm (8.7 in), C2 = 40 cm (15.7 in), C3 = 52 cm (20.5 in), C4 = 47 cm (18.5 in), C5 = 42 cm (16.5 in), and C6 = 7 cm (2.8 in).

Figure 15. Right side damage to the Honda

The CDC was 03RDAW4. The damage algorithm of the WinSMASH program calculated the total delta V as 70 km/h (44 mph). The longitudinal and lateral velocity changes were 12 km/h (7 mph) and -69 km/h (-43 mph). The results appeared reasonable.

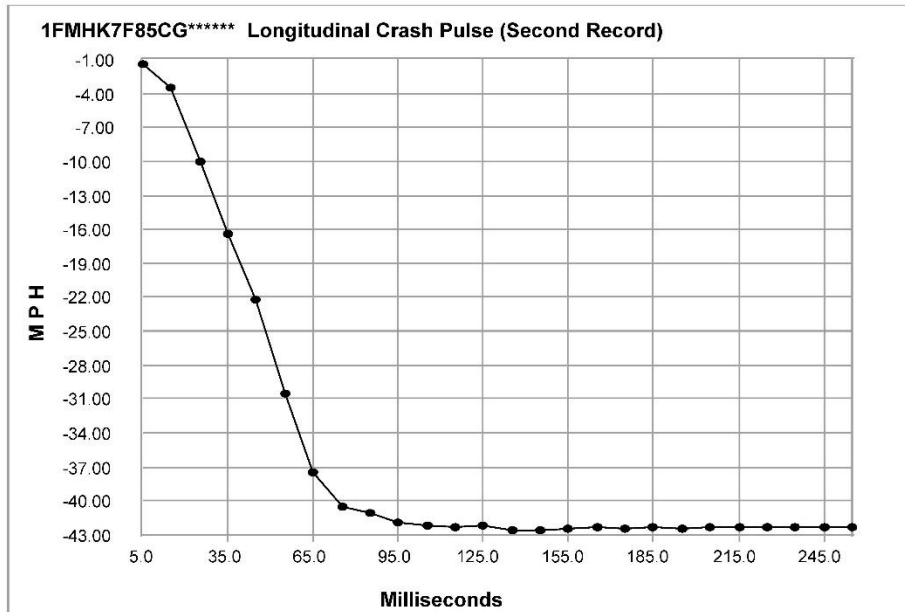
Longitudinal Crash Pulse (Second Record)

Time (msec)	Delta-V, longitudinal (MPH)	Delta-V, longitudinal (km/h)
5.0	-1.36	-2.19
15.0	-3.45	-5.55
25.0	-10.02	-16.12
35.0	-16.45	-26.47
45.0	-22.27	-35.84
55.0	-30.54	-49.15
65.0	-37.49	-60.34
75.0	-40.48	-65.14
85.0	-41.09	-66.13
95.0	-41.94	-67.49
105.0	-42.13	-67.80
115.0	-42.34	-68.14
125.0	-42.22	-67.94
135.0	-42.53	-68.44
145.0	-42.54	-68.45
155.0	-42.46	-68.33
165.0	-42.34	-68.13
175.0	-42.40	-68.23
185.0	-42.35	-68.16
195.0	-42.40	-68.23
205.0	-42.31	-68.09
215.0	-42.29	-68.06
225.0	-42.26	-68.01
235.0	-42.30	-68.07
245.0	-42.24	-67.99
255.0	-42.30	-68.07

damage extended 349 cm (137.4 in) along the left plane during the prolonged engagement. The damage algorithm of the WinSMASH program calculated the Ford's total delta V as 49 km/h (30 mph). The longitudinal and lateral velocity changes were -49 km/h (-30 mph) and 9 km/h (6 mph). The results appeared low. The EDR reported the maximum longitudinal and lateral delta Vs as -68.59 km/h (-42.62 mph) and 10.79 km/h (6.71 mph), respectively.

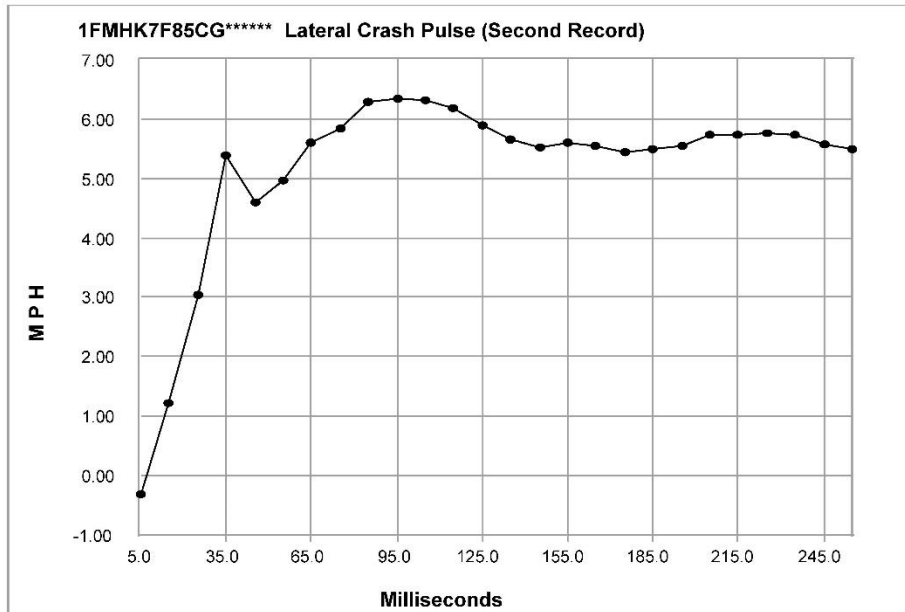
Lateral Crash Pulse (Second Record)

Time (msec)	Delta-V, lateral (MPH)	Delta-V, lateral (km/h)
5.0	-0.31	-0.50
15.0	1.21	1.94
25.0	3.05	4.90
35.0	5.39	8.68
45.0	4.60	7.41
55.0	4.97	8.00
65.0	5.60	9.01
75.0	5.84	9.40
85.0	6.29	10.13
95.0	6.33	10.19
105.0	6.32	10.17
115.0	6.17	9.93
125.0	5.89	9.48
135.0	5.66	9.11
145.0	5.53	8.91
155.0	5.61	9.03
165.0	5.55	8.93
175.0	5.45	8.77
185.0	5.49	8.83
195.0	5.55	8.92
205.0	5.74	9.23
215.0	5.73	9.22
225.0	5.77	9.29
235.0	5.72	9.21
245.0	5.58	8.98
255.0	5.49	8.84
