DOT HS 813 138

**Special Crash Investigations:
Remote Vehicle Fire/Child
Restraint System Crash
Investigation;
Vehicle: 2007 Dodge Magnum;
Location: Minnesota;
Crash Date: April 2016**

Special Crash Investigations
Remote Vehicle Fire/Child Restraint System Crash Investigation
Case Number: DS19024
Vehicle: 2007 Dodge Magnum
Location: Minnesota
Crash Date: April 2016

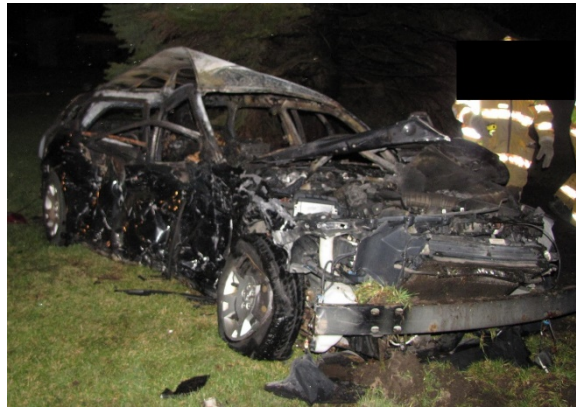
Figure 1. 2007 Dodge Magnum (police photo)

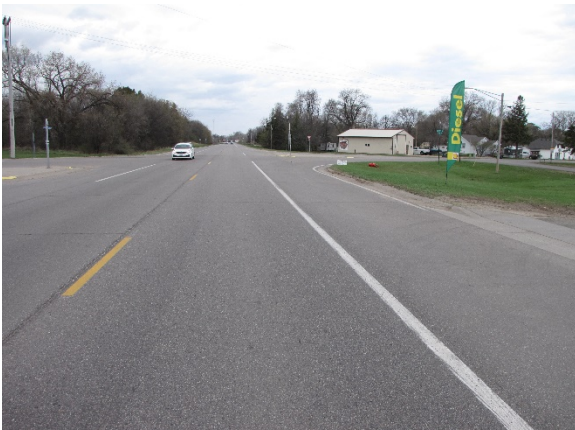
Figure 2. Westbound approach (police photo)

The Magnum was traveling westbound at police-estimated speed of 67 km/h (42 mph) approaching the intersection (Figure 2). The Charger was traveling southbound approaching the intersection at an EDR-reported speed of 104 km/h (64 mph) at 5 seconds prior to impact. At 0.3 seconds the service brake was applied. The Charger failed to stop at the stop sign and entered the intersection (Figure 3). The EDR-reported speed just prior to impact was 96 km/h (60 mph). The Charger's pre-crash speeds and distances covered are shown in the table on the next page.

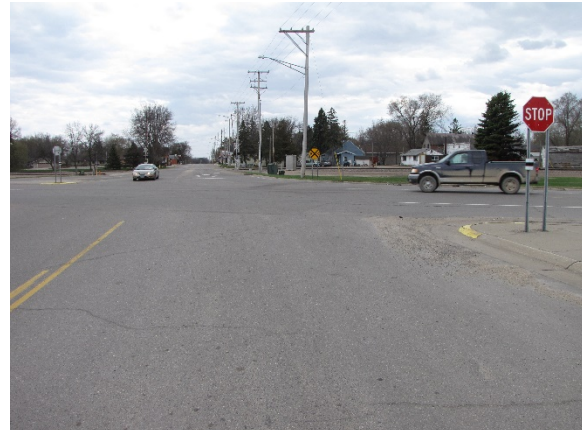
Figure 3. Southbound approach (police photo)

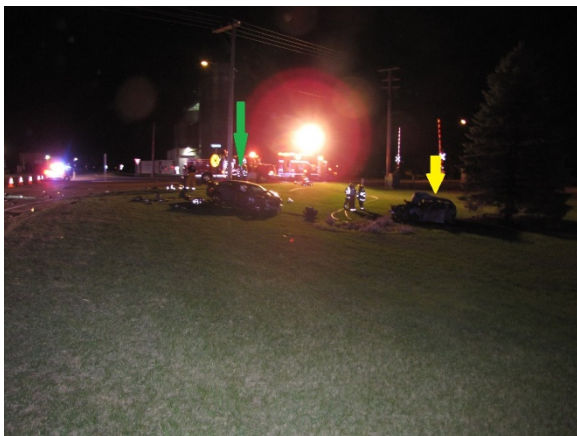
Figure 4. Final rest area, looking north (police photo), the 2007 Dodge Magnum (yellow arrow), the 2014 Dodge Charger (green arrow)

The front of the Charger struck the right side of the Magnum (Event 1). The Charger sustained an EDR-reported maximum longitudinal delta V of -77 km/h (-47.8 mph) and a maximum lateral delta V of 58 km/h (36.0 mph) at 238 ms. The calculated total delta V for the Charger was 96.2 km/h (59.8 mph). The Charger rotated clockwise, and the Magnum rotated counterclockwise. There was a secondary impact between the left plane of the Charger and the right plane of the Magnum (Event 2). The Charger sustained an EDR-reported maximum longitudinal delta V of -23 km/h (-14.3 mph) at 280 ms and a maximum lateral delta V of 6 km/h (3.7 mph) at 254 ms. Both vehicles were displaced toward the southwest corner of the intersection and departed the roadway (Figure 4). The Magnum struck the curb with the left tire (Event 3). The Magnum then tripped on the curb and rolled four quarter-turns (Event 4). It landed on its wheels and rolled backward approximately 3.6 m (12 ft). It came to rest upright and facing northeast and caught fire (Figure 5). The Charger came to rest facing west.

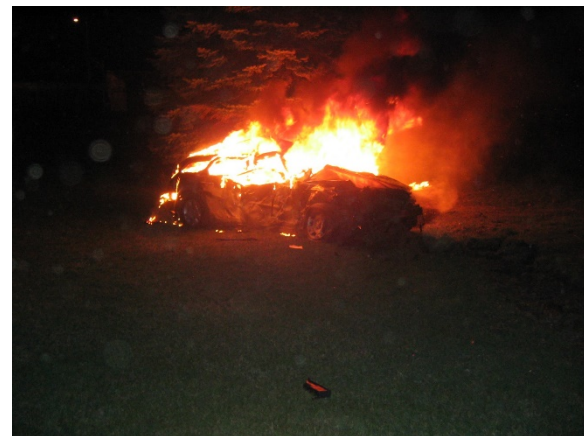
Figure 5. The 2007 Dodge Magnum (police photo)

It appears that the fuel tank was ruptured during the crash and that the vehicle caught fire after it came to rest. The fire fully involved the entire vehicle, and there was damage to the entire exterior and interior.

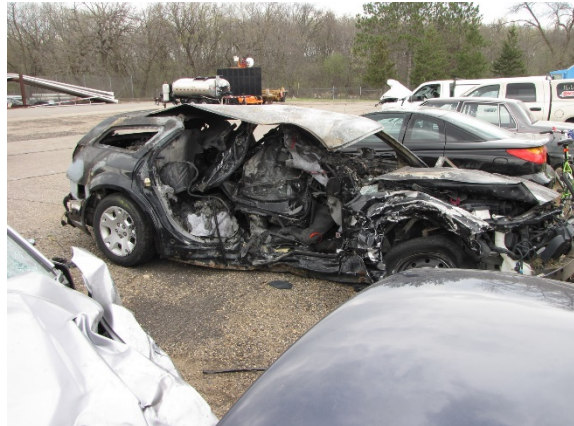
The Magnum sustained severe right plane damage from the impact with the Charger (Figure 6). The direct damage began at the front-right wheel and extended rearward to the B-pillar and second-row right door. The estimated Collision Deformation Classification (CDC) was 01RYEW5.

Figure 6. The 2007 Dodge Magnum, right plane damage (police photo)

There was secondary contact between the two vehicles during rotation that caused some minor damage to the right rear of the Magnum and the left rear of the Charger. The estimated CDC was 99RB9999. The left rear tire struck the curb as the vehicle departed the roadway. The estimated CDC for the curb impact was 09LBWN2. The Magnum sustained damage to the roof area during the four-quarter rollover. The damage was masked by the initial impact and the fire. The estimated CDC was 00TDYO2.

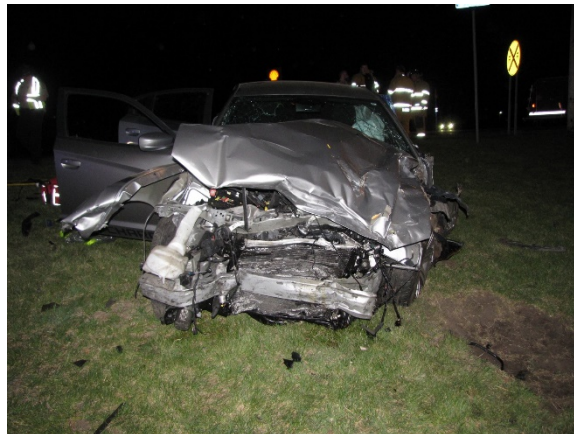
The Charger sustained moderate front plane damage from the impact to the right plane of the Magnum (Figure 7). The direct damage extended from bumper corner to bumper corner. The calculated principal direction of force (PDOF) was 320 degrees, and the estimated CDC was 11FDEW2. There was a secondary impact between the left plane of the Charger and the right plane of the Magnum. The calculated PDOF was 340 degrees, and the estimated CDC was 11LBGW2.

Figure 7. The 2014 Dodge Charger, front plane damage (police photo)

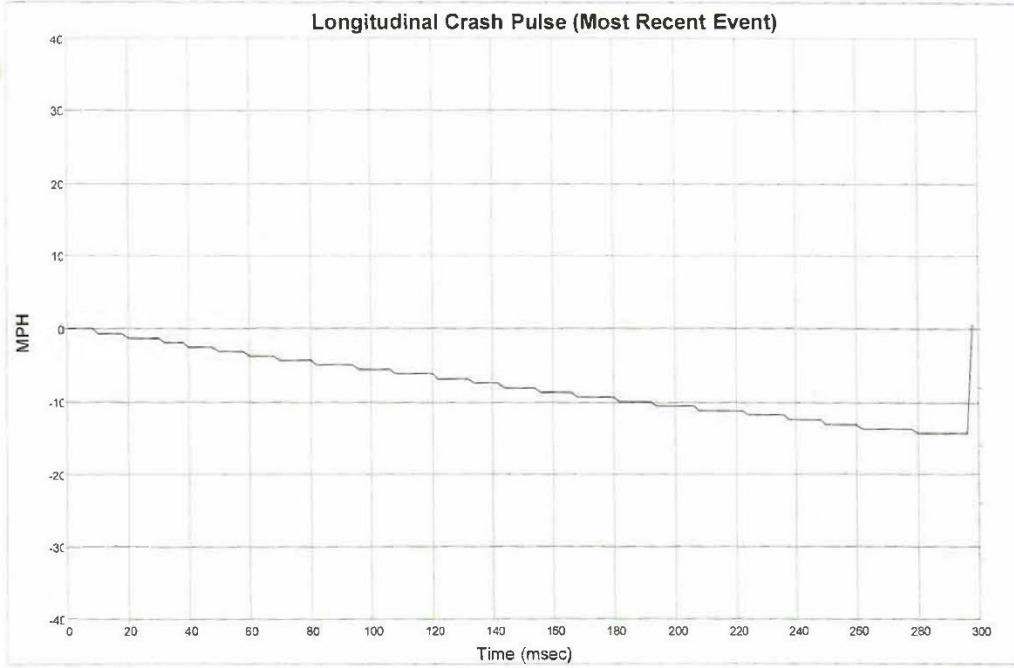
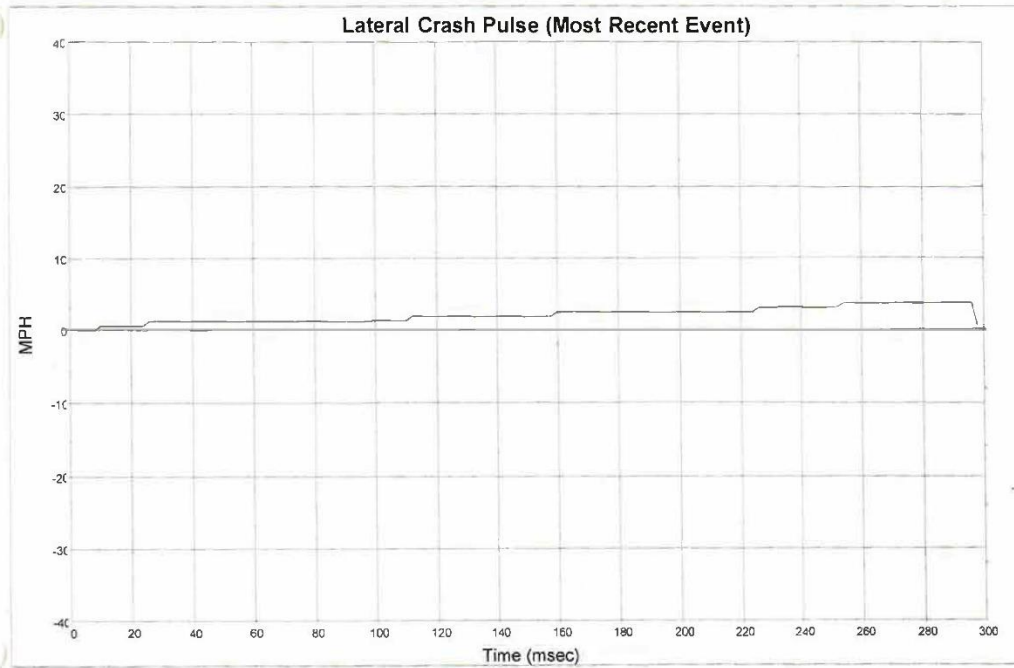
Longitudinal Crash Pulse (Most Recent Event)

The most recent event occurred 0.2 seconds after the first prior event and was likely related to the secondary impact with the Magnum. The maximum longitudinal delta V was -23 km/h (-14.3 mph) at 280 ms. The maximum lateral delta V was 6 km/h (3.7 mph) at 254 ms. There were no deployments or actuations. The pre-crash data were identical to the previous event with a 0.2 second offset.

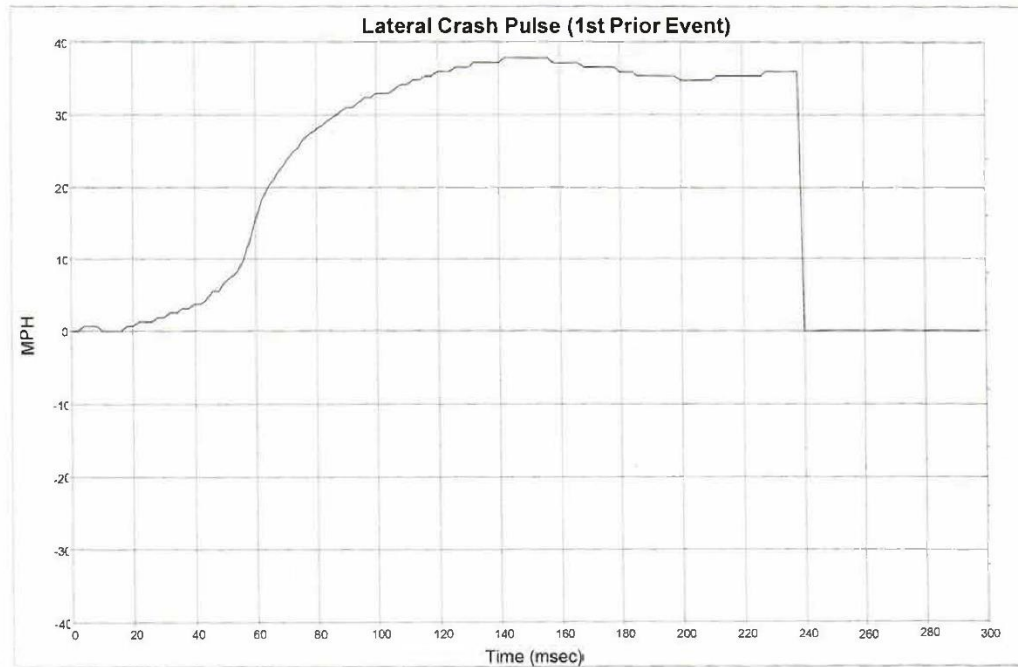
Longitudinal Crash Pulse (1st Prior Event)

The first prior event (Event 1) resulted from the impact to the right side of the Magnum. The maximum delta V was -77 km/h (-47.8 mph) 22 milliseconds (ms). The maximum lateral delta V was 61 km/h (37.9 mph) at 142 ms. The driver's frontal air bag deployed at 11 ms, and the second stage deployed at 31 ms. The driver's knee air bag deployed, and the buckle/retractor seat belt pretensioner actuated. The passenger's frontal air bag deployed at 11 ms, and the second stage deployed at 31 ms. The passenger's buckle/retractor seat belt pretensioner actuated. The seat belt status for the driver and passenger was "buckled."

Time (msec)	Delta-V, Longitudinal (MPH [km/h])
0	-0.6 [-1]
2	-1.2 [-2]
4	-1.9 [-3]
6	-1.9 [-3]
8	-2.5 [-4]
10	-2.5 [-4]
12	-2.5 [-4]
14	-3.1 [-5]
16	-4.3 [-7]
18	-5.6 [-9]
20	-6.8 [-11]
22	-7.5 [-12]
24	-8.7 [-14]
26	-8.7 [-14]
28	-9.3 [-15]
30	-9.3 [-15]
32	-11.2 [-18]
34	-12.4 [-20]
36	-13.7 [-22]
38	-14.3 [-23]
40	-14.9 [-24]
42	-16.2 [-26]
44	-18.0 [-29]
46	-19.3 [-31]
48	-20.5 [-33]
50	-22.4 [-36]
52	-23.6 [-38]
54	-24.2 [-39]
56	-24.2 [-39]
58	-24.9 [-40]
60	-24.9 [-40]
62	-25.5 [-41]
64	-25.5 [-41]
66	-25.5 [-41]
68	-25.5 [-41]
70	-26.1 [-42]
72	-26.7 [-43]
74	-26.7 [-43]
76	-27.3 [-44]
78	-28.0 [-45]
80	-28.0 [-45]
82	-28.6 [-46]
84	-29.2 [-47]
86	-29.8 [-48]
88	-30.4 [-49]
90	-31.1 [-50]
92	-31.7 [-51]
94	-31.7 [-51]
96	-32.3 [-52]
98	-32.9 [-53]

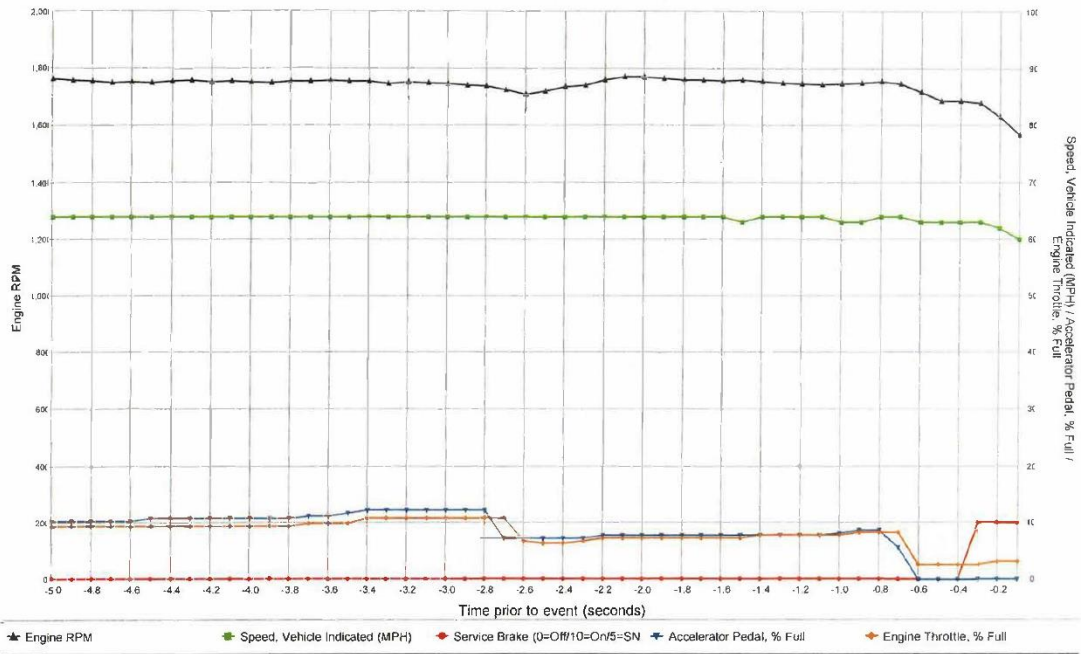
Pre-Crash Data (1st Prior Event)

Time Stamp (sec)	Vehicle Speed km/h (mph)	Accelerator Pedal Position, %	Engine Throttle	Service Brake	Engine rpm	Steering Input (deg)*
-5.0	104 (64)	10	9	Off	1,763	0
-4.5	104 (64)	11	9	Off	1,751	0
-4.0	104 (64)	11	9	Off	1,752	0
-3.5	104 (64)	12	11	Off	1,756	-2
-3.0	103 (64)	12	11	Off	1,747	-2
-2.5	103 (64)	7	6	Off	1,722	-2
-2.0	103 (64)	8	7	Off	1,770	0
-1.5	102 (63)	8	7	Off	1,760	0
-1.0	102 (63)	8	8	Off	1,748	0
-0.5	102 (63)	0	3	Off	1,685	-6
-0.1	96 (60)	0	3	Off	1,566	-56

SNA values will not be plotted on the graph
