DOT HS 813 150

**Special Crash Investigations:
On-Site Side Impact Crash
Investigation;
Vehicle: 2014 Infiniti QX60 Hybrid;
Location: North Carolina;
Crash Date: June 2018**

Special Crash Investigations
On-Site Side Impact Crash Investigation
Case Number: CR18020
Vehicle: 2014 Infiniti QX60 Hybrid
Location: North Carolina
Crash Date: June 2018

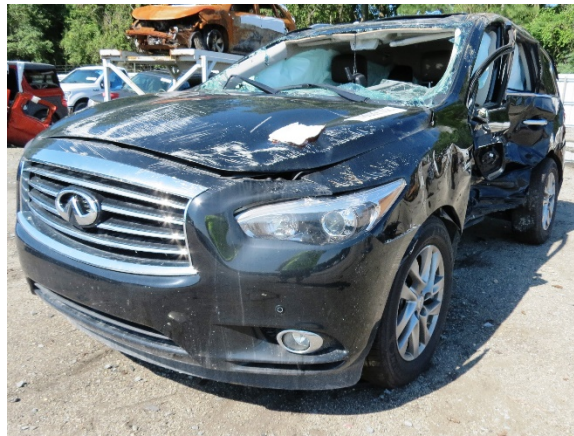
Figure 1. Front left oblique view of the Infiniti at the time of the SCI vehicle inspection

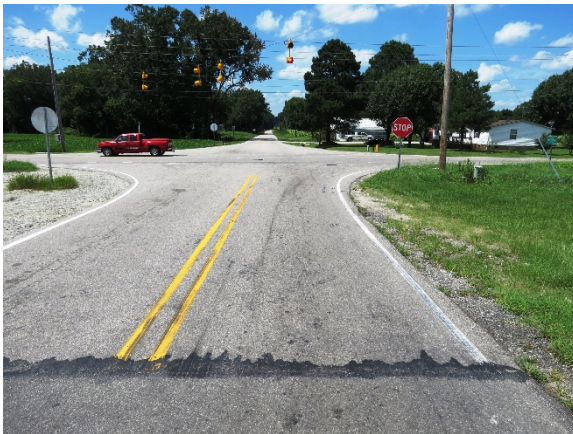
For the Infiniti's travel trajectory on approach to the intersection, the two-lane roadway was straight. There was a railroad crossing less than 40 m (131.2 ft) south of the intersection, and the roadway had a slight negative grade from the railroad crossing to the intersection. The north/south lanes were nominally 3.0 m (9.8 ft) wide, delineated by a double-solid yellow centerline and bordered by single-solid white fog lines with grassy roadsides. For northbound traffic, the intersection was controlled by a stop sign and a red-flashing overhead electronic beacon (Figure 2).

Figure 2. Northbound view of the Infiniti's pre-crash approach to the intersection and crash site

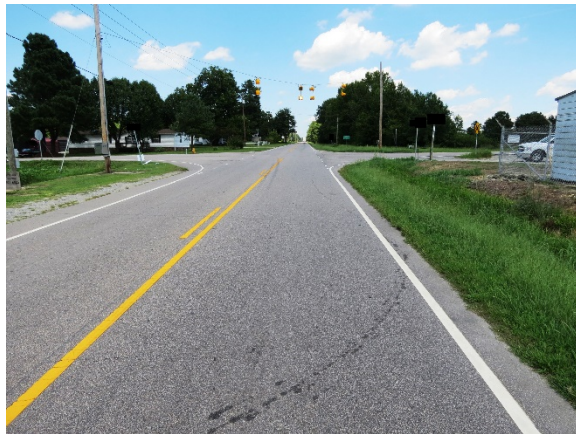
Figure 3. Eastbound view of the Ford's pre-crash approach to the intersection and crash site

For the Ford's eastbound travel trajectory on approach to the intersection, the two-lane roadway was straight and level. The east/west lanes were nominally 3.3 m (10.8 ft) wide, delineated by a double-yellow centerline that permitted passing for westbound traffic. Single solid white fog lines marked the roadway edges, bordered by grassy roadsides. East/west traffic on approach to the intersection was alerted by a cautionary, yellow-flashing, overhead electronic beacon, but otherwise uncontrolled (Figure 3).

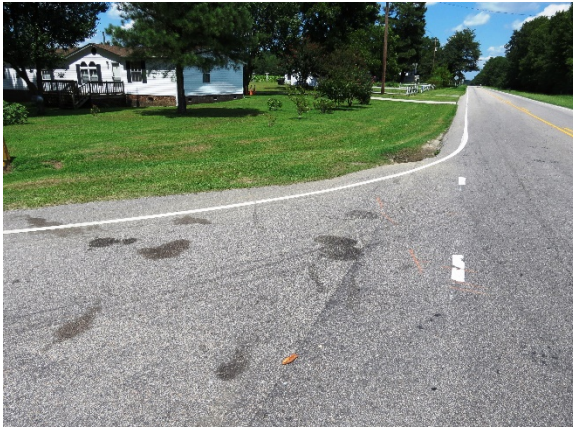
The Infiniti completed two quarter turns and slid off the roadway into the depressed grass roadside, where it came to rest on its top plane, facing northwest (Figure 4).

Figure 4. East-facing view of the rollover trajectory for the Infiniti into the grass roadside

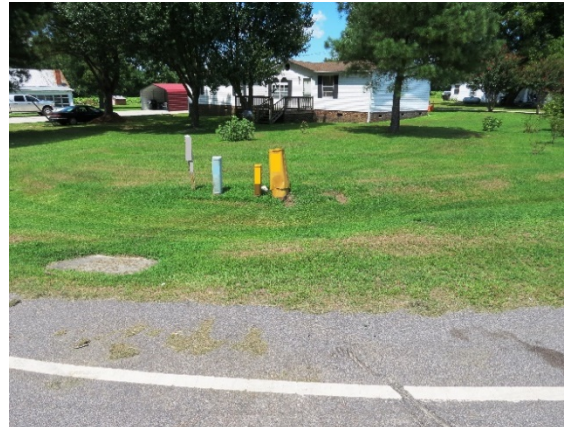
The Ford departed the northeast intersection quadrant at a low speed and entered the depressed grass area. As the Ford came to final rest facing northeast in the roadside, it struck a yellow metal utility box with the left corner of its front plane (Event 3, Figure 5).

Figure 5. Northeast view of the Ford's trajectory into the roadside and yellow utility box impact (Event 3)

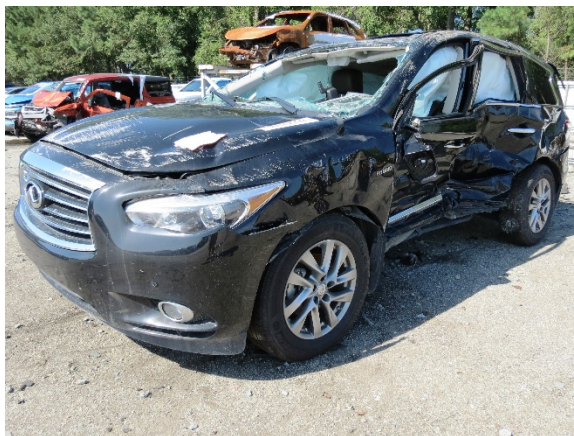
The 2014 Infiniti QX60 Hybrid (Figure 6) was identified by the vehicle identification number (VIN) 5N1CL0MM0ECxxxxxx. The electric odometer was inoperable at the time of the SCI inspection. The Infiniti was an all-wheel drive platform, powered by a 2.5-liter, inline, 4-cylinder, gasoline engine linked to a continuously variable speed transmission, with power-assisted 4-wheel disc brakes with antilock (ABS). Due to the jammed status of the left front door by direct crash damage, there was no access to view the manufacturer placards at the time of the SCI inspection. Therefore, the date of manufacture, gross vehicle weight rating, gross axle weight ratings, and recommended tire size/cold tire pressure remain unknown. At the time of the SCI inspection, the Infiniti was equipped with Michelin Latitude Tour tires of size P235/65R18 at all four axle positions. The tires had matching tire identification numbers (TINs) of B9MB 02BX xx16. All four tires had at least 5 mm (7/32 in) of tread, remained inflated, and were not damaged or restricted in relation to the crash.

Figure 6. Left front oblique view of the 2014 Infiniti QX60 Hybrid during the SCI vehicle inspection

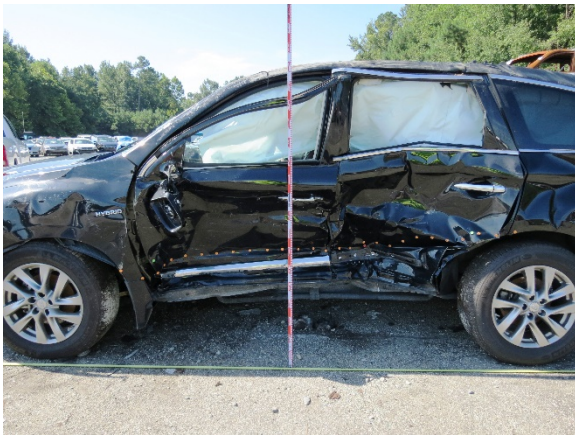
A residual crush profile was documented to the mid-door level of the Infiniti's left plane (Figure 7). The combined direct and induced damage width (Field-L) was 215 cm (84.6 in), beginning at the left A-pillar extending to the C-pillar and centered 17 cm (6.7 in) rearward of the center of the deformed left wheelbase dimension. Resultant measurements included: C1 = 0 cm (0 in), C2 = 18 cm (7.1 in), C3 = 28 cm (11.0 in), C4 = 28 cm (11.0 in), C5 = 29 cm (11.4 in), and C6 = 0 cm (0 in). Maximum crush was 29 cm (11.4 in), observed in the center aspect of the left rear door (Figure 8) and located 92 cm (36.2 in) forward of the left rear axle position. A collision deformation classification (CDC) of 09LPEW3 was assigned to the Infiniti's left plane damage profile. The damage algorithm of the WinSMASH model was used to calculate the severity of the crash. The Infiniti's total calculated vehicle velocity change (delta V) was 39 km/h (24.2 mph). Specific longitudinal and lateral components of the calculated delta V were -7 km/h (-4.3 mph) and 38 km/h (23.6 mph), respectively. These results were reasonable.

Figure 7. Left plane damage to the Infiniti as observed at the time of the SCI vehicle inspection

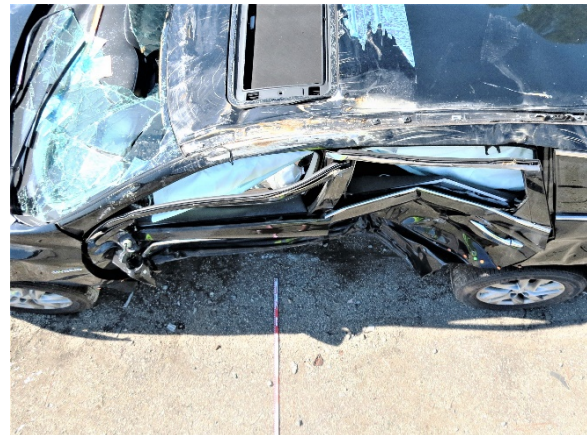
Figure 8. Overhead perspective of the SCI documentation of the Infiniti's left plane damage

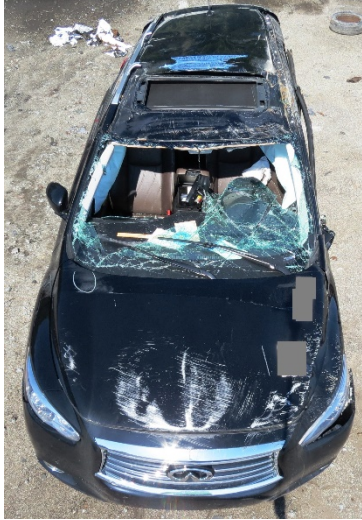
The Infiniti sustained minor right plane and top plane damage from the two-quarter turn rollover (Event 2). Right plane damage consisted of minor scratches and abrasions to body surfaces, with minor lateral crush and damage to the right roof side rail. The majority of the rollover damage was discernable on the top plane, including body scratches and abrasions to the hood and roof concentrated in two distinct areas: the windshield header and the rear right corner of the roof (Figure 9). Vertical crush to the windshield header area was less than 5 cm (2.0 in). However, crush at the junction of the right roof side rail and upper D-pillar measured 10 cm (3.9 in) laterally and 12 cm (4.7 in) vertically. The CDC assigned to the Infiniti for the rollover damage was 00TDDO3. No WinSMASH calculations could be calculated as the rollover event type was beyond the model's scope.

Figure 9. View of the Infiniti's rollover damage

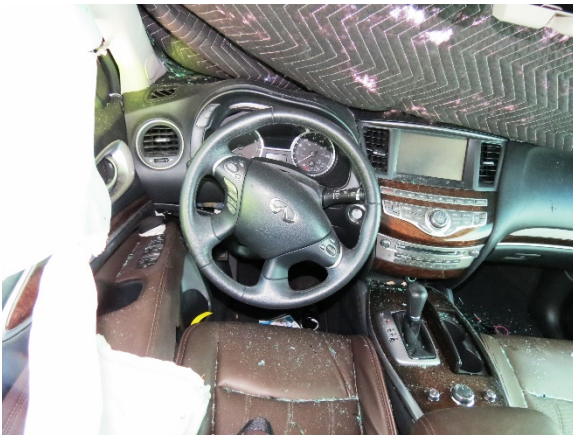
Figure 10 depicts the lateral intrusion of the left front door and corresponding deformation to the driver's area, while Figure 11 depicts the lateral intrusion of the left rear door and the deformation sustained by the second row left seat position and driver's seatback.

Figure 10. Intrusion of the left front door of the Infiniti that resulted in lateral deformation to the driver's seat

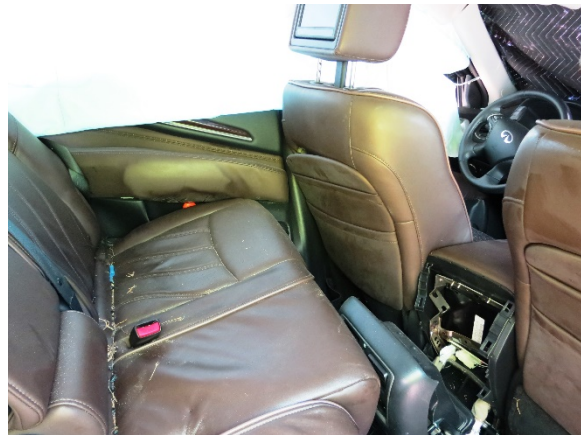
Figure 11. Left rear door and left B-pillar intrusion in the Infiniti that resulted in deformation to the second row left seat cushion, driver's seat, and center console

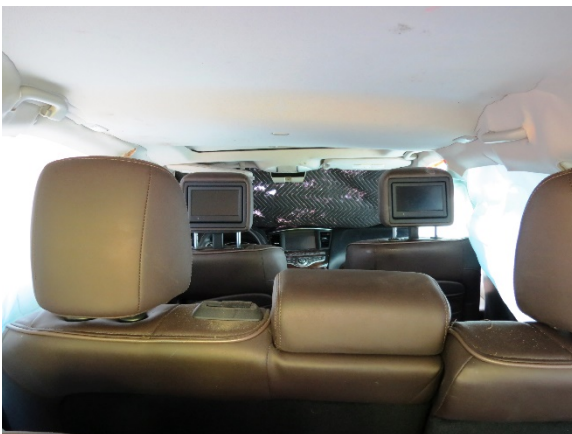
Figure 12. Deformation to the greenhouse structure of the Infiniti as viewed forward-facing from the third row

Additional intrusions in the Infiniti resulted from the secondary rollover event, which included both lateral and vertical intrusions. Lateral intrusions from the rollover included 15 cm (5.9 in) of the right roof side rail at the third row, 8 cm (3.1 in) of the right upper C-pillar, and 6 cm (2.4 in) of the right upper B-pillar. Vertical intrusions included 10 cm (3.9 in) of the right roof side rail at the third row and 4 cm (1.6 in) of the windshield header at the front row right position. Slight vertical deformation of the roof biased to the right side was discernable when the interior of the Infiniti was viewed from the rear of the vehicle, facing forward (Figure 12).

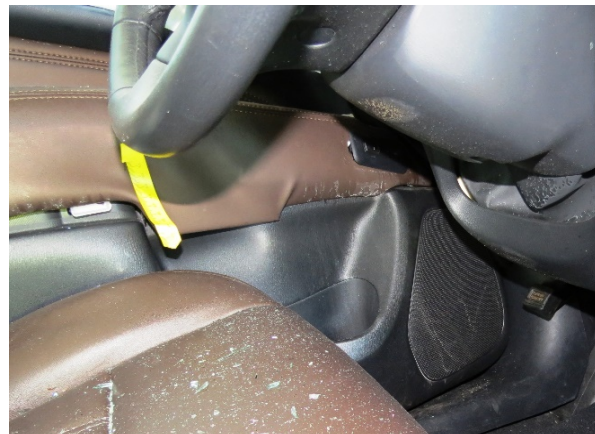
Figure 13. Driver contact to the left front door panel and underside of the steering column in the Infiniti

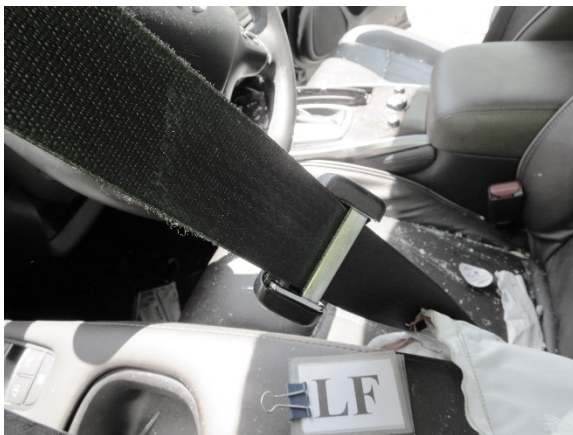
At the time of the inspection, the SCI investigator found the driver seat belt system hanging loosely against the B-pillar, with the webbing extended in a used position. The lower anchor and retractor pretensioners were actuated, and the webbing was locked in position with the D-ring in its lowest height position. Examination of the webbing identified an area of loading on the webbing in the likely location of the latch plate (Figure 14), with corresponding loading evidence discernable in the belt path on the latch plate. It was apparent to the SCI investigator that the driver's seat belt system was in use at the time of the crash.

Figure 14. Latch plate loading evidence on the webbing of the Infiniti driver's seat belt system

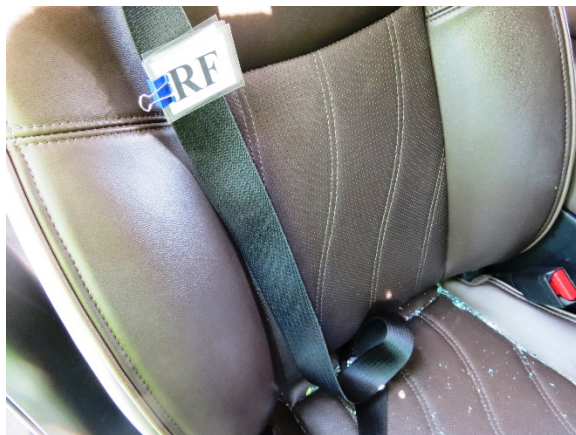
Figure 15. Loading evidence to the front right passenger's seat belt system in the Infiniti

The front right passenger's seat belt system was also found hanging loosely against the B-pillar, with the webbing extended in a used position. The lower anchor and retractor pretensioners were actuated, and the webbing was locked in position with the D-ring in its lowest height position. Examination of the webbing identified an area of loading on the webbing in the likely location of the latch plate, and the shoulder portion of the webbing from the location of the latch plate extending toward the B-pillar was waffled (Figure 15). It was apparent to the SCI investigator that the front right passenger's seat belt system was in use at the time of the crash.

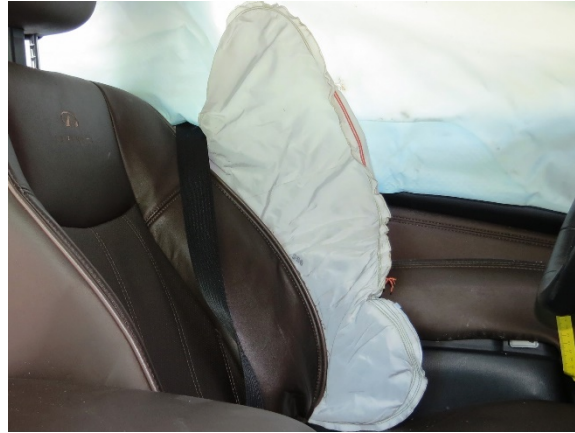
Figure 18. Left-facing view of the driver's deployed seat-mounted air bag in the Infiniti

The driver's seat-mounted side impact air bag deployed forward through the outboard edge stitching of the seatback. In its deflated state, the approximate dimensional measurements of the air bag were 68 cm (26.8 in) tall and a maximum of 25 cm (9.8 in) wide. A 4 cm (1.6 in) diameter vent port was located on the center outboard aspect of the air bag. There was no damage or discernable occupant contact to the Infiniti's deployed driver's seat-mounted air bag. Figure 18 depicts the air bag at the time of the SCI vehicle inspection.

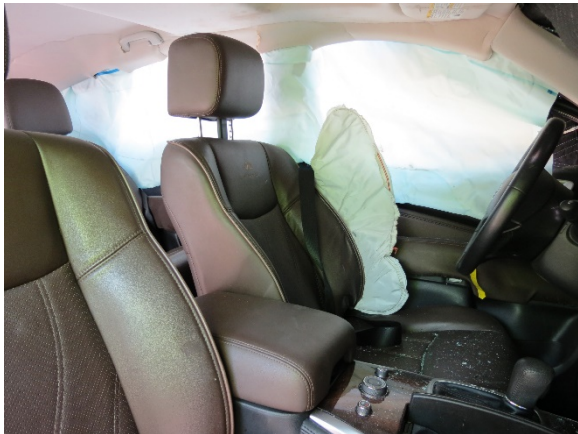
Figure 19. View of the deployed left IC air bag for the driver and second row positions in the Infiniti

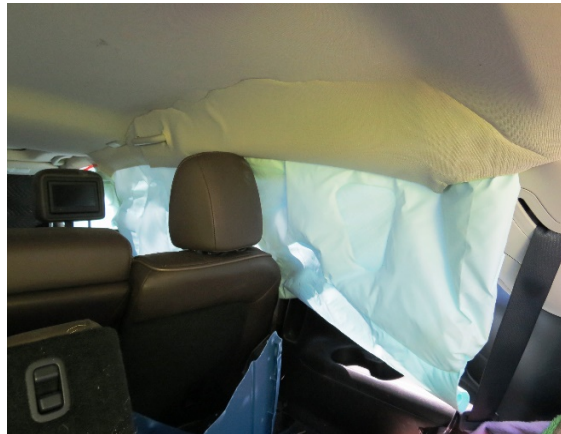
Figure 20. Forward-facing view of the deployed right IC air bag in the Infiniti from the third row

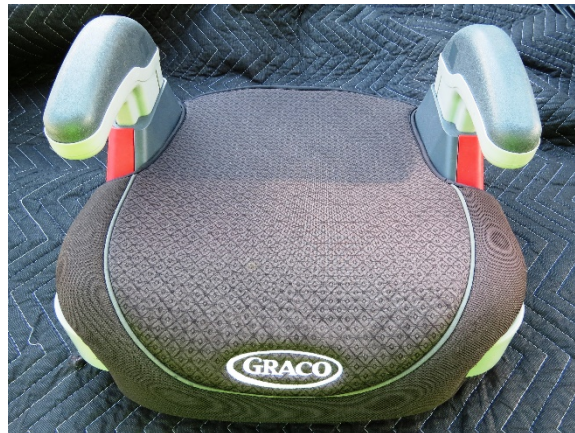
At the time of the crash, a booster CRS was in use for the restraint of the second row right occupant. The CRS remained in the Infiniti at the time of the SCI vehicle inspection. It was a Graco Model# 1920048 Turbo NB booster CRS, manufactured in China on June 23, 2017, by Graco Children's Products of Exton, PA. Figure 21 depicts the CRS at the time of the SCI inspection. It was used without the back support and had the following ratings for use under such condition: approximate age 4-10 years, for children weighing 18-45 kg (40-100 lbs) and measuring 101-145 cm (40-57 in) in height.

Figure 21. View of Graco booster CRS at the time of the SCI inspection

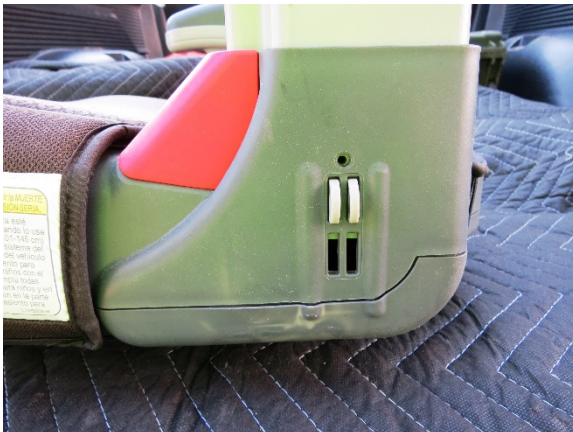
Figure 22. View of the left aspect of the CRS and stress marks to the shell

Inspection of the CRS revealed that the belt paths on both sides of the CRS were clean, with no discernable loading striations. An area of light stress marks to the polymer base was visible on the left aspect of the CRS, below the belt path (Figure 22). This loading was focused on the bottom left corner of the CRS base (Figure 23) and was consistent with the left lateral impact forces of the crash.

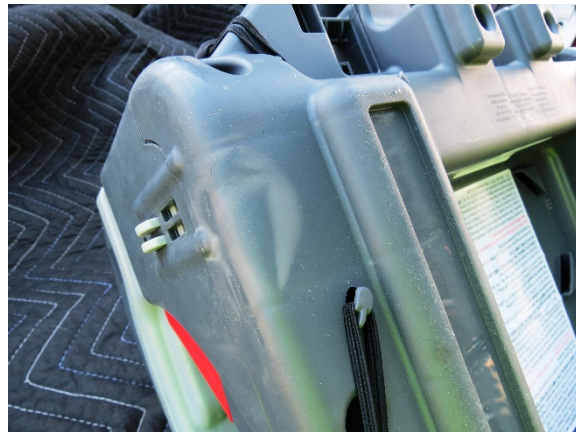
Figure 23. Loading stress marks on the lower left corner of the CRS base

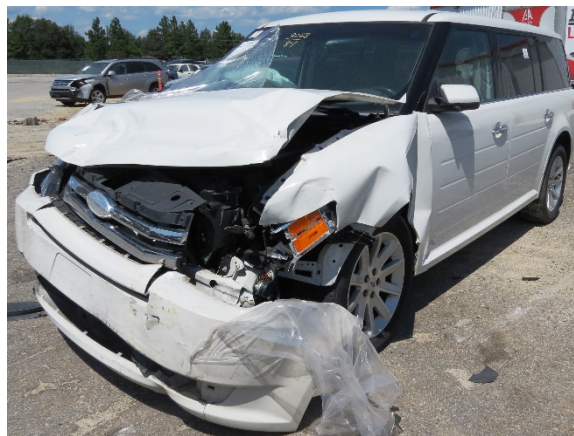
The 2012 Ford Flex (Figure 24) was manufactured in January of 2012 and identified by the VIN 2FMGK5CC7CBxxxxxx. Its electric odometer reading was 202,509 km (125,833 mi) at the time of the SCI inspection. The Ford was a 4-door crossover that had a 300 cm (118.1 in) wheelbase. It was powered by a 3.5-liter, V-6, gasoline engine linked to an automatic transmission. The Ford's gross vehicle weight rating was 2,708 kg (5,970 lb), with gross axle weight ratings of 1,311 kg (2,890 lb) front and 1,420 kg (3,130 lb) rear. The vehicle manufacturer's recommended tire size was P235/60R18, with recommended cold tire pressures of 240 kPa (35 PSI) for all four axle positions. At the time of the SCI inspection, the Ford was equipped with Uniroyal Laredo tires of the recommended size at all four axle positions, with matching TINs Y97A Y8UU xx15."All four tires had at least 3 mm (4/32 in) of tread, remained inflated, and were not damaged or restricted in relation to the crash. The Ford was equipped with the Select (SEL) level trim package. Its cloth-surfaced interior was configured for the seating of up to seven occupants, with multiple manual and supplemental restraint systems available.

Figure 24. Front left oblique view of the Ford at the time of the SCI inspection

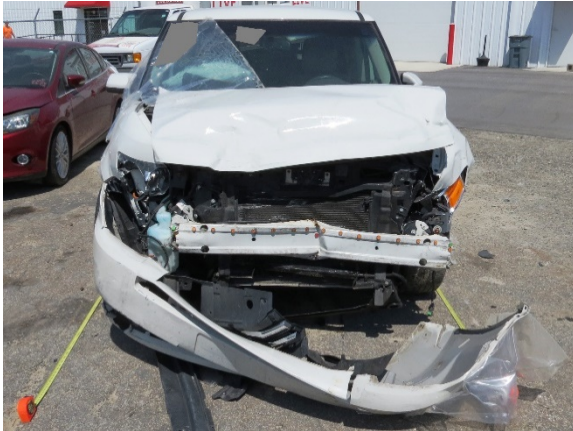
The Ford sustained front plane damage from the events of the crash. The observed damage was related to the impact with the Infiniti. The Ford did not sustain damage from the minor contact with the utility box. Damage from first event with the Infiniti spanned the Ford's entire front plane width. The undeformed end width was 160 cm (63.0 in). In the damage pattern was deformation to the hood, both front fenders, grille, bumper beam, and bumper fascia. Both headlight assemblies were fractured/disintegrated. Underhood components were also damaged/displaced. At the time of the SCI inspection, damage was documented to the exposed bumper beam, which had a width of 130 cm (51.2 in). A residual crush profile documented to the bumper beam using a total station mapping system produced the following resultant crush measurements: C1 = 28 cm (11.0 in), C2 = 31 cm (12.2 in), C3 = 34 cm (13.4 in), C4 = 36 cm (14.2 in), C5 = 31 cm (12.2 in), and C6 = 23 cm (9.1 in). Maximum crush measured 36 cm (14.2

Figure 25. Front plane view of the Ford at the time of the SCI vehicle inspection

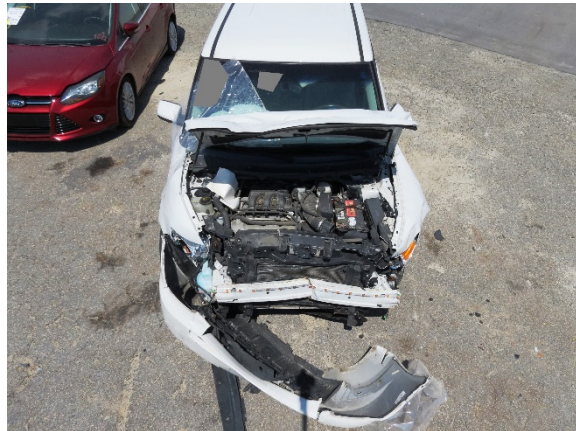
Figure 26. Overhead view of the damage profile to the Ford's front plane

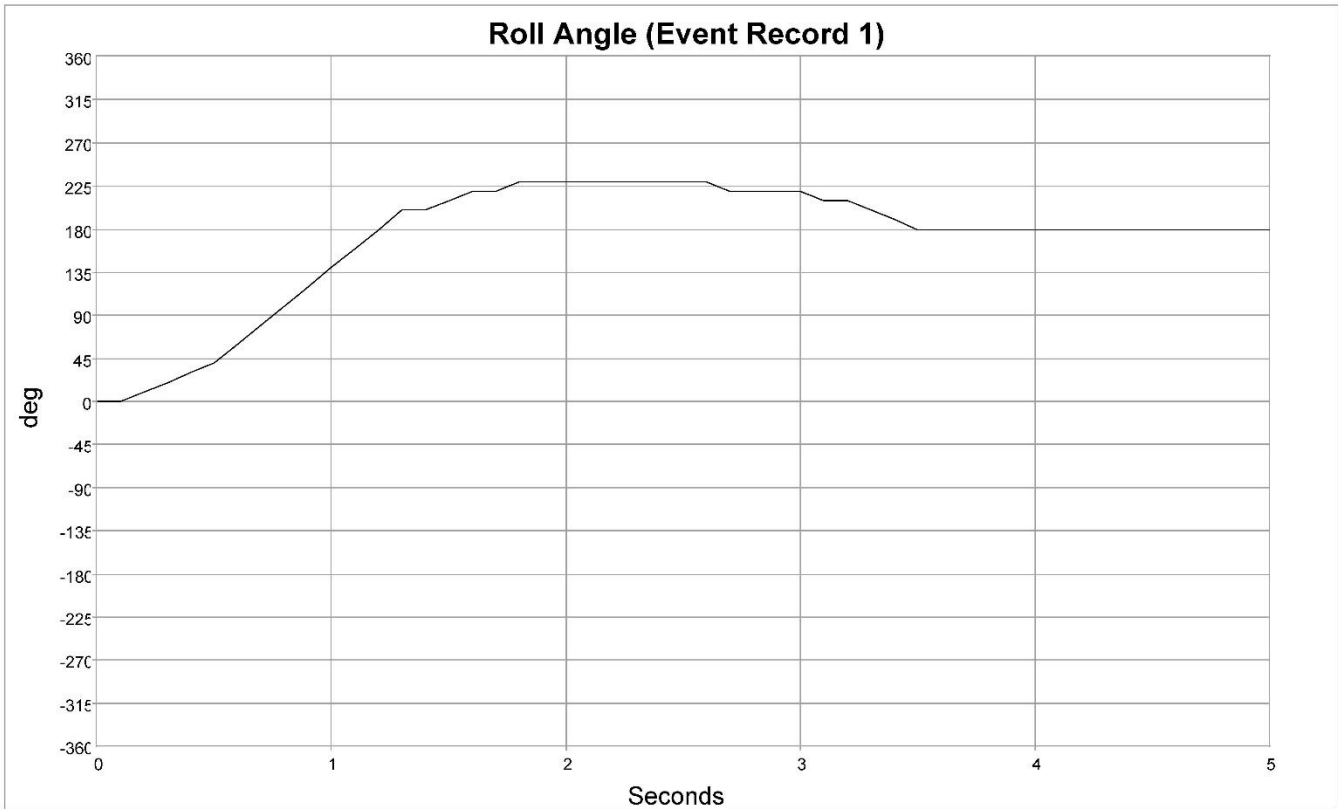
Roll Angle (Event Record 1)

Time (sec)	deg
0.0	0
0.1	0
0.2	10
0.3	20
0.4	30
0.5	40
0.6	60
0.7	80
0.8	100
0.9	120
1.0	140
1.1	160
1.2	180
1.3	200
1.4	200
1.5	210
1.6	220
1.7	220
1.8	230
1.9	230
2.0	230
2.1	230
2.2	230
2.3	230
2.4	230
2.5	230
2.6	230
2.7	220

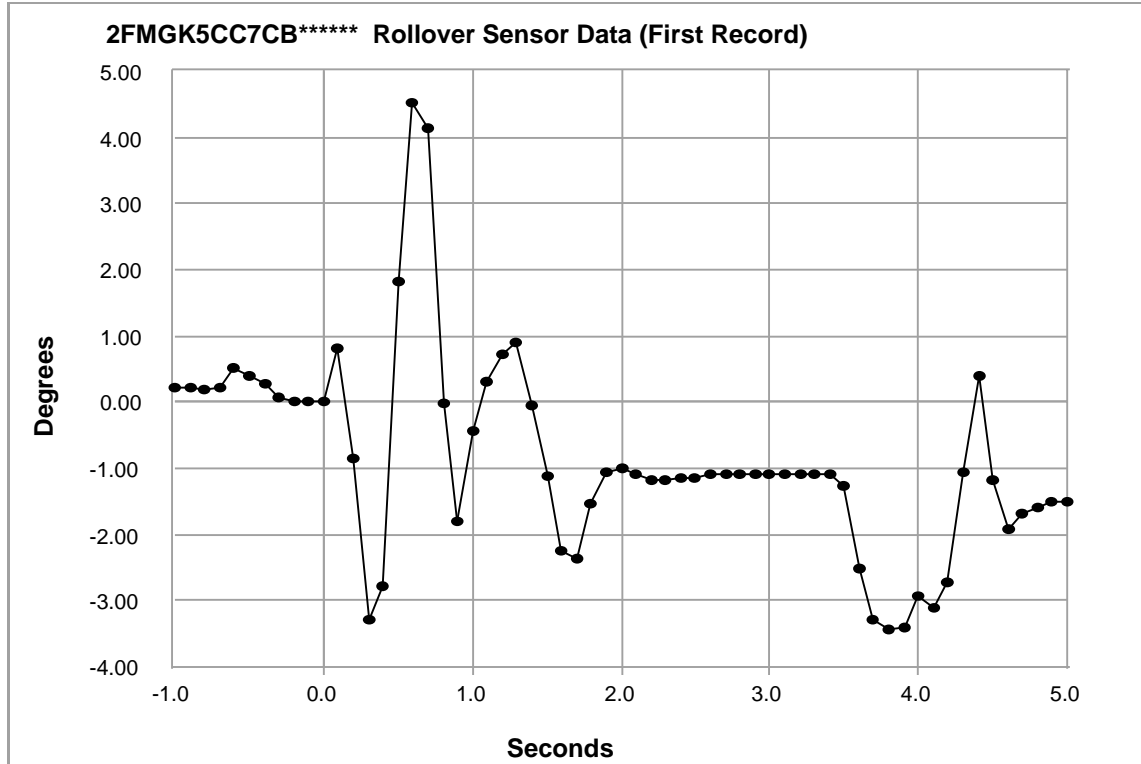
Rollover Sensor Data (First Record)

Time (sec)	Vehicle roll angle (degrees)
-1.0	0.2
-0.9	0.22
-0.8	0.18
-0.7	0.21
-0.6	0.53
-0.5	0.4
-0.4	0.27
-0.3	0.08
-0.2	0.0
-0.1	0.0
0.0	0.0
0.1	0.81
0.2	-0.85
0.3	-3.29
0.4	-2.78
0.5	1.81
0.6	4.54
0.7	4.13
0.8	-0.01
0.9	-1.81
1.0	-0.45
