DOT HS 813 158

**Special Crash Investigations:
On-Site Air Bag Non-Deployment
Crash Investigation;
Vehicle: 2018 Toyota Corolla;
Location: Delaware;
Crash Date: July 2018**

**Special Crash Investigations
Air Bag Non-Deployment Crash Investigation
Office of Defects Investigation
Case Number: CR18035
Vehicle: 2018 Toyota Corolla
Location: Delaware
Crash Date: July 2018**

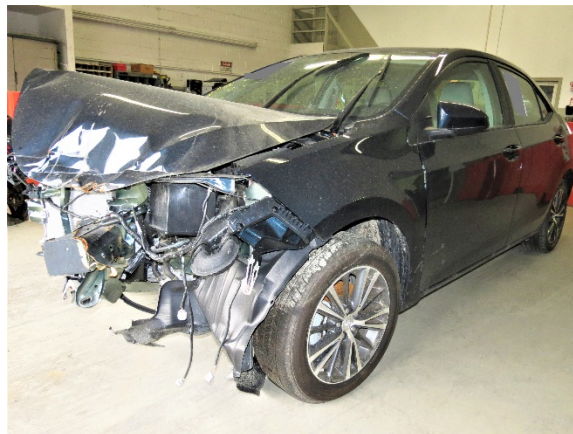
Figure 1. Left front oblique view of the Toyota at the time of the SCI vehicle inspection

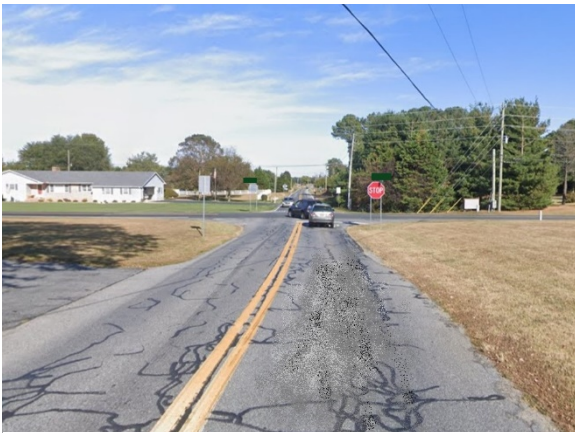
Figure 2. East-facing view of the local roadway for the Corolla's pre-crash travel trajectory (internet geo-mapping software image)

The crash occurred at the intersection of an east/west, two-lane local road with a north/south two-lane, State-maintained roadway. Traffic was controlled for the east/west roadway by stop signs with painted stop bars at the intersection, while the north/south roadway was uncontrolled. Speed was regulated by a posted limit of 80 km/h (50 mph) in all travel directions. According to the police report, environmental conditions were daylight, clear, and dry. No crash site inspection was conducted by SCI, as the location of the crash was unknown at the time of the on-site investigation. Figure 2 shows an east-facing view of the intersection for the Corolla's pre-crash trajectory, while Figure 3 shows a south-facing view of the Tacoma's pre-crash trajectory. A crash diagram is included at the end of this report.

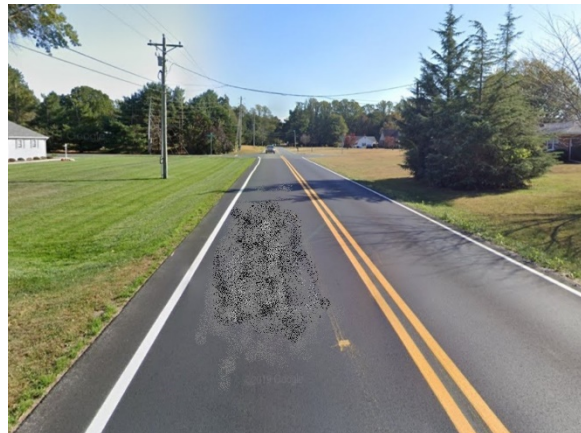
Figure 3. South-facing view of the State-maintained roadway for the Tacoma's pre-crash trajectory (internet geo-mapping software image)

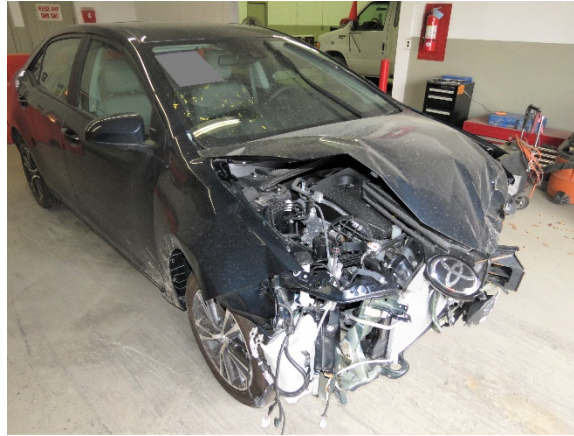
The 2018 Toyota Corolla (Figure 4) was manufactured in April 2018 and identified by the VIN 2T1BURHE2JCxxxxxx. At the time of the SCI vehicle inspection, its electronic odometer reading was 4,086 km (2,539 mi). The Corolla was a front-wheel-drive, 4-door sedan powered by a 1.8-liter, inline 4-cylinder, gasoline engine linked to an automatic transmission. It had a 270 cm (106.3 in) wheelbase and a gross vehicle weight rating (GVWR) of 1,733 kg (3,820 lb).

Figure 4. Right-front oblique view of the Corolla

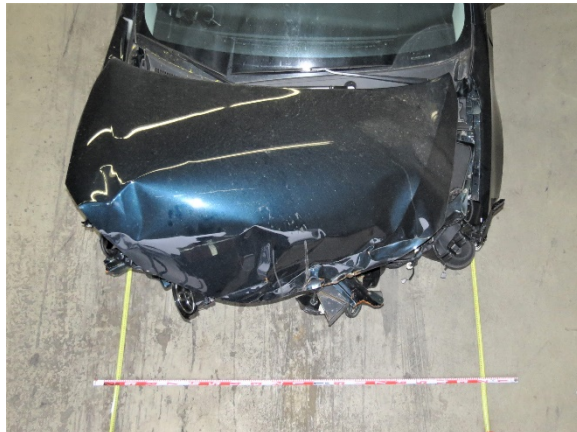
across the remnants of the front plane. The deformed frame rail ends defined the width, and the measurements were adjusted to account for free space. Resultant measurements were as follows: C1 = 2 cm (0.8 in), C2 = 5 cm (2.0 in), C3 = 10 cm (3.9 in), C4 = 11 cm (4.3 in), C5 = 15 cm (5.9 in), and C6 = 13 cm (5.1 in). Maximum crush was 13 cm (5.1 in), observed immediately left of the vehicle's right front bumper corner/deformed frame rail extension. Figure 6 shows the damage pattern from an overhead perspective. The collision damage classification (CDC) assigned to the Corolla for the front plane impact with the Tacoma was 10FDEW1.

Figure 6. Overhead view of the Corolla's damage profile

The “missing vehicle” algorithm of the WinSMASH model was used to calculate the severity (delta V) of the crash for analysis purposes. The total calculated delta V of the crash for the front plane impact to the Corolla was 23 km/h (14 mph). Longitudinal and lateral components of the calculated delta V were -15 km/h (-9 mph) and 17 km/h (11 mph), respectively. These results appeared to be overestimated, based on SCI expertise, the observed damage pattern, and the imaged EDR data.

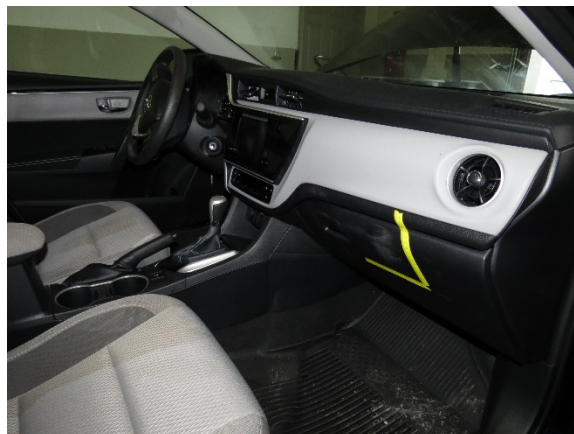
The Corolla interior was inspected and found to be in “like-new” condition. There was no discernable evidence of crash-related damage or occupant compartment intrusion. An inspection for occupant contact evidence revealed only one discernable area of contact, located on the polymer surface of the storage compartment door of the right lower instrument panel. This scuff (Figure 7) was attributed to probable right knee contact by the front row right occupant.

Figure 7. Probable front-row right occupant knee contact to the right lower instrument panel

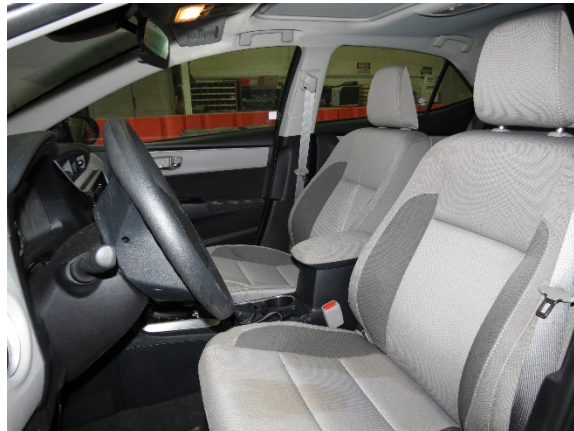
The Corolla had multiple inflatable supplemental restraints to protect both front-seat occupants. These included a certified advanced 208-compliant (CAC) frontal air bag system, a driver's knee air bag in the left lower instrument panel, seat pan air bag in the front-right passenger's seat cushion, front-seat-mounted side impact air bags, and dual-sensing (side impact and rollover) inflatable curtain (IC) air bags. The CAC frontal air bag system consisted of driver's and passenger's frontal air bags, with seat belt buckle switch sensors, seat track position sensors, and a front-right occupant classification (weight) sensor. None of the Corolla's supplemental restraint devices was commanded to actuate or deploy in relation to the minor severity crash (Figure 8).

Figure 8. Crossing view of the Corolla's front row from the left (driver's side)

Through the course of this SCI investigation, it was determined that the crash was of insufficient severity to deploy supplemental restraints. Although there was an active open recall issued after the date of the crash that related to the potential incomplete or non-deployment of the

supplemental restraint systems (NHTSA recall 20V024), it was determined that there were no performance anomalies relative to this crash or this specific vehicle. In this crash, the Corolla's ECU correctly and completely recorded the crash pulse. The Corolla was initially stopped, accelerated briefly to a speed less than 15 km/h (9 mph), and then slowed again prior to the crash. The slow speed of the Corolla and angle of the impact forces only produced a maximum longitudinal delta V recorded by the EDR of -8.6 km/h (-5.3 mph). Based on the low severity of the crash pulse and minor damage sustained by the Corolla, supplemental restraint device actuation/deployment would not be expected.
