U.S. Department  
of Transportation  
**National Highway  
Traffic Safety  
Administration**

DOT HS 813 200

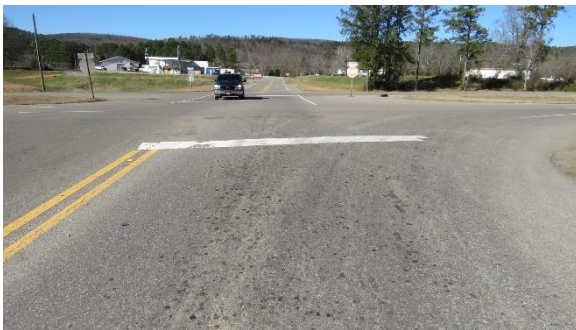
*Figure 2. Northwest view, the Toyota's travel path to impact*

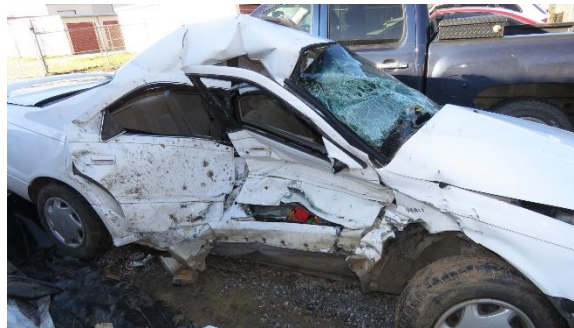
*Figure 4. The Toyota's right plane damage*

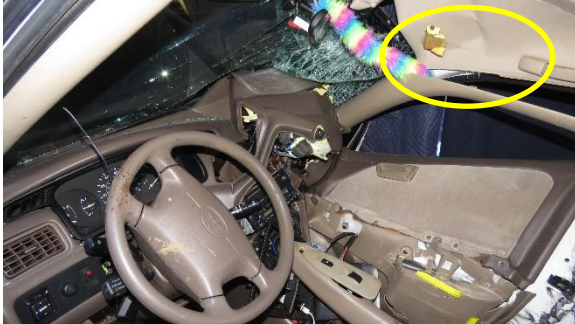
*Figure 5. Right sun visor and roof side rail contact by the driver*

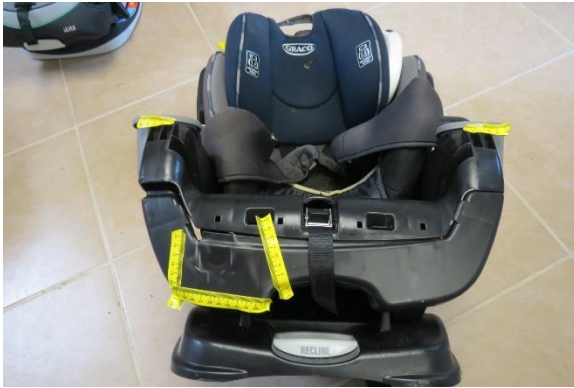
*Figure 9. Separation, cracks, and stress to the front of the CRS*

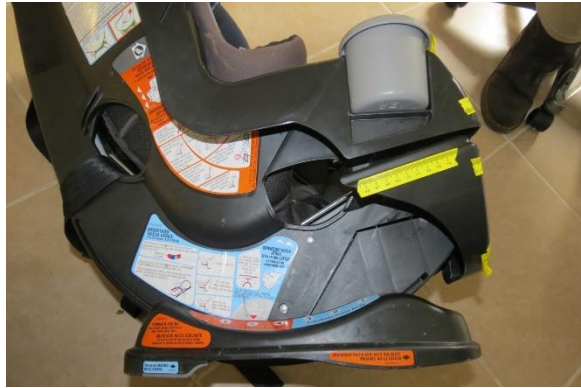
*Figure 10. Right side separation of the seat and housing*

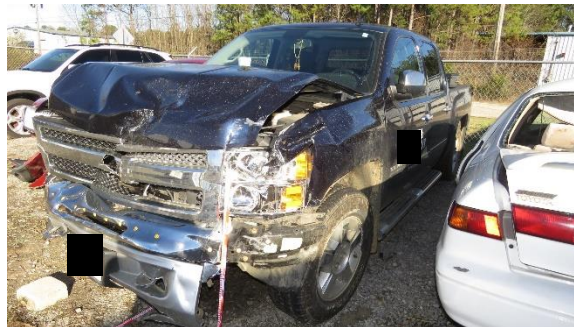
*Figure 11. Front plane damage to the Chevrolet*
