DOT HS 813 216

**Special Crash Investigations:  
Crash Avoidance Technology  
Investigation;  
Vehicle: 2018 Honda Accord;  
Location: Texas;  
Crash Date: July 2019**

**Special Crash Investigations**  
**Crash Avoidance Technology Investigation**  
**Case Number: DS19027**  
**Vehicle: 2018 Honda Accord**  
**Location: Texas**  
**Crash Date: July 2019**

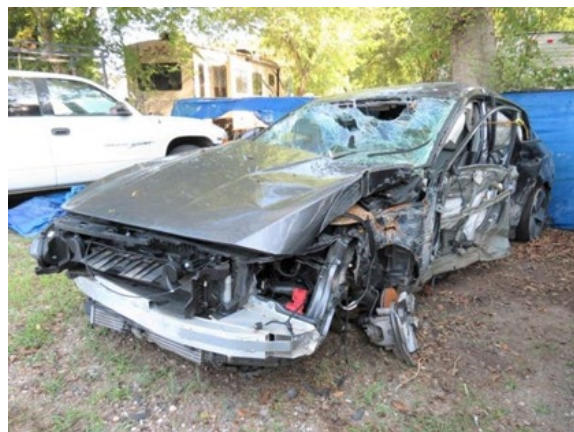
*Figure 1. The 2018 Honda Accord*

This report documents the investigation of a single-vehicle crash involving a 2018 Honda Accord (Figure 1) equipped with crash avoidance technology including a road departure mitigation system (RDMS), lane keeping assist system (LKAS), and collision mitigating braking system (CMBS). The vehicle departed a roadway and struck several off-road stationary objects, causing the unbelted 48-year-old male driver to sustain fatal injuries. The investigation was intended to determine what role, if any, the RDMS and LKAS played in the crash. The Special Crash Investigations (SCI) group of the National Highway Traffic Safety Administration initiated the investigation in response to a notification from the Fatality Analysis Reporting System (FARS). According to the Honda vehicle owner's manual, the LKAS and RDMS provide steering input to help keep the vehicle in the middle of a detected lane and prevent it from unintentionally crossing over a lane line or departing a roadway. The LKAS provides tactile and visual alerts and the RDMS provides tactile, visual, and audible alerts. SCI assigned the case to Dynamic Science in September 2019, and the field inspections were completed in September 2019. The police report, the driver's autopsy report, and on-scene police photos were obtained in September and October 2019. The Honda's Event Data Recorder (EDR) was supported by the Bosch Crash Data Retrieval system and was imaged during the vehicle inspection. The EDR report included crash avoidance technology data for the vehicle's CMBS, RDMS, LKAS, and adaptive cruise control (ACC). The EDR captured five seconds of pre-crash data and indicated the crash avoidance technology didn't activate during the five seconds prior to the initial impact. This is discussed in greater detail in the Crash Avoidance Technology section of this report.

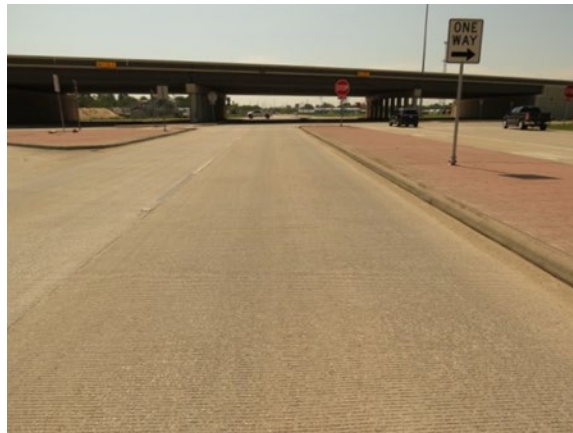
*Figure 2. Crash site, looking south from the northbound lanes*

The crash site was in an interchange of a north/south divided roadway and an elevated east/west interstate highway in Texas (Figure 2). The north/south roadway was paved concrete and configured with two lanes for each direction separated by a two-way, left-turn lane. Prior to the interchange, the two-way, left-turn lane ended, and a raised concrete median began that continued in the southbound direction for 146.0 m (479.0 ft) ending at an intersection in the interchange area. The lanes measured 4.4 m (14.4 ft) in width, and the median measured 7.2 m (23.6 ft) at its widest point. The roadway curved left in a radius measuring 120.0 m (393.7 ft) at the north fog line. The lanes were separated by dashed white painted stripes, and the roadway was bordered by solid white painted fog lines. Paved concrete shoulders measuring 3.0 m (9.8 ft) bordered the fog lines. The roadway passed beneath the elevated interstate highway, which was configured with on/off ramps and each corner of the intersection. The intersection was controlled by stop signs. The level roadway and painted lane striping were in good condition. Fog lines were not present on the road edge in all areas of the intersection. No rumble strips were present. The intersection was configured with painted pedestrian crosswalks and raised concrete islands measuring 16 cm (6.3 in) in height.

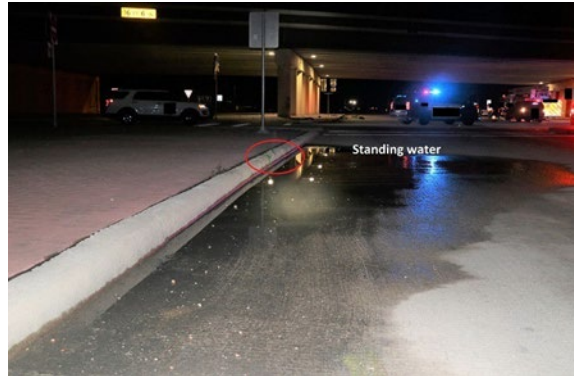
Figure 3. Area of departure (circled), looking south (on-scene police photo)

crash data and indicated the crash avoidance technology didn't activate in the five seconds prior to the initial impact. At T-2.0 seconds, according to EDR data, the steering angle was at 10 degrees to the left at a vehicle speed of 124.0 km/h (77.1 mph) with the brake and stability control "Off." It was not known if the driver was actively steering the vehicle at this time. The EDR-reported steering position over time suggested the vehicle was drifting and not actively being steered. At T-1.0 seconds, the brake was "On," and at approximately T-0.5 seconds the vehicle departed the roadway on the left edge in an area where no fog line or outer lane marker was present. Recent rain had left standing water along the curbed edge of the roadway at the area of departure (Figure 3).

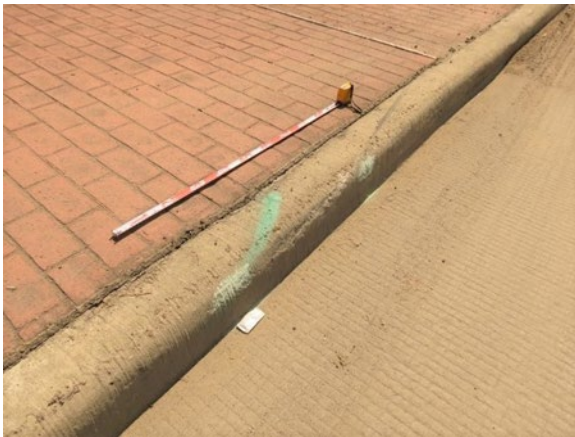
Figure 4. Point of curb impact (Event 1) looking south

The Honda struck the raised curb of a concrete island with its front plane (Event 1) (Figure 4). At that time, the EDR indicated a vehicle speed of 122.0 km/h (75.8 mph) with the service brake, ABS activity, and stability control “On.” This was a low-delta-V event not captured by the vehicle's EDR. It continued traveling southbound in a relatively straight path for 23.0 m (75.5 ft) before its front end struck a second raised curb (Event 2) that was captured by the EDR as a deployment-level event causing the driver's frontal and knee air bags to deploy. Continuing in a straight trajectory for approximately 10.0 m (32.8 ft), the vehicle's left plane struck a concrete column supporting the overpass (Event 3) (Figure 5). This event was captured by the EDR as a deployment-level event in which the driver's seat-mounted side impact and inflatable curtain (IC) air bags deployed. At some point during the crash, the driver's seat belt pretensioner actuated with the belt in the stowed position.

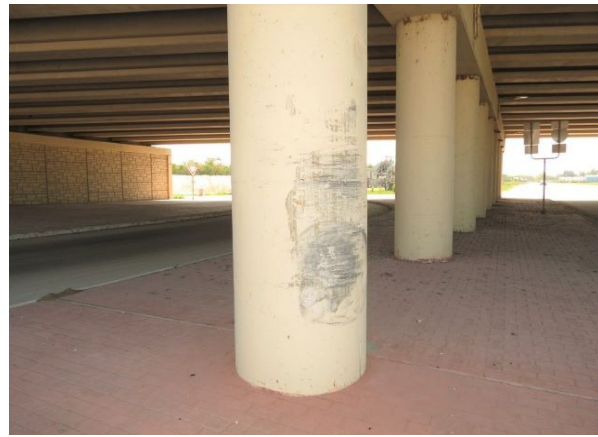
Figure 5. Point of column impact (Event 3) looking south

For the Honda in Event 3 (left plane to column), the barrier algorithm of WinSMASH calculated a total delta V of 19 km/h (12 mph) with a maximum longitudinal delta V of -9 km/h (-6 mph), a maximum lateral delta V of 16 km/h (10 mph), and a barrier equivalent speed (BES) of 19 km/h (12 mph). The results fit the model but appear low when compared to the EDR-reported maximum longitudinal delta V of -33 km/h (-21 mph) and maximum lateral delta V of 48 km/h (30 mph).

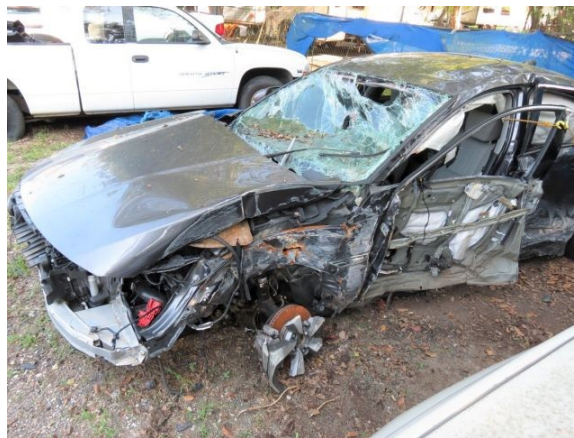
Direct damage to the left plane began at the left front corner and extended rearward 321 cm (126.4 in), and the induced damage extended 331 cm (130.3) rearward (Figure 6). Vertically, the damage extended from the sill extending upward 125 cm (49.2 in) to the upper left A-pillar. Thirty-five measurements were taken at mid-door level by the Nikon Total Station and the Faro Blitz program computed crush measurement in six increments as follows: C1 = 0 cm, C2 = 7 cm (2.8 in), C3 = 10 cm (3.9 in), C4 = 2 cm (0.8 in), C5 = 12 cm (4.7 in), and C6 = 0 cm. The Collision Deformation Classification (CDC) was 10LDEW4.

*Figure 6. Left plane damage, the 2018 Honda Accord*

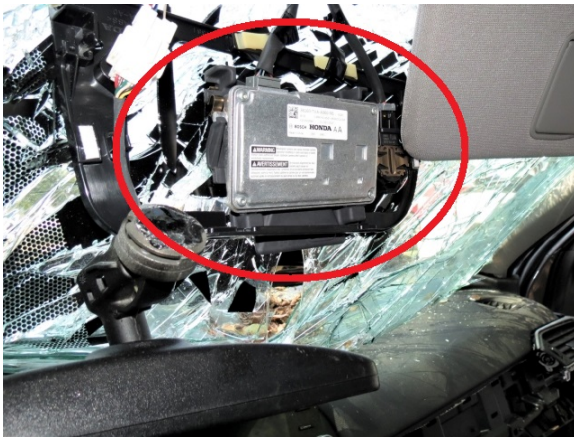
*Figure 7. Front sensor camera mounted to top center windshield, the 2018 Honda Accord*

This system provides steering input to help keep the vehicle in the middle of a detected lane and provides tactile and visual alerts if the vehicle is detected drifting out of its lane. The front sensor camera monitors lane lines and provides tactile and visual alerts when the vehicle is drifting out of a detected lane. If a lane departure occurs without a turn signal applied, the alerts activate and torque is applied to the steering. The system does not work if hands are off the steering wheel or the driver does not actively steer. According to the EDR report, this system was on prior to impact but did not activate during the five seconds prior to the initial impact.

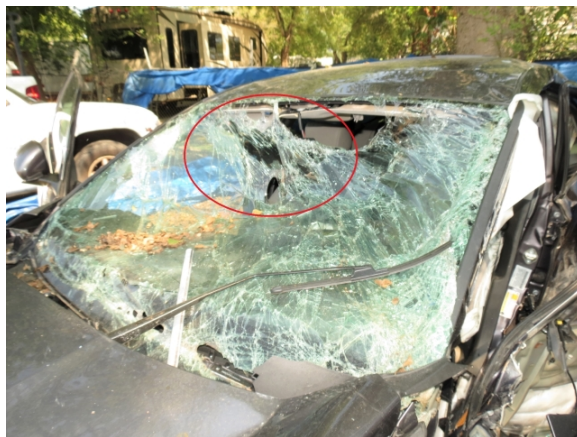
*Figure 8. Front sensor camera mounted to top center windshield, the 2018 Honda Accord*

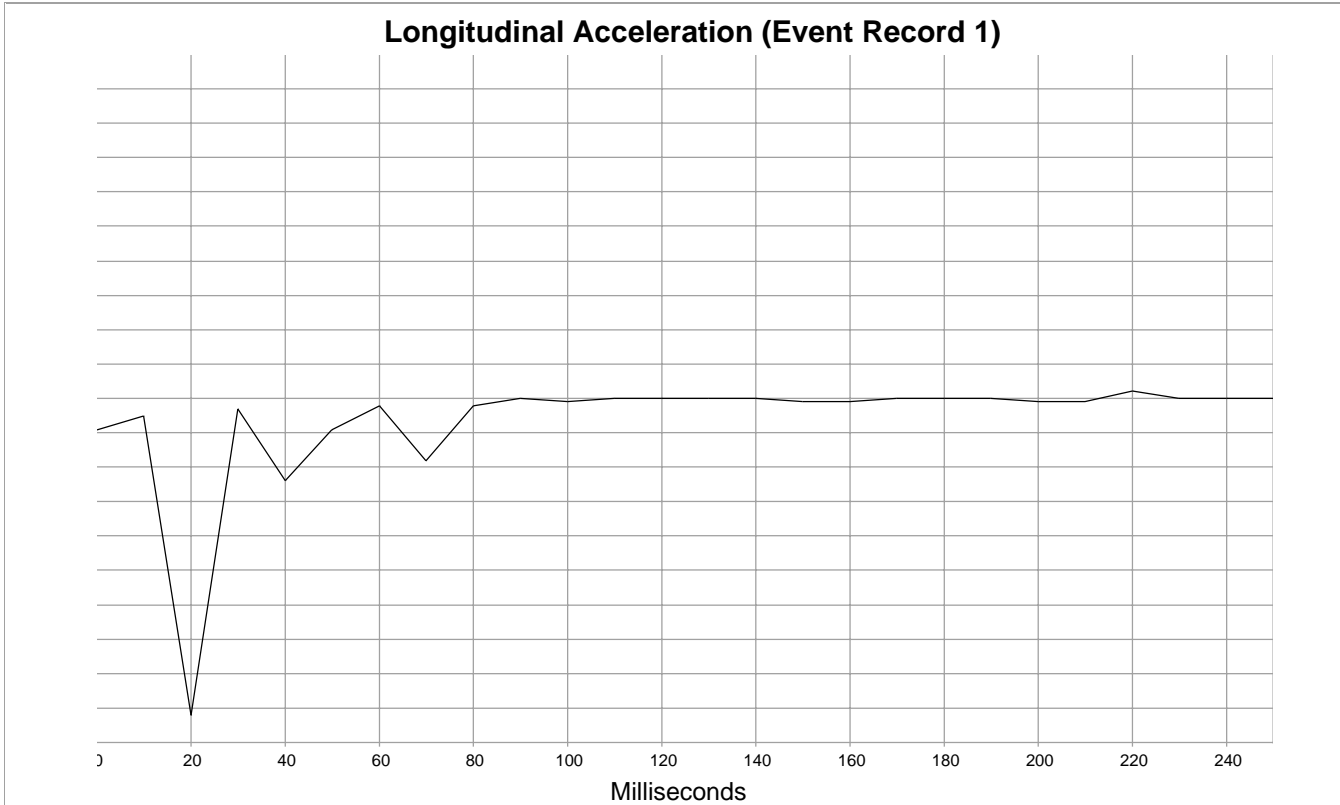
**Longitudinal Acceleration (Event Record 1)**

Time (msec)	g
0	-4.5
10	-2.5
20	-46.0
30	-1.5
40	-12.0
50	-4.5
60	-1.0
70	-9.0
80	-1.0
90	0.0
100	-0.5
110	0.0
120	0.0
130	0.0
140	0.0
150	-0.5
160	-0.5
170	0.0
180	0.0
190	0.0
200	-0.5
210	-0.5
220	1.0
230	0.0
240	0.0
250	0.0

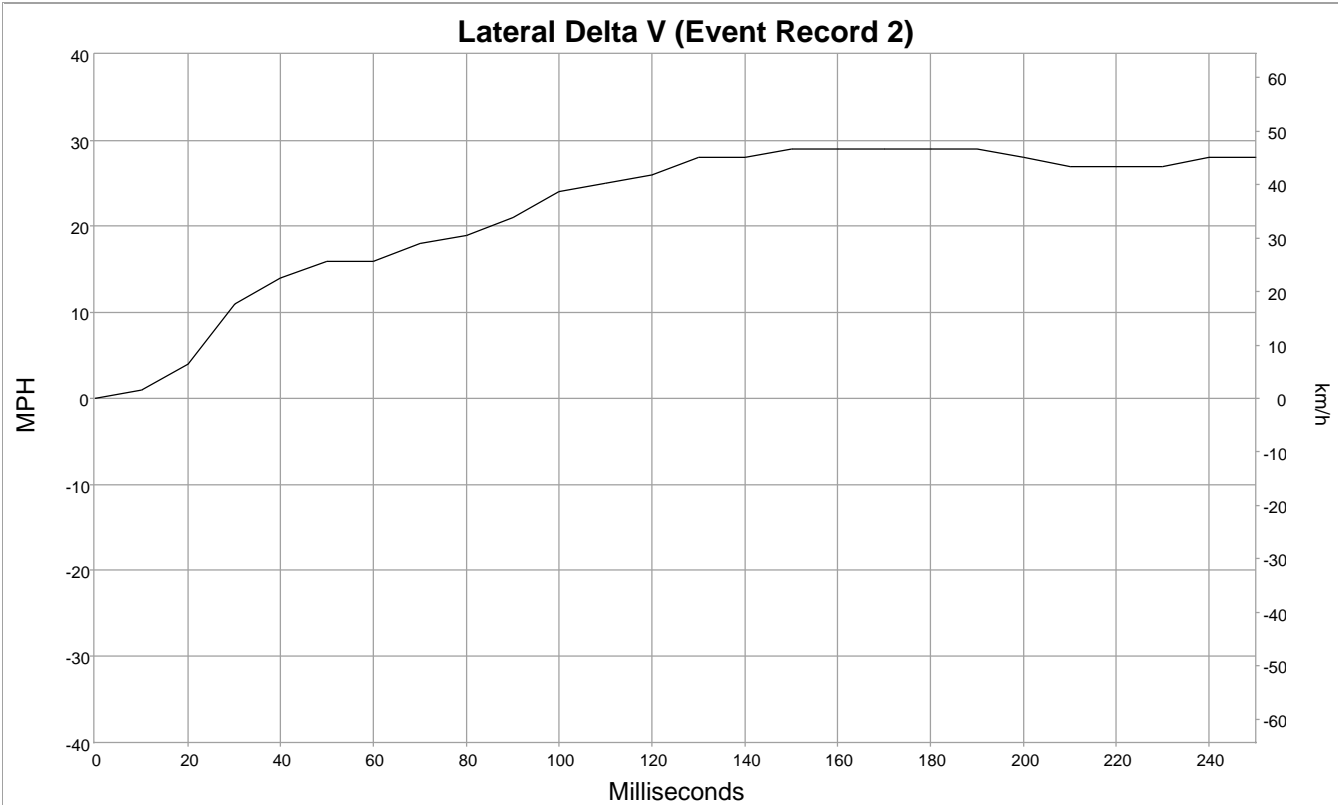
**Lateral Delta V (Event Record 2)**

Time (msec)	MPH [km/h]
0	0 [0]
10	1 [2]
20	4 [7]
30	11 [17]
40	14 [23]
50	16 [25]
60	16 [25]
70	18 [29]
80	19 [30]
90	21 [34]
100	24 [38]
110	25 [41]
120	26 [42]
130	28 [45]
140	28 [45]
150	29 [47]
160	29 [47]
170	29 [47]
180	29 [47]
190	29 [46]
200	28 [45]
210	27 [44]
220	27 [44]
230	27 [44]
240	28 [45]
250	28 [45]

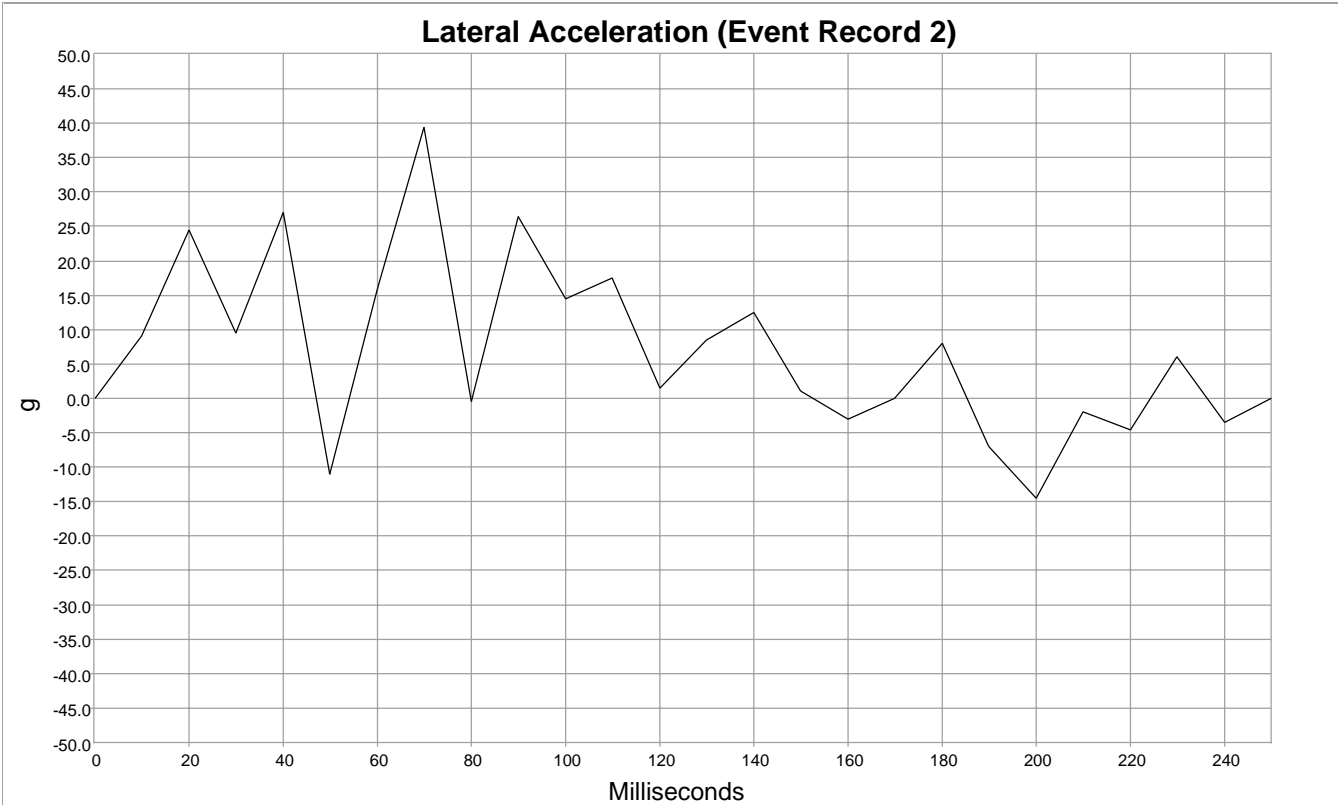
**Lateral Acceleration (Event Record 2)**

Time (msec)	g
0	0.0
10	9.0
20	24.5
30	9.5
40	27.0
50	-11.0
60	16.0
70	39.5
80	-0.5
90	26.5
100	14.5
110	17.5
120	1.5
130	8.5
140	12.5
150	1.0
160	-3.0
170	0.0
180	8.0
190	-7.0
200	-14.5
210	-2.0
220	-4.5
230	6.0
240	-3.5
250	0.0
