**Special Crash Investigations:  
On-Site Alleged Weld Separation  
Crash Investigation;  
Vehicle: 2018 Jeep Wrangler;  
Location: New York;  
Crash Date: August 2018**

16. Abstract  This report documents the on-site investigation of an alleged track bar weld separation of a 2018 Jeep Wrangler. The Jeep was involved in a right roadside departure crash, with impacts to a curb and wooden utility pole along a straight section of a two-lane roadway. Forces associated with the pole impact resulted in the deployment of the Jeep's driver's frontal air bag. The belted 34-year-old female driver was not injured in the crash. She initially reported to the investigating law enforcement agency that the right front tire blew out and caused her to crash. However, after receiving a recall announcement from the Jeep's manufacturer concerning the potential for track bar weld separation, she reported the crash to the National Highway Traffic Safety Administration and alleged mechanical failure. She stated during the SCI interview that the front end "gave out" while she was driving.  Through the course of this SCI investigation, it was determined that the Jeep traveled north on the roadway with a co

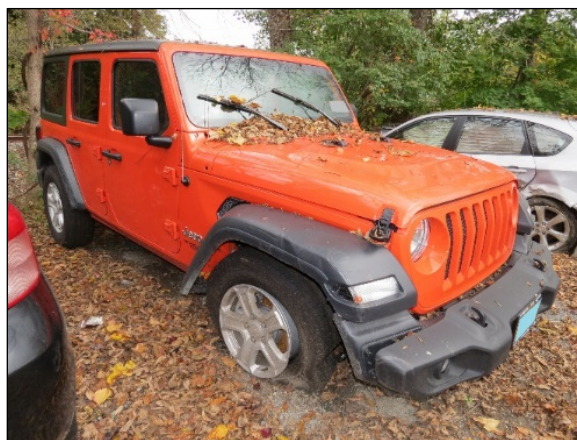
This report documents the on-site investigation of an alleged track bar weld separation of a 2018 Jeep Wrangler (Figure 1). The Jeep was involved in a right roadside departure crash, with impacts to a curb and wooden utility pole along a straight section of a two-lane roadway. Forces associated with the pole impact resulted in the deployment of the Jeep's driver's frontal air bag. The belted 34-year-old female driver was not injured in the crash. She initially reported to the investigating law enforcement agency that the right front tire blew out and caused her to crash. However, after receiving a recall announcement from the Jeep's manufacturer concerning the potential for track bar weld separation, she reported the crash to the National Highway Traffic Safety Administration and alleged mechanical failure. She stated during the SCI interview that the front end "gave out" while she was driving.

*Figure 1. Right front oblique view of the Jeep at the time of the SCI vehicle inspection*

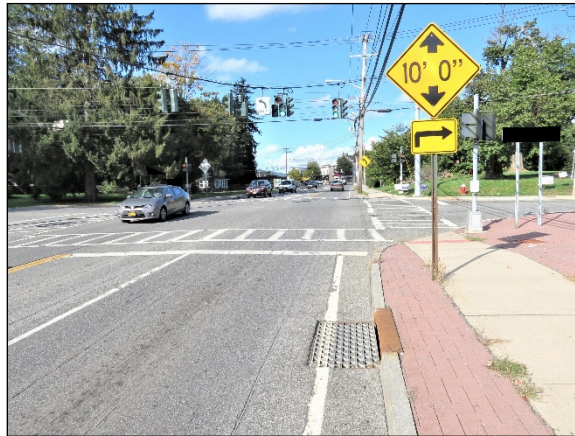
The asphalt-surfaced roadway consisted of a northbound lane and a southbound lane, which were separated by a center two-way turn lane. The center lane transitioned into a left turn-only lane for the respective travel directions on approach to multiple intersections along the roadway. All three lanes measured 3.3 m (10.8 ft) in width. The travel lanes were delineated by a single solid white fog line and a double yellow left lane line. Raised concrete curbs served as the road edges. Along the north edge of the roadway, 40 cm (15.7 in) diameter wooden utility poles were located immediately adjacent to the curb, spaced an average distance of approximately 40 m (131 ft) apart. This crash occurred at the northeast intersection quadrant of a controlled intersection. For the Jeep's northbound approach, the roadway was straight and had an incline of less than two percent (Figure 2). The posted speed limit was 48 km/h (30 mph). An electronic signal controlled traffic at the intersection. A crash diagram is included at the end of this report.

*Figure 2. North-facing view of the roadway for the Jeep's pre-crash travel trajectory approximately 40 m (131 ft) south of the impact*

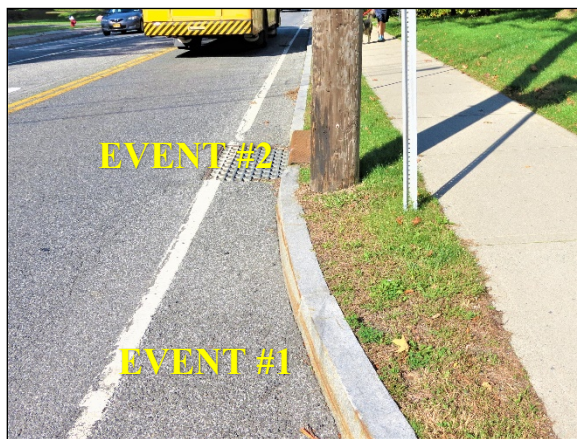
The Jeep struck the curb with its right front tire/wheel at the northeast intersection quadrant (Event #1), evidenced by a black rubber tire mark on the curb as observed at the time of the SCI crash site inspection. The Jeep then struck a large-diameter wooden utility pole (Event 2) with its front plane, right corner. This sideswiping impact primarily involved engagement of the tire/wheel with the wooden pole, which induced significant damage to the Jeep’s front axle and produced sufficient deceleration to result in supplemental restraint system actuation and deployment. The impact only gouged the surface of the wooden pole, which remained intact. Figure 3 shows the curb strike and utility pole located at the end of the curb return of the northeast intersection quadrant. The separation distance between the location of the curb strike and the pole measured 2.0 m (6.6 ft).

Figure 3. North-facing view of the impacts to the curb and utility pole

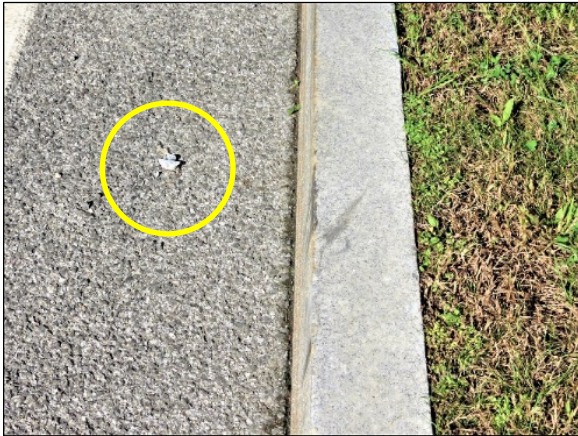
The location of this impact 9.5 m (31.2 ft) north of the utility pole was evidenced by gouging in the curb surface and the deposit of a cast aluminum fragment onto the road surface. The Jeep

ultimately came to final rest in the roadway facing north, with its right side tires adjacent to the curb. Figure 4 shows the impact evidence to the curb and the metallic fragment. The final rest position was evidenced by a fluid spill (lubricant from the Jeep's front axle), located 21.5 m (70.5 ft) north of the utility pole (Figure 5).

*Figure 4. Impact to the curb from the Jeep's front axle (Event 3) and metallic fragment*

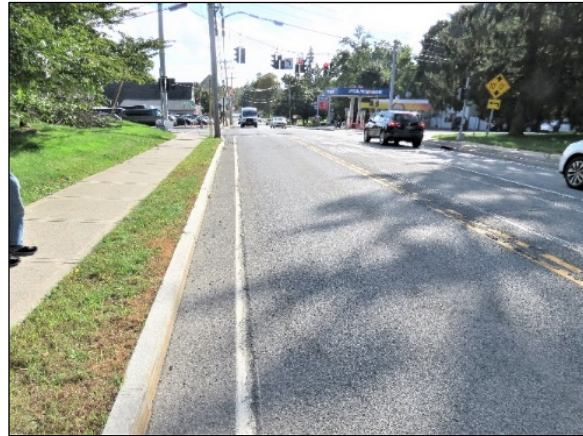
*Figure 5. South-facing lookback view of the roadway from the Jeep's final rest position*

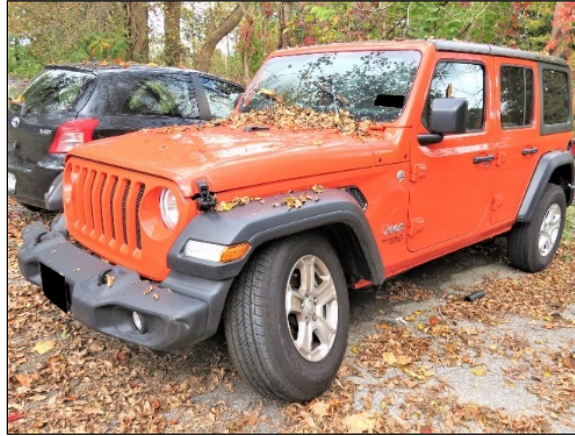
The Jeep (Figure 6) was a 4-door SUV manufactured in May 2018, and was identified by the Vehicle Identification Number 1C4HJXDG1JWxxxxxx. It was built on a 295 cm (116.1 in) wheelbase with a 3.6 liter, V-6, gasoline engine. The Jeep's electronic odometer reading at the time of the SCI inspection was 7,207 km (4,478 mi). It had a gross vehicle weight rating of 2,405 kg (5,300 lb), with front and rear axle ratings of 1,225 kg (2,700 lb) and 1,361 kg (3,000 lb), respectively. The curb weight was 1,905 kg (4,201 lb).

*Figure 6. Left front oblique view of the 2018 Jeep Wrangler at the time of the SCI vehicle inspection*

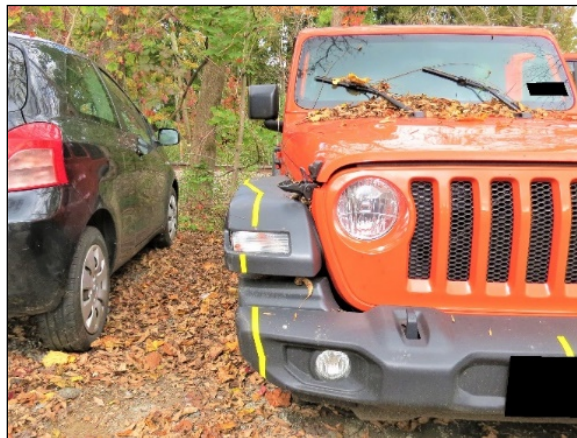
The second impact event with the wooden utility pole began on the Jeep's front plane. Direct contact was visible on the extreme right edge of the front bumper corner, 80 to 85 cm (31.5-33.5 in) right of center (Figure 7). In this area, there was no underlying front bumper structure, and no residual longitudinal deformation to the front plane occurred. The right edge of the bumper fascia was discolored and fractured, and the right amber turn signal/marker light was fractured in the housing.

*Figure 7. View of the damage to the Jeep's right front corner, from a frontal perspective*

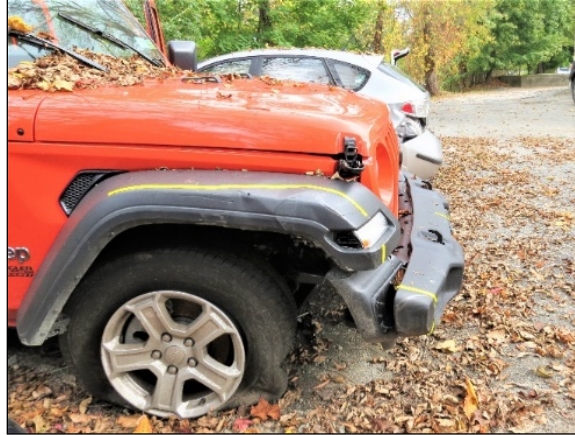
Direct contact extended down the right plane along the polymer right front fender cover, and included engagement of the right front tire/wheel with the utility pole (Figure 8). Significant damage to the components of the axle and suspension at the right front position resulted from the impact. No specific right wheelbase dimension could be obtained due to the free-floating nature of the damaged right front axle position. Based on the observed damage to the Jeep, the CDC assigned for the Event 2 utility pole impact was 12FRES4. The third impact event of the undercarriage with the curb was located in the area of the front axle assembly, right of the vehicle's centerline. The axle, already fractured from the prior event (pole impact) contacted and engaged the curb 9.5 m (31.2 ft) north of the utility pole. This impact was not of sufficient magnitude to alter or otherwise affect the vehicle's trajectory, but it did gouge the axle assembly and fracture the cast aluminum housing. A small fragment of the housing was deposited on the roadway edge at the base of the curb. The CDC assigned to the Jeep for the undercarriage impact was 00UFRN99. No WinSMASH calculations could be performed for any of the impact events, as the lack of residual damage to the vehicle's structure prevented documentation of a residual crush profile.

*Figure 8. Right plane view of the front of the Jeep and the crash damage*

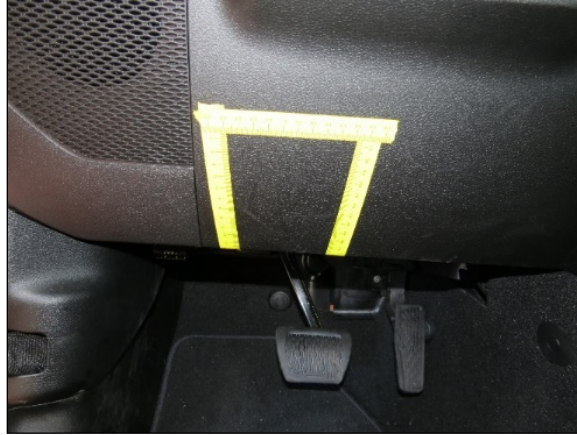
A small area of occupant contact that evidenced the kinematics of the Jeep's occupant was observed to the left lower instrument panel, beneath the steering column (Figure 9). The evidence consisted of a scuff with minor discoloration to the polymer surface of the panel, and was related to contact and loading by the driver's left lower extremity. No occupant injury was associated with this contact.

*Figure 9. Driver left knee contact to the Jeep's left lower instrument panel*

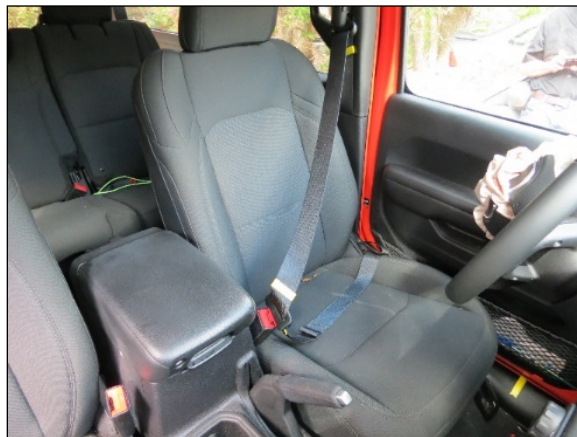
At the time of the SCI inspection, the driver's D-ring was adjusted fully downward. The webbing was locked in an extended position, presumably as a result of retractor pretensioner actuation. The SCI investigator also observed that the lower anchor pretensioner was actuated. Three 5 cm (2.0 in) long polymer transfers were observed on the webbing: one from contact with the polymer fascia on the left side of the seat cushion/frame, one from latch plate loading, and one from D-ring loading. There were also subtle loading abrasions observed to the polymer surface of the latch plate in the belt path. It was apparent to the SCI investigator that the driver of the Jeep was using the system for manual restraint when the crash occurred. Figure 10 shows the driver's seat belt system in the Jeep at the time of the SCI vehicle inspection.

*Figure 10. Driver's seat belt system in the Jeep, with areas of loading evidence highlighted by yellow tape*

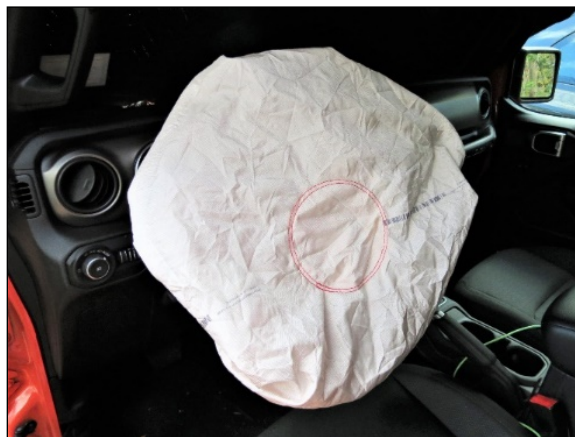
The driver's frontal air bag was mounted in the center hub of the steering wheel and concealed by tri-configuration cover flaps. In its deflated state, the overall diameter of the air bag was 68 cm (26.8 in). Venting was achieved by a pair of 2 cm (0.8 in) vent ports and an 8 cm (3.1 in) vent port on the back side of the air bag. Internal tethering was secured by a 15 cm (5.9 in) diameter stitch pattern sewn to the face of the air bag. No contact evidence or crash-related damage to the deployed driver's air bag was observed (Figure 11).

*Figure 11. View of the Jeep's deployed driver air bag*

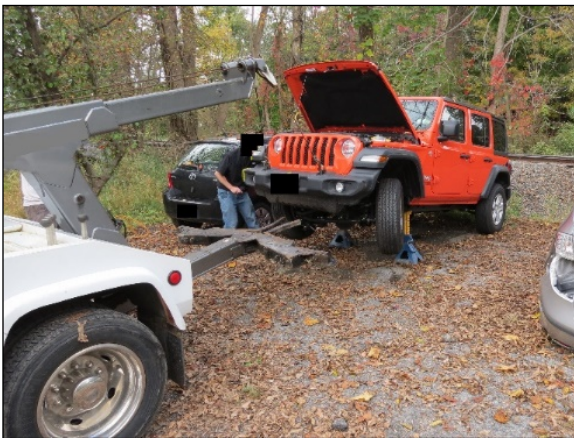
To facilitate this examination, the Jeep was elevated using a recovery vehicle and placed onto jack stands. Figure 12 shows the Jeep elevated for inspection. The first inspected components were the track bar, track bar bracket, and associated welds in relation to the driver's allegation and the unresolved active recall. The SCI investigator observed that the welds for the track bar bracket were on seam along the top and bottom, and the bracket remained entirely affixed to the Jeep's frame (Figure 13). There was no weld material along the front or back of the seam.

*Figure 12. Elevation of the Jeep using a recovery vehicle and jack stands during the SCI vehicle inspection*

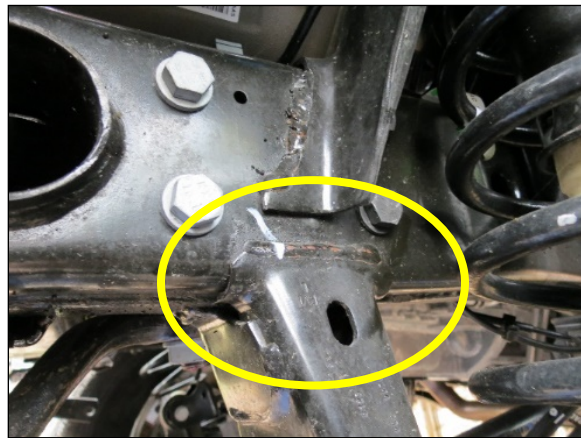
*Figure 13. View of the Jeep's front track bar bracket and the intact weld on the outside of the left frame rail*

3. There were no separations of any welds observed by the SCI investigator during the SCI vehicle inspection.
4. Although the vehicle was subject to a recall issued after the date of the crash concerning the track bar bracket, the SCI investigator observed that the track bar bracket remained rigidly welded to the left frame rail and the entire track bar remained securely mounted in position.

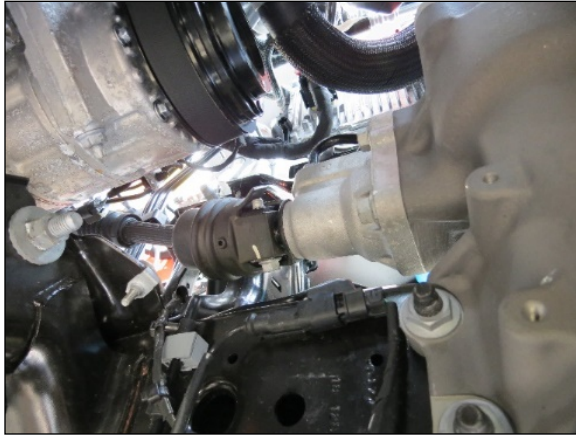
The SCI investigator then inspected the entire steering system and its components. The bolt remained in place holding the steering column and shaft above the steering gear (Figure 14), and the pitman arm, idler arm, and center link all remained connected and intact. The SCI investigator was able to manipulate the steering wheel and observe that the entire steering system remained functional. Figure 15 shows the center link, pitman arm, and steering gear. The only damaged component of the steering system was the steering damper. The steel piston sheared at the attachment end to the front axle position.

*Figure 14. View of the Jeep's intact steering column assembly*

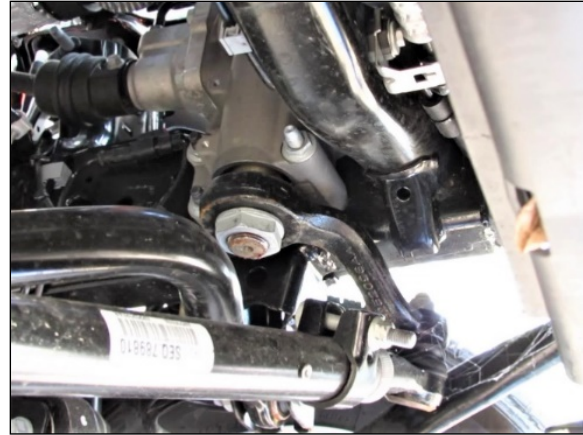
*Figure 15. Center link, pitman arm, and steering gear of the Jeep's steering system*

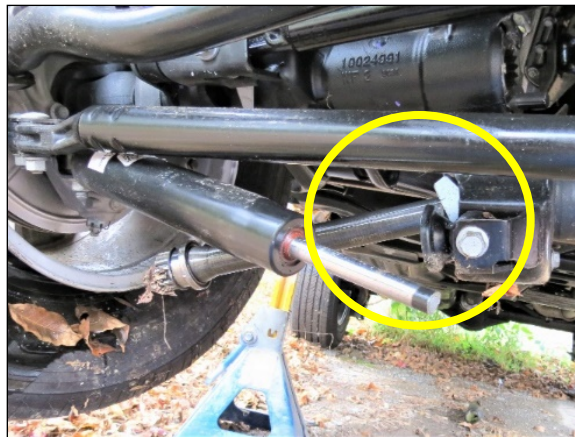
Figure 16 shows the sheared steering damper.

*Figure 16. View of the Jeep's sheared steering damper at the right front axle position*

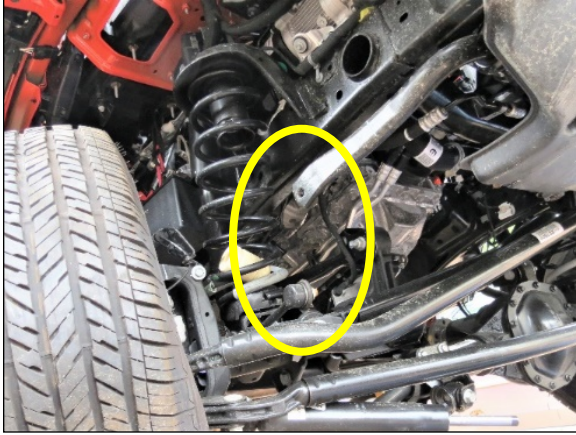
Continued inspection of the Jeep's undercarriage revealed that the sway bar was disconnected from its linkage to the right front axle position due to the shear of the attachment bolt by the crash forces (Figure 17). However, the sway bar support brackets holding the sway bar against the frame of the Jeep remained rigidly intact, their welds on seam and undamaged. The SCI investigator then observed that the spring and shock absorber for the right front position were deformed rearward by the utility pole impact forces (Figure 18). All support brackets and attachment points to the frame remained rigid and intact.

*Figure 17. View of the Jeep's separated front sway bar linkage*

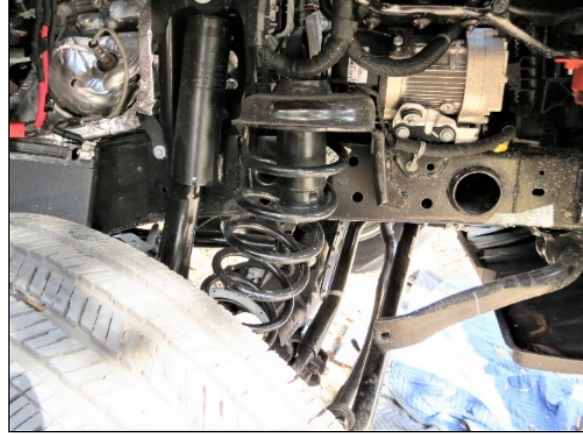
*Figure 18. Left-facing view of the right front suspension showing rearward deflection of the spring and shock*

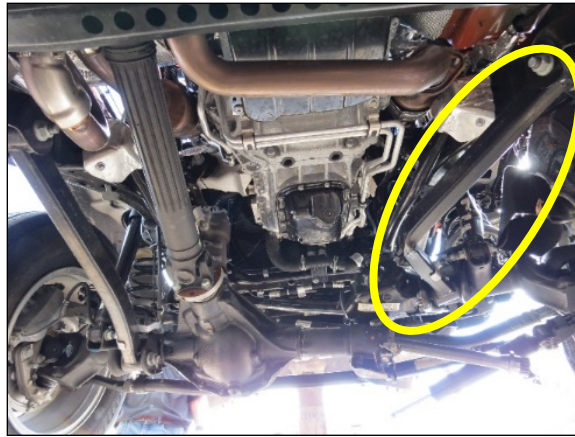
The Jeep's right control arm was also damaged. Although it remained attached to the mounting brackets at each end, and the brackets remained rigidly welded at their mounted locations, the control arm itself was bent by compression forces from the pole impact. The left control arm was undamaged. Figure 19 shows a forward-facing view of the Jeep's control arms, with the right control arm visible in the right aspect of the image. The undamaged left control arm is visible in the left aspect of the image.

*Figure 19. Forward-facing view of the Jeep's bent right control arm and undamaged left control arm*

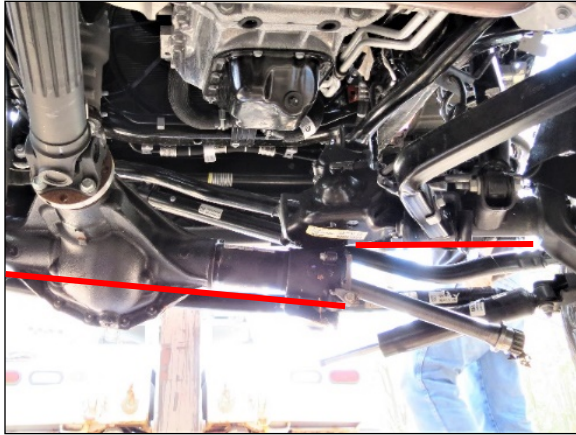
The final damaged component of the Jeep's undercarriage as observed by the SCI investigator was the front axle assembly. It was fractured near the right front position by the crash forces, and the internal drive link extended outward (Figure 20). The axle at the fracture location and the steering damper mount were the location of the Event 3 undercarriage impact (Figure 21).

*Figure 20. Forward-facing view of the Jeep's fractured front axle assembly*

The SCI investigator concluded that all of the damage observed to the undercarriage components of the Jeep was resultant from the forces associated with the crash events. There was no evidence that any of the welds, bolts, or other attachment points were loose or had separated prior to the crash. There was no evidence observed by the SCI investigator to support the driver's allegation of weld separation or other component malfunction.

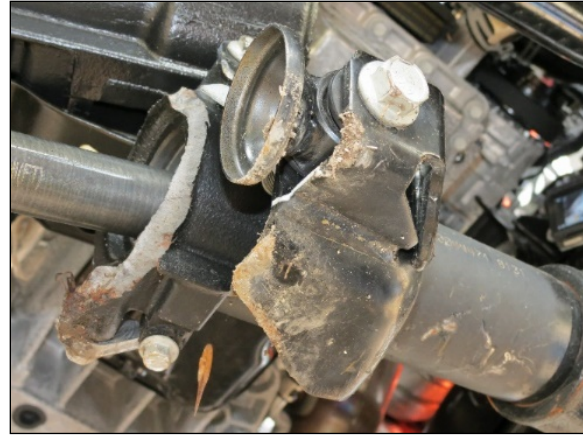
*Figure 21. Underside view of the direct contact damage to the fractured front axle and steering damper mount*

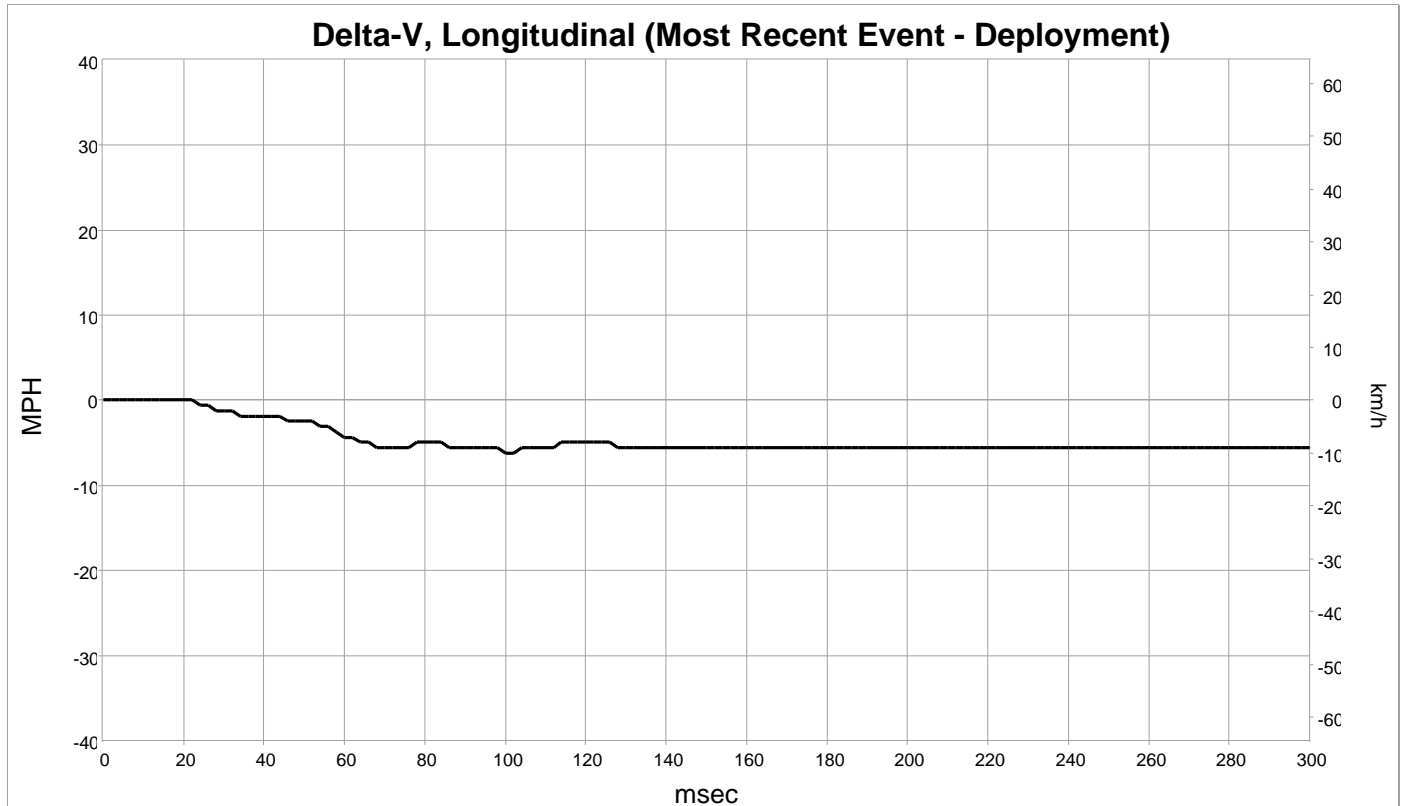
### Longitudinal Crash Pulse (Most Recent Event - Deployment)

Time (msec)	Delta-V, Longitudinal (MPH [km/h])
0	0 [0]
2	0 [0]
4	0 [0]
6	0 [0]
8	0 [0]
10	0 [0]
12	0 [0]
14	0 [0]
16	0 [0]
18	0 [0]
20	0 [0]
22	0 [0]
24	-1 [-1]
26	-1 [-1]
28	-1 [-2]
30	-1 [-2]
32	-1 [-2]
34	-2 [-3]
36	-2 [-3]
38	-2 [-3]
40	-2 [-3]
42	-2 [-3]
44	-2 [-3]
46	-2 [-4]
48	-2 [-4]
50	-2 [-4]
52	-2 [-4]
54	-3 [-5]
56	-3 [-5]
58	-4 [-6]
60	-4 [-7]
62	-4 [-7]
64	-5 [-8]
66	-5 [-8]
68	-6 [-9]
70	-6 [-9]
72	-6 [-9]
74	-6 [-9]
76	-6 [-9]
78	-5 [-8]
80	-5 [-8]
82	-5 [-8]
84	-5 [-8]
86	-6 [-9]
88	-6 [-9]
90	-6 [-9]
92	-6 [-9]
94	-6 [-9]
96	-6 [-9]
98	-6 [-9]

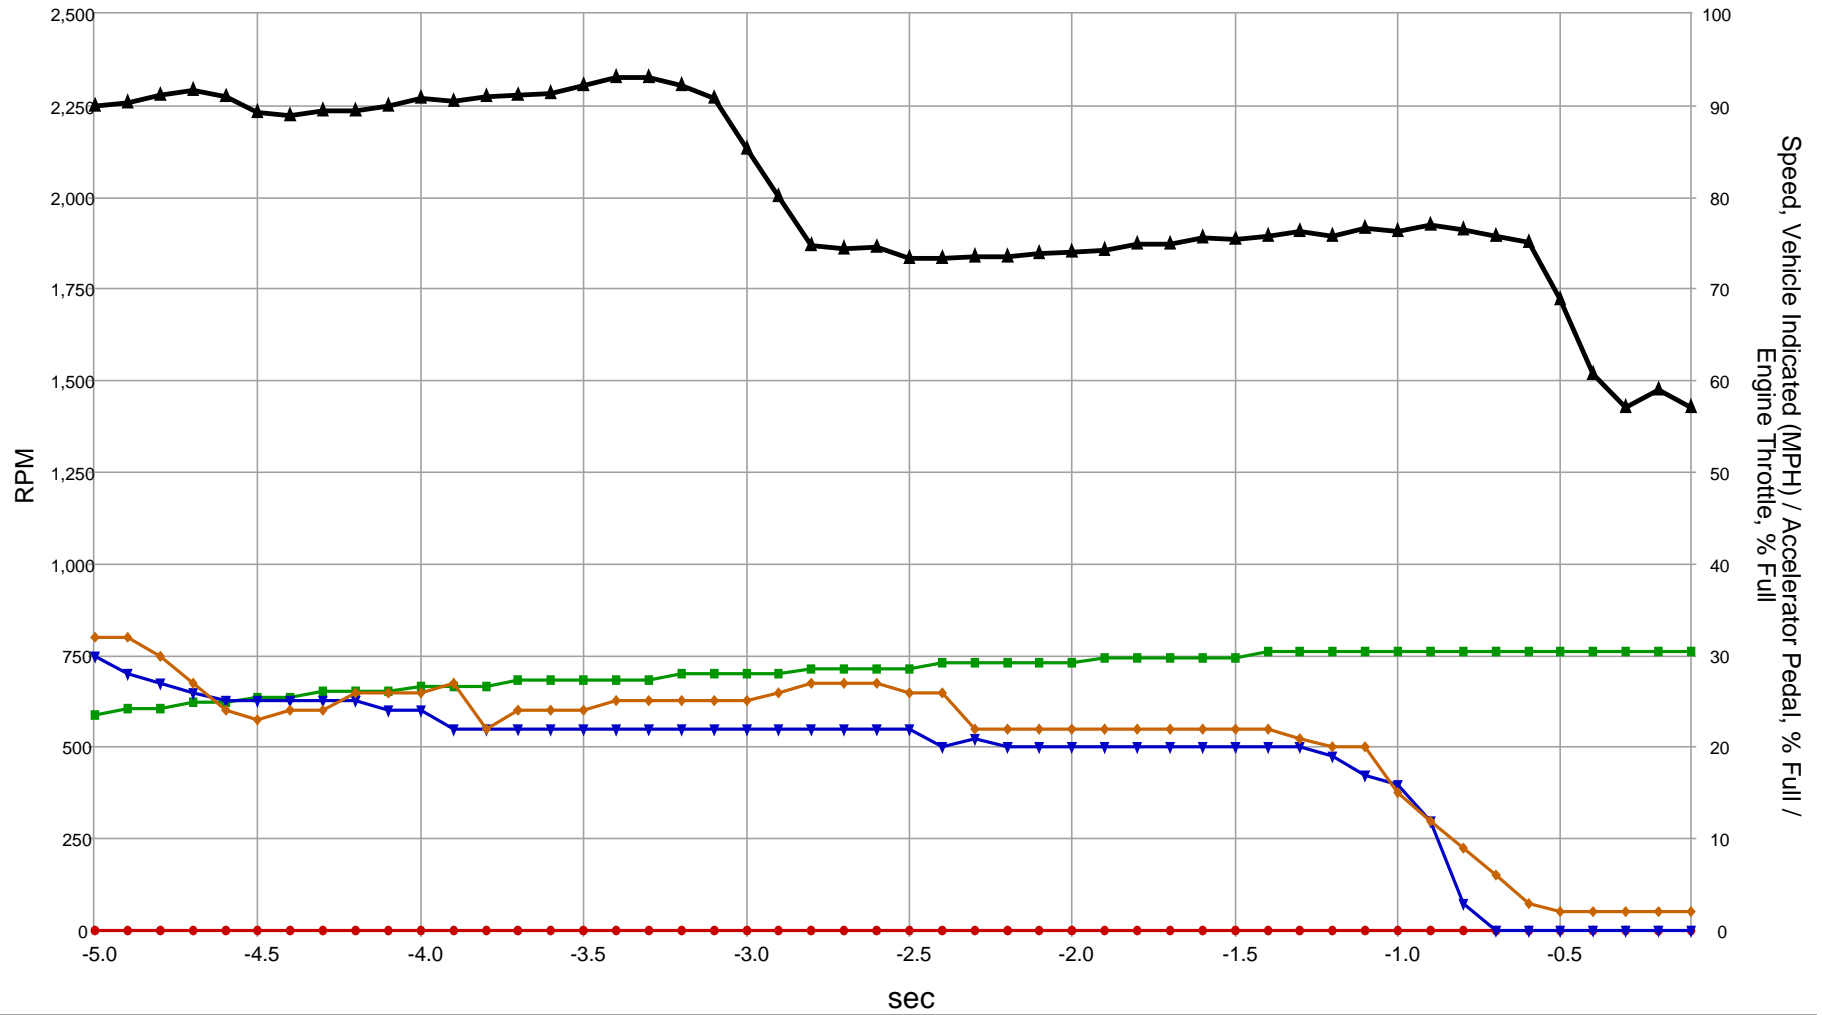
### Pre-Crash Data -5 to 0 Sec

▲ Engine RPM      ■ Speed, Vehicle Indicated (MPH)      ● Service Brake (0=Off/10=On)      ▼ Accelerator Pedal, % Full      ◆ Engine Throttle, % Full
