DOT HS 813 228

**Special Crash Investigations:  
On-Site Crash Avoidance  
Technology Investigation;  
Vehicle: 2019 Honda Civic;  
Location: California;  
Crash Date: October 2019**

**Special Crash Investigations**  
**On-Site Crash Avoidance Technology Investigation**  
**Case Number: DS20002**  
**Vehicle: 2019 Honda Civic**  
**Location: California**  
**Crash Date: October 2019**

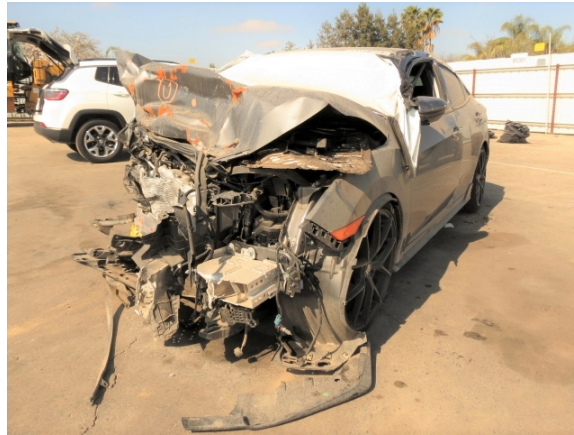
*Figure 1. 2019 Honda Civic*

This report documents the investigation of a fatal crash involving a 2019 Honda Civic (Figure 1) equipped with standard crash avoidance technology including lane keeping assist system (LKAS), road departure mitigation (RDM) system, collision mitigating braking system (CMBS), adaptive cruise control (ACC), blind spot detection, rear visibility system, vehicle stability assist (VSA), and antilock braking system (ABS). The 2019 Honda Civic was traveling southbound when, for unknown reasons, it crossed over the centerline and entered a northbound lane, where it struck a northbound 1995 Honda Civic head-on, killing its driver.

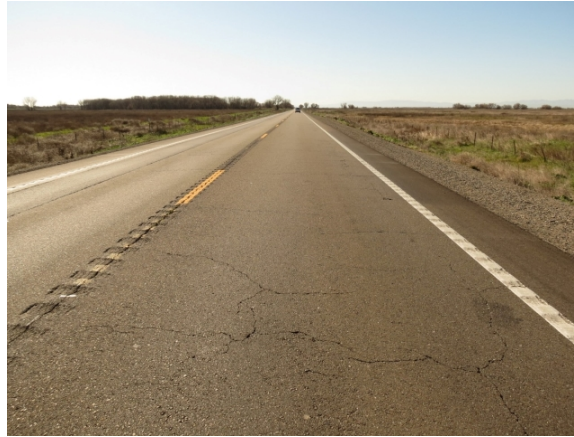
*Figure 2. Approach to crash site looking south*

The crash site was on a two-lane, undivided north/south State highway in California (Figure 2). The roadway was paved asphalt and configured with one lane for each direction separated by a dashed yellow painted stripe and bordered by solid white painted fog lines. The centerline striping was configured with dashed lines measuring 3.7 m (12.0 ft) in length and spaces measuring 11.0 m (36.0 ft) in length.

Raised yellow reflectorized markers were placed in the spaces midway between the dashed lines. Each lane measured 3.7 m (12.0 ft) wide and the pavement edges were 1.3 m (4.3 ft) wide outside of the fog lines. The centerline and fog lines measured 15 cm (6.0 in) wide. A milled-in type rumble strip in a pattern measuring 30 cm (12.0 in) wide was present on the centerline and milled-in type rumble strips in a pattern measuring 15 cm (6.0 in) wide were present on the left and right fog lines. The asphalt pavement and painted lane striping were in good condition. The roadway was straight and level and was configured with a super-elevation measuring negative 1.0 percent for each lane. The east roadside consisted of a gravel shoulder and unpaved ground having a descending slope of 26 percent. The gravel shoulder measured 3.1 m (10.2 ft) wide and the slope ended at a drainage ditch located 4.5 m (14.8 ft) east of the east fog line. A wire fence with wooden posts was located 4.3 m (14.1 ft) east of the drainage ditch. The posted speed limit was 89 km/h (55 mph). Conditions at the time of the crash were dark without artificial illumination, clear, and dry. A crash diagram is at the end of this report.

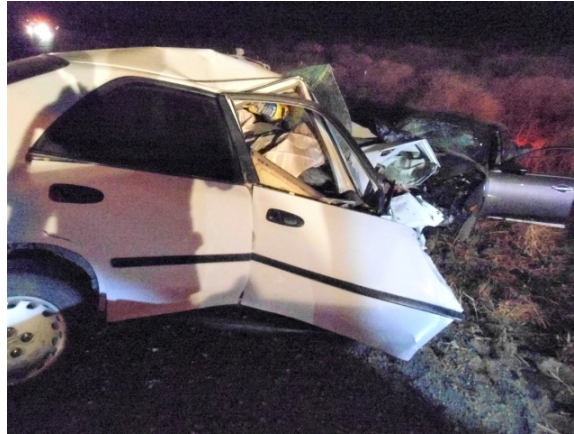
*Figure 3. Final rest position, 1995 Honda Civic (police photo)*

the front right seat-mounted side impact air bag and right inflatable curtain (IC) air bag deployed. Following impact, both vehicles rotated clockwise and departed the roadway on the east edge. The vehicles deposited fluid spills and three scrape marks located between the east fog line and roadway edge with the longest measuring 1.6 m (5 ft) in length. The 2019 Civic traveled 12.0 m (39 ft) and came to rest facing southwest on the roadside. The 1995 Civic traveled 8.0 m (26 ft) east of the roadway and came to rest facing east on the east shoulder (Figure 3). A debris field was located on the east roadside in the area of final rest.

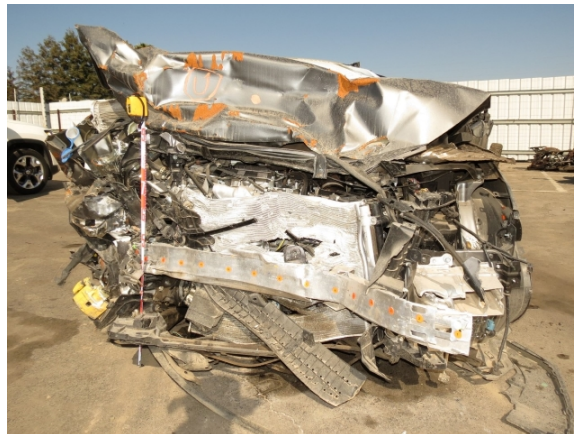
*Figure 4. Front plane damage, 2019 Honda Civic*

The 2019 Civic sustained severe front plane crush damage caused by frontal impact with the other vehicle (Figure 4). The front bumper fascia, grille, and headlamps were displaced, the left front tire was restricted, the left wheelbase was increased by 4 cm (1.6 in), the right front wheel was detached from the axle, the hood and right front fender were crumpled, and the right side view mirror was displaced.

Direct damage to the front plane began at the front right bumper corner and extended 132 cm (52.0 in) to the left. The bumper backing bar was used to measure crush. Fifteen measurements were taken at bumper level by the Nikon Total Station and the Faro Blitz program computed crush measurement in six increments as follows: C1 = 0 cm, C2 = 27 cm (10.6 in), C3 = 45 cm (17.7 in), C4 = 56 cm (22.0 in), C5 = 64 cm (25.2 in), C6 = 76 cm (29.9 in). Maximum crush was located at the front right bumper corner and the Collision Deformation Classification (CDC) was 12FDEW4.

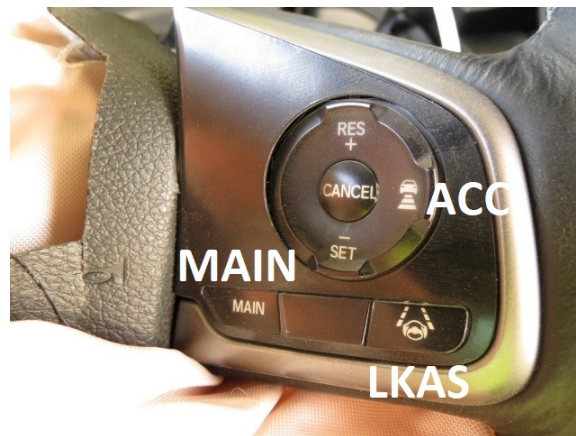
*Figure 5. MAIN, LKAS, and ACC Interval control buttons, steering wheel, 2019 Honda Civic*

According to the 2019 Civic owner's manual, LKAS provides steering input to help keep the vehicle in the middle of a detected lane and provides tactile and visual alerts if the vehicle is detected drifting out of its lane. The system is activated by pressing the "MAIN" and "LKAS" buttons on the right steering wheel spoke (Figure 5), and is deactivated by pressing either of the buttons. The front sensor camera monitors lane lines and provides tactile and visual alerts when the vehicle is drifting out of a detected lane. If a lane departure occurs without a turn signal applied, the alerts activate and torque is applied to the steering. The owner's manual states the system is not a substitute for driver control of the vehicle and does not work or may be automatically suspended if the driver's hands are off the steering wheel or not actively steering. The system has limitations including, among others, it may not detect lane lines at night or in dark conditions such as a tunnel. According to the EDR report, this system was "On" and "Not Engaged." The EDR report indicated the driver was actively braking continuously from T-3.0 seconds to T-0.0 seconds. The system will not perform when the brake pedal is depressed.
