DOT HS 813 232

# **Special Crash Investigations: On-Site Child Restraint System Investigation; Vehicle: 2014 Dodge Journey; Location: Idaho; Crash Date: May 2016**

**Special Crash Investigations  
On-Site Child Restraint System Investigation  
Case Number: DS16018  
Vehicle: 2014 Dodge Journey  
Location: Idaho  
Crash Date: May 2016**

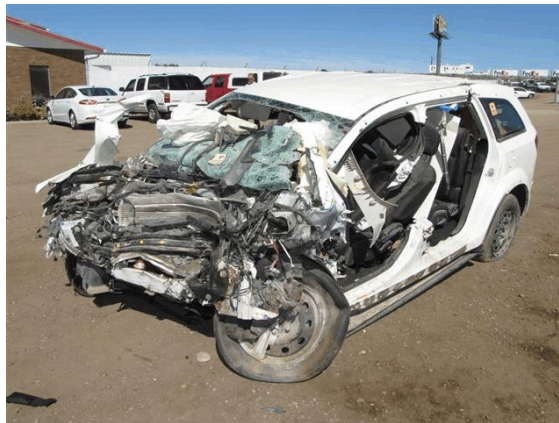
*Figure 1. The 2014 Dodge Journey*

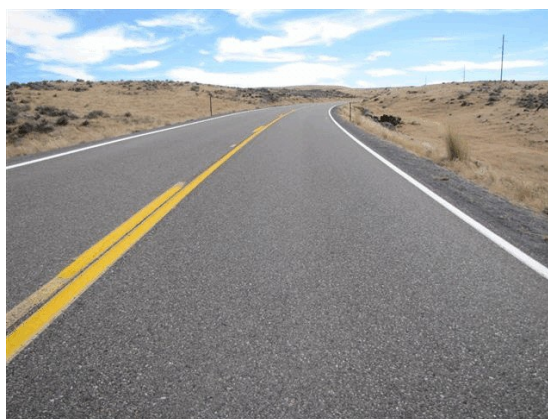
The crash occurred on a two-lane, north/south State highway in a rural area of Idaho (Figure 2). The roadway was asphalt-surfaced and was configured with one lane for each direction. The lanes were separated by a double yellow solid and dashed painted stripe that facilitated passing in the northbound direction, bordered by solid white painted fog lines. Both lanes measured 3.7 m (12.0 ft) in width and were configured with narrow paved shoulders measuring 0.5 m (1.6 ft) in width. The east edge of the roadway was configured with an additional gravel shoulder measuring 1.2 m (3.9 ft) in width. Heading southbound at the area of the crash, the roadway curved right in a radius of 622.5 m (2,042.3 ft) measured from the east fog line. Heading southbound, the roadway ascended at a slope of positive 7.0 percent, and the southbound lane had a super elevation of positive 7.0 percent. The posted speed limit was 105 km/h (65 mph).

*Figure 2. Crash site, looking south*

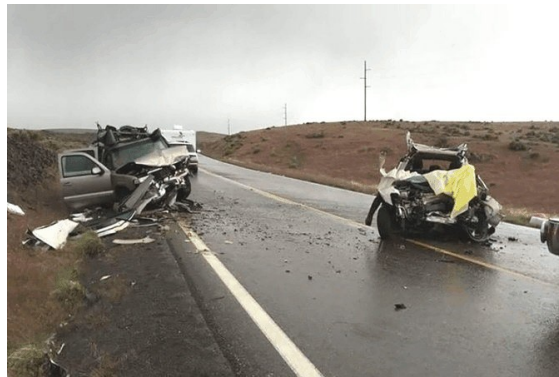
*Figure 3. Crash site looking south with the Chevrolet on the left and the Dodge on the right (online photo)*

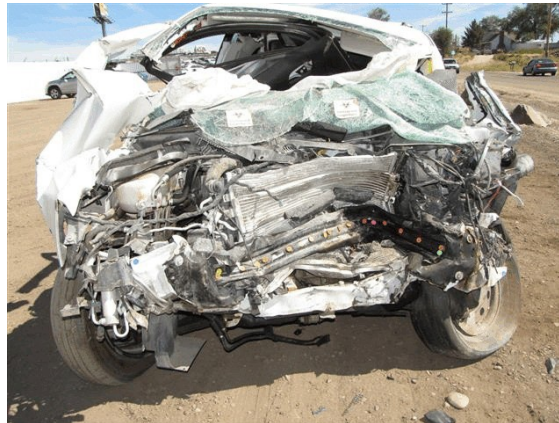
The Dodge sustained severe crush damage to the front plane caused during the impact with the Chevrolet (Figure 4). The front bumper fascia, the grille, the right front fender, and the left front fender were displaced from the vehicle. The left front tire was displaced rearward and restricted. The hood was crumpled. Additional damage was sustained during post-crash extrication

activities. The A- and B-pillars were cut through, and the roof was folded backward; the left front, left rear, and right front doors were removed. The front bumper backing bar was used to measure crush damage. Direct damage began at the front left bumper corner and extended 113 cm (44.5 in), and the Field L extended from bumper corner to bumper corner and measured 84.0 cm (33.1 in). Thirteen measurements were taken at bumper level using the Nikon Total Station, and the Faro Blitz program computed crush measurement in six increments as follows:  $C_1 = 80.0$  cm (31.5 in),  $C_2 = 100.0$  cm (39.4 in),  $C_3 = 110.0$  cm (43.3 in),  $C_4 = 83.0$  cm (32.7 in),  $C_5 = 66.0$  cm (26.0 in), and  $C_6 = 45.0$  cm (17.7 in). Maximum crush was located 37 cm (14.6 in) right of the front left bumper corner, and the Collision Deformation Classification (CDC) for the Dodge in Event 1 was 12FDEW5.

*Figure 4. Front plane crush damage, the 2014 Dodge Journey*

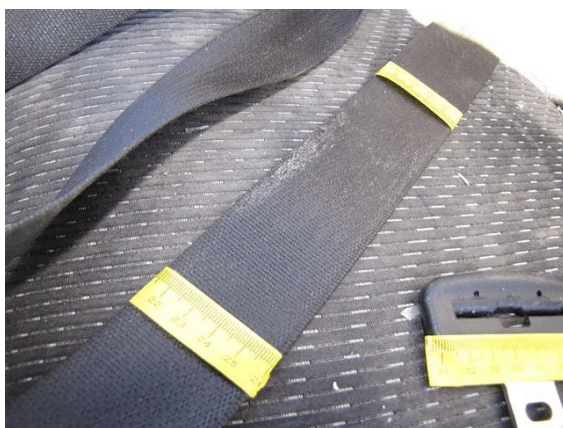
belt was “Buckled.” The report indicated that the retractor pretensioner actuated, but that the buckle pretensioner was not actuated. The reason for this was not known. On the passenger side, both pretensioners actuated, although this seat was not occupied, and the belt was not buckled. The driver’s belt was cut during post-crash activities. The webbing was still attached at the lower anchorage, and the latch plate was found in the vehicle. Both the latch plate and the webbing exhibited evidence of driver loading. The latch plate was scuffed on the plastic cladding, and the webbing was scuffed beginning 110.0 cm (43.3 in) above the stop button (Figure 5).

*Figure 5. Driver's seat belt components, driver loading evidence, the 2014 Dodge Journey*

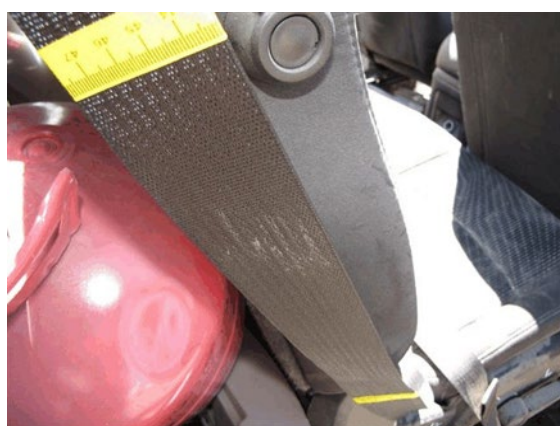
*Figure 6. Second row right position seat belt webbing, occupant loading evidence, the 2014 Dodge Journey*

The second row right position belt (Figure 6) was used by the 4-year-old male occupant in combination with a forward-facing booster safety seat. Both the latch plate and the webbing exhibited evidence of occupant loading. The latch plate was scuffed on the plastic cladding, and the webbing was scuffed beginning 110.0 cm (43.3 in) above the stop button. During the SCI inspection, the retractor was manipulated, and both ELR and ALR settings were functional. The latch plate was inserted into the buckle that was functional. Aside from the occupant loading evidence, the belt was unremarkable.

The driver stated during the interview that the child occupant had a history of pulling the shoulder belt away from his shoulder, causing it to loosen and rest on his upper arm. She believed he likely did that prior to the crash, causing a fracture to his upper right arm. Loosening the shoulder section can also potentially cause slack in the lap portion of the belt.

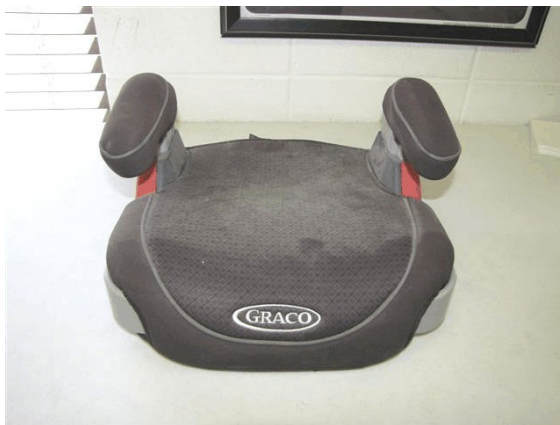
Graco TurboBooster Booster Safety Seat. The Graco TurboBooster was a backless belt-positioning BSS (Figures 7 and 8). At the time of the crash, it was positioned in a forward-facing orientation in the second row right position and used in combination with the vehicle's lap and shoulder seat belt.

*Figure 7. Graco TurboBooster BSS, the 2014 Dodge Journey*

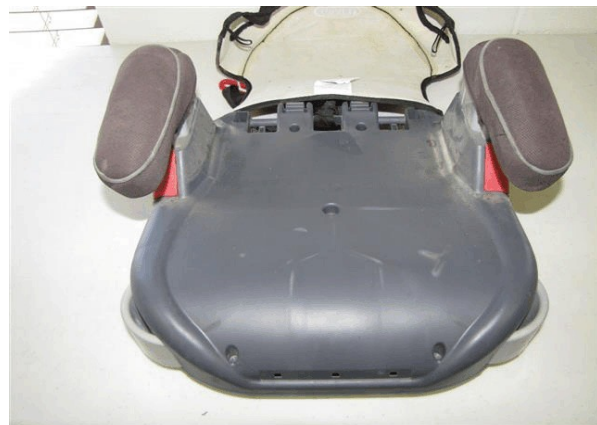
*Figure 8. Graco TurboBooster BSS shell with padding removed, the 2014 Dodge Journey*

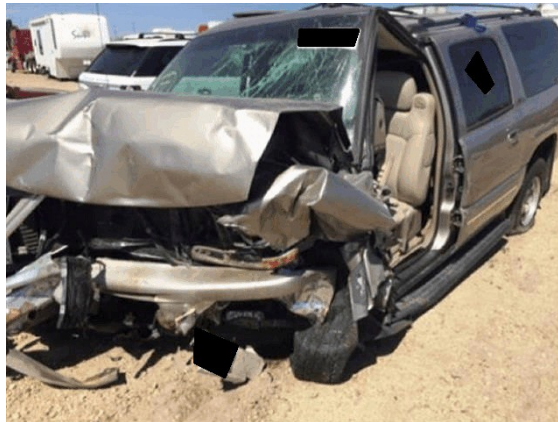
*Figure 9. Front plane damage, the 2002 Chevrolet Suburban (insurance photo)*

On-scene images and insurance images were obtained by SCI and used to conduct a partial exterior vehicle inspection. The Chevrolet sustained crush damage to the front plane during the impact with the Dodge in Event 1 (Figure 9). The front bumper was crushed, and the grille was displaced; the hood, the left front fender, and the right front fender were crumpled. The left front door was removed during post-crash activities. Direct damage on the front plane appeared to be distributed from bumper corner to bumper corner. The estimated CDC for the Chevrolet in Event 1 was 12FDEW4.
