DOT HS 813 238

**Special Crash Investigations:
On-Site Crash Avoidance
Technology Investigation;
Vehicle: 2018 Honda CR-V;
Location: Washington;
Crash Date: January 2020**

Special Crash Investigations
On-Site Crash Avoidance Technology Investigation
Case Number: DS20007
Vehicle: 2018 Honda CR-V
Location: Washington
Crash Date: January 2020

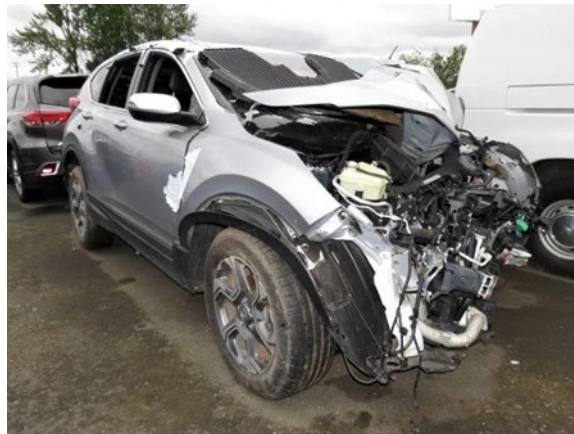
Figure 1. The 2018 Honda CR-V

This report documents the investigation of a crash involving a 2018 Honda CR-V (Figure 1) with standard crash avoidance technology, including adaptive cruise control (ACC), a road departure mitigation (RDM) system with lane departure warning (LDW), a lane keeping assist system (LKAS), a collision mitigation braking system (CMBS), vehicle stability assist (VSA), blind spot information (BSI), and a rear visibility system (RVS). According to the Honda owner's manual, the RDM alerts and helps to assist the driver when the system detects a possibility of the vehicle unintentionally crossing over detected lane markings, and the LKAS provides steering input to help keep the vehicle in the middle of a detected lane and provides tactile and visual alerts if the vehicle is detected drifting out of its lane. The investigation was intended to determine what role, if any, the crash avoidance technology played in the crash. The investigation was initiated by the Special Crash Investigations (SCI) group of the National Highway Traffic Safety Administration in response to a notification from the Fatality Analysis Reporting System (FARS). SCI assigned the case to Dynamic Science, Inc., in June 2020, and the vehicle and scene field inspections were completed in July 2020.

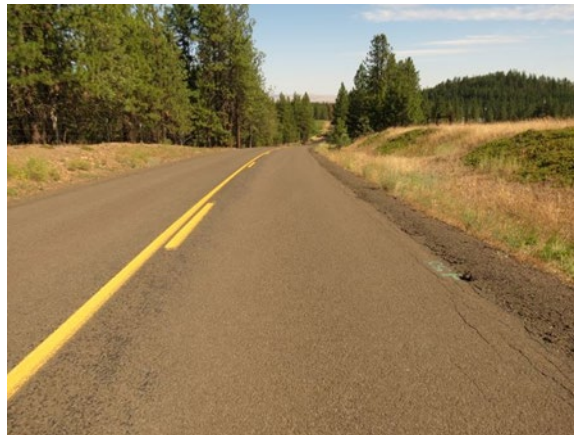
The crash site was a two-lane undivided north/south state highway in Washington (Figure 2). The roadway was paved with asphalt, in good condition, with one lane for each direction. The centerline separating the lanes was a double yellow painted stripe in good condition that was dashed (passing zone) for southbound traffic and solid (no passing zone) for opposing northbound traffic. The roadway had no fog lines or any lane markings other than the centerline. Each lane measured 3.3 m (10.8 ft) wide from centerline to pavement edge. The centerline striping had dashed lines measuring 3.2 m (10.5 ft) long and spaces measuring 8.6 m (28.0 ft) long. The stripes measured 15 cm (6.0 in) wide. The asphalt pavement was in traveled condition, and the painted lane striping was in good condition.

Figure 2. Approach to crash site looking south

The southbound roadway had a straight section measuring 60.0 m (196.9 ft) long preceding a right curve beginning 105.0 m (344.5 ft) north of the point of impact (POI). The curve radius measured at the centerline was 475.0 m (1,558.4 ft).

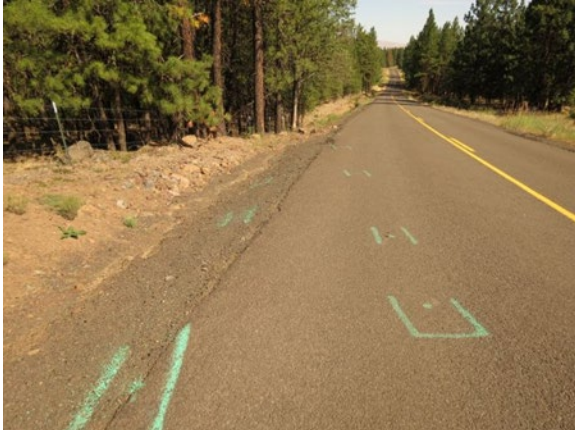
At approximately T-1.5 seconds, the Honda departed the left edge of the roadway, depositing left and right side tire tracks in the dirt roadside (Figure 3). The roadway edge had no lane markings or fog line at the point of departure. Tire tracks indicated a departure angle of 10 degrees relative to the edge of pavement. At T-0.5 seconds, the vehicle was completely off the roadway, and the EDR data indicated that the VSA was “On, Engaged” and that the steering input was -75 degrees.¹ The service brake remained “Off,” and the vehicle continued traveling on a straight trajectory to POI. According to the EDR data, none of the vehicle’s crash avoidance systems initiated a warning or engagement prior to impact. The vehicle’s pre-crash speed and distance calculations derived from the EDR data are included in the table below.

Figure 3. Police markings at the area of departure looking south

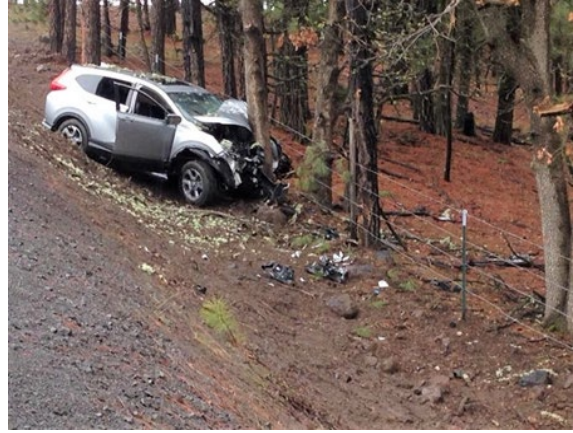
Figure 4. The 2018 Honda CR-V at final rest looking north (police photo)

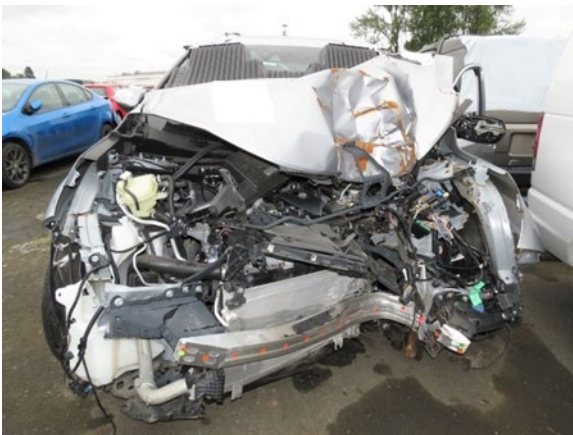
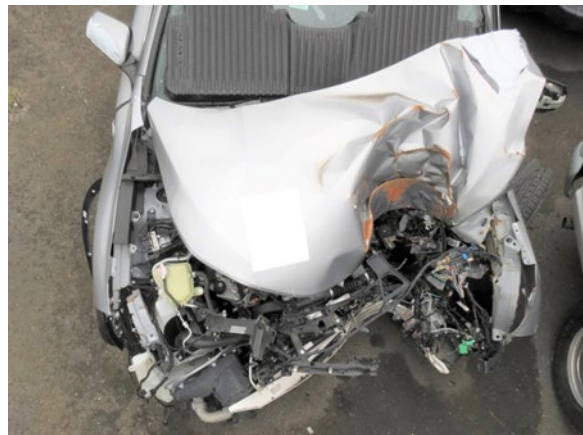
Figure 5. Front plane damage, the 2018 Honda CR-V Figure 6. Front plane damage, the 2018 Honda CR-V

The Honda sustained severe front plane crush damage at impact with a tree measuring 35 cm (13.7 in) in diameter. The front bumper fascia, grille, radiator, upper radiator support, and headlamps were displaced; the left and right front tires were restricted; the left front wheel was detached from the suspension; the hood, left front fender, and left front door were crumpled; and the right side view mirror was displaced. The bumper backing bar was used to measure crush. The damage flow represented a classic between-rails frontal pole or tree crash type (Figures 5 and 6). Direct damage to the front plane at bumper level began in the left sector at 30 cm (11.8 in) right of the front left bumper corner and extended 50 cm (19.7 in) to the right ending the center sector. The field L extended from bumper corner to bumper corner and measured 110 cm (43.3 in). Fifteen measurements were taken at bumper level by the Nikon Total Station, and the Faro Blitz program computed crush measurement in six increments as follows: $C_1 = 34$ cm (13.4 in), $C_2 = 67$ cm (26.4 in), $C_3 = 63$ cm (24.8 in), $C_4 = 38$ cm (15.0 in), $C_5 = 17$ cm (6.7 in), and $C_6 = 0$ cm. Maximum crush measured 67 cm (26.4 in) and was located at 40 cm (15.7 in) right of

the front left bumper corner. The calculated principal direction of force was 350 degrees, and the collision deformation classification (CDC) for the Honda in Event 1 was 12FYEW3.

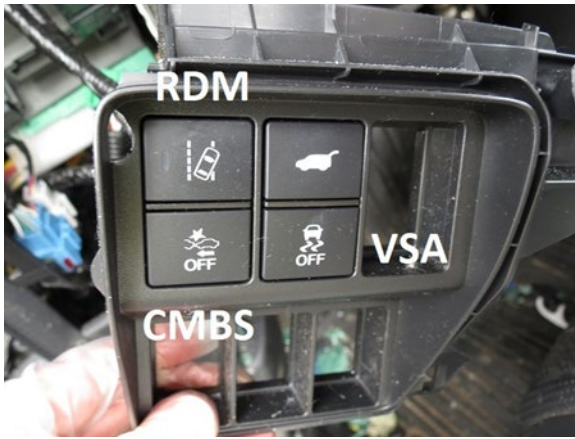
Figure 7. Crash avoidance technology controls, left instrument panel, the 2018 Honda CR-V

As previously stated, the Honda's crash avoidance technology included a road departure mitigation system with LDW, LKAS, CMBS, ACC with low-speed follow (LSF), VSA, BSI, and RVS. The crash avoidance systems employed a radar sensor located at the lower aspect of the front bumper and a front sensor camera mounted to the interior windshield and located behind the rearview mirror. The Honda had manual controls on the left IP (Figure 7) and steering wheel (Figure 8) allowing the user to change settings for LKAS, RDM, LDW, CMBS, ACC, and VSA. The ACC had four user settings to adjust the following intervals to short, middle, long, and extra-long. The Honda had two primary users, including the driver in this crash and her spouse. The spouse stated during the SCI interview that he historically set the adaptive cruise control to a shorter following interval and that the driver in this crash historically set the system to a longer following interval. The EDR report indicated that all crash avoidance systems were "On," with the exceptions of the RDM and LDW, which had been manually disabled by the driver. The crash avoidance systems for this vehicle were as follows.

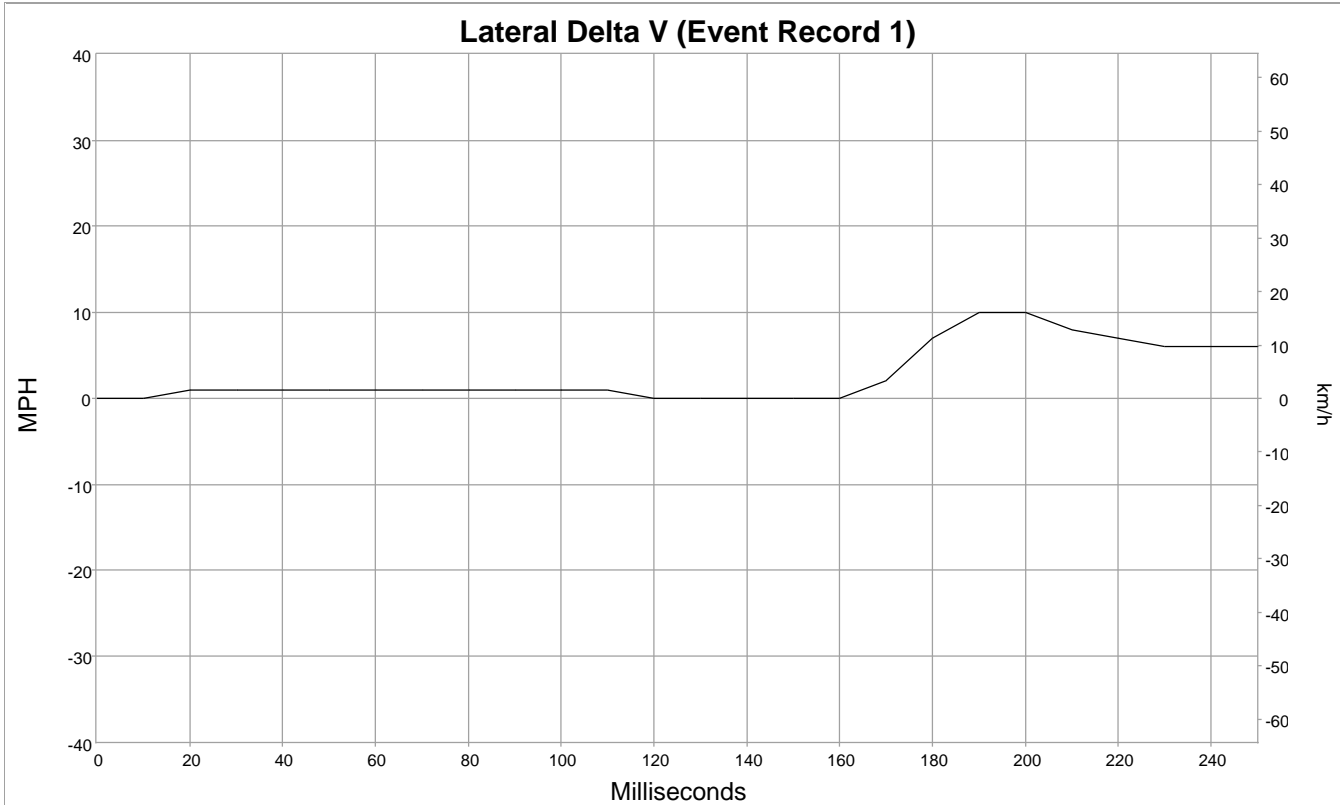
Lateral Delta V (Event Record 1)

Time (msec)	MPH [km/h]
0	0 [0]
10	0 [0]
20	1 [1]
30	1 [1]
40	1 [1]
50	1 [1]
60	1 [1]
70	1 [1]
80	1 [1]
90	1 [1]
100	1 [1]
110	1 [1]
120	0 [0]
130	0 [0]
140	0 [0]
150	0 [0]
160	0 [0]
170	2 [4]
180	7 [11]
190	10 [16]
200	10 [16]
210	8 [13]
220	7 [11]
230	6 [10]
240	6 [10]
250	6 [10]
