**Special Crash Investigations:  
On-Site Crash Avoidance Technology  
Investigation;  
Vehicle: 2017 Honda Civic Touring;  
Location: Florida;  
Crash Date: December 2019**

**Special Crash Investigations**  
**On-Site Crash Avoidance Technology Investigation**  
**Case Number: CR20007**  
**Vehicle: 2017 Honda Civic Touring**  
**Location: Florida**  
**Crash Date: December 2019**

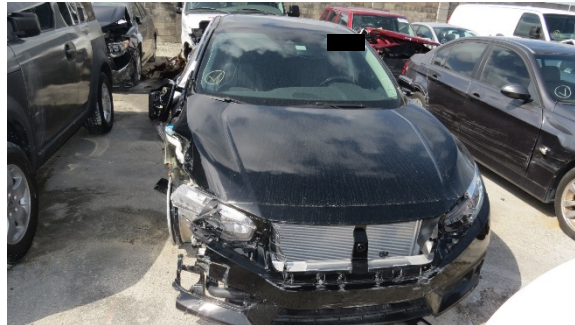
*Figure 1. Front view of the 2017 Honda during the SCI investigation*

This report documents the on-site investigation of the frontal crash of a 2017 Honda Civic (Figure 1) into a QuadGuard II impact attenuator that protected the blunt end of a concrete Jersey barrier. The police crash report (PCR) reported that the driver fell asleep at the wheel and drifted off the roadway to the right. The Honda was equipped with multiple crash avoidance (CA) systems, including forward collision warning (FCW) with crash imminent braking (CIB), roadway departure mitigation (RDM), lane departure warning (LDW) with lane keeping assist (LKAS), blind spot detection, adaptive cruise control (ACC), dynamic brake support, daytime running lights, and a rearview video system. The Honda's belted 33-year-old male driver did not detect the vehicle drifting off the roadway, and the front right corner of the Honda struck the impact attenuator. The PCR reported no injuries to the driver.

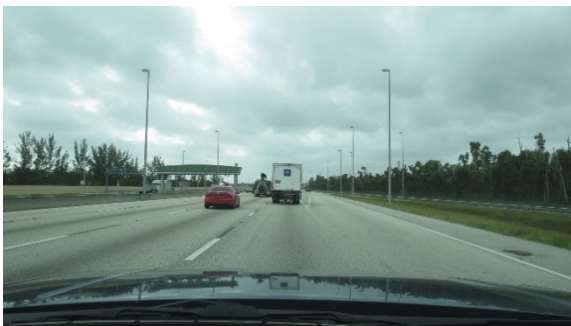
*Figure 2. Southbound view of the Honda's pre-crash approach to the crash site*

The Honda traveled south on the roadway, driven by a belted 33-year-old male. According to the PCR, he fell asleep and drifted right into the impact attenuator. However, during the SCI investigation, it was determined that the vehicle drifted to the right and entered the mouth of an exit lane (Figure 3) approximately seven seconds prior to algorithm enabled (AE). The vehicle began drifting back left at the top of the painted gore (highlighted by red arrows in Figure 3). The vehicle never laterally crossed a painted lane line. Rather, the painted lane line at the top of the painted gore was driven over by the front of the vehicle. Data imaged from the vehicle's EDR indicated that the Honda was traveling at a speed of 84 km/h (52 mph) 5.0 seconds prior to AE and increasing its travel speed to 87 km/h (54 mph) 1.5 seconds prior to AE. The FCW, CIB, roadway departure mitigation/LDW, ACC, and lane keeping assist systems were all "On." No warnings were recorded by the EDR. As the Honda approached the impact attenuator, the EDR indicated that the driver attempted avoidance by steering to the left and braking.

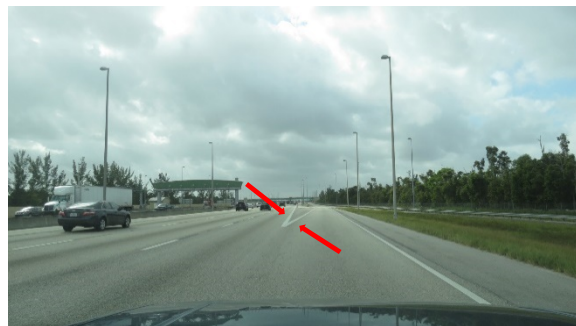
*Figure 3. Southbound view of the original travel lane and the exit travel lane lines where they meet*

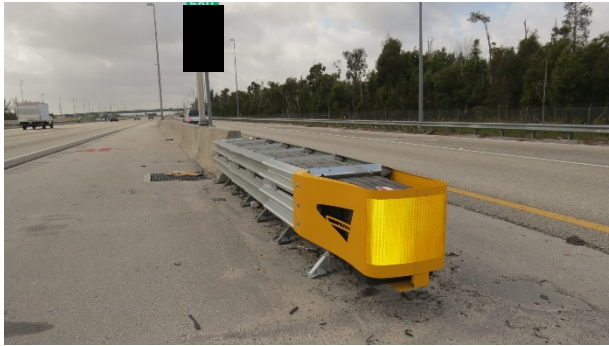
The QuadGuard II impact attenuator (Figure 4), manufactured by Trinity Highway (<https://trinityhighway.com/product/quadguard-ii/>), was originally installed in November 2013. The QuadGuard II, which does not use anchor chains or tension cables, features a self-supporting steel nose (Figure 5), monorail guide shims to stabilize the diaphragms, high strength Quad-Beam panels, and a design tested to speeds from 40 km/h (25 mph) to 100 km/h (62 mph). This impact attenuator is considered a Test Level 3 Five-Bay Unit per the manufacturer's description. According to the QuadGuard manual, during a head-on collision, within criteria, the QuadGuard II is designed to telescope rearward to absorb the energy of the impact, and when impacted from the side, it is designed to redirect the vehicle back toward its original travel path and away from the roadside obstacle. It should be noted that at the time of the inspection, the nose and first bay of the impact attenuator system had been replaced, so there was no evidence at the scene of impact.

Figure 4. QuadGuard II impact attenuator system

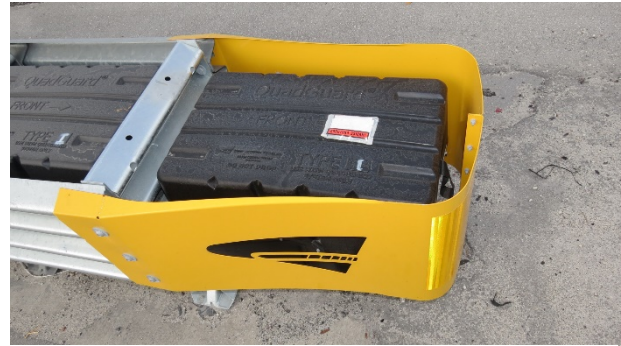
Figure 5. Nose section of the QuadGuard II impact attenuator system

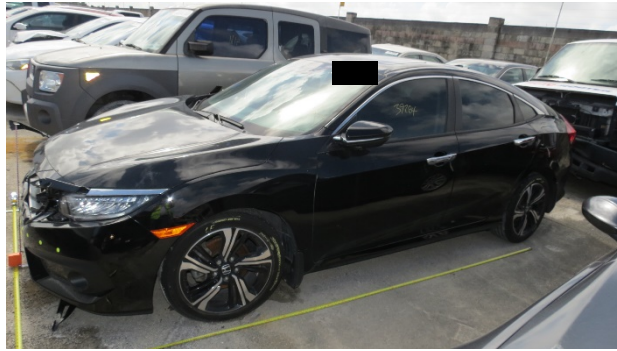
The 2017 Honda Civic (Figure 6), manufactured in September of 2018, was identified by the vehicle identification number 2HGFC1F93HHxxxxxx. The electric odometer reading was 63,221 km (39,284 miles) at the inspection. The Honda was a front-wheel drive platform, powered by a 1.5-liter, 4-cylinder gasoline engine linked to a continuous variable transmission. Its service brakes were power-assisted, 4-wheel disc with antilock. The gross vehicle weight rating was 1,770 kg (3,902 lb), with gross axle weight ratings of 955 kg (2,105 lb) in front and 820 kg (1,808 lb) in rear. The vehicle manufacturer's recommended tire size was P215/50R17, with recommended cold tire pressures of 220 kPa (32 PSI) for all four axle positions. At the time of the SCI inspection, the Honda was equipped with Firestone FT140 tires of the recommended size at the left front, left rear, and right rear positions. The right front tire was not present at the time of inspection. The left front, left rear, and right rear tires had at least 6 mm (7/32) of tread, remained inflated, and were not damaged in the crash.

*Figure 6. View of the 2017 Honda Civic during the SCI vehicle inspection*

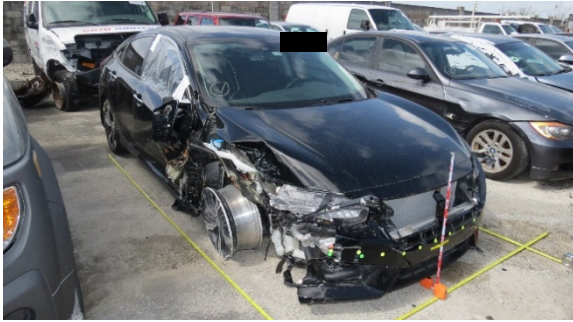
This crash involved the front and right planes of the Honda, and the damage pattern resembled a corner impact configuration. Although the bumper fascia had scratching across the entire front of it, these markings were not representative of the crash and attributed to pre-existing damage. The front reinforcement bar was deformed minimally at the right front corner. Figure 7 depicts the front plane damage pattern, while Figure 8 depicts the front right corner reinforcement bar damage.

*Figure 7. Front plane damage to the Honda as documented during the SCI vehicle inspection*

A residual crush profile was documented to the front bumper beam. The corresponding direct damage width was 16 cm (6.2 in) beginning at the right edge of the beam. The field-L was 170 cm (66.9 in). The crush measurements at the bumper level were C1 = 0 cm (0 in), C2 = 0 cm (0 in), C3 = 0 cm (0 in), C4 = 0 cm (0 in), C5 = 0 cm (0 in), and C6 = 9 cm (3.5 in). Maximum crush was observed at the right front bumper corner of the vehicle. The damage pattern extended along the right plane 198 cm (77.9 in). A corresponding collision deformation classification (CDC) of 12FREE06 was assigned to the Honda's damage profile.

This yielding object impact was out-of-scope for analysis by the WinSMASH program. However, a barrier equivalent speed (BES) was calculated using the barrier algorithm of the program for comparison purposes. The calculated BES was 15 km/h (9 mph). Based on SCI expertise and observed vehicle damage, the borderline reconstruction underestimated the severity of the crash.

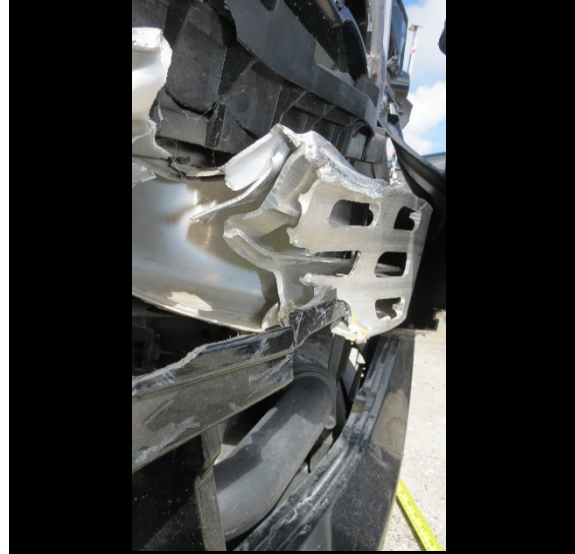
*Figure 8. Front right corner of the Honda's reinforcement bar damage as documented during the SCI vehicle inspection*

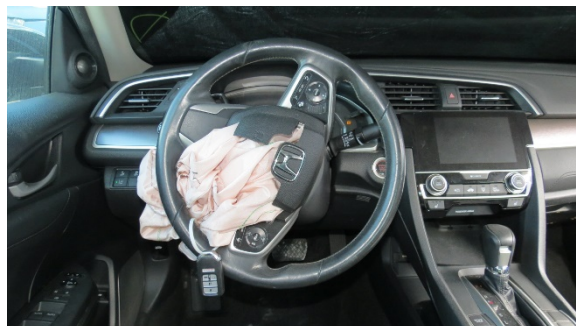
There was no loss of integrity to the interior occupant compartment of the Honda, relative to the crash. All doors remained closed and were operational post-crash. The windshield was cracked, and the front right side window was disintegrated by the crash forces, relative to the corner impact. All other glazing remained intact, not damaged or contacted by the occupant (driver). The only discernable evidence in the Honda’s interior from occupant contact was the loading of the safety belt, as described in the Manual Restraint Systems section of this report. Figure 9 depicts the front row left (driver’s) position of the Honda and the surrounding components.

*Figure 9. View of the interior of the Honda during the SCI vehicle inspection*

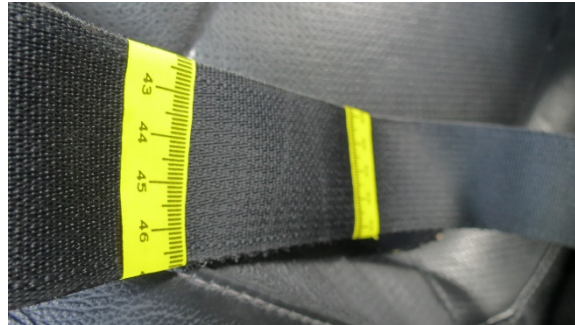
An area of polymer transfer and apparent loading (Figure 10) was observed. The SCI investigator also observed a polymer transfer on the webbing from the D-ring. Based on the post-crash condition of the driver's seat belt system, it was apparent that the driver was belted at the time of the crash.

*Figure 10. Latch plate loading evidence on the driver's seat belt system in the Honda*

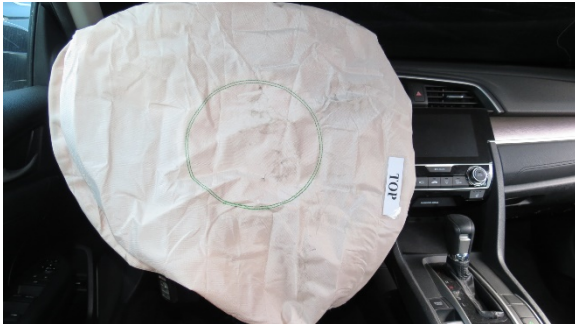
The driver's frontal air bag deployed from the steering wheel hub-mounted module and through the cover flaps without damage. In its deflated state, the driver's frontal air bag measured approximately 60 cm (23.6 in) in overall diameter. It had an 11 cm (4.3 in) wide circular center stitch pattern, to which internal tethers were affixed. The air bag was vented on its rear aspect by a pair of 4 cm (1.6 in) diameter vent ports, located at the 11 o'clock and 1 o'clock positions. There was no discernable occupant contact evidence or other crash-related damage to the Honda's deployed driver's frontal air bag. The Honda's right IC air bag deployed downward from the roof side rail mounting location through the edge of the headliner. The right IC air bag was cut and removed prior to the SCI inspection of the vehicle.

There was no discernable occupant contact to the right IC air bag. Figure 11 depicts the deployed driver's frontal air bag at the time of the SCI inspection, while Figure 12 depicts the remnants of the deployed right IC air bag.

Figure 11. View of the deployed driver's frontal air bag in the Honda at the time of the SCI inspection

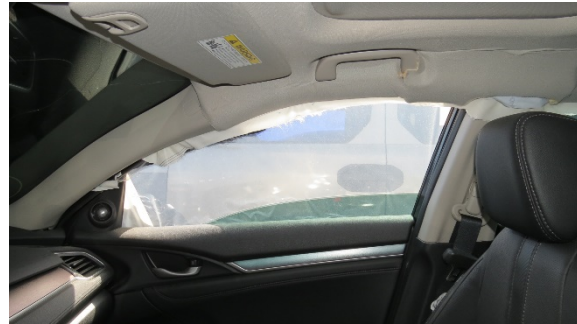
Figure 12. View from the removed deployed right IC air bag in the Honda

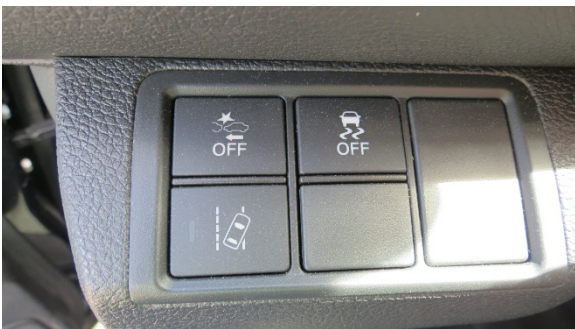
The Honda was equipped with multiple CA systems designed to assist/support the driver in both avoiding a potential crash and/or mitigating the severity of a crash event should a collision become imminent. The driver was able to turn three of the CA systems on or off by pushing a button representative of the CA system located on the instrument panel, left of the steering column. Figure 13 shows the on/off buttons for the FCW (top left), stability control (top right), and LDW (bottom left). The Honda's CA systems used two distinct sensors to support their functionality, including a radar sensor and an optical camera sensor. The radar sensor was located in the front grille, while the optical sensor was located on the interior of the windshield in front of the rearview mirror (Figure 14).

Figure 13. View of the Crash Avoidance System Buttons located on the instrument panel left of the steering column

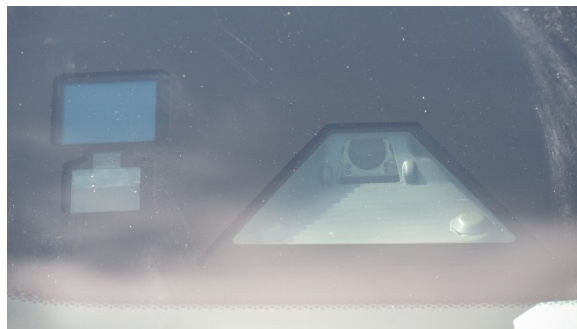
Figure 14. View of the Honda's optical sensor for the FCW and LDW systems

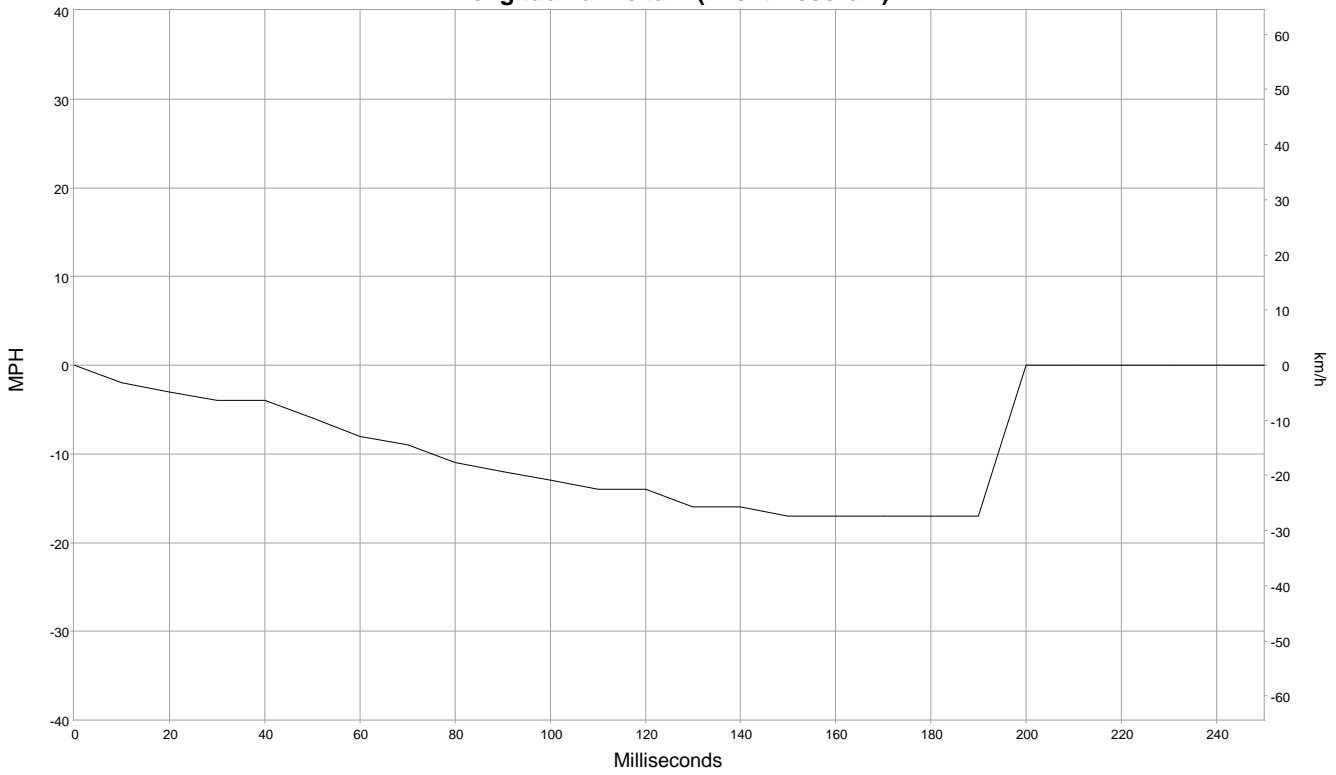
**Longitudinal Delta V (Event Record 1)**

Time (msec)	MPH [km/h]
0	0 [0]
10	-2 [-3]
20	-3 [-5]
30	-4 [-6]
40	-4 [-7]
50	-6 [-10]
60	-8 [-13]
70	-9 [-14]
80	-11 [-18]
90	-12 [-19]
100	-13 [-21]
110	-14 [-22]
120	-14 [-23]
130	-16 [-25]
140	-16 [-26]
150	-17 [-27]
160	-17 [-27]
170	-17 [-27]
180	-17 [-28]
190	-17 [-28]
200	0 [0]
210	0 [0]
220	0 [0]
230	0 [0]
240	0 [0]
250	0 [0]

The maximum longitudinal delta V reported was -28 km/h (-17 mph) at 190 milliseconds after time zero. The maximum lateral delta V was -6 km/h (-4 mph), which occurred at 100 milliseconds after time zero. Associated with the frontal event were the following supplemental restraint system deployment/actuation commands relative to time zero: driver’s retractor pretensioner at 3 ms, driver’s frontal air bag first stage at 18 ms, driver’s frontal air bag second stage at 58 ms, passenger outboard side air bag at 78 ms, and right IC air bag at 25 ms.

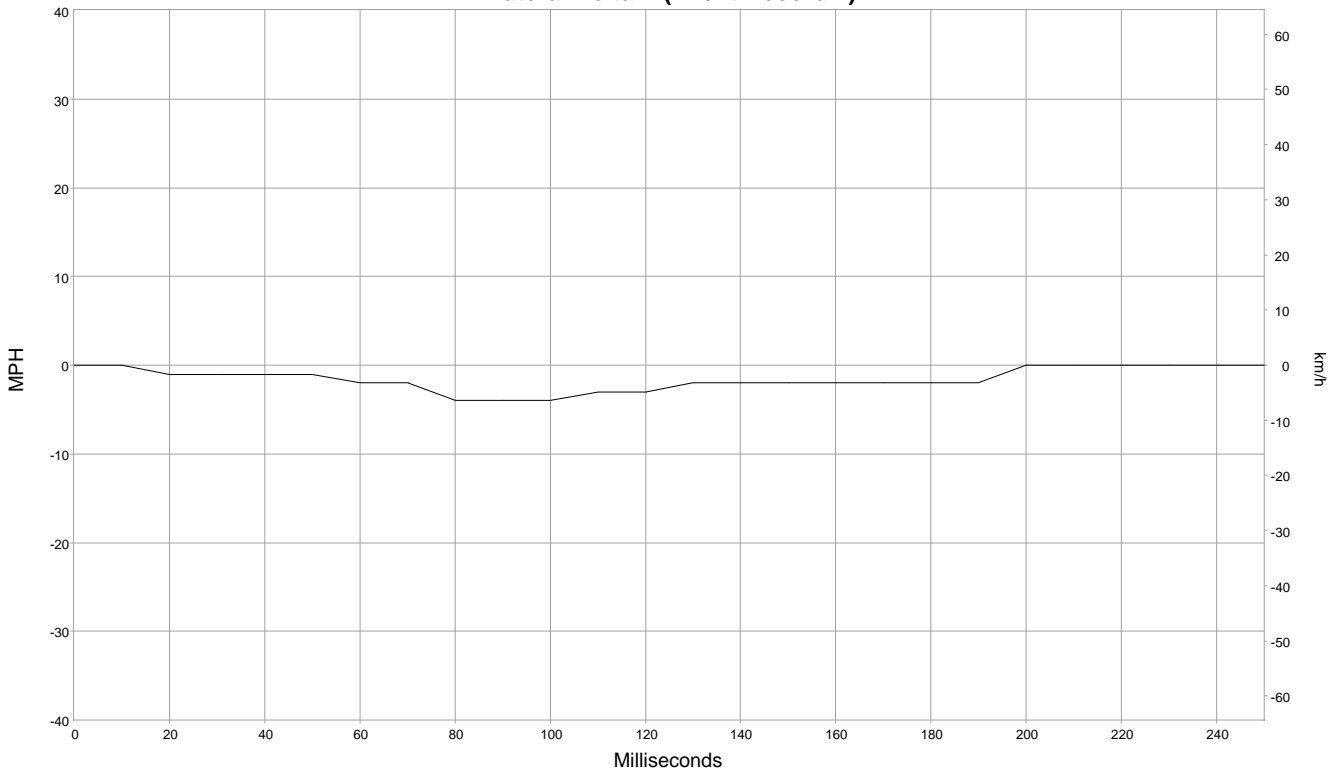
**Lateral Delta V (Event Record 1)**

Time (msec)	MPH [km/h]
0	0 [0]
10	0 [0]
20	-1 [-1]
30	-1 [-1]
40	-1 [-2]
50	-1 [-2]
60	-2 [-3]
70	-2 [-4]
80	-4 [-6]
90	-4 [-6]
100	-4 [-6]
110	-3 [-5]
120	-3 [-5]
130	-2 [-4]
140	-2 [-4]
150	-2 [-4]
160	-2 [-4]
170	-2 [-4]
180	-2 [-4]
190	-2 [-3]
200	0 [0]
210	0 [0]
220	0 [0]
230	0 [0]
240	0 [0]
250	0 [0]

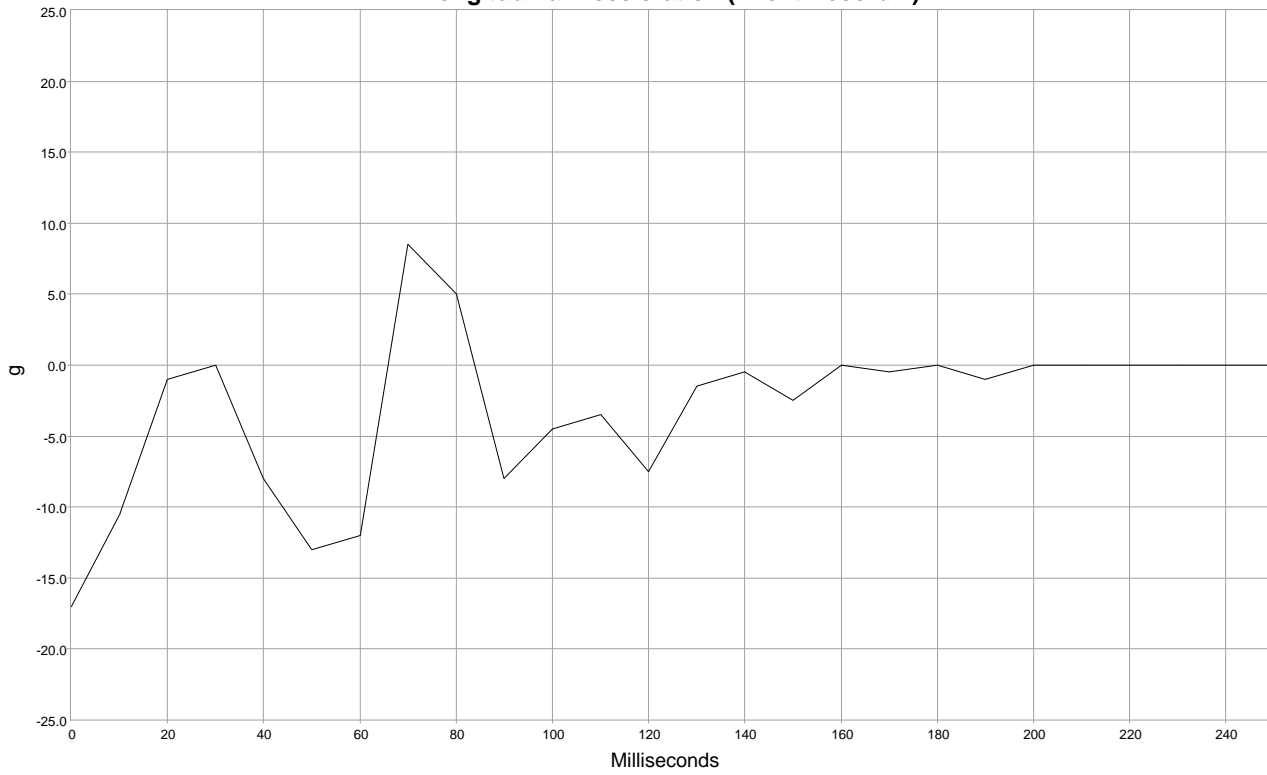
**Longitudinal Acceleration (Event Record 1)**

Time (msec)	g
0	-17.0
10	-10.5
20	-1.0
30	0.0
40	-8.0
50	-13.0
60	-12.0
70	8.5
80	5.0
90	-8.0
100	-4.5
110	-3.5
120	-7.5
130	-1.5
140	-0.5
150	-2.5
160	0.0
170	-0.5
180	0.0
190	-1.0
200	0.0
210	0.0
220	0.0
230	0.0
240	0.0
250	0.0

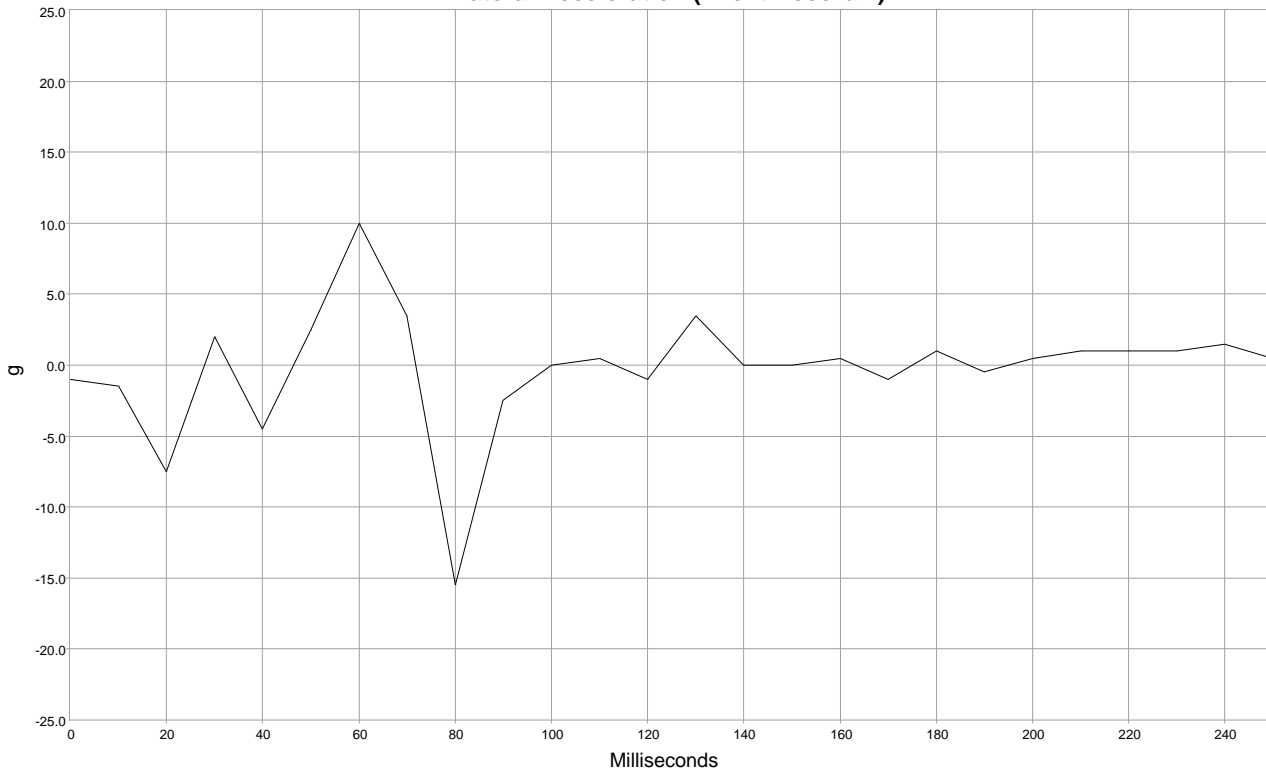
**Lateral Acceleration (Event Record 1)**

Time (msec)	g
0	-1.0
10	-1.5
20	-7.5
30	2.0
40	-4.5
50	2.5
60	10.0
70	3.5
80	-15.5
90	-2.5
100	0.0
110	0.5
120	-1.0
130	3.5
140	0.0
150	0.0
160	0.5
170	-1.0
180	1.0
190	-0.5
200	0.5
210	1.0
220	1.0
230	1.0
240	1.5
250	0.5

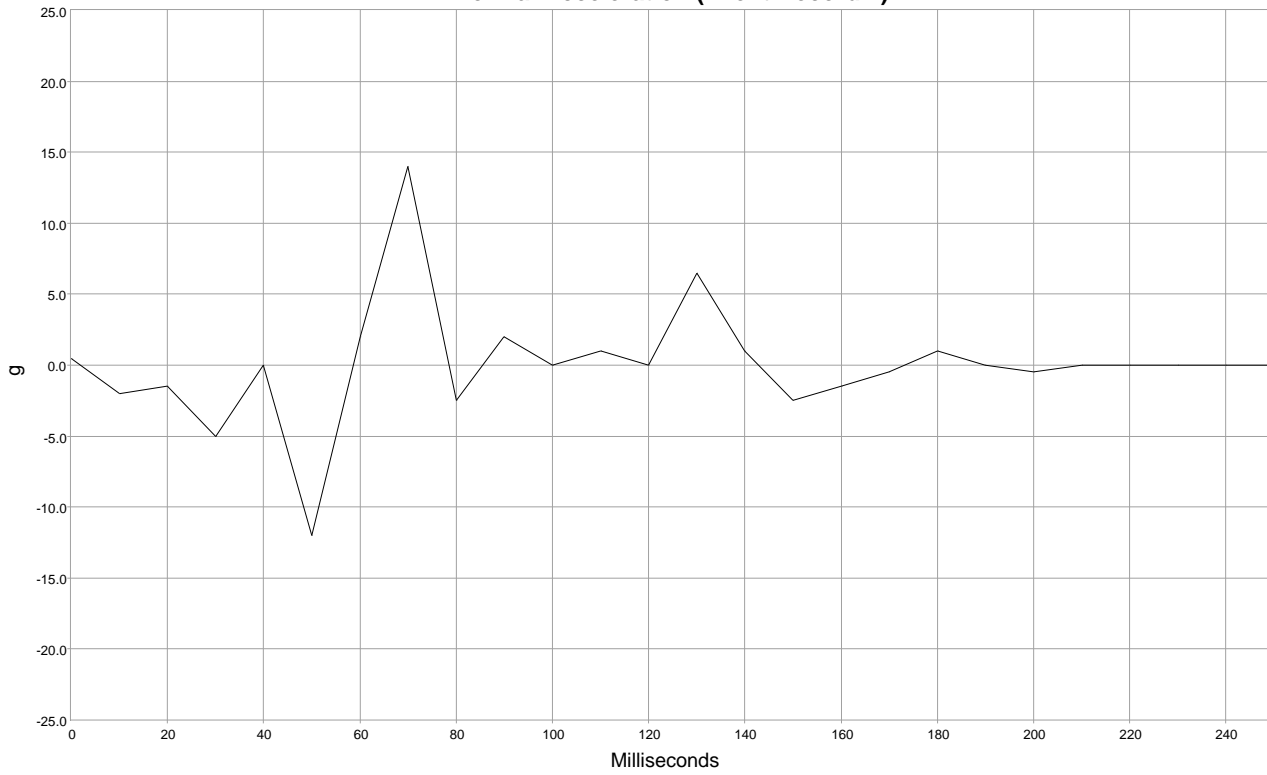
**Normal Acceleration (Event Record 1)**

Time (msec)	g
0	0.5
10	-2.0
20	-1.5
30	-5.0
40	0.0
50	-12.0
60	2.0
70	14.0
80	-2.5
90	2.0
100	0.0
110	1.0
120	0.0
130	6.5
140	1.0
150	-2.5
160	-1.5
170	-0.5
180	1.0
190	0.0
200	-0.5
210	0.0
220	0.0
230	0.0
240	0.0
250	0.0
