U.S. Department  
of Transportation  
**National Highway  
Traffic Safety  
Administration**

DOT HS 813 257

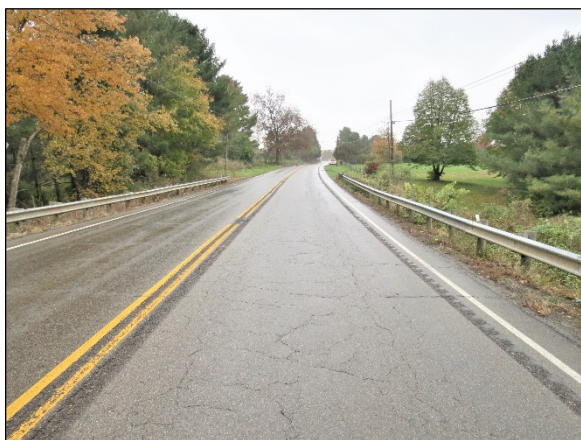
*Figure 2. South-facing view of the roadway for the ambulance's pre-crash travel trajectory*

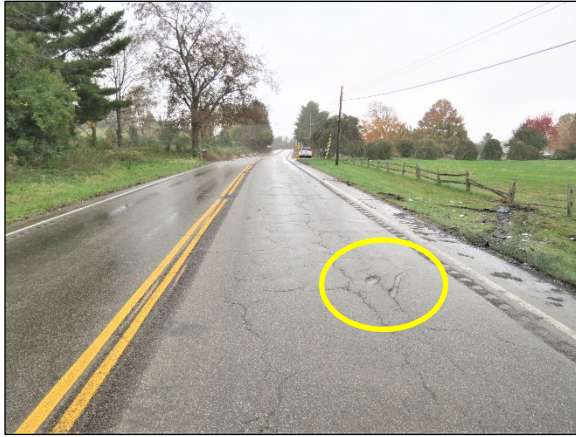
*Figure 4. South-facing view of the roadway and gouge marks at the area of impact*

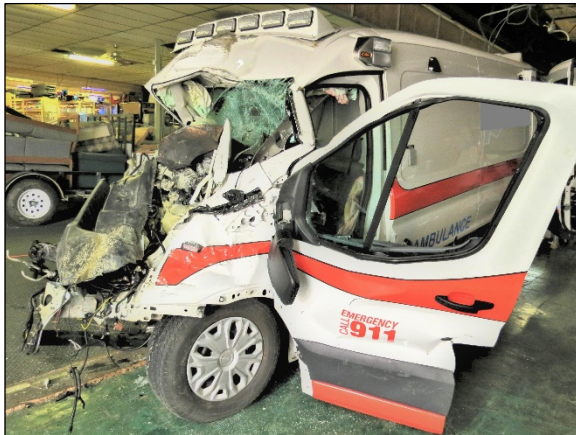
*Figure 7. Left front oblique view of the 2017 Ford Transit Type II ambulance*

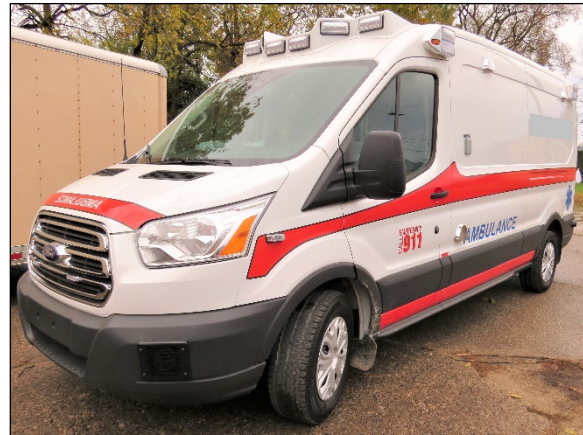
*Figure 8. Left front oblique view of an exemplar Ford Transit ambulance of the same agency*

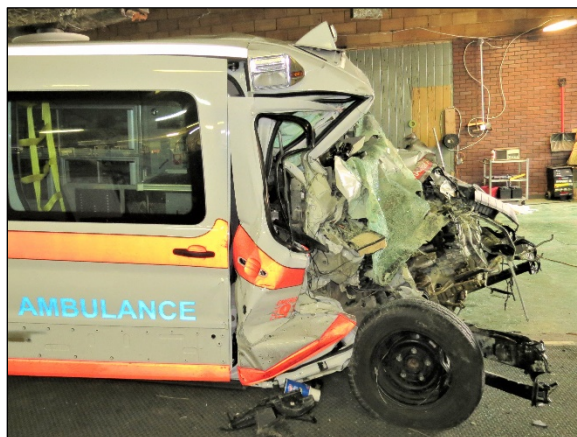
*Figure 10. Right crossing view of the severe front plane damage profile to the ambulance*

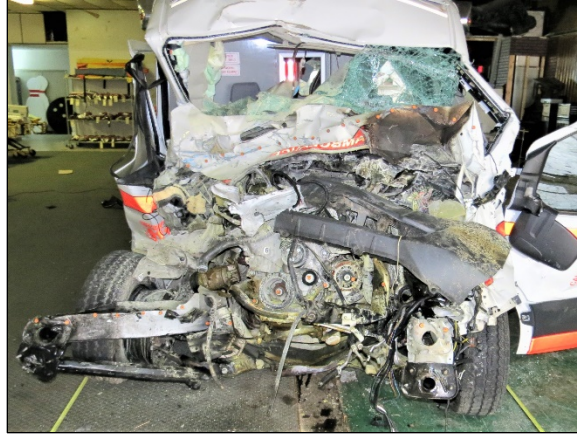
*Figure 11. View of the front plane of the ambulance and the magnitude of the damage extent*

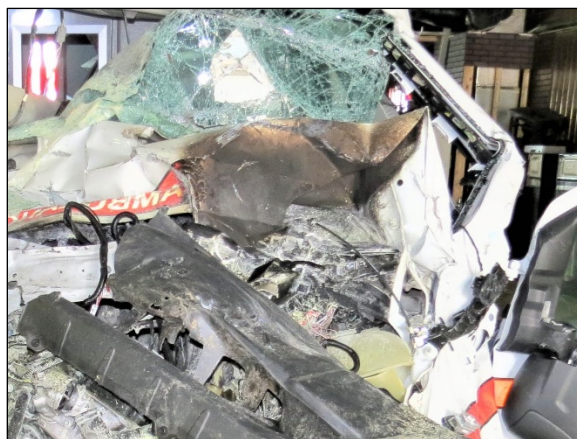
*Figure 12. Discoloration and charring to the ambulance's hood from the minor post-crash fire*

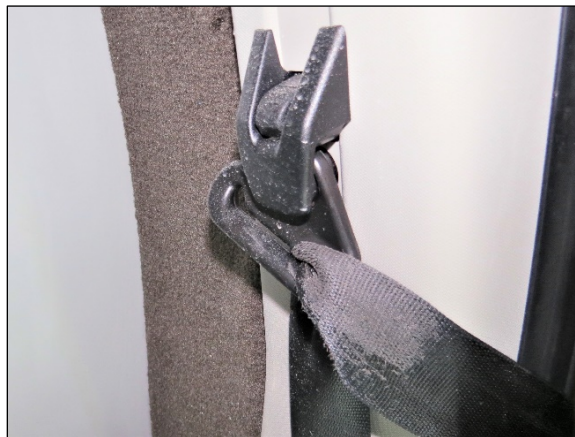
*Figure 15. Driver's seat belt system loading and webbing gathered in the D-ring*

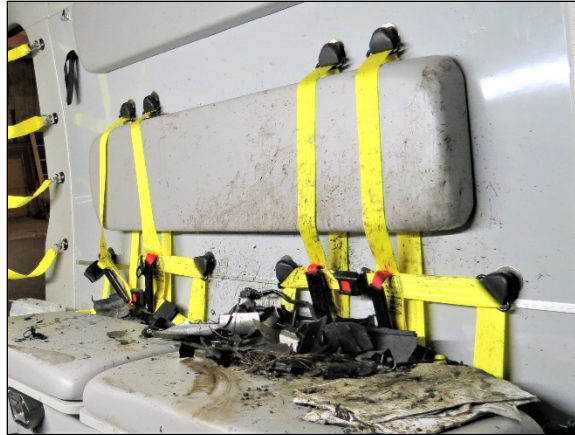
*Figure 16. Multi-point harness systems for the bench seat occupants of the ambulance's patient compartment*

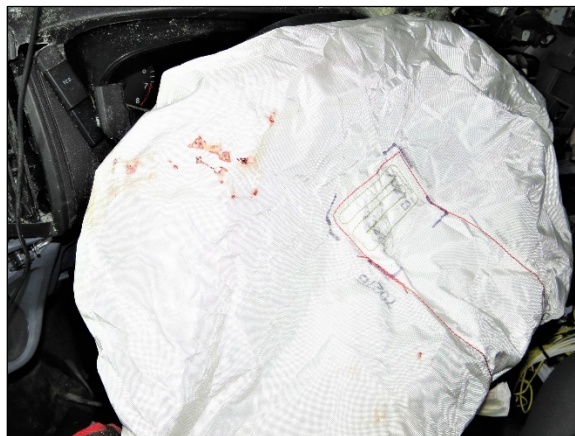
*Figure 17. Deployed driver's frontal air bag in the ambulance at the time of the SCI inspection*

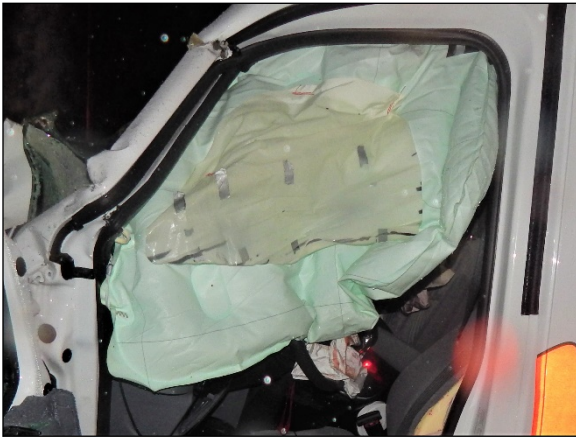
*Figure 18. View of the deployed left IC air bag (on-scene law enforcement image)*

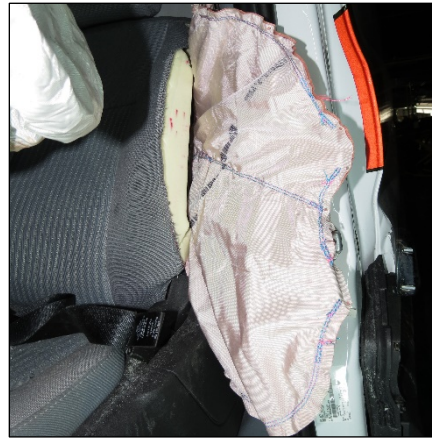
*Figure 19. Deployed driver's seat-mounted side-impact air bag in the ambulance*

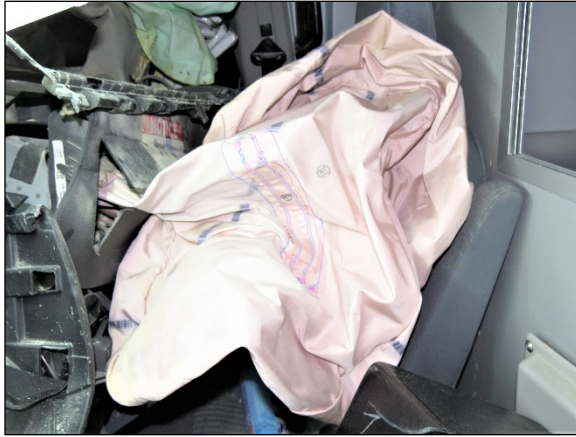
*Figure 20. Deployed passenger's frontal air bag in the ambulance*

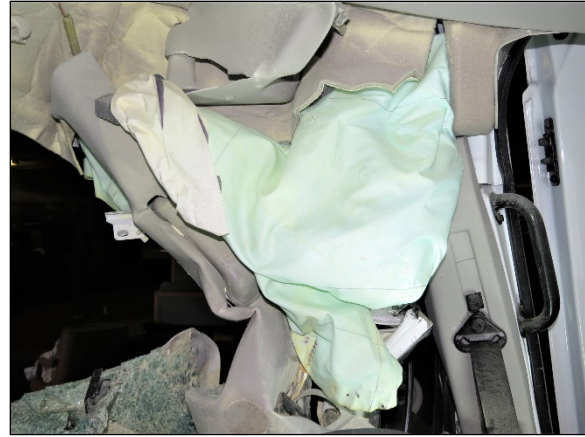
*Figure 21. Right IC air bag deployed in the ambulance and captured in the damage pattern*

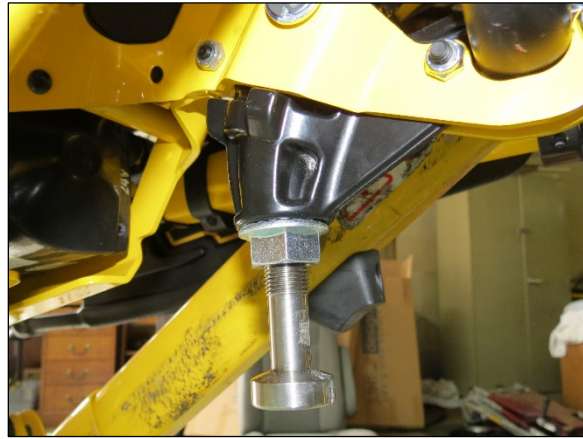
*Figure 26. Head-end bolt securement for the cot.*

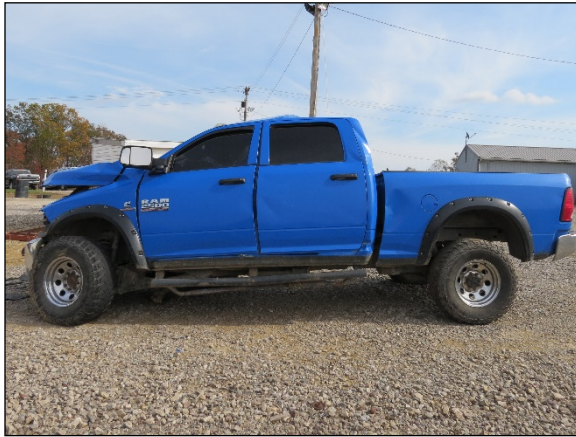
*Figure 27. Left plane view of the RAM at the time of the SCI inspection*

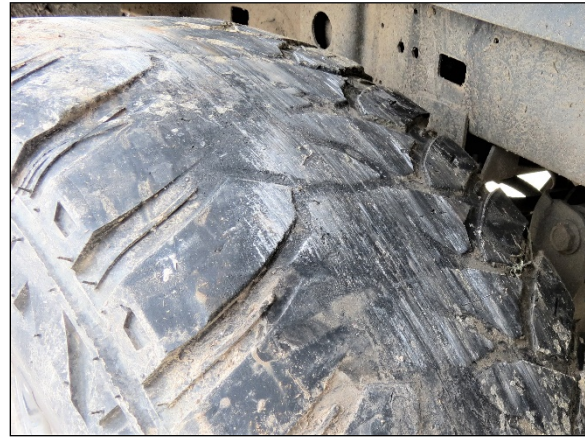
*Figure 28. View of the bald tread of the RAM's right rear tire*

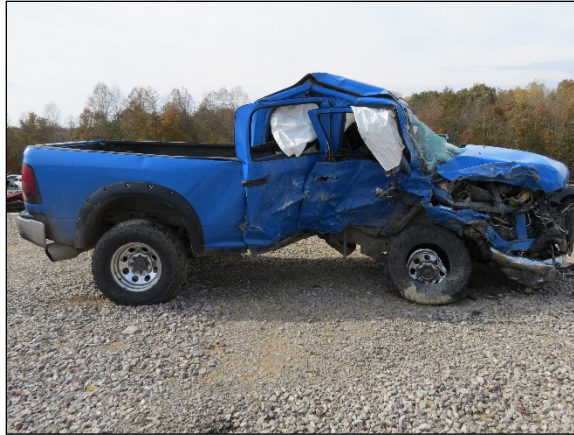
*Figure 29. Right plane damage pattern to the RAM as documented during the SCI inspection*

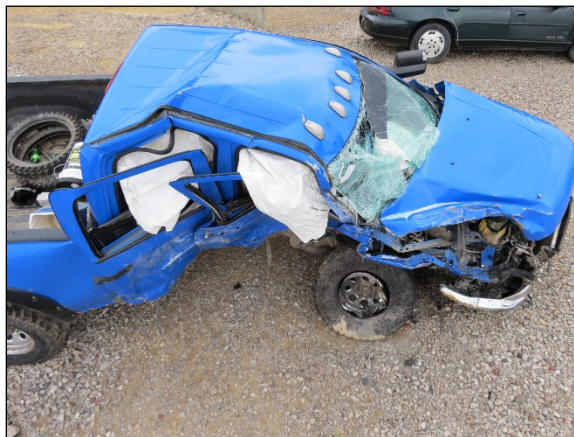
*Figure 30. View of the right plane damage profile to the RAM from an overhead perspective*
