**Special Crash Investigations:
Remote Hyperthermia Fatality
Investigation;
Vehicle: 2016 Toyota Highlander;
Location: Virginia;
Date: June 2020**

Special Crash Investigations
Remote Hyperthermia Fatality Investigation
SCI Case No. CR20021
Vehicle: 2016 Toyota Highlander
Location: Virginia
Incident Date: June 2020

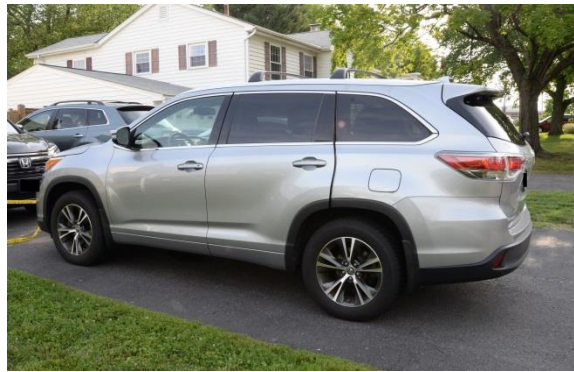
*Figure 1. Involved 2016 Toyota Highlander
(Image provided by the investigating police department.)*

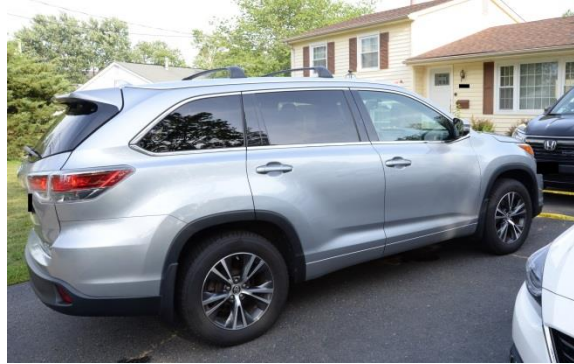
Figure 4. Right plane of the involved 2016 Toyota

Note: This parked location of the Toyota was at the daycare facility where the child was found.

The involved vehicle was a 2016 Toyota Highlander SUV (Figure 4) with the XLE trim package and was an all-wheel-drive platform with four doors and a rear lift gate. The Toyota was identified by Vehicle Identification Number: 5TDJKRFH0GSxxxxxx. Glazing consisted of an AS1 laminated windshield, AS2 operable front door windows, AS3 (deep tint) operable second-row door windows, and AS3 fixed side quarter windows and backlight. The Toyota had an operable roof window that was AS3 deep-tinted. During this event, all operable windows were closed and the interior cover for the roof window was closed. The exterior color of the Toyota was silver with a matching silver interior with leather surfaced seats and interior trim.

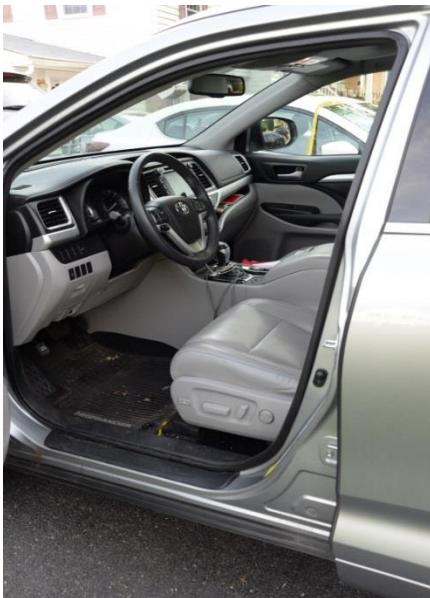
*Figure 5. Front row of the Toyota Highlander
(Image provided by the investigating police
department.)*

The interior of the Toyota had front-row bucket seats (Figure 5), second-row captain's chairs (Figure 6), and a three-passenger third-row seat.

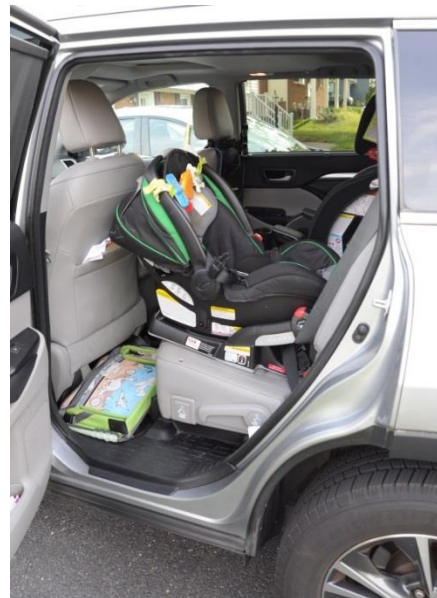
*Figure 6. Second row of the Toyota
Highlander and the rear-facing CRS (Image
provided by the investigating police
department.)*

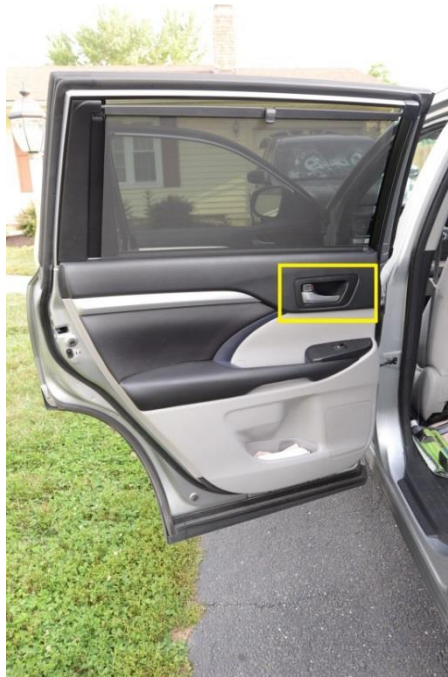
The interior door release levers were flush-mounted in pockets in the upper forward quadrants of the door panels (Figure 7). The levers were hinged at the aft aspect. In the locked mode, the doors did not open by pulling on the door lever. Additionally, the rear doors had child locks to prevent unwarranted opening of the rear doors by children. The status of this manually operated locking feature was not reported.

Figure 7. Left rear door panel documenting the door release lever, the lock lever, and the sun shade (Image provided by the investigating police department.)

The rear door windows had retractable interior sun shades. Based on the images provided by police, the sun shade for the left rear door was in the up/used position.

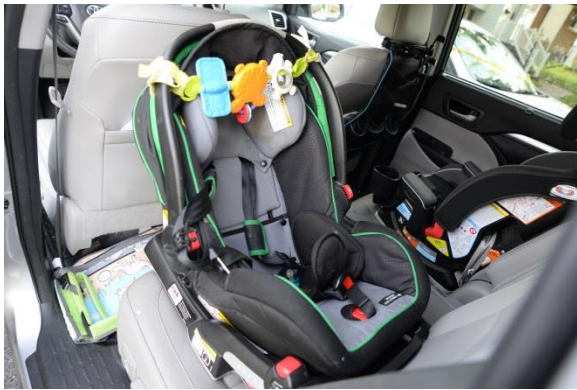
The 11-month old child was secured in a rear-facing CRS by the integrated 5-point harness system throughout the duration of this incident. The CRS was a Graco Snug CK 40 with a model number of 1914326 and a date of manufacture of April 7, 2014 (Figure 8). The CRS was recommended for rear-facing use only for children 1.8 to 18 kg (4 to 40 lb) and less than 89 cm (35 in) in height. The CRS consisted of a molded plastic shell with a detachable base. Eight recline positions were provided and at the time of this incident the CRS was adjusted to position 1 (Figure 9). The CRS had a 5-point integrated harness system with a chest clip and a center-mounted buckle for securing the individual harness latch plates.

Figure 8. Graco CRS (Image provided by the investigating police department.)

The CRS had LATCH (lower anchors and tethers for children) to secure the base to the LATCH anchors in the vehicle. The shell of the CRS had a designated belt path to use when using the vehicle's 3-point seat belt system for restraint. Based on the on-scene police images, the base of the CRS was secured with the lower anchors and the vehicle's seat belt was routed through the belt path of the shell. Both belt systems appeared to be taut.

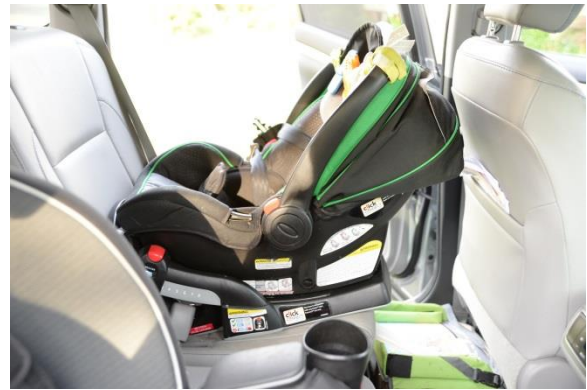
Figure 9. Reclined position of the CRS behind the driver's seat (Image provided by the investigating police department.)
