DOT HS 813 297

**Special Crash Investigations:  
On-Site Reported Cruise Control  
Malfunction Crash Investigation;  
Vehicle: 2017 GMC Acadia;  
Location: Pennsylvania;  
Crash Date: July 2018**

**Special Crash Investigations**  
**On-Site Reported Cruise Control Malfunction Crash Investigation**  
**Office of Defects Investigation**  
**Case Number: CR18022**  
**Vehicle: 2017 GMC Acadia**  
**Location: Pennsylvania**  
**Crash Date: July 2018**

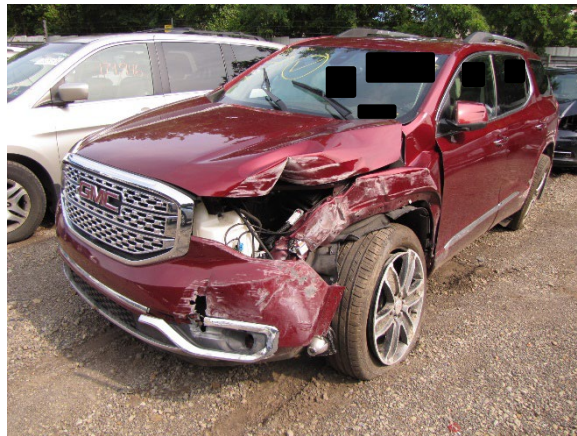
*Figure 1. Left-front oblique view of the GMC Acadia*

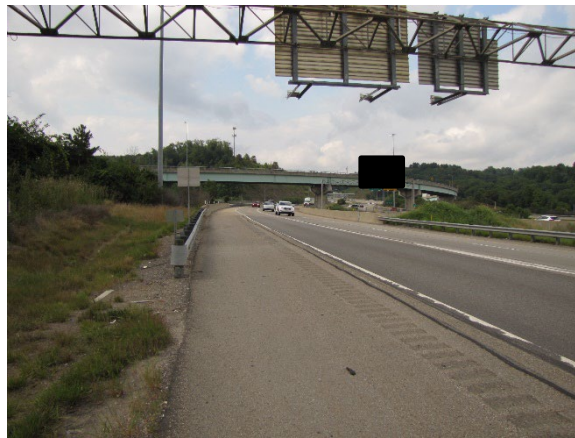
*Figure 2. Lookback view northward along the GMC's pre-crash travel trajectory*

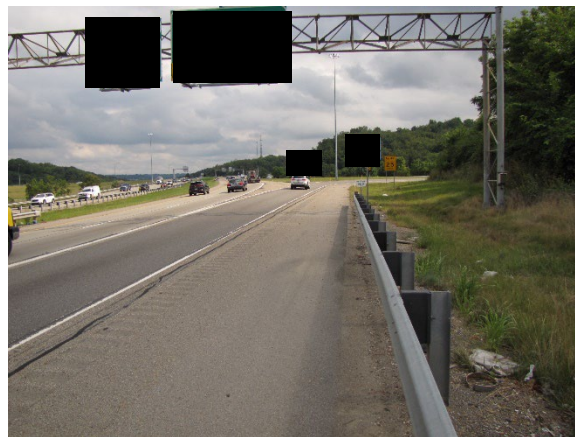
*Figure 3. South-facing trajectory view of the GMC at the exit*

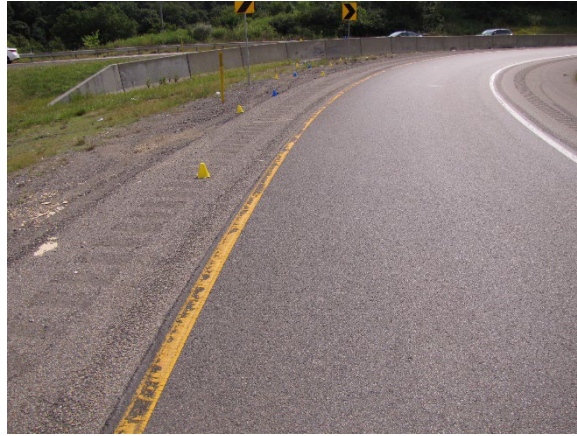
*Figure 4. South-facing trajectory view of the GMC on the exit ramp and its road departure*

The exit ramp was 4.0 m (13.1 ft) wide (Figure 4). A solid yellow line on the left and a solid white line on the right delineated the ramp. At the point of the roadway departure, the radius of the curve measured 60.0 m (196.9 ft) with a level grade and the super-elevation measured 7.3 percent. There were a 1.6 m (5.2 ft) wide left shoulder and a 3.3 m (10.8 ft) wide right shoulder, both of which contained rumble strips cut into their surfaces. Jersey-style concrete barrier sections oriented parallel to the ramp were located on the roadside 6.1 m (20.0 ft) from the left pavement edge. Each barrier section measured 3.7 m (12.1 ft) long and 1.2 m (3.9 ft) tall. Three arcing tire marks on the left shoulder and roadside evidenced the GMC's road departure. The left rear tire mark began on the yellow line and led to the barrier impact, with a total length that measured 24.2 m (79.4 ft). The yellow and blue cones in the images denote the tire marks. The tire marks indicated that the GMC was in a clockwise yaw. A crash diagram is included at the end of this report.

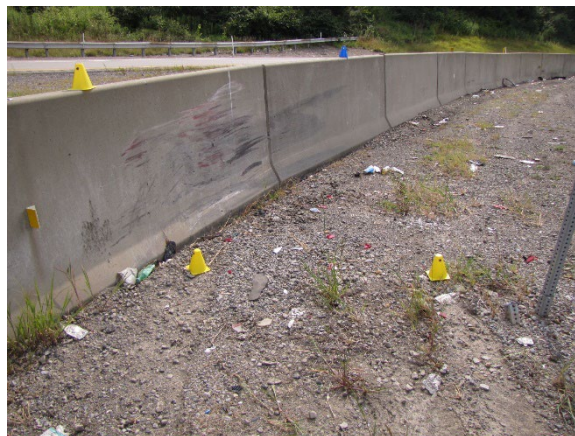
The left-front corner of the GMC struck the barrier (Event 1). Figure 5 is a southwest-facing trajectory view of the GMC at impact with the barrier. The yellow cones in the center of the image denote the ends of the left-front and right tire marks. The signpost in the image was not struck by the GMC. Abrasions and paint transfer to the concrete surface of the barrier evidenced the impact. Based on the reconstructed trajectory of the vehicle, the angle between the barrier face and the left plane of the GMC measured approximately 30 degrees. At impact, the air bags in the GMC deployed. The impact force of the GMC displaced two of the barrier sections approximately 15 cm (6 in) to the south. The barrier redirected the heading angle of the GMC to the west and the left plane/rear aspect of the vehicle struck the barrier in a side-slap. The length of the direct contact to the barrier measured 4.4 m (14.4 ft). The corresponding damage to the GMC was located at the forward third (Event 1) and the aft third of its left plane (Event 2). The GMC separated from the barrier, and with its momentum depleted, came to rest on the roadside at an unspecified location.

*Figure 5. Southwest-facing image of the barrier showing its impact damage*

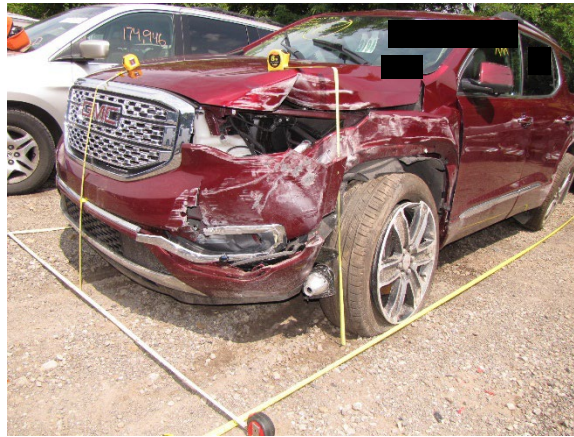
The GMC sustained impact damage to its front and left planes during the barrier impact. The Event 1 damage, located on the front plane, began 59 cm (23.2 in) left of center and extended 30 cm (11.8) to the left corner (Figure 7). The extreme left end of the bumper reinforcement was involved in the impact (Figure 8). It was abraded, without residual crush. This damage pattern wrapped around the left corner, extended 148 cm (58.3 in) along the left fender, and ended at the leading edge of the left-front door. The fender was crushed laterally and abraded. The left-front wheel rim was fractured, and the tire was aired out. The collision deformation classification assigned to this damage pattern was 11FLEE5. Analysis of this corner impact was beyond the scope of the WinSMASH program due to the corner impact configuration.

*Figure 7. Left-front oblique view of the GMC's Event 1 damage*

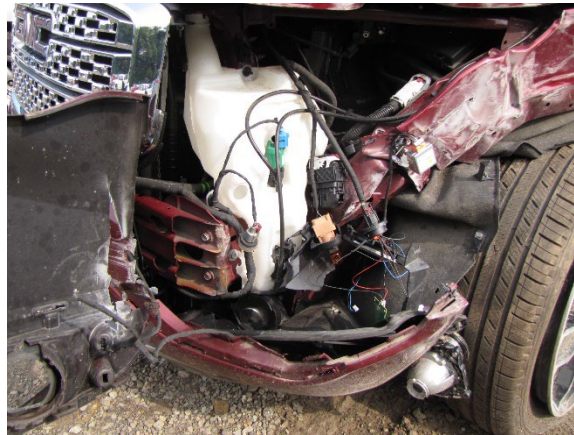
*Figure 8. Close-up view of the minimal damage at the left end of the GMC's front bumper reinforcement*

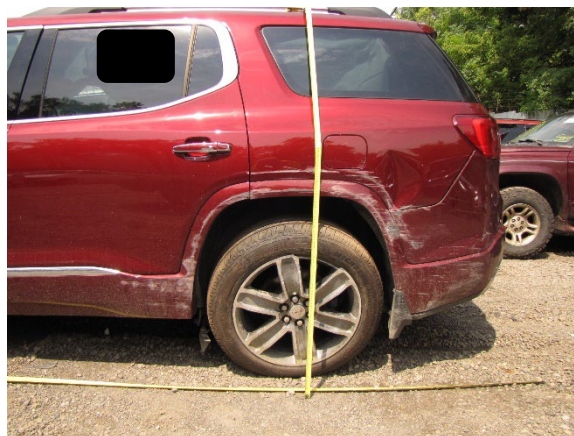
The left plane sustained damage located at its rear third (Figure 9). This region of damage began 75 cm (29.5 in) forward of the left rear axle and extended rearward 164 cm (64.6 in) spanning the quarterpanel. The damage consisted of longitudinal abrasions along the body panel with minimal lateral deformation. The left-rear wheel rim was fractured, and the wheel was canted.

The axle was bent. The wheelbase dimension was unchanged. The CDC assigned to this damage pattern was 10LZEW1. Analysis of this impact was beyond the scope of the WinSMASH program.

*Figure 9. Left view of the GMC's Event 2 damage*

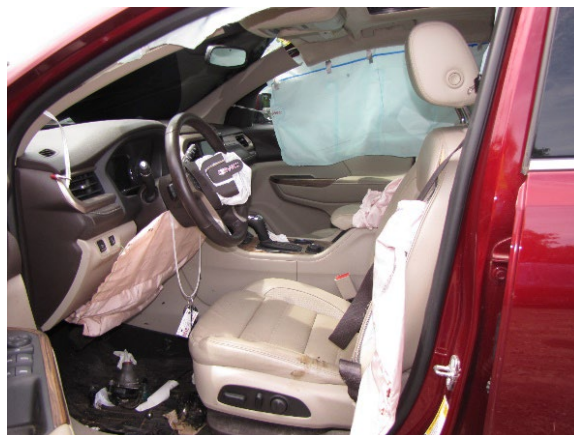
There was no observed interior damage or intrusion to the GMC attributable to the exterior force of the crash (Figure 10). All the glazing remained intact. There was no residual evidence of occupant contact to any components of the interior. The only interior damage was associated with the deployment of the vehicle’s safety systems.

*Figure 10. Left interior view of the GMC's front row*

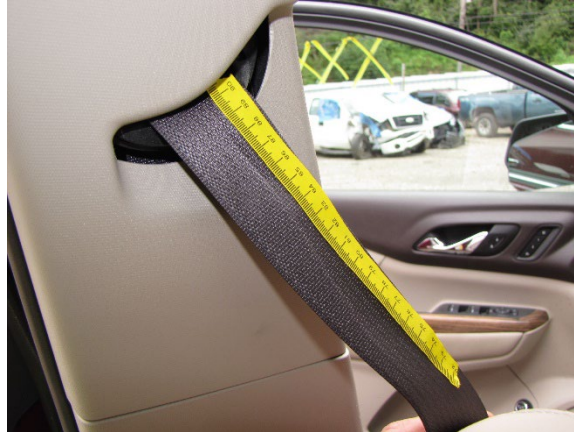
The physical evidence observed during the SCI vehicle inspection indicated that the driver used the seat belt system at the time of the crash. The retractor pretensioner actuated with 134 cm (52.8 in) of webbing extended from the D-ring to the lower anchor. Driver loading of the seat belt system was evidenced by a 13 cm (5.1 in) crease in the shoulder portion of the webbing (Figure 11), originating at the D-ring and extending toward the latch plate. There was an additional crease located at the buckled position of the latch plate. The observed evidence of use was consistent with the buckled status recorded by the EDR.

*Figure 11. GMC interior image showing the crease in the driver's shoulder belt webbing at the left D-ring*

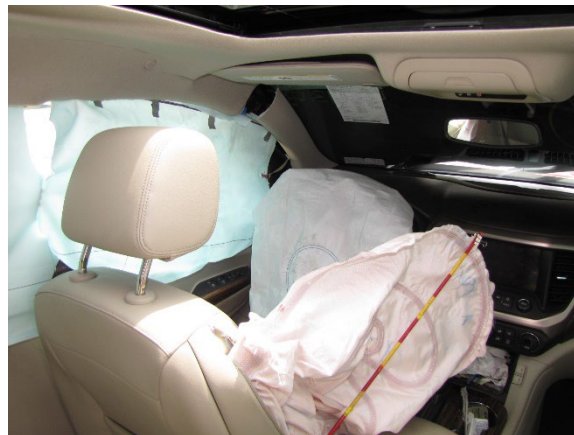
The driver's frontal air bag, knee air bag, seat-mounted side impact air bag, seat inboard air bag, and combination IC air bags deployed (Figures 12 and 13) as a result of the crash. All air bags deployed as designed and were devoid of occupant contact evidence. The driver, surrounded and cocooned by the deployed air bags, was protected from contacting the hard surfaces of the vehicle's interior, which likely mitigated injury.

*Figure 12. Oblique interior view showing the deployed air bags at the driver's position*

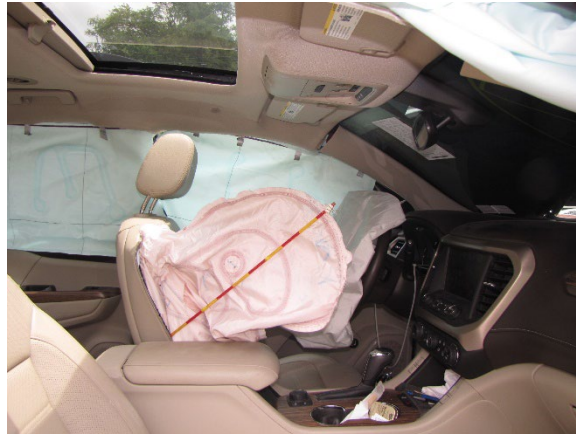
*Figure 13. Right interior view of the GMC's front row and the deployed air bags*

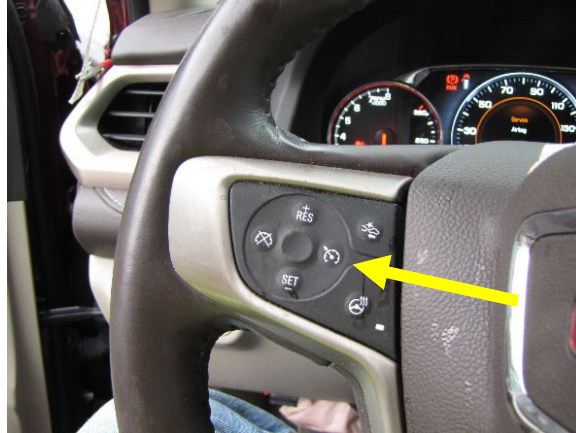
The cruise control operated via a control pad integrated into left spoke of the steering wheel rim (Figure 14). The driver stated that he was operating the vehicle at a set speed of 97 km/h (60 mph) as he approached the exit. He stated in his crash notification that during the approach he turned the cruise control off, apparently planning to coast to a safe speed. A short time later, he realized that the cruise control did not disengage, and he attempted to disengage it by applying the brakes. He reported to the police investigator that it seemed like the car kept going.

*Figure 14. Interior view of the GMC's steering wheel and the operational pad for the cruise control*

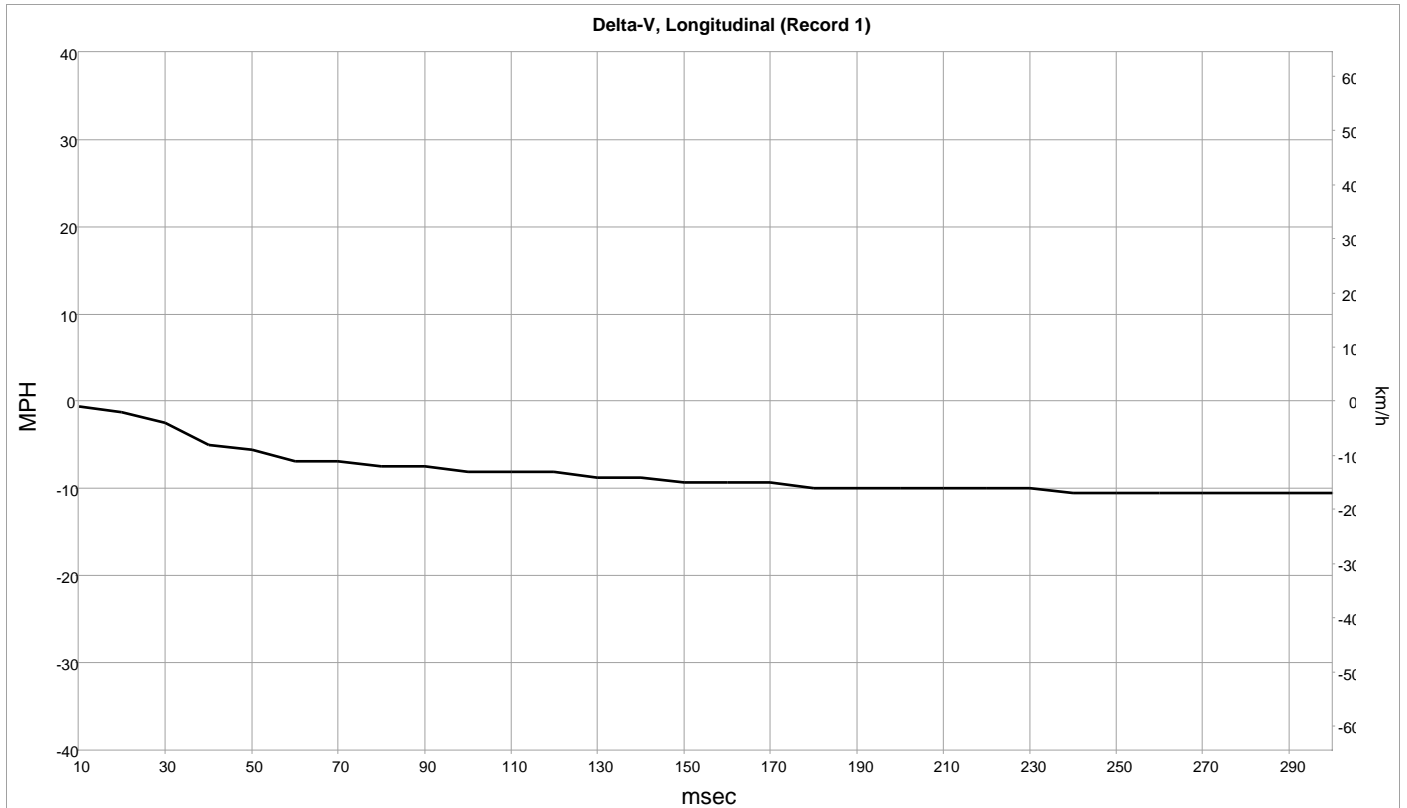
**Longitudinal Delta-V (Record 1)**

The reported maximum recorded longitudinal delta V was -17 km/h (-10.6 mph) at 252 milliseconds. The maximum lateral delta V was 33 km/h (20.5 mph) at 220 milliseconds. The recorded actuation/deployment times for supplemental safety systems of the GMC are listed below:

<b>Time (msec)</b>	<b>Delta-V, Longitudinal (SDM Recorded Vehicle Longitudinal Velocity Change for FSR Event) (MPH [km/h])</b>
10	-1 [-1]
20	-1 [-2]
30	-2 [-4]
40	-5 [-8]
50	-6 [-9]
60	-7 [-11]
70	-7 [-11]
80	-7 [-12]
90	-7 [-12]
100	-8 [-13]
110	-8 [-13]
120	-8 [-13]
130	-9 [-14]
140	-9 [-14]
150	-9 [-15]
160	-9 [-15]
170	-9 [-15]
180	-10 [-16]
190	-10 [-16]
200	-10 [-16]
210	-10 [-16]
220	-10 [-16]
230	-10 [-16]
240	-11 [-17]
250	-11 [-17]
260	-11 [-17]
270	-11 [-17]
280	-11 [-17]
290	-11 [-17]
300	-11 [-17]

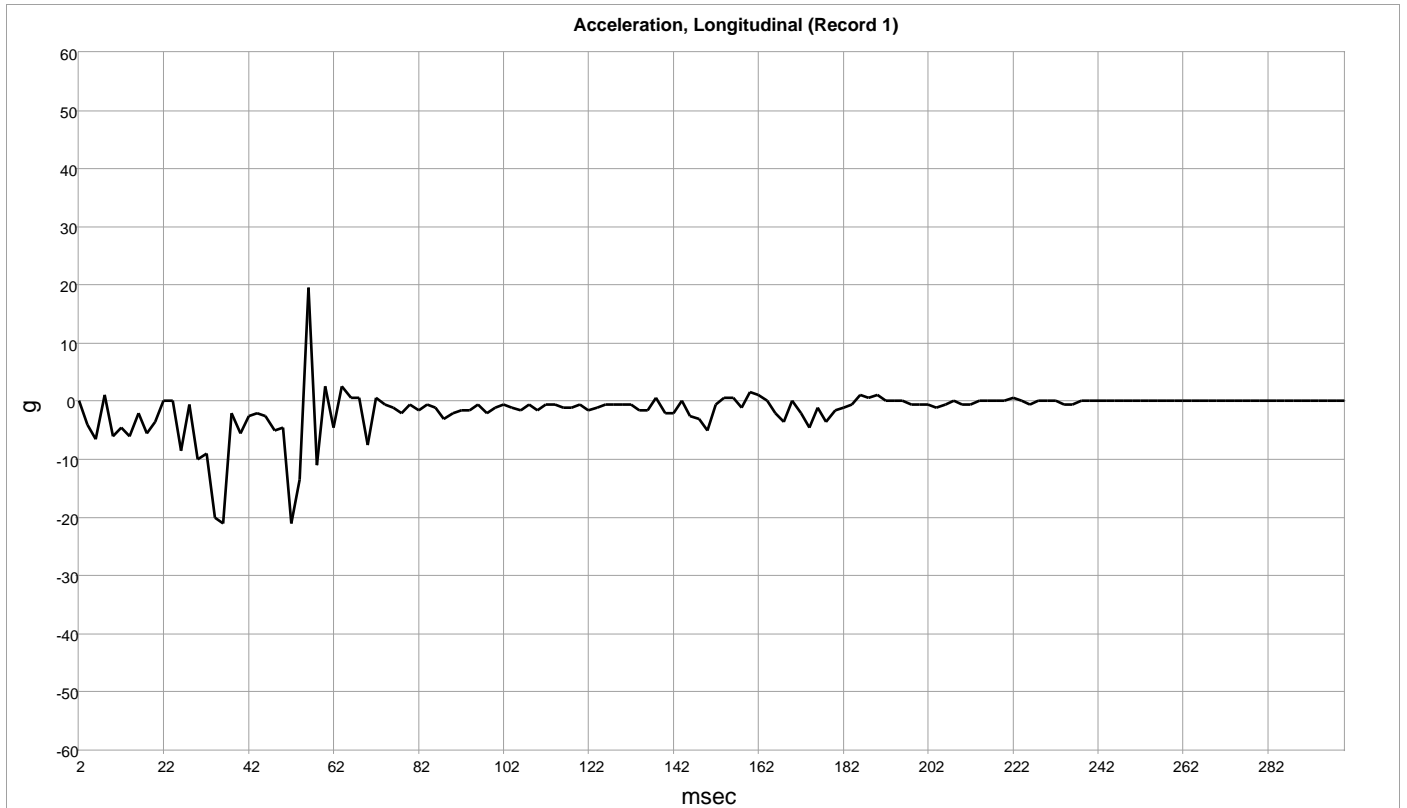
### Longitudinal Acceleration (Record 1)

Time (msec)	Longitudinal Acceleration (SDM Recorded Vehicle Longitudinal Acceleration for FSR Event) (g)
2	0.00
4	-4.00
6	-6.50
8	1.00
10	-6.00
12	-4.50
14	-6.00
16	-2.00
18	-5.50
20	-3.50
22	0.00
24	0.00
26	-8.50
28	-0.50
30	-10.00
32	-9.00
34	-20.00
36	-21.00
38	-2.00
40	-5.50
42	-2.50
44	-2.00
46	-2.50
48	-5.00
50	-4.50
52	-21.00
54	-13.50
56	19.50
58	-11.00
60	2.50
62	-4.50
64	2.50
66	0.50
68	0.50
70	-7.50
72	0.50
74	-0.50
76	-1.00
78	-2.00
80	-0.50
82	-1.50
84	-0.50
86	-1.00
88	-3.00
90	-2.00
92	-1.50
94	-1.50
96	-0.50
98	-2.00
100	-1.00
102	-0.50
104	-1.00
106	-1.50
108	-0.50
110	-1.50
112	-0.50

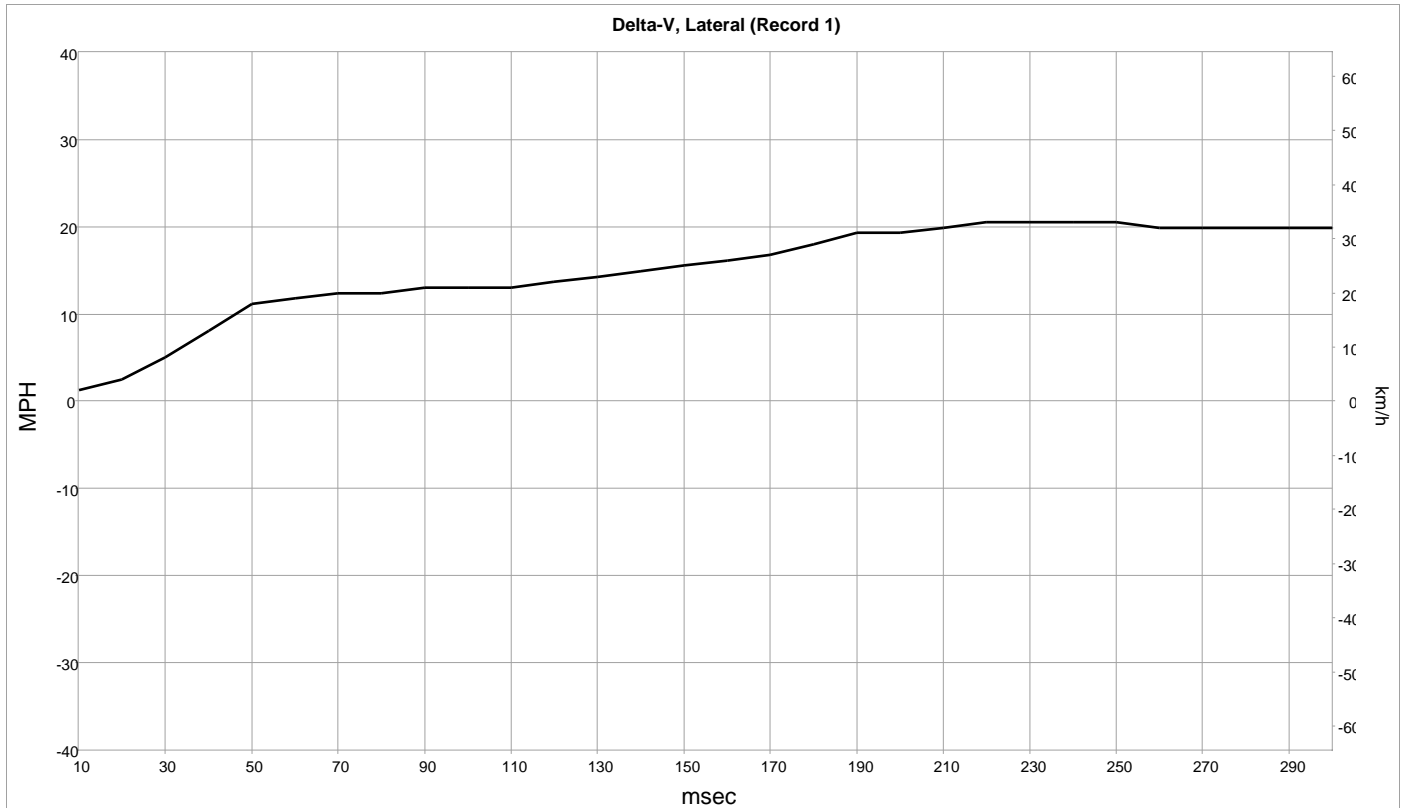
**Lateral Delta-V (Record 1)**

<b>Time (msec)</b>	<b>Delta-V, Lateral (SDM Recorded Vehicle Lateral Velocity Change for FSR Event) (MPH [km/h])</b>
10	1 [2]
20	2 [4]
30	5 [8]
40	8 [13]
50	11 [18]
60	12 [19]
70	12 [20]
80	12 [20]
90	13 [21]
100	13 [21]
110	13 [21]
120	14 [22]
130	14 [23]
140	15 [24]
150	16 [25]
160	16 [26]
170	17 [27]
180	18 [29]
190	19 [31]
200	19 [31]
210	20 [32]
220	21 [33]
230	21 [33]
240	21 [33]
250	21 [33]
260	20 [32]
270	20 [32]
280	20 [32]
290	20 [32]
300	20 [32]

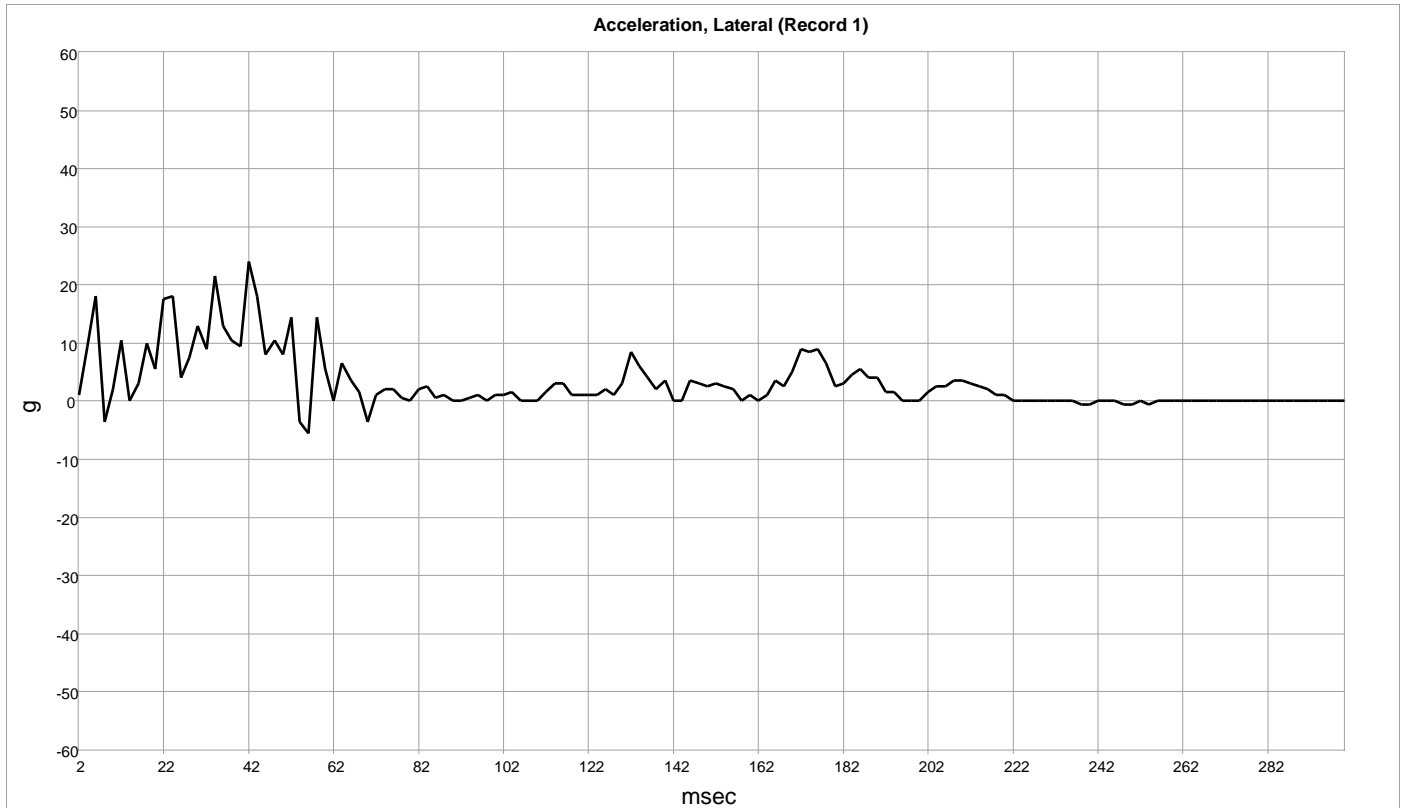
### Lateral Acceleration (Record 1)

Time (msec)	Lateral Acceleration (SDM Recorded Vehicle Lateral Acceleration for FSR Event) (g)
2	1.00
4	9.50
6	18.00
8	-3.50
10	2.00
12	10.50
14	0.00
16	3.00
18	10.00
20	5.50
22	17.50
24	18.00
26	4.00
28	7.50
30	13.00
32	9.00
34	21.50
36	13.00
38	10.50
40	9.50
42	24.00
44	18.00
46	8.00
48	10.50
50	8.00
52	14.50
54	-3.50
56	-5.50
58	14.50
60	5.50
62	0.00
64	6.50
66	3.50
68	1.50
70	-3.50
72	1.00
74	2.00
76	2.00
78	0.50
80	0.00
82	2.00
84	2.50
86	0.50
88	1.00
90	0.00
92	0.00
94	0.50
96	1.00
98	0.00
100	1.00
102	1.00
104	1.50
106	0.00
108	0.00
110	0.00
112	1.50
114	3.00
