U.S. Department
of Transportation

**National Highway
Traffic Safety
Administration**

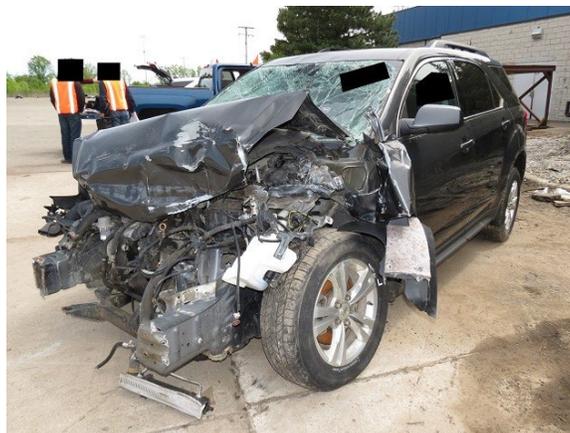
Figure 1. The 2011 Chevrolet Equinox

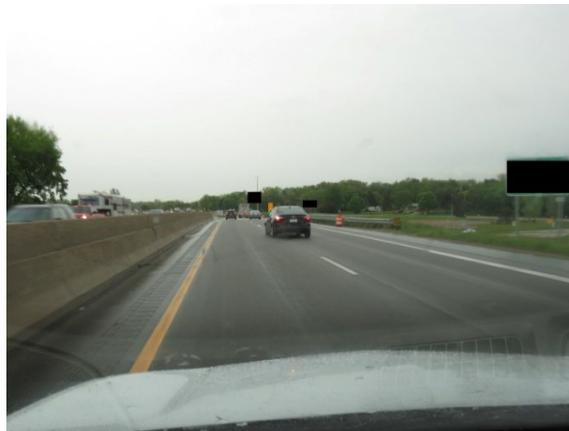
Figure 2. Crash site looking north

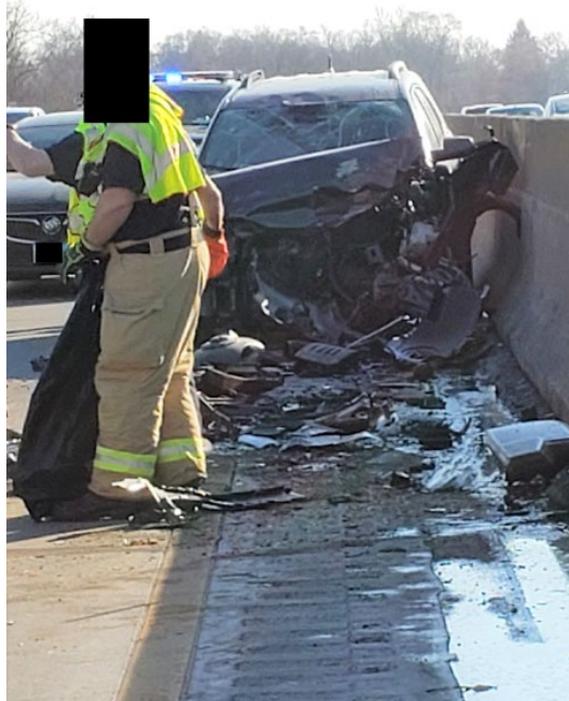
Figure 3. Final rest view looking south, the 2011 Chevrolet Equinox (driver on-scene image)

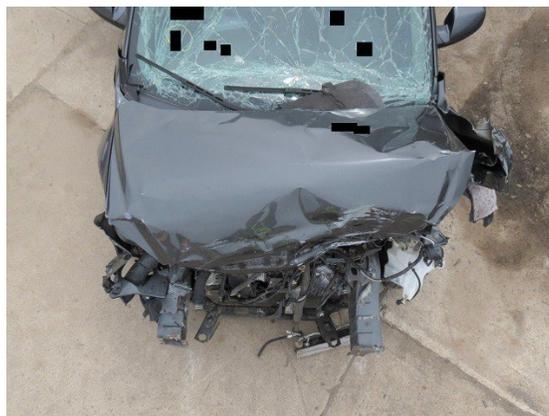
Figure 4. Front-plane damage, the 2011 Chevrolet Equinox

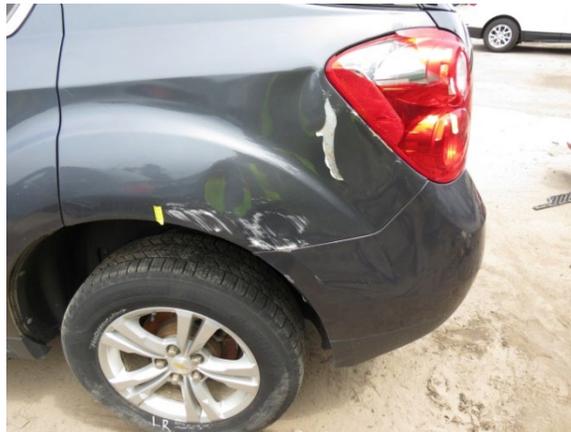
Figure 5. Left-plane damage, the 2011 Chevrolet Equinox

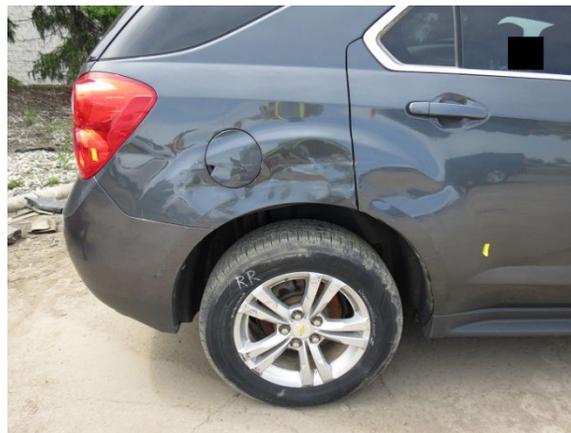
Figure 6. Right-plane damage, the 2011 Chevrolet Equinox

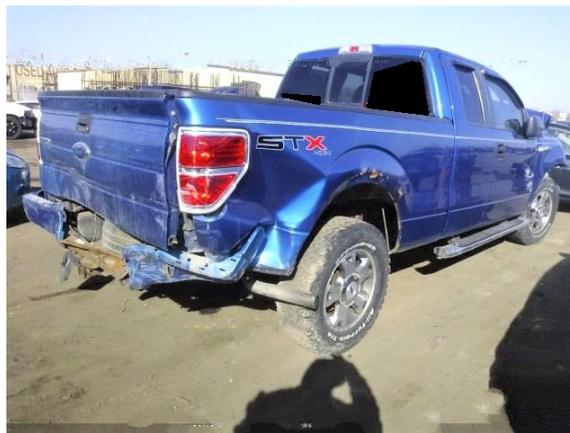
Figure 7. Back- and right-plane damage, the 2010 Ford F-150 (salvage lot image)

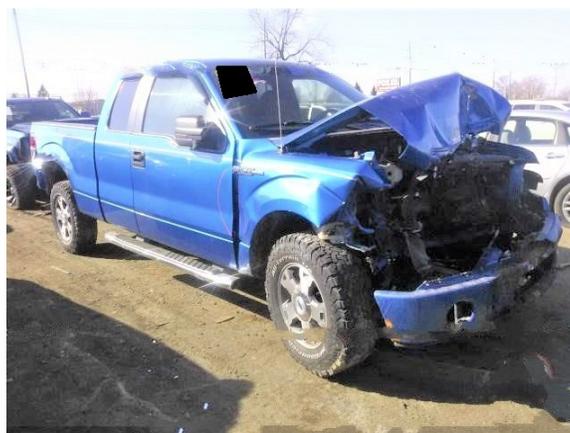
Figure 8. Front- and right-plane damage, the 2010 Ford F-150 (salvage lot image)

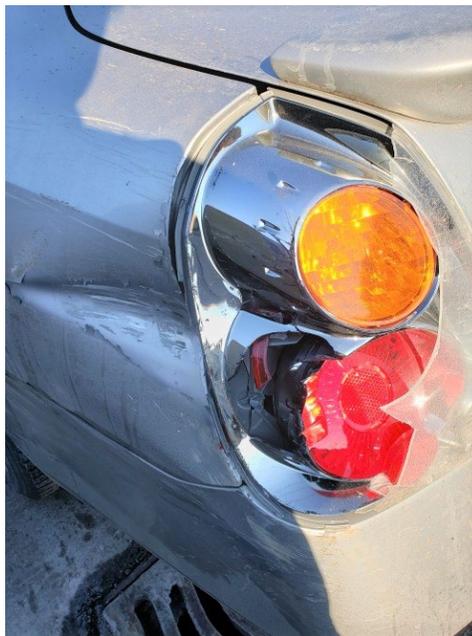
Figure 9. Impact damage, the 2004 Nissan Altima (driver image)
