DOT HS 813 361

**Special Crash Investigations:
On-Site Reported Brake System
Malfunction Crash Investigation;
Vehicle: 2014 Chevrolet Silverado
1500;
Location: North Carolina;
Crash Date: June 2019**

Special Crash Investigations
On-Site Reported Brake System Malfunction Crash Investigation
Office of Defects Investigation
Case Number: CR19035
Vehicle: 2014 Chevrolet Silverado 1500
Location: North Carolina
Crash Date: June 2019

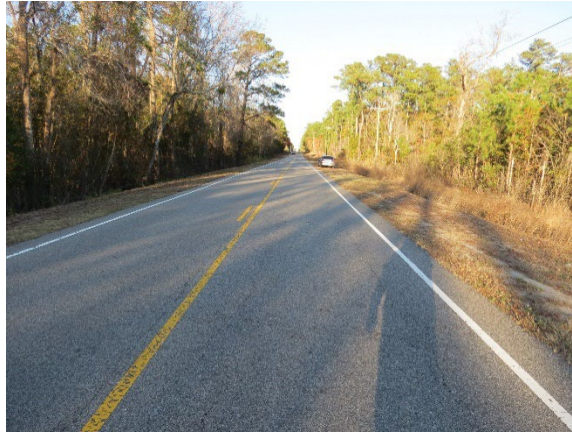
Figure 2. Eastbound view of the Chevrolet's pre-crash approach to the crash site

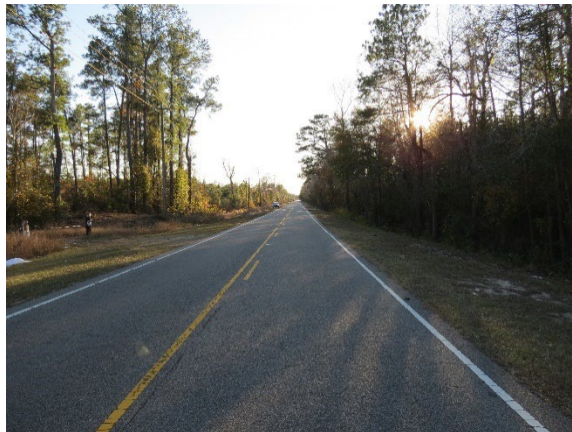
Figure 3. Westbound view of the Mitsubishi's pre-crash approach to the crash site

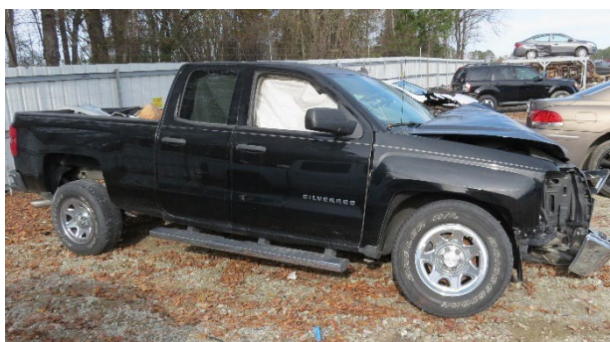
Figure 4. Right plane view of the 2014 Chevrolet Silverado 1500 during the SCI vehicle inspection

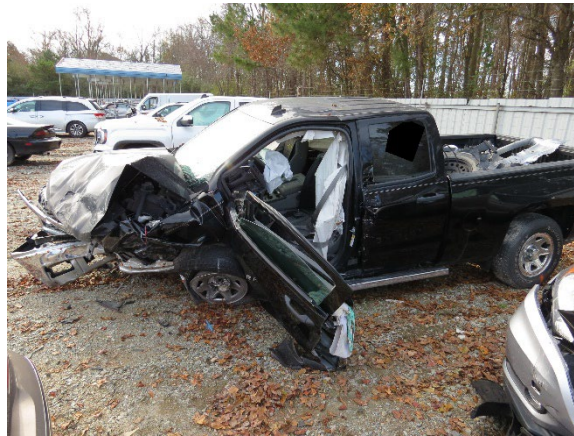
This crash involved the Chevrolet's front plane and the damage pattern resembled an off-set profile heavily biased to the front left aspect. There was significant deformation/crush to the front plane, distributed across the Chevrolet's width. In the damage pattern was deformation and rearward displacement/compression of the engine and surrounding components. The left front axle position was deformed and displaced rearward, shortening the left wheelbase (Figure 4) by 62 cm (24.4 in). Direct contact on the hood began directly on the centerline and extended 82 cm (32.3 in) to the left front corner. Significant deformation was observed to the bumper beam, with direct contact from the engagement and rotation of the vehicles following initial contact extending 40 cm (15.7 in) right of center.

Figure 5. Front plane damage and left wheelbase reduction to the Chevrolet

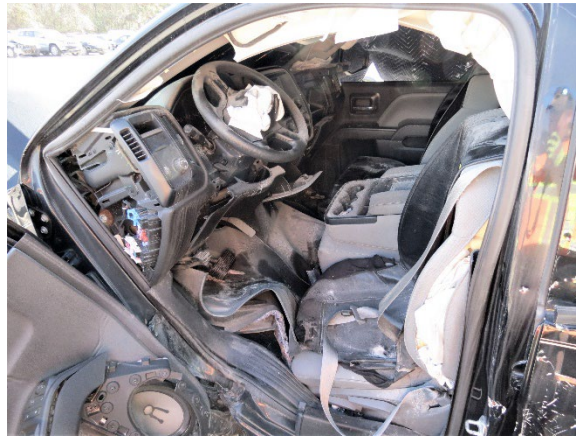
Interior inspection of the Chevrolet revealed significant intrusion into the occupant compartment, with several areas of identifiable occupant contact. The significant crush to the left front aspect of the Chevrolet and corresponding reduction in the left wheelbase resulted in intrusion of the left toe pan, foot pedals, floor, left lower A-pillar, left instrument panel, left sill, and left B-pillar. Induced deformation buckled the Chevrolet's floor and deformed the driver seat. There was also induced deformation to the floor in the second row, as well as along the center tunnel of the vehicle. Figure 7 shows the driver's position and the surrounding intrusions/deformed components. Note that the floor/toe pan intrusions deformed and displaced the foot controls, such that the floor was engaged against the foot controls. This prevented the SCI investigator from depressing the brake pedal to verify functionality of the system during the SCI vehicle inspection process.

Figure 7. View of the intruded components surrounding the driver's position of the Chevrolet

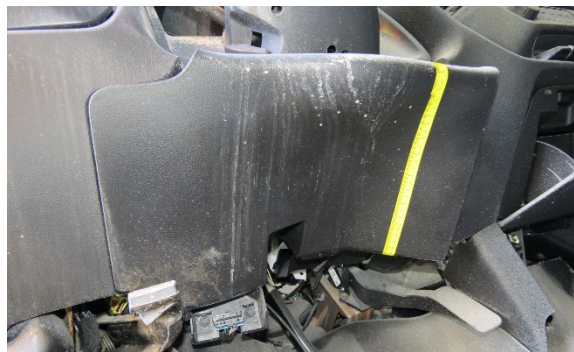
Figure 9. Occupant contact to the Chevrolet's left lower instrument panel from the driver's knees

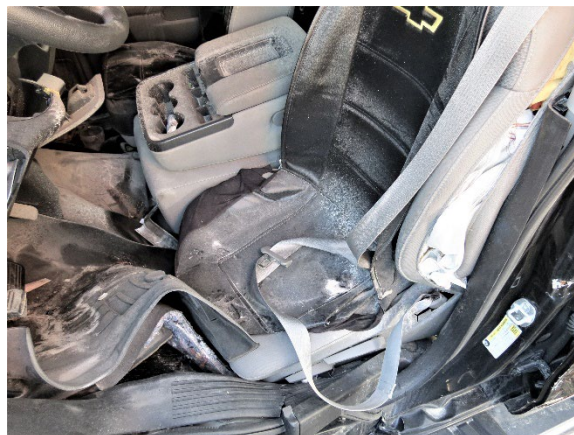
Figure 10. Chevrolet driver's seat belt system at the time of the SCI vehicle inspection

At the time of the inspection, the SCI investigator found the driver seat belt system tied around the upper frame of the driver's door in an apparent attempt by a prior unknown person to hold the door closed. This had exposed the webbing and latch plate to the environment over time prior to the SCI inspection. Despite its exposure to the elements, a 20 cm (7.9 in) long area of stretching from the D-ring remained visible on the webbing. The webbing was extended (Figure 10) from the retractor, which was locked in position. The length of exposed webbing measured 195 cm (76.8 in) from the lower anchor to the D-ring. This represented an excess of 130 cm (51.2 in) webbing, as the length of exposed webbing if the belt were in a stowed position would be only 65 cm (25.6 in). There was also a portion of the webbing loosely gathered in the forward aspect of the D-ring.

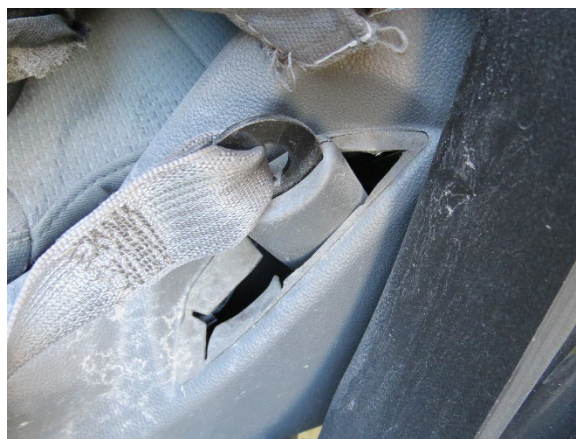
The locked status of the retractor was presumably related to the actuation of the retractor pretensioner and engagement of the ELR. The SCI investigator observed that the lower anchor pretensioner was noticeably actuated, as the lower anchor was drawn most of the way down into the polymer cover on the outboard side of the driver seat (Figure 11). Intrusions and deformation to the Chevrolet prevented direct inspection of the pretensioners by the SCI investigator, as the B-pillar and left sill were rigidly engaged against the left side of the driver seat (Figure 12).

Figure 11. View of the Chevrolet driver's lower anchor visibly drawn into the fascia by pretensioner actuation

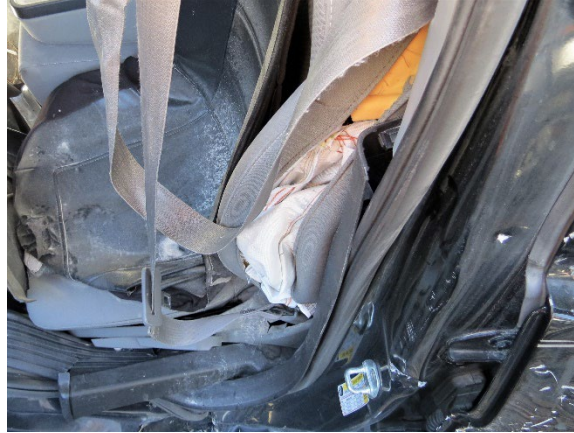
Figure 12. Deformed driver's seat engaged against the intruded left sill and B-pillar of the Chevrolet

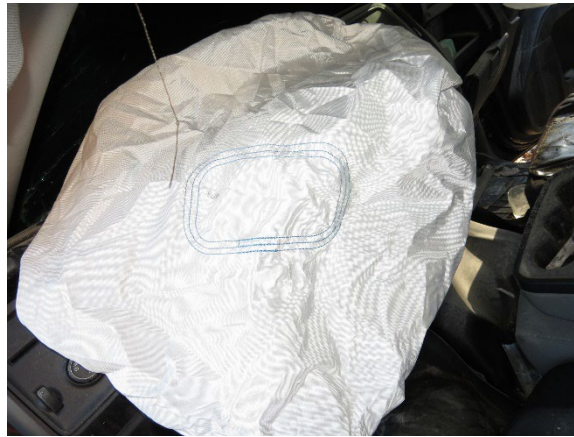
The driver frontal air bag deployed from the steering wheel hub-mounted module and through the cover flaps without damage. In its deflated state, it measured approximately 60 cm (24 in) in overall diameter. It had a 16 cm (6.3 in) wide by 9 cm (3.5 in) tall oval center stitch pattern, to which internal tethers were affixed. The air bag was vented on its rear aspect by a pair of 4 cm (1.6 in) diameter vent ports, located at the 11 o'clock and 1 o'clock positions. The SCI investigator observed that there was some discoloration to the lower aspect/bottom of the air bag

fabric, presumably remnants of blood/body fluid from the driver. Figure 13 shows the deployed driver frontal air bag at the time of the SCI inspection.

Figure 13. View of the deployed driver's frontal air bag in the Chevrolet at the time of the SCI inspection

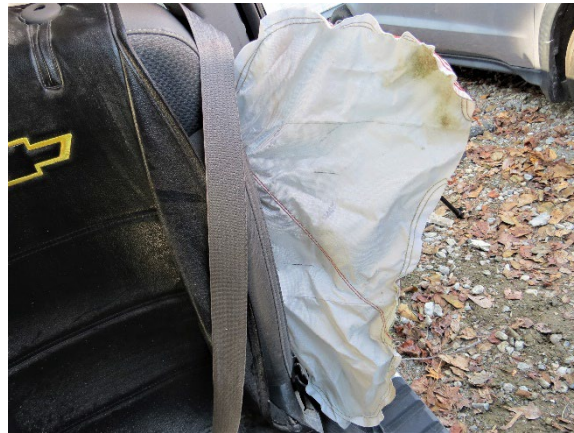
The driver seat-mounted side impact air bag deployed from the outboard aspect of the seat back through the fabric/stitching of the seat. In its deflated state, it measured 62 cm (24.4 in) tall and 25 cm (9.8 in) wide. There was an 8 cm (3.1 in) vent in the stitching on the forward aspect. Some minor discoloration (source unknown) was visible on the upper aspect of the air bag. Figure 14 shows the driver seat-mounted side impact air bag.

Figure 14. Chevrolet driver's deployed seat-mounted side impact air bag

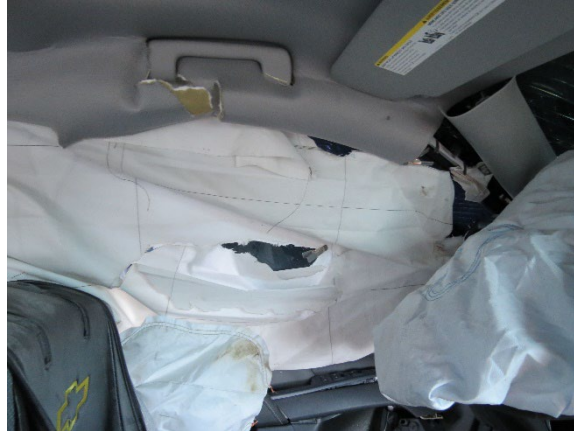
At the time of the SCI vehicle inspection, the left IC air bag had been cut post-crash, presumably by on-scene EMS personnel to gain unobstructed access to the interior. There was no discernable occupant contact to either of the IC air bags. Figure 15 shows the deployed left IC air bag, while Figure 16 shows the deployed right IC air bag.

Figure 15. View of the Chevrolet's left IC (cut forward aspect), left seat-mounted, and driver's frontal air bags

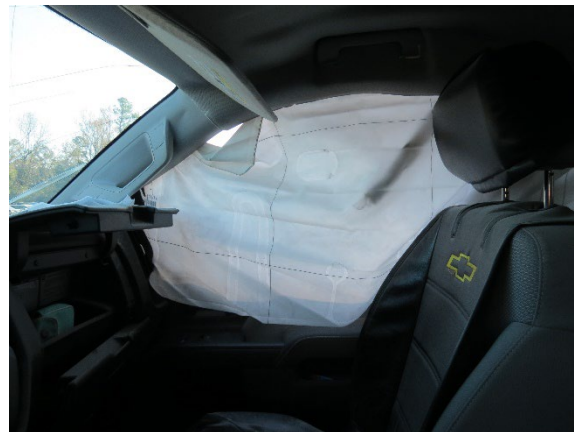
Figure 16. View of the Chevrolet's deployed right IC air bag, forward aspect, at the time of the SCI inspection

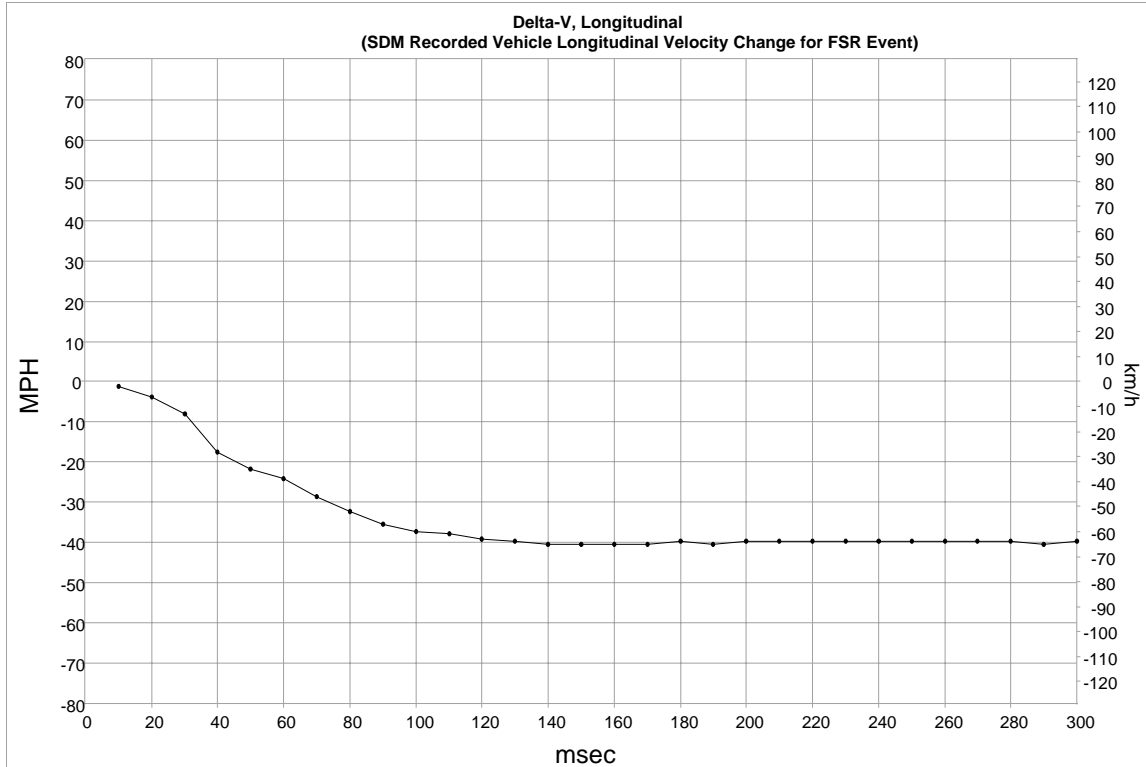
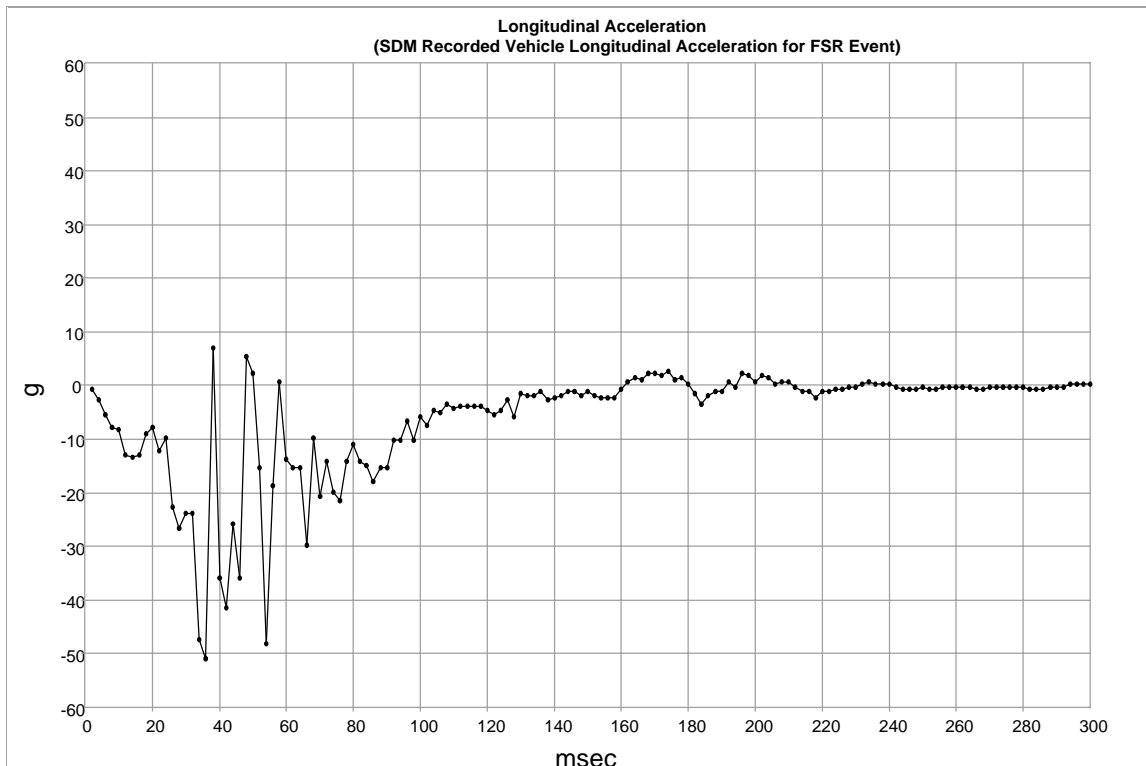
Longitudinal Crash Pulse (Event Record 1)

The maximum longitudinal delta V reported was -65 km/h (-40 mph) at 158 milliseconds after time zero. The maximum lateral delta V was 14 km/h (9 mph), which occurred at 56 milliseconds. The following supplemental restraint system deployment/actuation commands were associated with the frontal event.
