DOT HS 813 380

**Special Crash Investigations:
Remote Hyperthermia Fatality
Investigation;
Vehicle: 2012 Honda Pilot;
Location: Delaware;
Incident Date: July 2019**

Special Crash Investigations
Remote Hyperthermia Fatality Investigation
Case Number: CR21002
Vehicle: 2012 Honda Pilot
Location: Delaware
Incident Date: July 2019

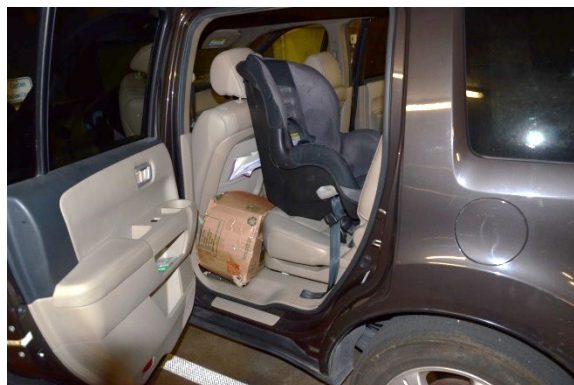
Figure 1. CRS and position of the infant in the 2012 Honda Pilot

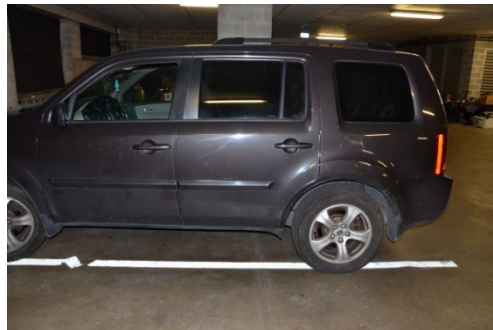
The vehicle was a 2012 Honda Pilot 4-door SUV (Figure 3). The exterior color was bronze (dark amber metallic). The windows were original with standard tint on the front door windows and deep tint on the second row doors, rear quarter windows, and back window. At the time of this incident, all windows and doors were closed. The Honda had three rows of seating (2/3/3) with eight occupant positions. The interior had beige leather with black trim for the upper door panels and the top of the instrument panel (Figure 4). The front row had two bucket seats with adjustable head restraints and a fixed center console. The driver's head restraint was adjusted approximately 3 cm (1.2 in) above the seatback. The front right head restraint was in the full-down position. The second and third row seats had forward-folding seatbacks and adjustable head restraints. All seatbacks were upright to facilitate occupant seating. The rear-facing CRS (make and model unknown) was installed in the second row left position. It was removed during the police investigation and loosely repositioned as shown in the police image.

Figure 3. Exterior view of the Honda. Image provided by the investigating police officer.

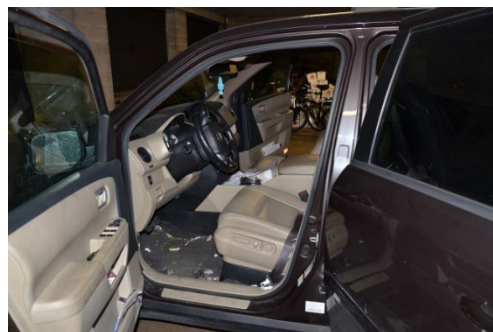
Figure 4. Front row interior of the Honda. Image provided by the investigating police officer.

The four door windows were power-activated. The master switch console was located on the forward aspect of the driver's door armrest and was horizontally positioned. The switches required down pressure to open and a vertical pull force to close. The front row right and second row doors each had a singular switch of the same configuration.

The exterior door handles were horizontally mounted, hinged at the forward aspect. A pocket was formed into the exterior door panel to facilitate finger grip. The interior door release levers were flush-mounted in the upper forward aspect of the door panels. The levers were chrome, U-shaped, and hinged at the aft aspect. A shallow pocket was formed into the door panel to allow for finger grip of the lever. Located in the hinge portion of the lever was a locking lever. The lock lever rotated forward to a flush position when locked and rotated approximately 30 degrees rearward in the unlock position. Power locking was achieved by switches on the front door armrests or via the remote key fob. The father stated to police that when he arrived home in the morning, he exited the vehicle and locked the doors with the key fob. The infant was left forgotten in the vehicle with the windows closed and the doors locked.

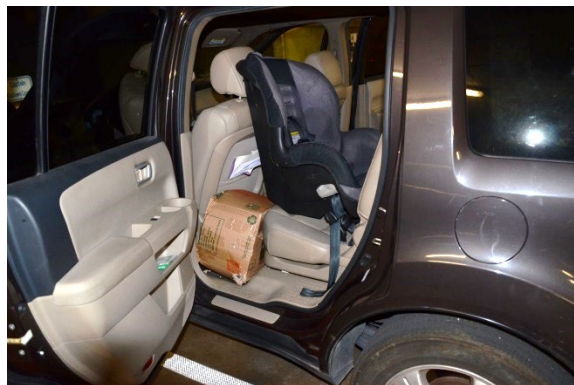
The CRS was a convertible-type restraint (Figure 5), unknown make and model. The CRS was constructed of a molded plastic shell and a fabric cover. An integral five-point harness system provided restraint for the infant. The shoulder straps appeared to have been adjusted to the lower set of three slots. Based on the police image of the CRS and the adjusted position of the driver's seat, it appeared the CRS was installed in a more vertical position than the recommended 45-degree recline for the rear-facing position. It also appeared that the CRS was secured to the vehicle by the lower anchors of the LATCH system.

Figure 5. CRS in the second row left position of the Honda. Image provided by the investigating police officer.

The police towed the Honda to an impound lot, where they conducted an inspection of the vehicle. The CRS was found to be secure in the second row left position of the vehicle.
