DOT HS 813 510

**Special Crash Investigations:
On-Site Reported Power Steering
Malfunction Crash Investigation;
Vehicle: 2021 Ford F-150 Pickup;
Location: Georgia;
Crash Date: September 2021**

Special Crash Investigations
Reported Power Steering Malfunction Crash Investigation
Office of Defects Investigation
Case Number: CR21025
Vehicle: 2021 Ford F-150 Pickup
Location: Georgia
Crash Date: September 2021

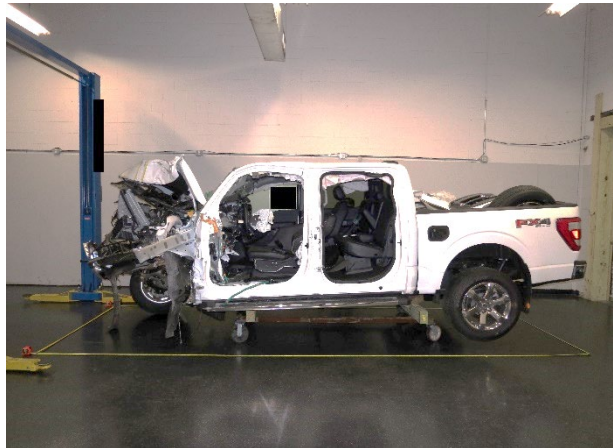
Figure 1. Left side view of the Ford

This on-site investigation documents the road departure crash and the reported power steering malfunction of a 2021 Ford F-150 pickup (Figure 1). The crash resulted in fatal injuries to the belted 68-year-old male driver. The Ford was traveling north on a divided highway approaching an exit ramp. The police crash report indicated that the Ford, traveling in the right lane, entered the gore at the exit and struck a road sign. The Ford continued through the gore area and along the roadside for approximately 92 m (300 ft) before striking a large diameter tree with the front plane, left aspect. The force of the crash caused several safety systems in the Ford to actuate/deploy. The driver was removed from the vehicle by EMS personnel and transported to a medical center where he was pronounced deceased 4 hours later.

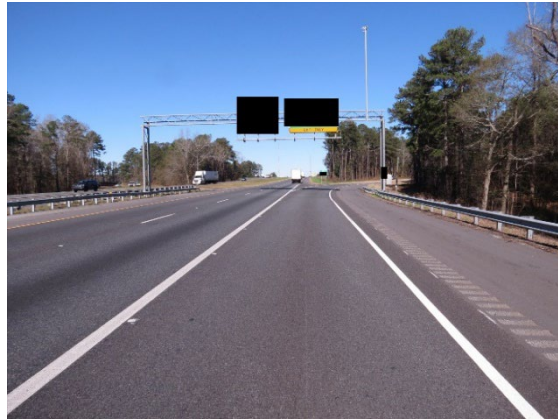
Figure 2. Viewing north along the Ford's approach

The crash occurred in the afternoon of September 2021. The police reported the environmental conditions as clear, daylight, and dry. The National Weather Service reported a temperature of 30.5 °C (87 °F), 46 percent relative humidity, 9.6 km/h (6 mph) east southeasterly winds, and mostly cloudy sky conditions. The crash site (Figure 2) was a four-lane State highway with two lanes heading north and two lanes heading south with an exit lane on the right side of the northbound travel lanes.

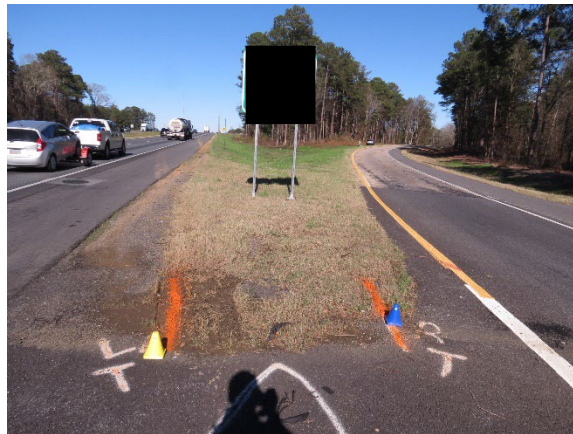
Figure 3. Viewing north at the Ford's road departure

The exit lane had an 18° curve to the right creating a triangular grass gore (Figure 3) that separated the exit ramp from the northbound lanes. Tire marks indicating the trajectory of the Ford were identified during the police investigation at the pavement edge where the surface of the gore changed to grass.

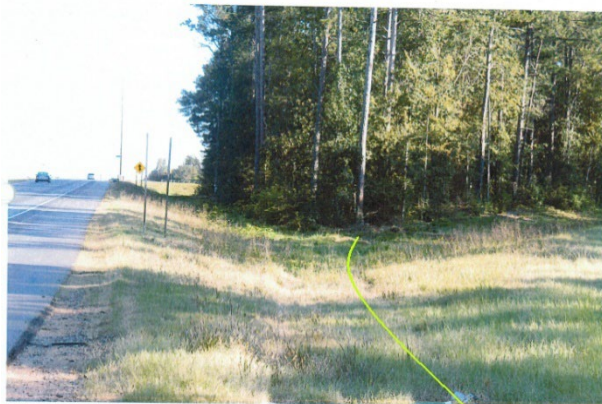
Figure 4. Viewing north of the Ford's tire tracking, yellow line represents inside of left tire tracks. (On-scene image from law enforcement)

The Ford struck the exit sign posts with the front plane and separated the breakaway bases (Event1). The Ford displaced the signposts forward and the sign fell onto the vehicle fracturing the upper aspect of the windshield (Event 2). The driver reacted to the off-road trajectory by an EDR-recorded brake application that disengaged the cruise control and with an increase in the right steering input. The Ford continued towards the center of the wood line in a tracking mode with a slight arc to the right (Figure 4).

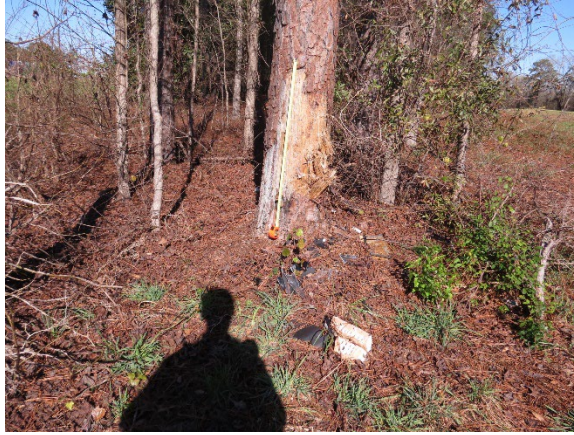
Figure 5. North view of the tree impact

Approximately 75.0 m (246 ft) from where the Ford left the road, the rear drive train coupling and differential struck the raised mound that measured 121.9 cm (48.0 in) in diameter (Event 3). This impact was the source of algorithm enable (AE). The EDR-recorded speed of the Ford was 88 km/h (54.4 mph) at AE. The Ford then ran over a 12.7 cm (5.0 in) diameter tree stump (Event 4) and struck the large diameter tree (Event 5/Figure 5). Crash diagrams are included at the end of this report.

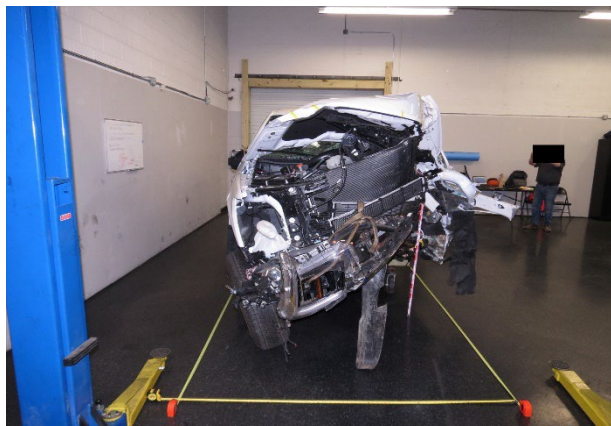
Figure 6. Front view of the Ford

The Ford F-150 (Figure 6) was a 4-door, SuperCrew pickup equipped with FX4 trim. The vehicle was manufactured in May 2021 and identified by the Vehicle Identification Number 1FTFW1ED3MFxxxxxx. The vehicle's odometer reading was unknown due to crash damage. Constructed on a 369 cm (145.3 in) wheelbase, the Ford was powered by a 3.5-liter, V-6, hybrid engine linked to a 10-speed automatic transmission with 4-wheel drive. The gross vehicle weight rating was 3,334 kg (7,350 lb) with gross axle weight ratings of 1,769 kg (3,900 lb) front and 1,882 (4,150 lb) rear. The Ford had vehicle manufacturer recommended size 275/60R20 tires mounted on OEM alloy wheels. The tread depth of the tires measured 7 mm (9/32 in) or greater. The service brakes were power-assisted, 4-wheel disc brakes with an antilock braking system (ABS). Safety features included electronic stability control, a post-collision safety system, traction control, and a tire pressure monitoring system. Crash avoidance features included adaptive cruise control, crash imminent braking, dynamic brake support, lane departure warning, lane keeping assist, blind spot detection and advanced lighting. It was not equipped with Ford's BlueCruise system. Steering was achieved via an electronic power-assisted rack.

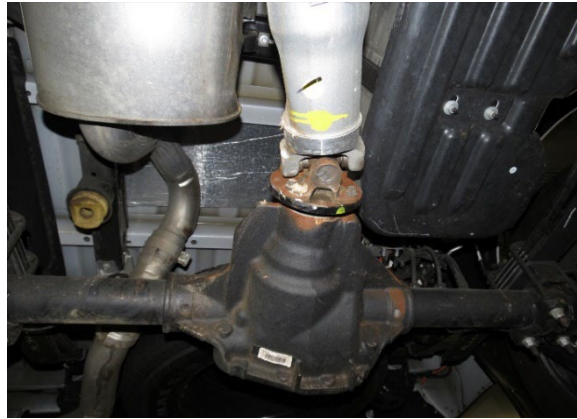
The Event 3 contact to the ground caused damage to the rear drive train coupling and differential that consisted of minor scarring to the components and embedded bark (Figure 8). The CDC assigned to this event was 00UBCN1.

Figure 7. Damage from Event 3 (mound versus coupling)

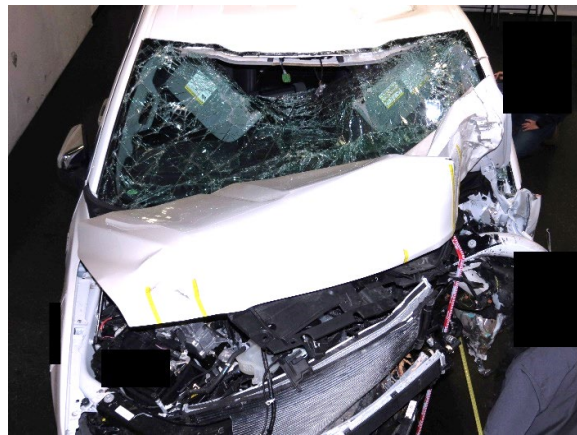
The Ford sustained minor damage from impacts with the exit sign posts (Event 1) and impact from the falling exit sign (Event 2). The front bumper struck the posts with associated damage to the hood face. The posts separated at the ground connections and the sign came down onto the

windshield holing its upper aspect. The Collision Deformation Classification (CDC) assigned to these damage patterns were 12FDMW1 and 00FDGW6 (Figure 7).

Figure 8. Signpost and sign damage to the Ford

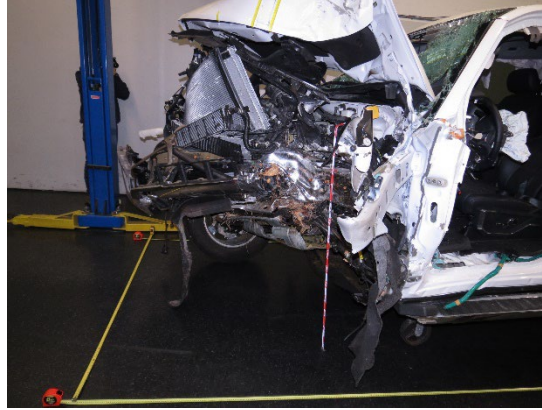
The Ford sustained major damage from the impact with the large diameter tree (Event 5). The left aspect of the front plane struck the tree at the left frame rail. The left front upper ball joint, drive axle, and outer tie rod separated resulting in complete separation of the left front wheel assembly. There was significant fracturing of the alloy rim (Figure 9). The CDC assigned to this damage pattern was 12FYEW5 (Figure 10 and Figure 11).

Figure 9. Lateral view of the direct damage from Event 5

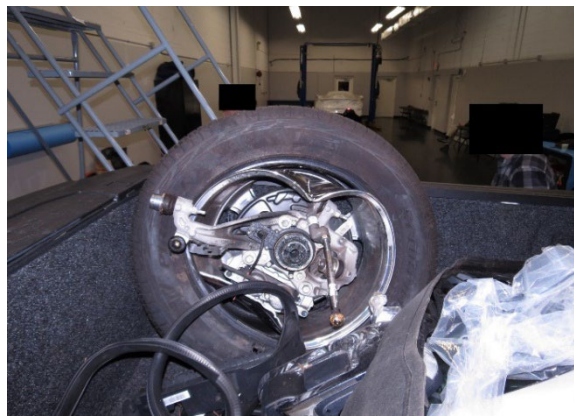
Figure 10. Damage from Event 5 to left front tire

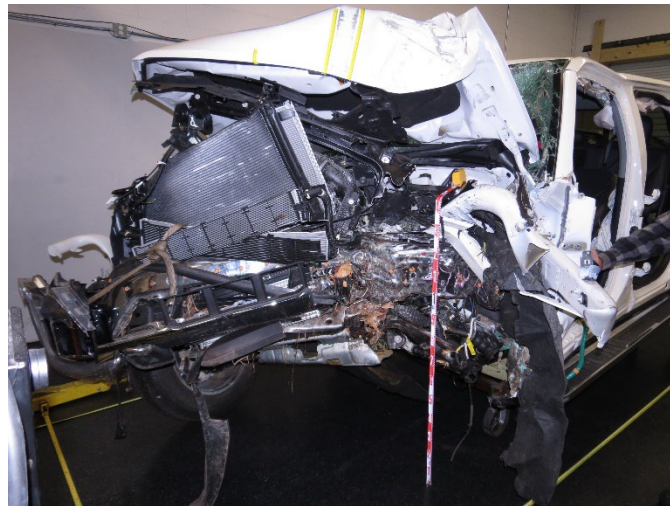
Figure 11. Left front oblique view of damage from Event 5

The combined width of the direct and induced damage extended across the 190 cm (75.0 in) end-width. The direct contact damage began 29 cm (11.4 in) left of the centerline and measured 66 cm (26.0 in) wide. The residual crush profile was C1 = 129 cm (51 in), C2 = 135 cm (53 in), C3 = 113 cm (44 in), C4 = 64 cm (25 in), C5 = 29 cm (11 in) C6 = 6 cm (2 in). Maximum crush was

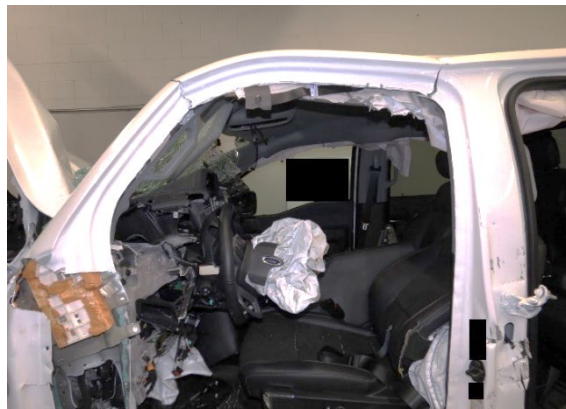
The interior damage was moderate in the occupant compartment. The forces from the crash caused the driver's door sill and body spot welds to separate by overload (Figure 12). Buckling at the top of the A and B pillars were also observed (Figure 13). The windshield was sagging into the instrument panel. The left instrument panel was intruded 13.9 cm (5.5 in). The left toe pan intruded an estimated 15 cm (6 in) into the foot pedal area. The steering wheel/column was offset to the left from center, the wheel rotated 30° clockwise and jammed (Figure 14). It was deformed 13 cm (5.1 in) at 12 o'clock, 10 cm (4.0 in) at 3 o'clock, 2 cm (0.8 in) at 6 o'clock and 1 cm (0.3 in) at 9 o'clock. The right spoke was fractured due to driver loading (Figure 15).

Figure 12. Buckling of the Ford's A and B pillars

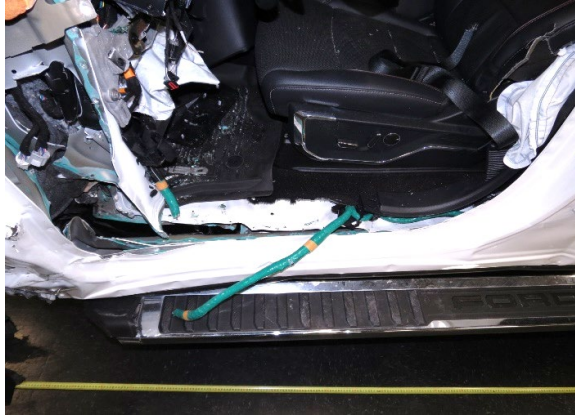
Figure 13. Driver door sill weld separation

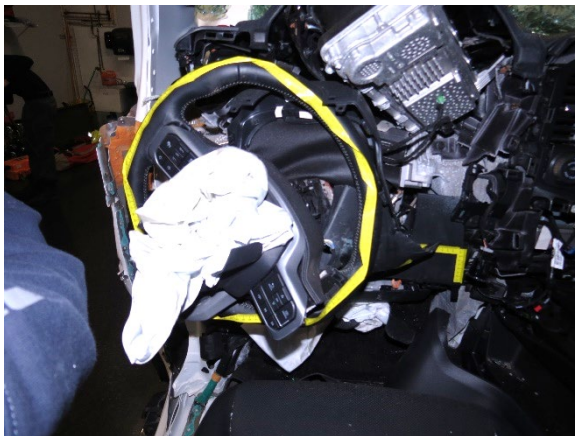
Figure 14. Overview of deformed steering wheel

Chest loading severely deformed the wheel rim, fractured the right spoke and fully compressed the energy absorbing steering column. As a result of this loading, the driver sustained an abdominal contusion, bilateral rib fractures with left flail chest, a sternal fracture, bilateral upper lobe pulmonary contusions, and a small left pneumothorax. His forward motion and severe loading of the steering assembly produced fractures of the vertebral bodies at T1 and T3 and fractures of the spinous process at L1 and L2. The driver's face contacted the upper aspect of the deployed air bag and steering wheel rim, resulting in a left forehead laceration and contusion and a laceration of the chin.

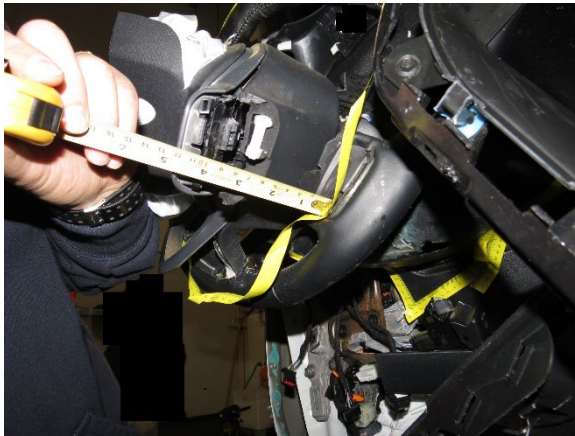
Figure 15. Steering wheel rim damage at 3 o'clock

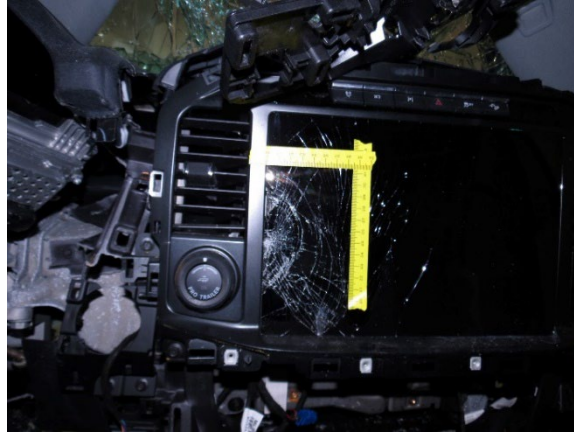
Figure 16. Driver right hand contact

The driver's knees contacted the deployed knee air bag and loaded the knee bolster/lower instrument panel (Figure 16). His right hand deflected off the steering wheel and struck the center console screen, fracturing its left aspect (Figure 17).

During his forward trajectory, the driver's right hand probably deflected off the steering wheel rim and struck the center instrument panel monitor, fracturing the screen and causing abrasions to the hand. He also sustained a left elbow laceration from possible contact with the left door panel and left hand abrasions from left instrument panel contact.

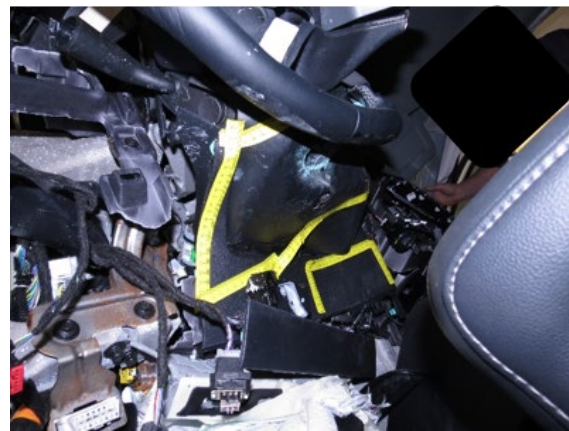
Figure 17. Driver knee contacts to the intruded bolster

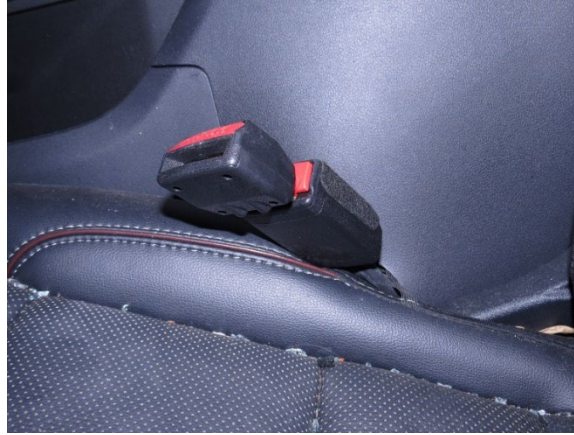
At the time of the SCI inspection it was observed that the seat belt had been cut by EMS approximately 88.9 cm (35 in) from the anchor pretensioner. There was 30 cm (12.0 in) of webbing extending from the D-ring. The latch plate was not found in the vehicle. However, the SCI investigator did find a rigid belt extender latched in the buckle (Figure 18). There was no webbing connected to the belt extender. The front passenger's seat belt was intact and stowed against the B-pillar.

Figure 18. Driver buckle extender

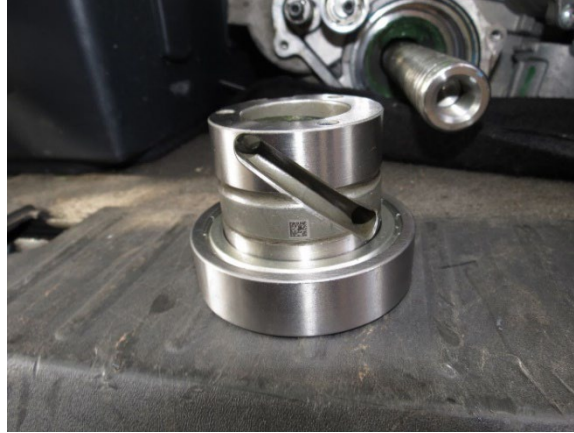
The part that was in question that was the subject of the NHTSA recall with the steering gear ball nut retainer. The ball nut retainer (Figure 19) consisted of a closed bearing connected to the holed shaft with an interior single-helical channel. This channel housed more than 100 small bearing-like balls. These greased bearing balls contacted the channel of the steering pinion and acted as guides thus reducing the metal-to-metal contact between the pinion and the retainer while translating the rotation from the reduction gear to the steering pinion.

Figure 19. Exemplar ball retainer nut

As described in NHTSA Recall No. 21V-407, “A broken steering gear ball nut retainer can allow balls in the ball nut assembly to displace and wedge. Continued steering wheel movement can further wedge the balls and displace the retainer, resulting in increased steering effort. Should this continue and the balls do not transition back into the return guides, the ball nut may not be able to rotate. As a consequence, the driver may not be able to rotate the steering wheel while driving, increasing the risk of a crash.”¹

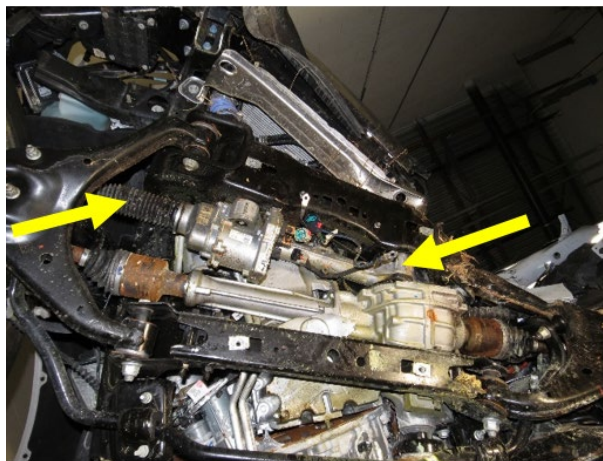
Over the duration of the inspection, the entire steering rack was removed as a complete unit. The steering rack (Figure 20 denoted by the yellow arrows) was located behind and bolted to the lower front cross-member. It was jammed in the deformation. Front components were removed from the vehicle in a step-wise manner and the front cross-member was cut away for access (Figure 21). Hydraulic spreaders were used to release the tension of the impact deformation at the left side of the steering rack and the rack was removed after a 3-hour process (Figure 22 and Figure 23).

Figure 20. Undercarriage view of the Ford and the steering rack

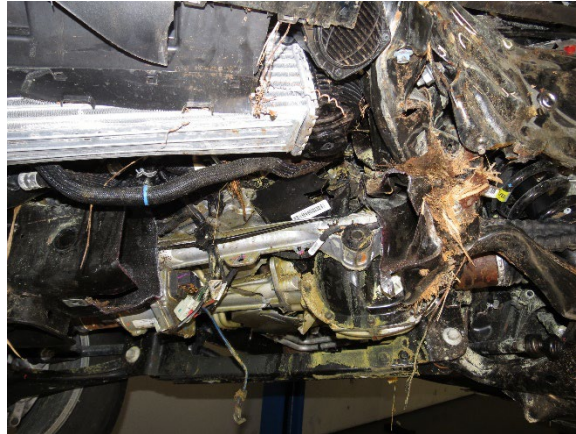
Figure 21. View of the Ford's steering rack with the front cross-member removed

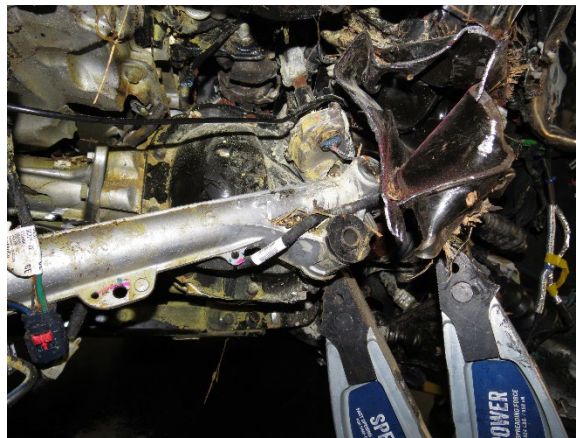
Figure 22. Hydraulic spreaders used to release tension and allow the steering rack removal

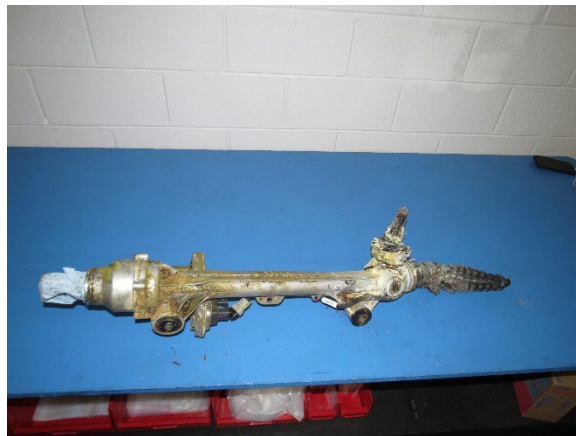
Figure 23. Steering rack after removal from the Ford

Due to the nature of the retaining ball nut and the fact that if rotated to remove it from the steering pinion, the current ball positions and conditions would be at risk, it was decided to send the steering rack to a third party to have a CT scan completed. The steering rack remained in the custody of the driver's legal team. Neither NHTSA nor SCI were party to the CT scan or any

follow-up inspection. As of the date of this report, no further information regarding the CT scan of the steering rack was received from the driver's legal representatives. The root cause of the road departure and crash could not be identified.

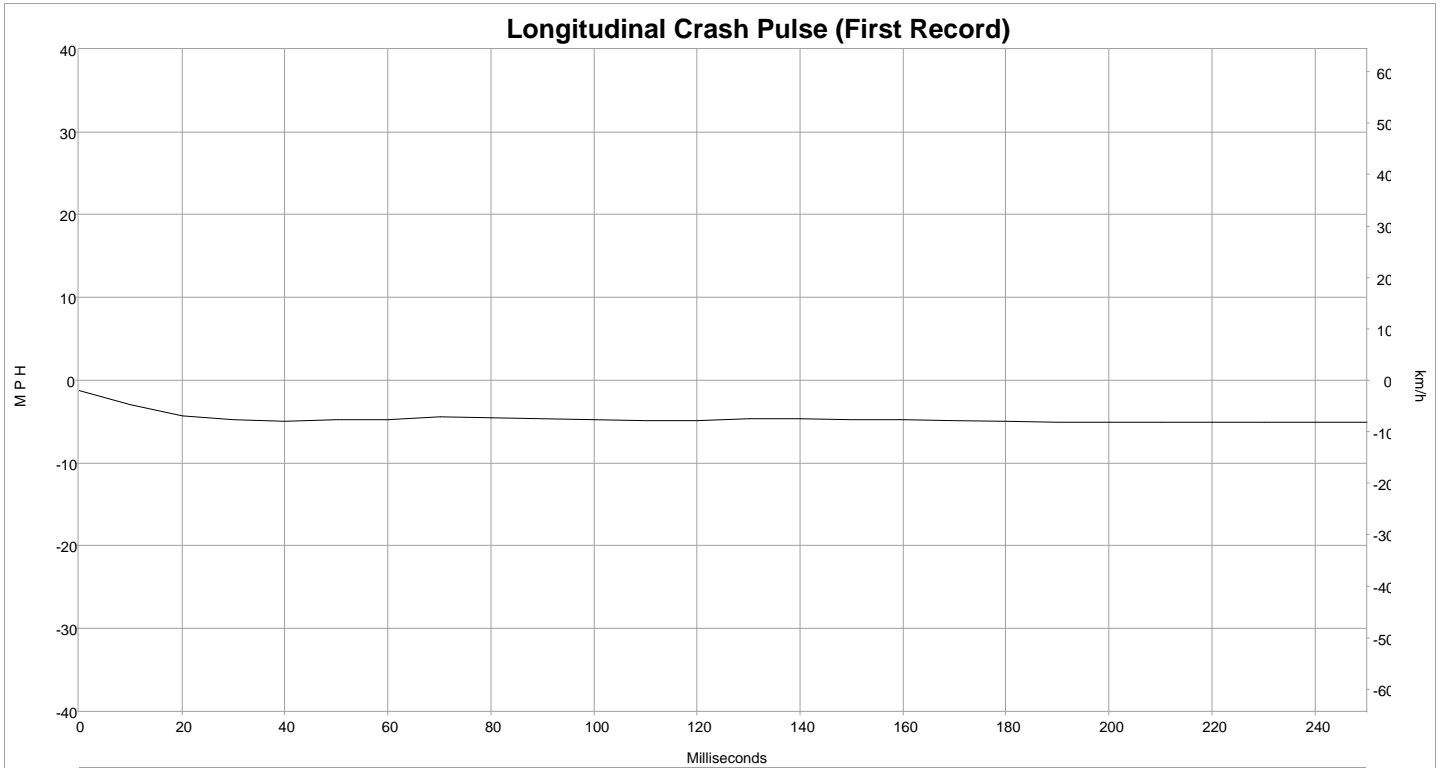
Longitudinal Crash Pulse (First Record)

Time (msec)	Delta-V, longitudinal (MPH)	Delta-V, longitudinal (km/h)
0	-1.21	-1.95
10	-2.88	-4.63
20	-4.31	-6.94
30	-4.74	-7.63
40	-4.90	-7.89
50	-4.78	-7.70
60	-4.69	-7.55
70	-4.40	-7.08
80	-4.53	-7.29
90	-4.62	-7.43
100	-4.70	-7.56
110	-4.84	-7.79
120	-4.83	-7.77
130	-4.60	-7.40
140	-4.61	-7.42
150	-4.72	-7.59
160	-4.74	-7.63
170	-4.88	-7.86
180	-5.00	-8.05
190	-5.07	-8.16
200	-5.11	-8.22
210	-5.06	-8.14
220	-5.05	-8.13
230	-5.01	-8.07
240	-5.02	-8.08
250	-5.10	-8.21

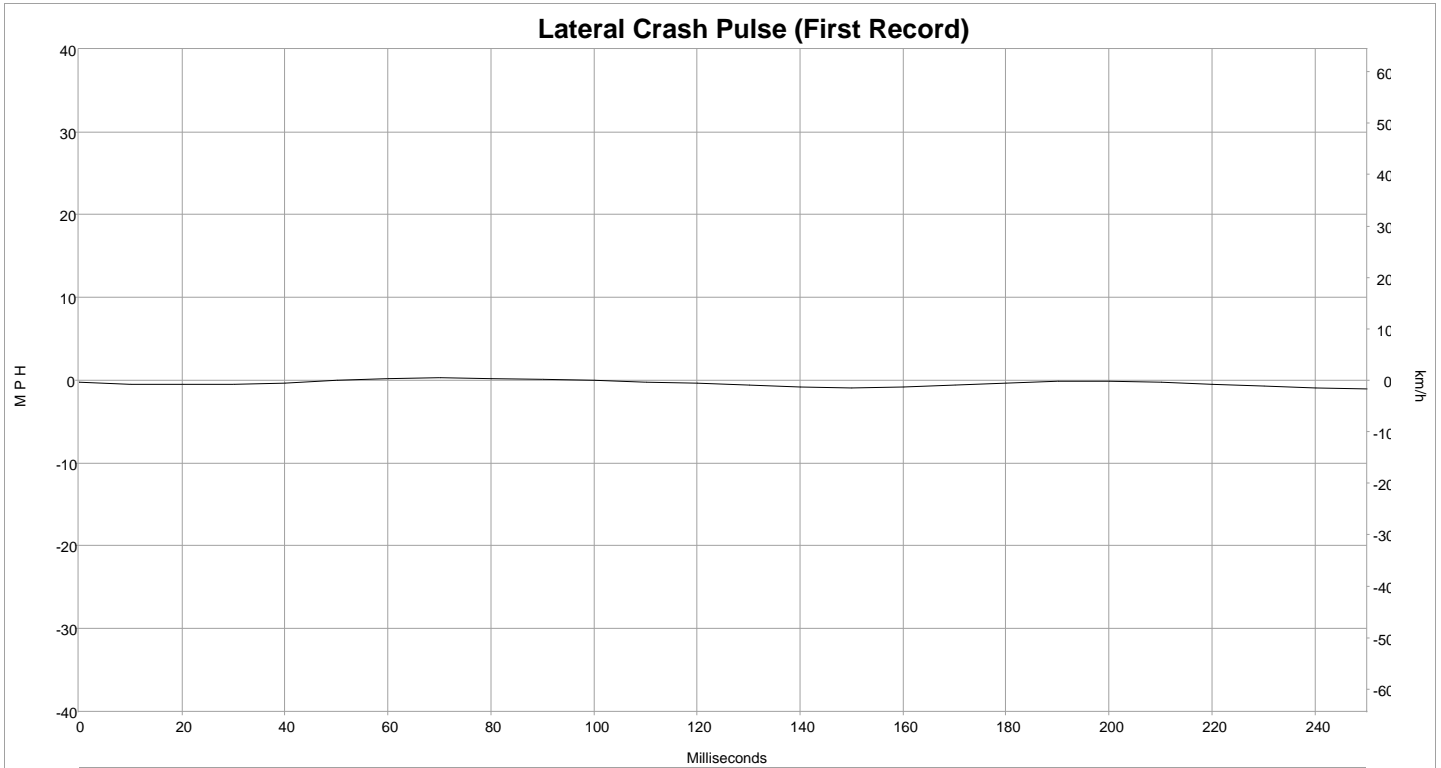
Lateral Crash Pulse (First Record)

Time (msec)	Delta-V, Lateral (MPH)	Delta-V, Lateral (km/h)
0	-0.24	-0.38
10	-0.42	-0.67
20	-0.45	-0.73
30	-0.49	-0.79
40	-0.30	-0.48
50	-0.02	-0.04
60	0.20	0.32
70	0.30	0.49
80	0.23	0.37
90	0.11	0.18
100	-0.06	-0.09
110	-0.28	-0.45
120	-0.39	-0.62
130	-0.58	-0.94
140	-0.78	-1.26
150	-0.91	-1.47
160	-0.81	-1.30
170	-0.57	-0.91
180	-0.32	-0.52
190	-0.14	-0.23
200	-0.09	-0.14
210	-0.25	-0.41
220	-0.44	-0.71
230	-0.65	-1.04
240	-0.87	-1.40
250	-0.99	-1.60

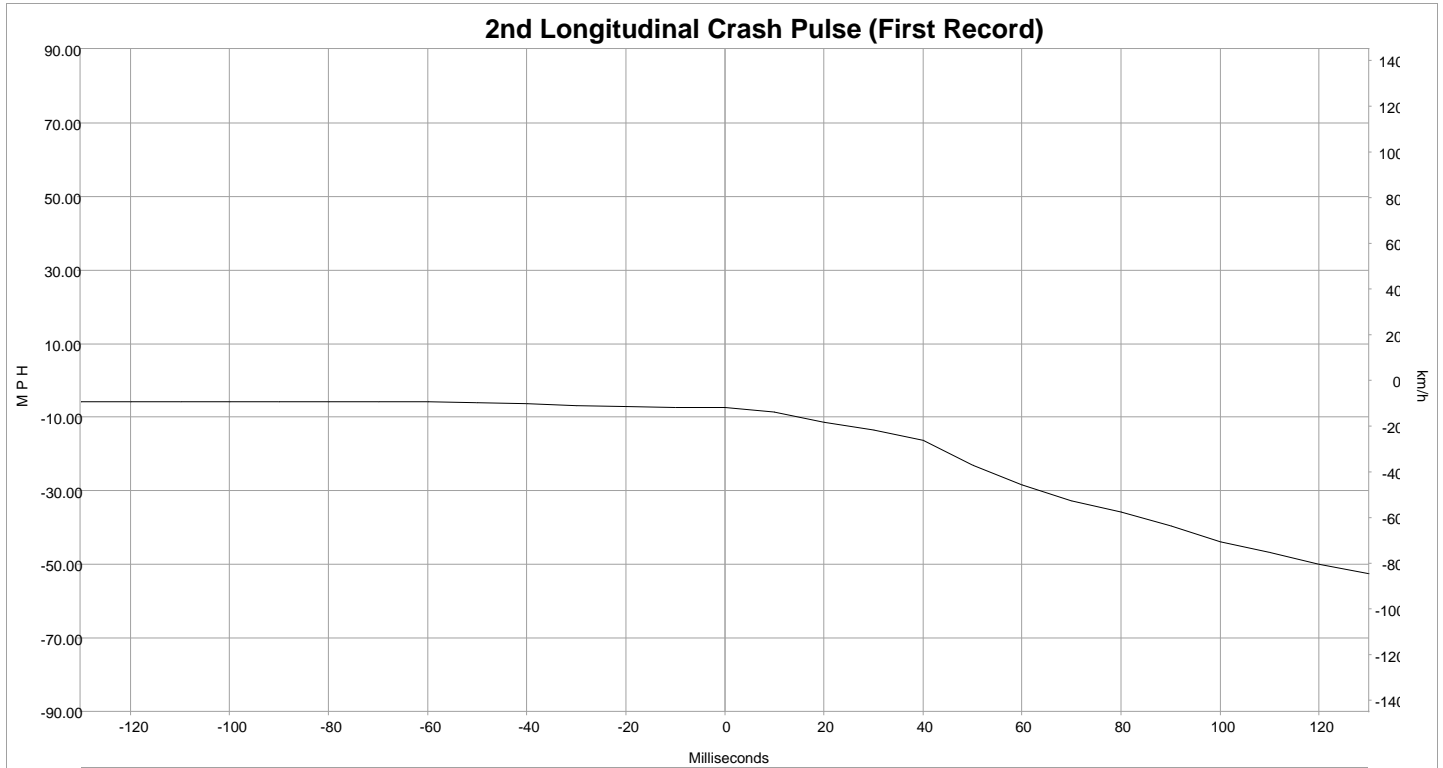
2nd Longitudinal Crash Pulse (First Record)

Time (msec)	2nd Delta-V, longitudinal (MPH)	2nd Delta-V, longitudinal (km/h)
-130	-5.91	-9.51
-120	-5.82	-9.36
-110	-5.72	-9.21
-100	-5.77	-9.28
-90	-5.79	-9.32
-80	-5.76	-9.27
-70	-5.82	-9.36
-60	-5.90	-9.50
-50	-6.06	-9.75
-40	-6.28	-10.10
-30	-6.78	-10.91
-20	-7.13	-11.47
-10	-7.30	-11.75
0	-7.29	-11.73
10	-8.61	-13.85
20	-11.35	-18.26
30	-13.33	-21.46
40	-16.22	-26.10
50	-22.96	-36.95
60	-28.43	-45.75
70	-32.63	-52.51
80	-35.74	-57.52
90	-39.58	-63.70
100	-43.89	-70.64
110	-46.73	-75.20
120	-50.00	-80.46
130	-52.60	-84.65

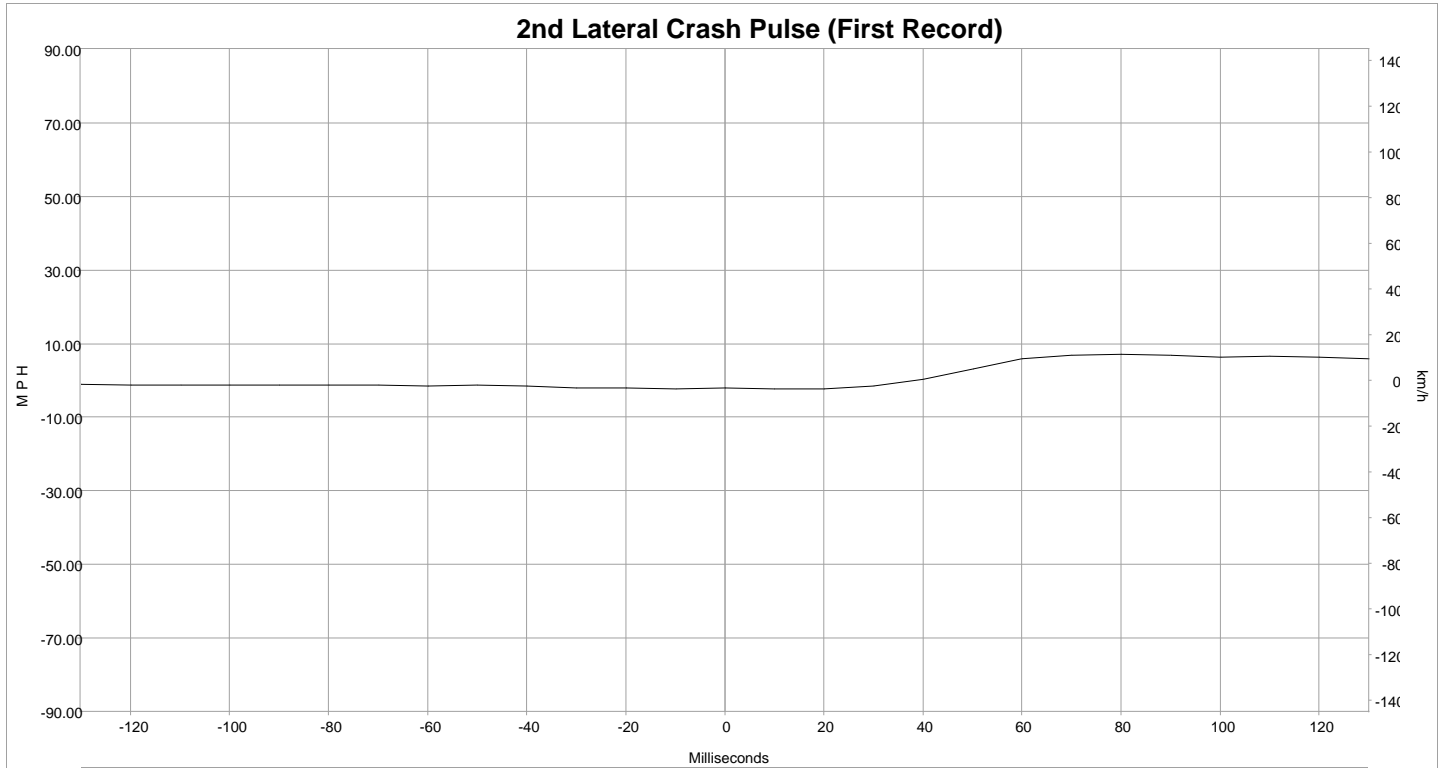
2nd Lateral Crash Pulse (First Record)

Time (msec)	2nd Delta-V, Lateral (MPH)	2nd Delta-V, Lateral (km/h)
-130	-1.11	-1.79
-120	-1.24	-1.99
-110	-1.29	-2.08
-100	-1.30	-2.10
-90	-1.31	-2.11
-80	-1.33	-2.14
-70	-1.37	-2.21
-60	-1.42	-2.28
-50	-1.37	-2.21
-40	-1.60	-2.58
-30	-1.91	-3.07
-20	-2.03	-3.27
-10	-2.16	-3.47
0	-2.09	-3.36
10	-2.26	-3.64
20	-2.17	-3.50
30	-1.57	-2.52
40	0.20	0.32
50	3.11	5.00
60	5.84	9.40
70	6.80	10.94
80	7.00	11.26
90	6.81	10.96
100	6.26	10.08
110	6.63	10.67
120	6.35	10.22
130	5.79	9.32

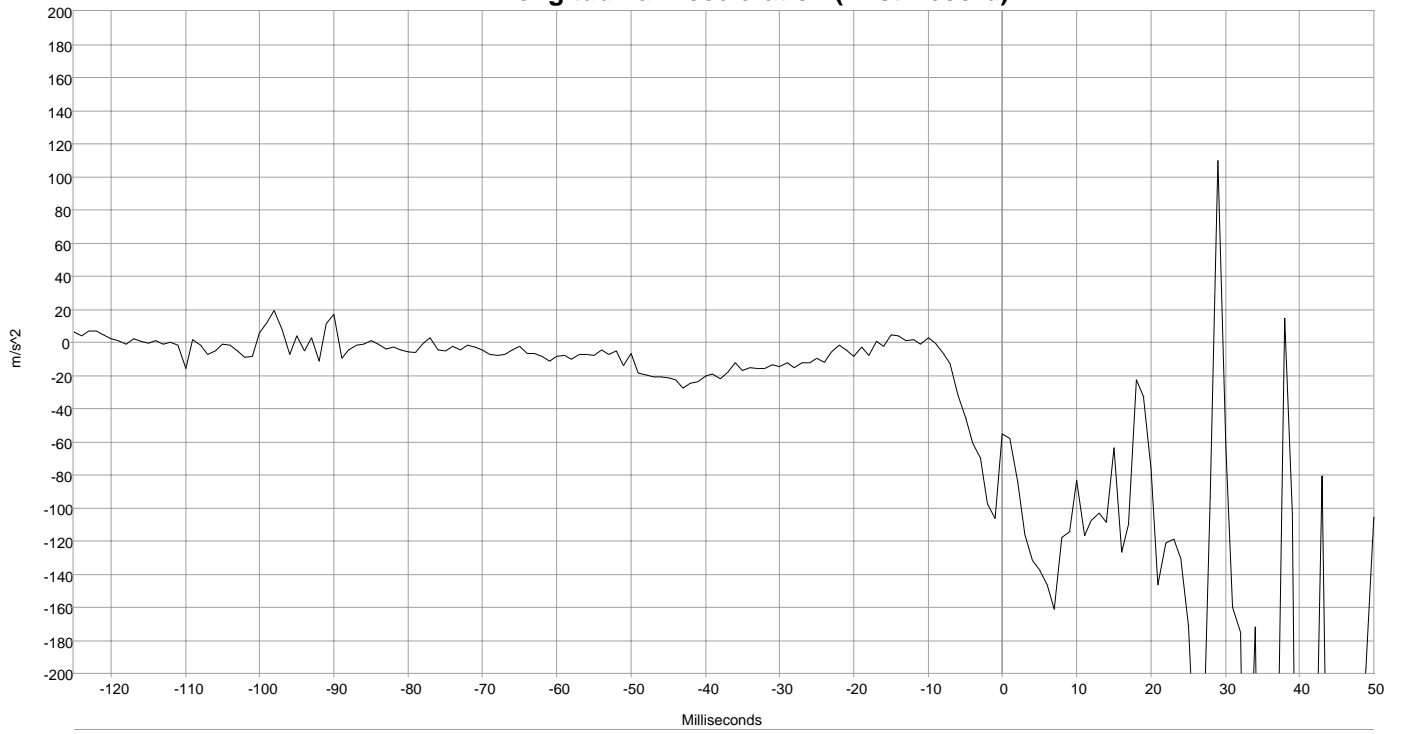
Longitudinal Acceleration (First Record)

Time (msec)	Longitudinal Acceleration (RCM internal high-G accel) (m/s^2)
-125	6.13
-124	3.68
-123	6.74
-122	6.74
-121	4.29
-120	2.45
-119	1.23
-118	-1.23
-117	2.45
-116	0.61
-115	-0.61
-114	1.23
-113	-1.23
-112	0.00
-111	-1.84
-110	-15.94
-109	1.84
-108	-1.84
-107	-7.36
-106	-4.90
-105	-1.23
-104	-1.84
-103	-4.90
-102	-9.19
-101	-8.58
-100	5.52
-99	11.65
-98	19.00
-97	7.97
-96	-7.36
-95	3.68
-94	-4.90
-93	3.06
-92	-11.03
-91	11.03
-90	17.16
-89	-9.81
-88	-4.29
-87	-1.84
-86	-1.23
-85	1.23
-84	-1.23
-83	-3.68
-82	-3.06

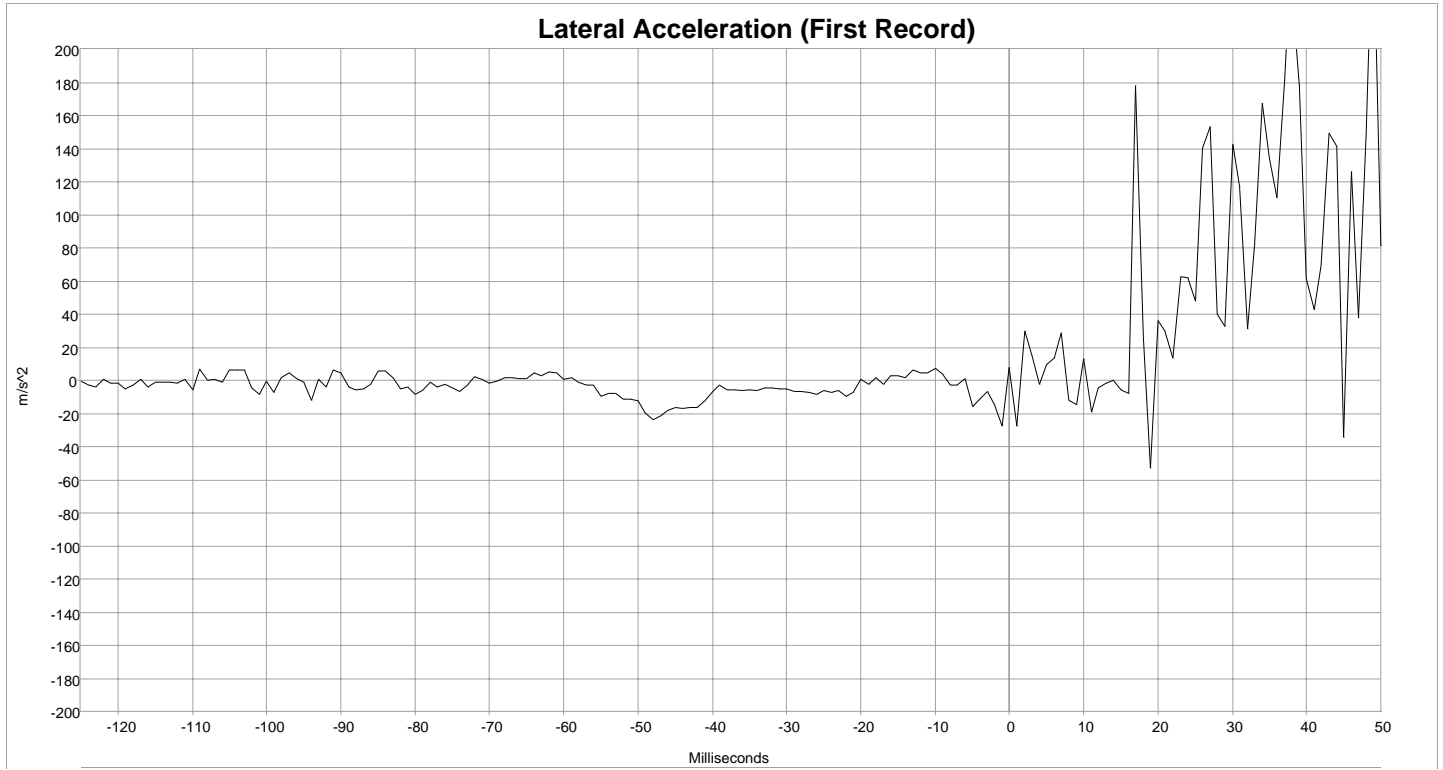
Lateral Acceleration (First Record)

Time (msec)	Lateral Acceleration (RCM internal high-G accel) (m/s^2)
-125	-0.61
-124	-3.06
-123	-3.68
-122	0.61
-121	-1.84
-120	-1.84
-119	-4.90
-118	-3.06
-117	0.61
-116	-3.68
-115	-1.23
-114	-1.23
-113	-1.23
-112	-1.84
-111	0.61
-110	-5.52
-109	6.74
-108	0.00
-107	0.61
-106	-1.23
-105	6.13
-104	6.13
-103	6.13
-102	-4.29
-101	-8.58
-100	-0.61
-99	-7.36
-98	1.84
-97	4.29
-96	1.23
-95	-1.23
-94	-11.65
-93	0.61
-92	-3.68
-91	6.13
-90	4.29
-89	-3.68
-88	-5.52
-87	-4.90
-86	-2.45
-85	5.52
-84	5.52
-83	1.84
-82	-4.90

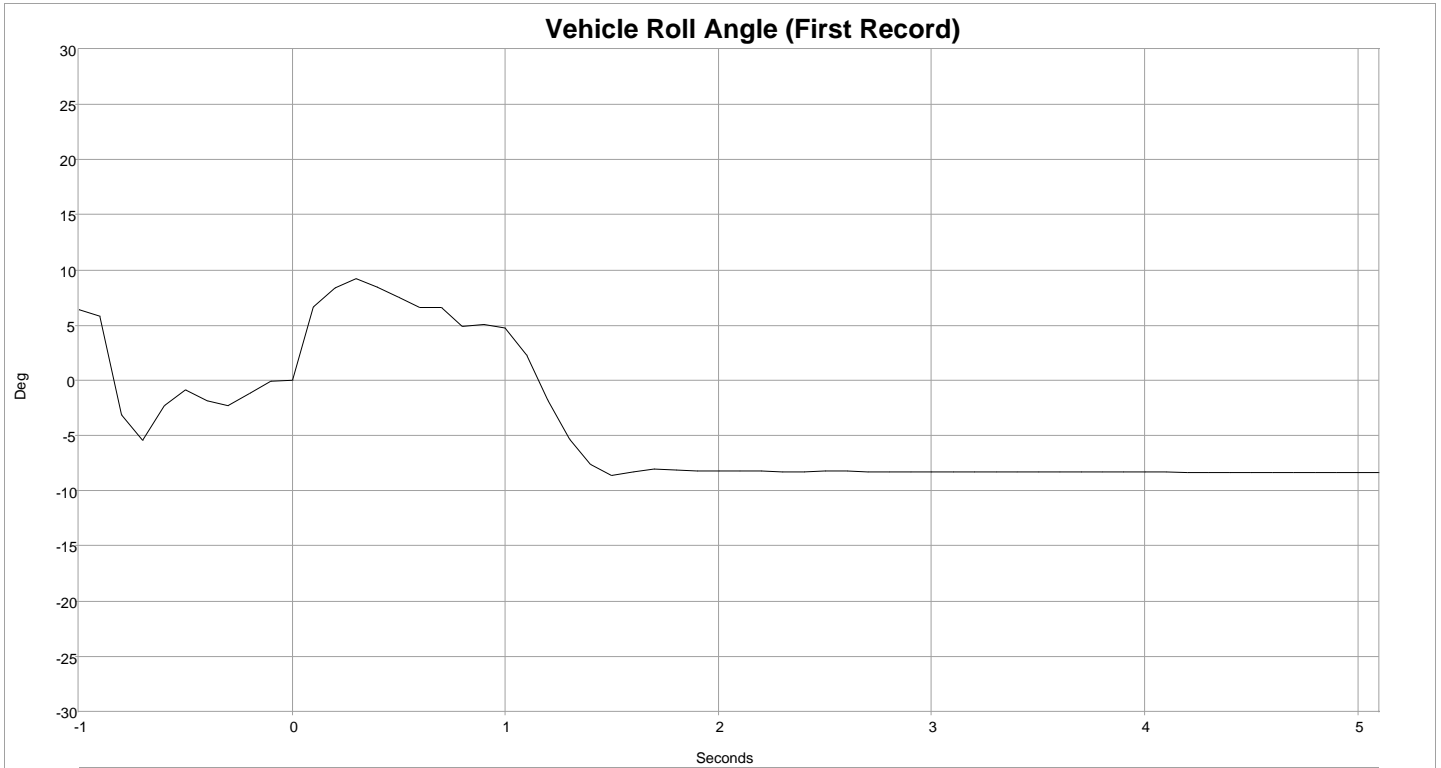
Vehicle Roll Angle (First Record)

Time (sec)	Vehicle Roll Angle (deg)
-1.0	6.43
-0.9	5.86
-0.8	-3.12
-0.7	-5.39
-0.6	-2.30
-0.5	-0.86
-0.4	-1.86
-0.3	-2.29
-0.2	-1.17
-0.1	-0.12
0.0	0.00
0.1	6.64
0.2	8.33
0.3	9.24
0.4	8.41
0.5	7.55
0.6	6.56
0.7	6.55
0.8	4.91
0.9	5.09
1.0	4.71
