DOT HS 813 529

**Special Crash Investigations:  
On-Site Reported Advanced Driver  
Assistance System Crash  
Investigation;  
Vehicle: 2022 Genesis GV70;  
Location: Michigan;  
Date: June 2022**

**Special Crash Investigations**  
**On-Site Reported Advanced Driver Assistance System Crash Investigation**  
**Office of Defects Investigation**  
**Case Number: CR22010**  
**Vehicle: 2022 Genesis GV70**  
**Location: Michigan**  
**Crash Date: June 2022**

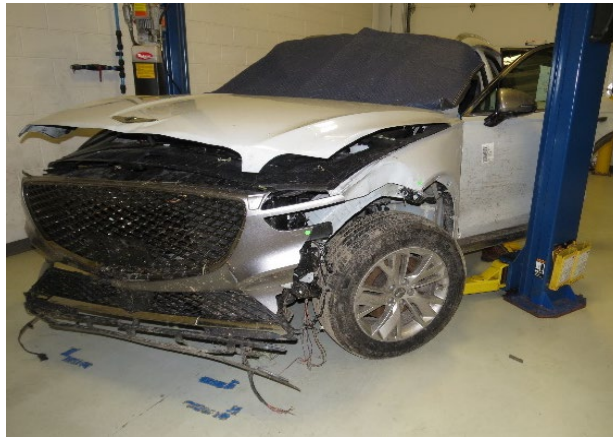
*Figure 1. Left front oblique view of the Genesis*

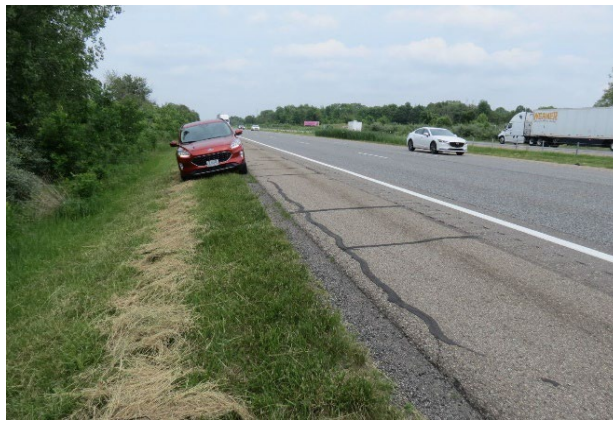
The crash occurred in the afternoon in June 2022. At the time of the crash, it was daylight and the police reported that the roads were wet. The National Weather Service reported conditions were rain, no wind, and a temperature of 22.8°C (73°F). The Genesis driver reported intermittent puddles of standing water on the roadway. The crash occurred on the westbound lanes of a six-lane divided interstate roadway (Figure 2). There were three lanes in each direction separated by a grass median and a cable barrier. The roadway was straight, level, and bituminous. The westbound lanes measured 3.7 m (12.1 ft) wide and were separated by broken white lines. The lanes were bordered by a solid yellow edge line on the left and a solid white edge line on the right. The right shoulder was 2.7 m (8.9 ft) wide. The north roadside was a grass embankment that transitioned into a brush/tree line approximately 6 m (20 ft) from the edge of the pavement. The speed limit was 113 km/h (70 mph). A crash diagram is included at the end of this report.

*Figure 2. Eastward lookback view of the interstate from the roadside*

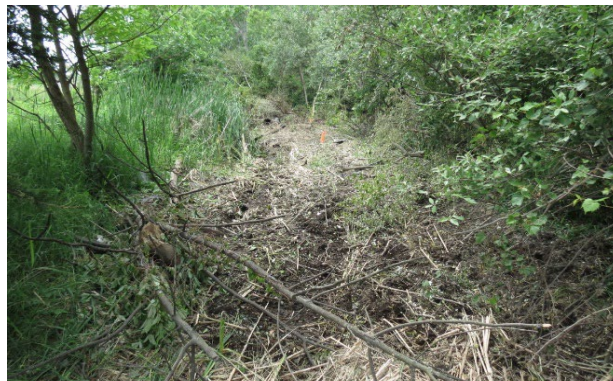
As the Genesis entered the brush along the roadside, the vehicle yawed counterclockwise. Rotating and tracking tire marks from the Lincoln were present on the grass roadside as the Lincoln followed the Genesis into the overgrown area that consisted of small diameter trees, brush, cattails, and a marshy area (Figure 4).

*Figure 4. Facing Southwest at the path of the Genesis and Lincoln into the brush/tree line*

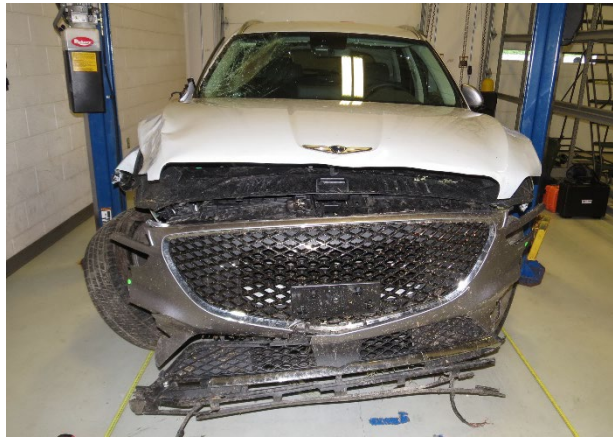
The 2022 Genesis GV70 (Figure 5) was a four-door SUV manufactured by Hyundai in an unknown month of 2021. The Genesis did not have a Vehicle Identification Number (VIN) or certification label; however, the technical center assigned the partial VIN KMUMA4TB1MU as a general class number to obtain EDR data. The Genesis was constructed on a 287 cm (113.0 in) wheelbase and powered by a 2.5-liter, inline 4-cylinder gasoline engine linked to an 8-speed automatic transmission with rear-wheel drive. The service brakes were a power-assisted four-wheel disc system. Steering was a speed-sensitive electric rack and pinion system. It had an anti-lock braking system, electronic stability control, traction control, automatic crash notification, crash imminent braking, forward collision warning, pedestrian automatic emergency braking, blind spot detection and collision assist, lane departure warning, lane keeping assistance, lane centering assistance, lane following assist, highway driving assist, daytime running lights, and adaptive/smart cruise control.

*Figure 5. Front view of the Genesis*

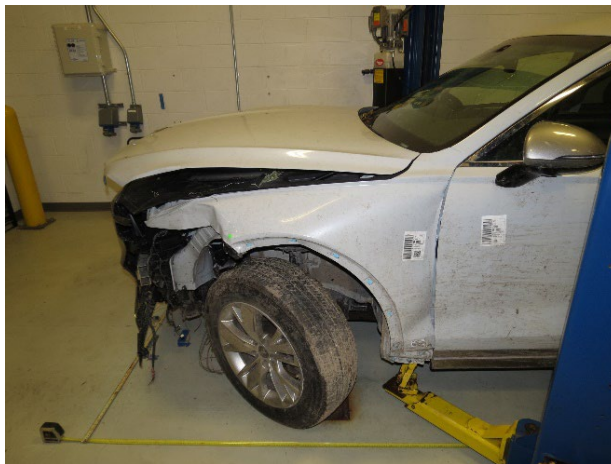
During the crash sequence the Genesis sustained damage to its front, right, and back planes. Minor damage was located at the front-left corner from the initial contact with the Lincoln (Figure 6, Event 1). The direct contact damage began 71 cm (28.0 in) left of the bumper fascia centerline and extended 18 cm (7.1 in) to the left corner. The direct contact damage continued along the left plane 47 cm (18.5 in). This corner impact did not involve any structural component of the Genesis. The direct contact damage from the Event 1 impact was limited to the left bumper fascia corner, headlight components, and left fender. The corner impact was outside the scope of the WinSMASH program. However, for crash reconstruction purposes the barrier equivalent speed of 22 km/h (14 mph) was calculated for this event. This is considered high due to the crash configuration and method of analysis. The Collision Deformation Classification (CDC) assigned to the damage pattern for Event 1 was 12FLEE2.<sup>3</sup>

*Figure 6. Left plane/forward aspect of the Genesis*

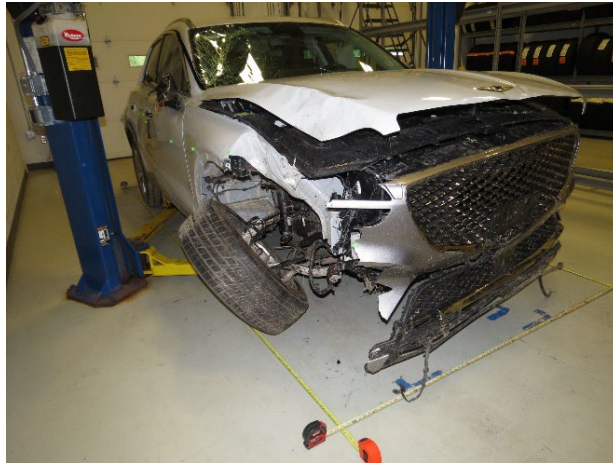
The Genesis sustained moderate damage at the front-right corner due to impact with a small diameter tree (Figure 7, Event 2). The direct contact damage began 71 cm (28.0 in) right of the bumper fascia centerline and extended 18 cm (7.1 in) to the right corner. The direct contact damage then extended along the right plane 354 cm (139.4 in) and involved impact damage to the right-front suspension, right aspect of the windshield, and minor body panel deformation of the right doors. There was no structural damage to the bumper or right frame rail. Much of the impact force was absorbed by the right-front suspension, which led to the separation of the wheel assembly from the stabilizing arm. This corner impact was also outside the scope of the barrier algorithm of the WinSMASH program. The CDC assigned to the damage pattern for Event 2 was 12FREE9.

*Figure 7. Right front oblique view of the Genesis*

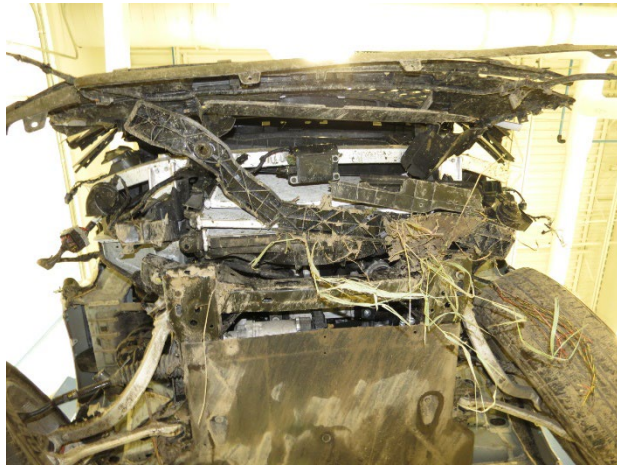
Due to the soft terrain directly after the tree location for Event 2, the Genesis bottomed out and the undercarriage struck the ground (Event 3). There were abrasions across the undercarriage guard directed from the right-front corner to the left-rear corner indicating the Genesis was rotating counterclockwise on its path to final rest (Figures 8 and 9). The CDC assigned to the damage pattern for Event 3 was 00UDDW1.

*Figure 8. Undercarriage damage across the front of the Genesis*

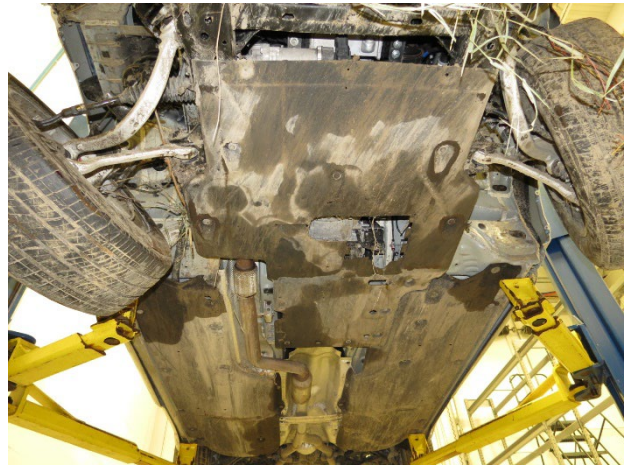
*Figure 9. Undercarriage damage to the center and rear of the Genesis*

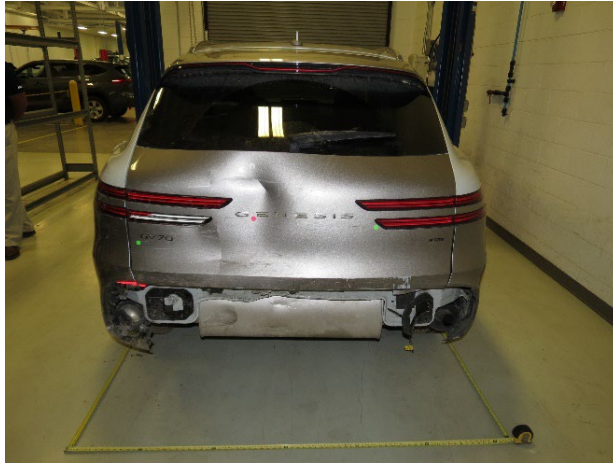
The back plane damage (Figure 10, Event 7) consisted of an 89 cm (35.0 in) wide damage pattern with a 4 cm (1.6 in) maximum crush. The maximum crush was located 12 cm (4.7 in) left of the centerline. The direct damage contact began 60 cm (23.6 in) left of center and extended to 29 cm (11.4 in) right of center. Paint transfer and damage flow was directed from the vehicle's left to its right. The rear bumper fascia was separated. The nature of the damage was consistent with the damage to the left-front corner of the Lincoln. The CDC assigned to the damage pattern was 07BDEW2.

*Figure 10. Back plane of the Genesis*

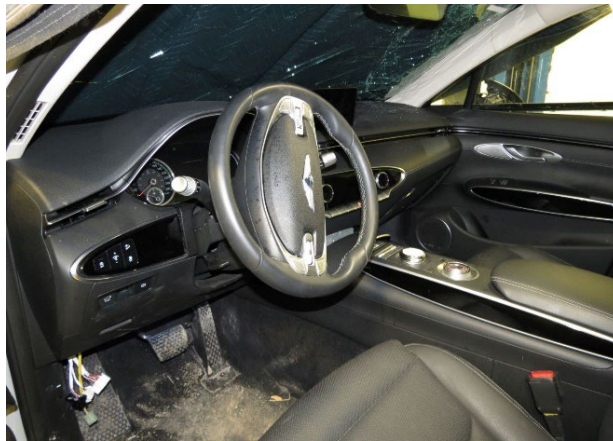
There was no significant interior damage (Figure 11) associated with the exterior forces of the crash events. There were two possible contacts to the driver's lower knee bolster as well as post-crash mud and dirt on the driver's door panel. The center console was not bolted down prior to the crash to facilitate equipment changes to the test vehicle by the technical center.

*Figure 11. Left view of the Genesis front-row interior*

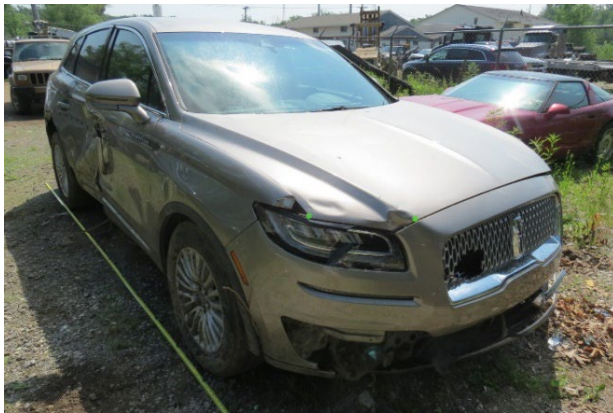
*Figure 12. Front right oblique view of the Lincoln*

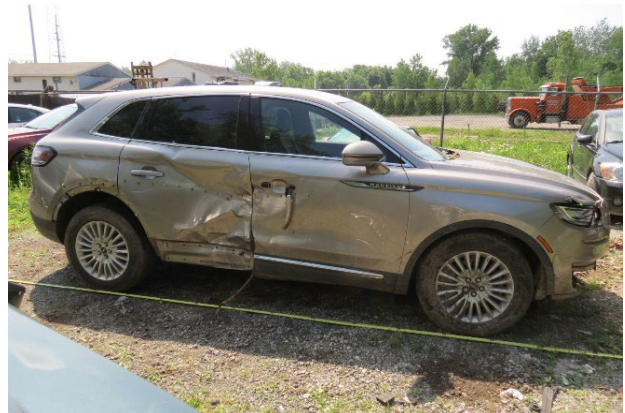
*Figure 13. Right side view of the Lincoln*

The Lincoln sustained contact damage to the right side (Figure 13) during the impact with the Genesis (Event 1). There was direct damage to the right doors and quarter panel. The direct damage started 312 cm (122.8 in) rear of the right-front axle and extended 197 cm (77.6 in) forward. Crush measurements were documented at the mid-door level and the Field L was 197 cm (77.6 in). The crush values were C1 = 3 cm (1.2 in), C2 = 3 cm (1.2 in), C3 = 0 cm, C4 = 5 cm (2.0 in), C5 = 1 cm (0.4 in), C6 = 1 cm (0.4 in). The maximum residual crush was 5 cm (2.0 in), occurring 177 cm (69.7 in) rear of the right-front axle. The CDC assigned to this damage pattern was 05RZEW1. The missing vehicle CDC algorithm of the WinSMASH program calculated the Lincoln's total delta V as 15 km/h (9 mph). The longitudinal and lateral velocity changes were 15 km/h (9 mph) and -5 km/h (-3 mph).

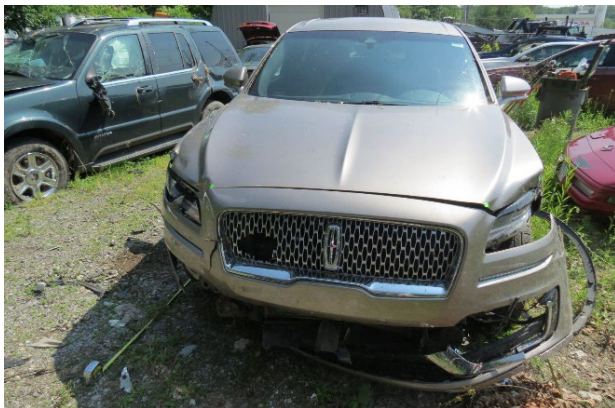
During the Lincoln's travel through the brush, the front and undercarriage struck soft ground and brush (Event 6, Figure 14). Direct damage was noted on the structures under the bumper, including the radiator and bumper fascia. The CDC for this damage pattern was 00UFDW1.

*Figure 14. Front view of the Lincoln*

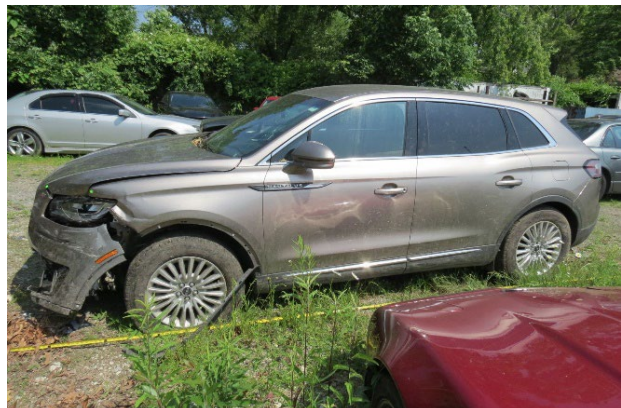
The front-left aspect of the Lincoln sustained damage during contact with the back plane of the Genesis at the end of the crash sequence (Event 7, Figure 15). The hood, bumper fascia, left fender, and head and turn lamp assembly all sustained minor direct contact damage. The direct damage began 50 cm (19.7 in) left of the centerline and extended 40 cm (15.7 in) to the left. Maximum crush was estimated to be 3 cm (1.2 in), located 72 cm (28.3 in) left of the centerline on the front-left corner. The CDC for this damage pattern was 12FLEE2.

*Figure 15. Left side view of the Lincoln*
