DOT HS 813 607

**Special Crash Investigations:
On-Site Rollover Crash
Investigation;
Vehicle: 2022 Hyundai Tucson;
Location: Pennsylvania;
Crash Date: February 2022**

Special Crash Investigations
On-Site Rollover Crash Investigation
Case Number: CR22004
Vehicle: 2022 Hyundai Tucson
Location: Pennsylvania
Crash Date: February 2022

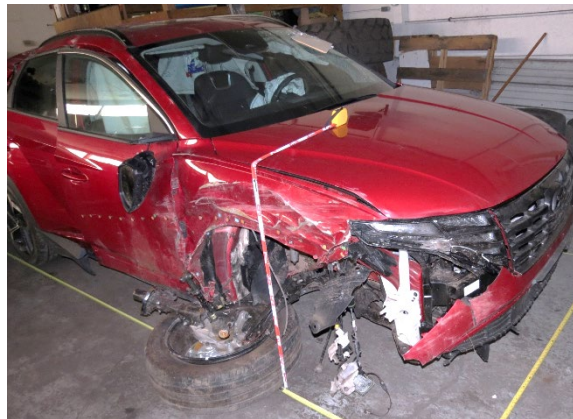
Figure 1. Front view of damage to the Hyundai

This report documents the on-site investigation of the rollover crash of a 2022 Hyundai Tucson (Figure 1). The Hyundai was traveling northbound on a two-lane roadway. The police crash report (PCR) stated that the belted 64-year-old female driver was distracted by the vehicle's infotainment system and failed to negotiate a left curve in the roadway. The Hyundai departed from the right side of the roadway into a drainage ditch, where it rolled over for approximately 11 m (36 ft) before coming to rest on its roof at the bottom of the ditch. There were several supplemental restraints that deployed as a result of the crash. The driver was transported by ambulance to a local hospital where she was treated for police-reported suspected minor (B-level) injuries. The vehicle was towed to a secure location due to disabling damage, where it remained for this investigation.

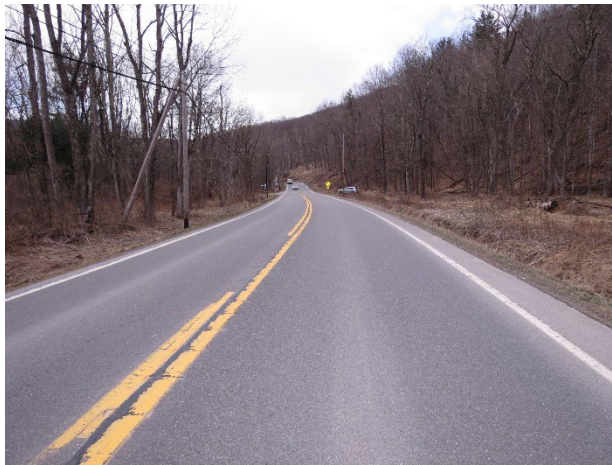
Figure 2. North view of the Hyundai's approach

The crash occurred during the day on an undivided two-lane north/south directional roadway. At the time of the crash the National Weather Service reported conditions as fair, -1.6 °C (29 °F), 54 percent humidity, and south-southeast winds at 14.4 km/h (9 mph). The dry bituminous roadway alignment consisted of a large radius curve to the left that terminated into a straight segment. The posted speed limit was 72 km/h (45 mph). The roadway was 7.3 m (24.0 ft) wide with lanes measuring 3.6 meters (11.8 ft) wide. The lanes were separated by a solid double yellow centerline and bordered by a white edge line. The east shoulder of the roadway was 1.5 meters (4.9 ft) wide and transitioned into a drainage ditch. The ditch was 2.9 meters (9.5 ft) wide and 0.8 meters (2.6 ft) deep. A utility pole was positioned 20.7 meters (67.9 ft) north from where the vehicle departed the roadway and 4 meters (13.1 ft) from the roadway edge. Figures 2 and 3 show the roadway curvature and the departure into the drainage ditch.

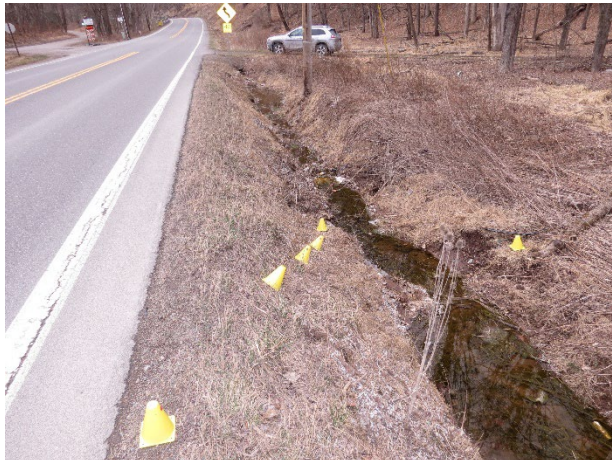
Figure 3. North view of the roadway departure (Event 1) indicated by the cones on the left

As the Hyundai entered the straight segment of the road, it continued in its prior trajectory and tracked off-road to the right (Figure 3), denoted by the yellow cones. The steering angle did not change significantly until just prior to impact. The steering input recorded by the EDR indicated the driver's attempt to redirect the Hyundai back to the roadway as a crash avoidance maneuver. There was a momentary fluctuation of the master cylinder pressure for the brake system that was attributed to the stability control engaging at algorithm enabled (AE).

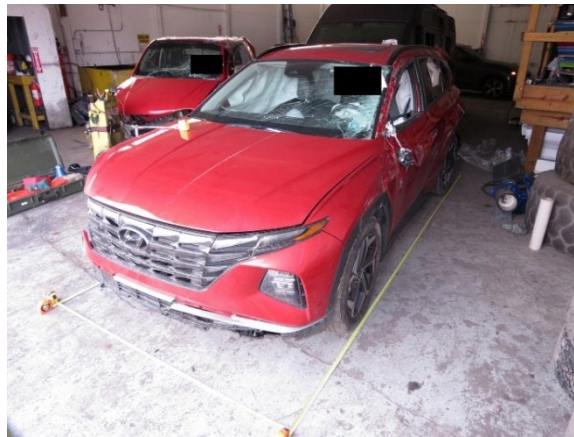
Figure 4. Left front oblique view of the Hyundai

The 2022 Hyundai Tucson was a four door SUV (Figure 4) manufactured in June 2021 and identified by Vehicle Identification Number 5NMJCCA8NHxxxxxx. It was constructed on a 267 cm (105.1 in) wheelbase and powered by a 2.5-liter, inline 4-cylinder, gasoline engine linked to an 8-speed automatic transmission with four-wheel drive. The service brakes were a power-assisted four-wheel disc system. Steering was set up as a speed-sensitive electric rack and pinion system. The Hyundai had an antilock braking system, electronic stability control, traction control, automatic crash notification, crash imminent braking, forward collision warning, pedestrian automatic emergency braking, blind spot detection, lane departure warning, lane keeping assist (LKA), lane follow assist (LFA), daytime running lights, and SCC.

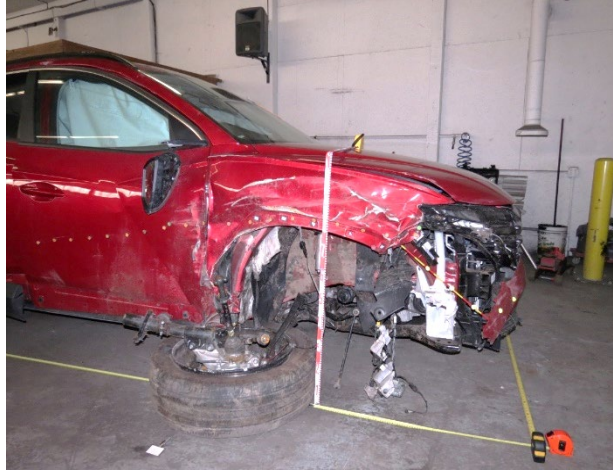
The Hyundai sustained damage at the front-right corner area from initial contact with the ditch bank (Event 1) (Figures 5 and 6). The direct contact damage began 59 cm (23.2 in) right of the bumper fascia centerline and extended 21 cm (8.2 in) to the right corner. The direct contact damaged continued along the right plane 223 cm (87.8 in). Due to the nature of this corner type impact, no front structural component of the Hyundai contacted the ditch bank. The direct contact damage from Event 1 involved the right bumper fascia, headlight components, right-front wheel assembly, and passenger's right door panel. Most of the force associated with this event was absorbed by the right-front tire and suspension, which led to the separation of the wheel/suspension assembly from the CV joint and the associated ball joints/steering rods. This corner impact was outside the scope of the barrier algorithm of the WinSMASH program. The collision deformation classification (CDC) assigned to the damage pattern for Event 1 was 01FREE8.

Figure 5. Right side view of damage associated with Event 1

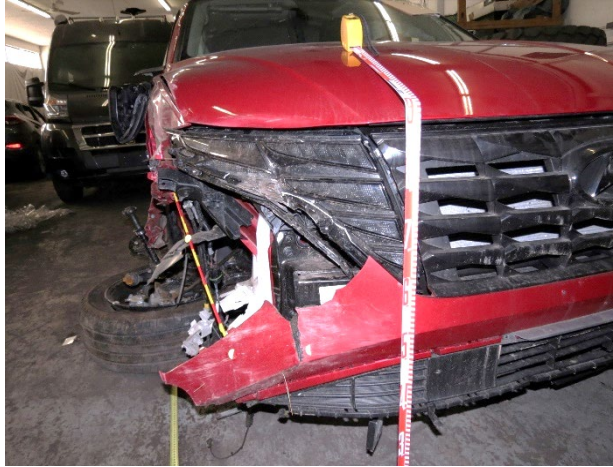
Figure 6. Front plane view of damage associated with Event 1

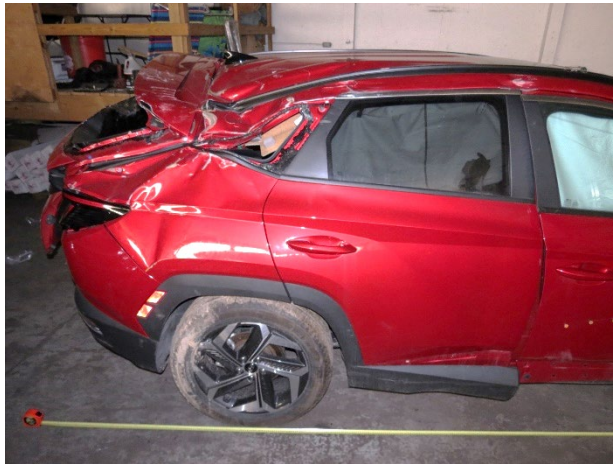
The Hyundai sustained moderate damage during the rollover (Event 2). The Hyundai landed on its right D-pillar, crushing it into the greenhouse space 15 cm (5.9 in) vertically and 15 cm (5.9 in) laterally. There were several heavy surface abrasions (Figures 7 and 8) across the entire vehicle as well as minor trim damage. The left side mirror was missing from the vehicle and the right mirror was dangling from its sensor wires. The abrasions and mirror damage are attributed to the Hyundai sliding through the ditch to its final rest on its roof top. The CDC assigned to this event is 00TZZO3.

Figure 7. Right side view of damage associated with Event 2

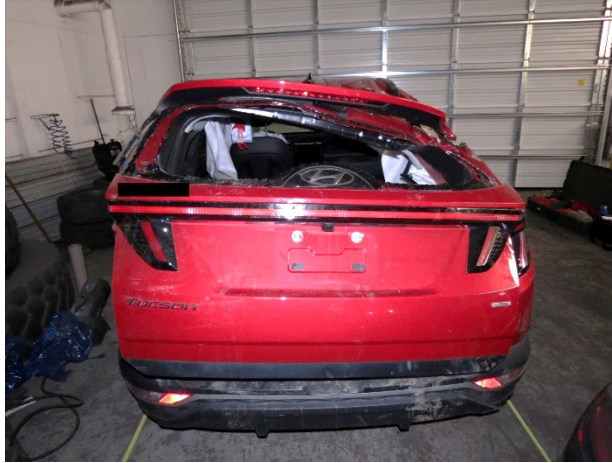
Figure 8. Rear view of damage associated with Event 2

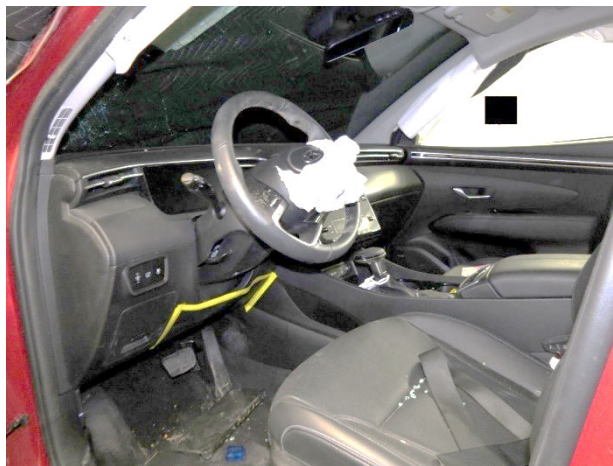
There was minor interior damage that was associated with air bag deployment and occupant contacts for this crash. There were no intrusions to the front row of the interior (Figures 9 and 10). The driver contacts consisted of scuffs to the polymer knee bolster/lower instrument panel at the base of the steering column. Blood evidence that probably occurred post-crash was noted to the sunroof window cover. The driver's IC air bag had been cut by the EMS personnel and placed in the rear cargo area. The Hyundai's cargo area was significantly reduced in size as a result of the rollover (Event 2).

Figure 9. Oblique overview of the front row

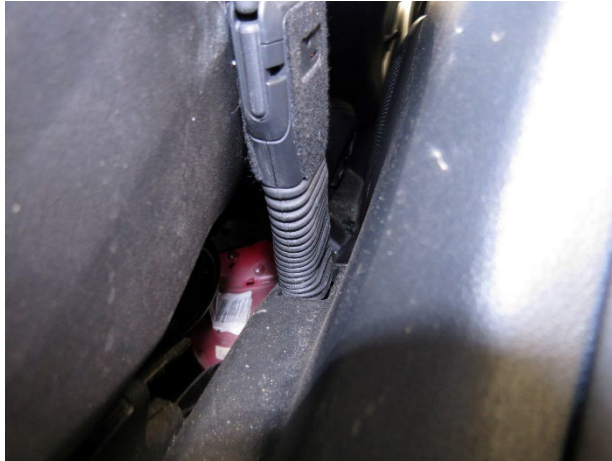
The Hyundai had 3-point continuous loop lap and shoulder seat belts for each of the five seat positions. The front row used sliding latch plates and adjustable D-rings. Both front seat positions had retractor and lower anchor pretensioners. Both pretensioners actuated as a result of the crash (Figure 11). The belted driver was the sole occupant of the vehicle during the crash.

Figure 11. Driver's seat belt anchor showing signs of actuation

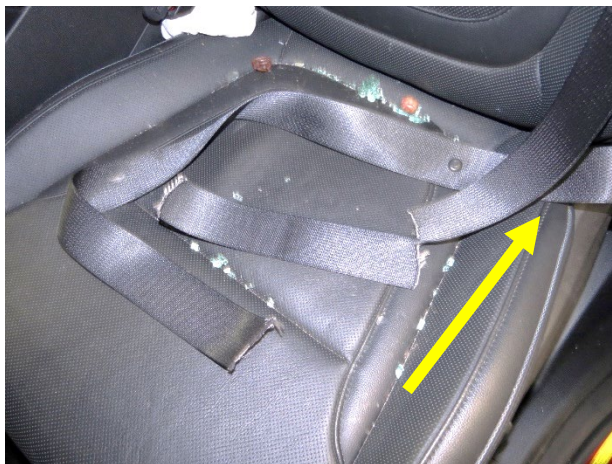
At the time of the SCI inspection, it was observed that the driver's seat belt was hanging loose from the D-ring with the retractor locked. The D-ring position was full up. The seat belt had been cut twice by EMS personnel post-crash (Figure 12). The first cut was made 70 cm (27.5 in) below the adjustable D-ring. The second cut was 24 cm (9.4 in) below the first cut with the remaining 85 cm (33.4 in) of webbing extending to the lower anchor. The latch plate was still positioned in the buckle. Frictional abrasions were present on the polymer surface of the latch plate (Figure 13) that resulted from driver loading during the crash.

Figure 12. View of the driver's seat belt as found

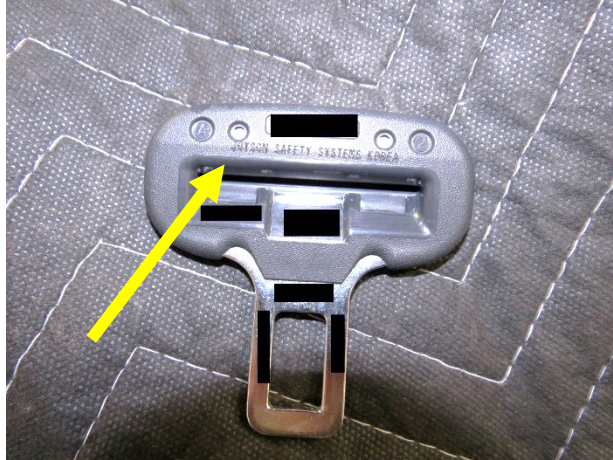
Figure 13. Driver seat belt latch plate with friction burns denoted by yellow arrow

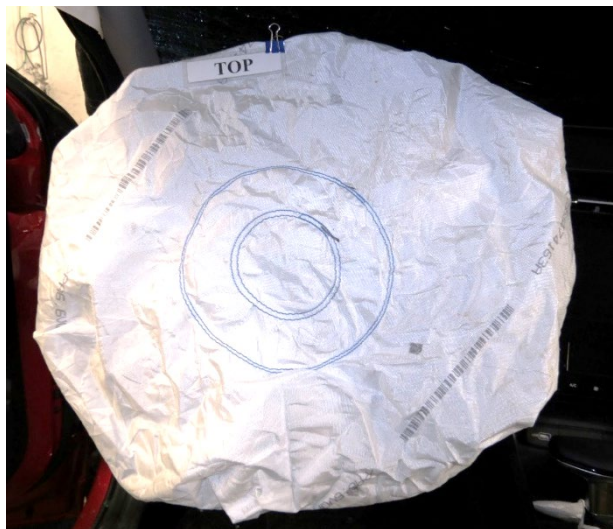
Figure 14. Driver's frontal air bag

The Hyundai had dual-stage driver's and passenger's frontal air bags, outboard seat-mounted side impact air bags, and IC air bags. The driver's frontal steering wheel mounted air bag deployed (Figure 14). Both front seat side impact air bags (Figures 15 and 16) and both IC air bags (Figures 17 and 18) also deployed. At the time of the SCI investigation, it was observed that the left IC air bag had been cut out by EMS personnel post-crash.

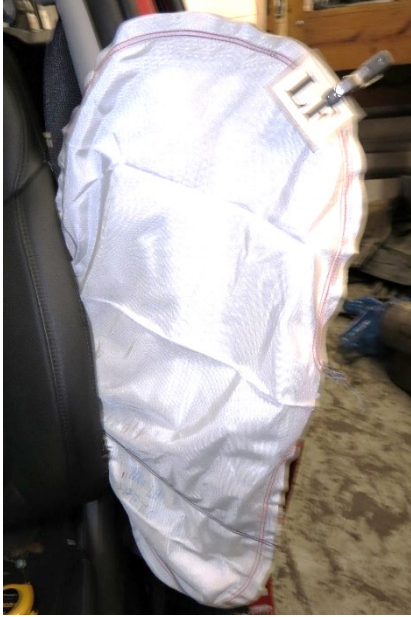
Figure 15. Driver's seat-mounted side impact air bag

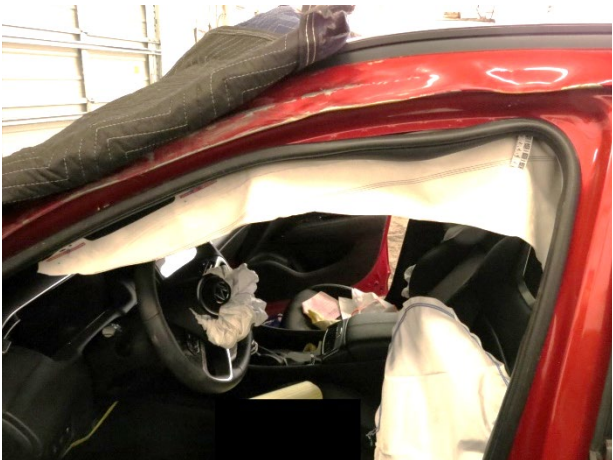
Figure 17. Driver's IC air bag cut out

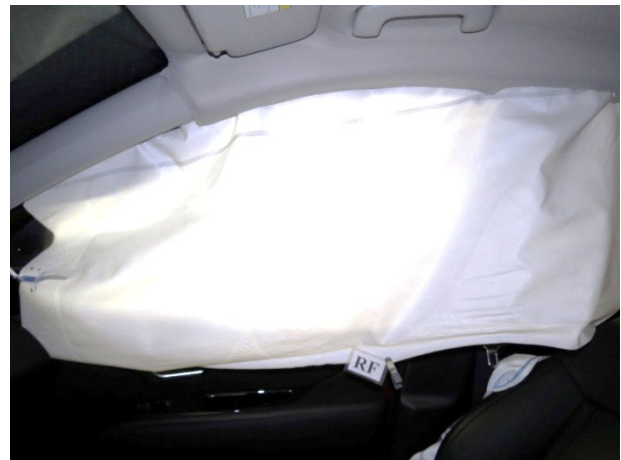
Figure 18. Front passenger's IC air bag
