**Special Crash Investigations:
On-Site Ambulance Crash
Investigation;
Vehicle: 2019 Ford F-450 Type I
Ambulance;
Location: Ohio;
Date: November 2021**

16. Abstract This report documents the on-site investigation of the offset frontal crash of a 2019 Ford F-450 Type I ambulance and a 2001 Dodge Ram 2500 that resulted in injuries to the occupants in both vehicles. The ambulance was driven by a belted 23-year-old male, with a belted 33-year-old male front right passenger, and an unrestrained 50-year-old male paramedic in the patient compartment. The ambulance was returning to the fire station after transporting a patient to a hospital and was not operating in an emergency mode. The Dodge Ram was driven by an unbelted 37-year-old male. The ambulance was negotiating a right curve when the Dodge, traveling in the opposite direction, crossed the centerline into the travel lane resulting in the offset frontal collision. The ambulance driver and front right passenger sustained B-level (non-incapacitating) injuries and were transported to a local hospital where they were treated and released. The paramedic in the patient compartment sustained A-level (incapacitating) injuries and was trans

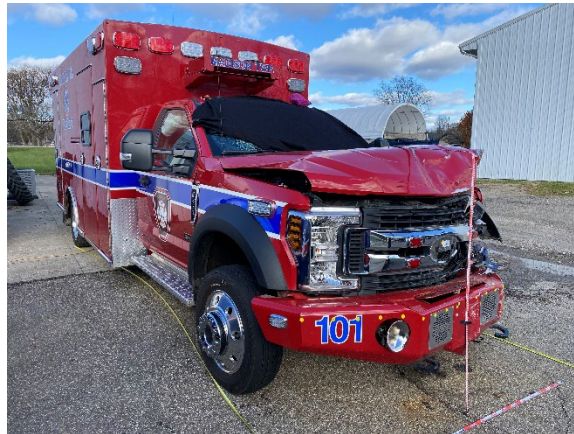
Figure 1. Right front oblique view of the 2019 Ford F-450 Type I ambulance

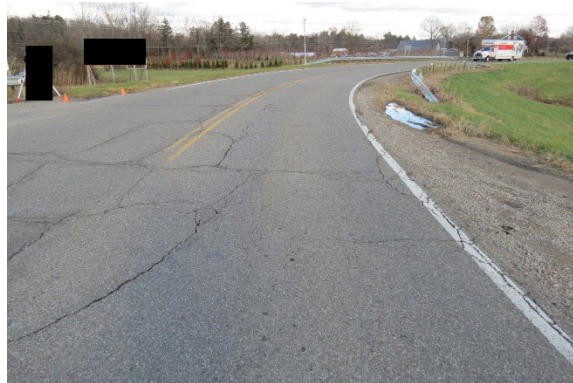
This crash occurred on a two lane, undivided rural roadway at night. At the time of the crash, the National Weather Service listed the conditions as cloudy with a temperature of 56 °F, 72 percent humidity, and eastward winds at 20 km/h (12 mph). The dry, bituminous roadway traversed in a general east-west direction with one through lane in each direction that curved right for the ambulance's path of travel (Figure 2). The roadway was dark and unlit. Roadway markings had a solid white fog line on the road edges and a double yellow median lane line to separate the east and west lanes. Both roadsides were protected by W-beam guardrail systems. The posted speed limit was 89 km/h (55 mph).

Figure 2. Eastward view of the ambulance's pre-crash approach to the crash site

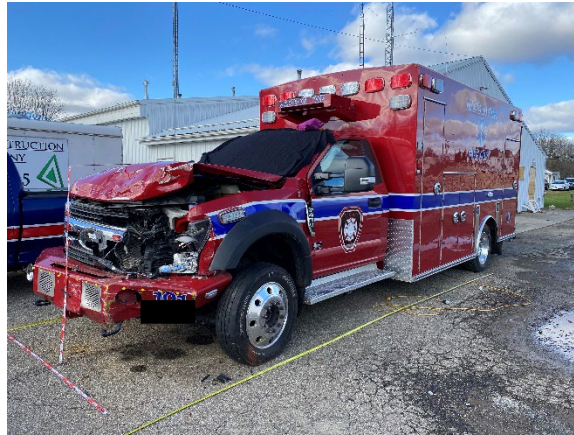
The 2019 Ford F-450 Type I Ambulance (Figure 3) was manufactured in May 2019 and was identified by vehicle identification number (VIN) 1FDUF4HT9KDxxxxxx. It was built on a rear-wheel drive platform and powered by a 6.7 liter, 8-cylinder diesel engine linked to a 6-speed automatic transmission.

Figure 3. Left front oblique view of the 2019 Ford F-450 Type I ambulance

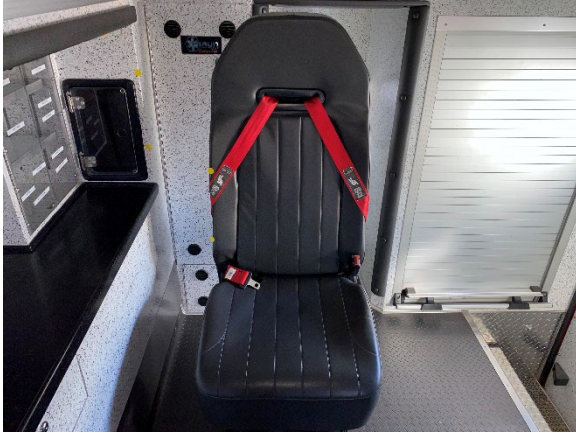
The patient compartment had a rear-facing, high back pedestal-mounted captain’s seat (Figure 4) at the forward aspect of the patient compartment, a single passenger seat on the right wall, a single passenger seat on the left wall (Figure 5), and a centrally located single occupant patient cot and containment system. All seating positions in the patient compartment had integrated four-point lap and shoulder seat belts.

Figure 4. Rear facing captain's seat in the patient compartment

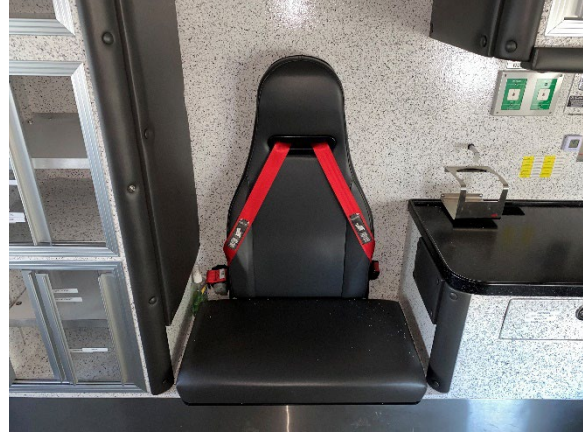
Figure 5. Passenger seat along the left wall in the patient compartment

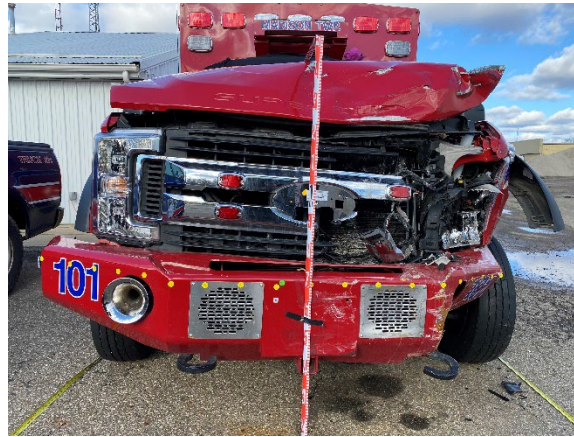
Figure 6. Crush damage of the 2019 Ford F-450 Type I ambulance

The collision with the Dodge resulted in damage to the front plane of the Ford (Figure 6). The front reinforced bumper, front left headlight, and hood all sustained direct damage from the Dodge. The direct damage was 115 cm (45.2 in) wide beginning 11 cm (4.3 in) right of the front center point extending left. The field-L was 208 cm (81.8 in). The maximum crush was located at the left front bumper corner with a corresponding collision deformation classification (CDC) of 12FYEW1. The WinSMASH program could not determine velocity change since the vehicle type was out of the scope of the program.

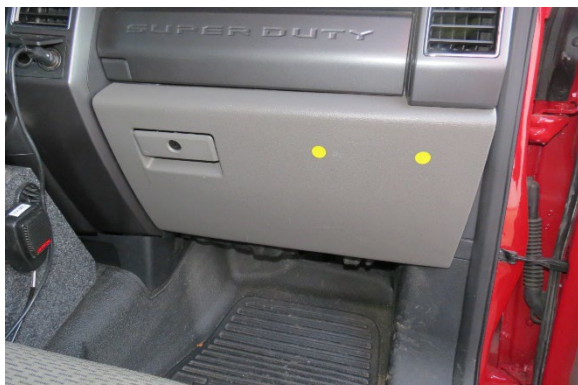
The ambulance cab and patient compartment were not damaged during the crash. A scuff was noted on the glove box door (Figure 7). Another contact point was in the patient compartment on the left sidewall corner just behind the rear-facing captain's seat (Figure 8). A contact to the back of the captain's chair and a contact to the patient cot system were determined during the reconstruction process after medical records were received. No physical evidence of these

Figure 7. Contact point on front right passenger's lower instrument panel in the passenger compartment

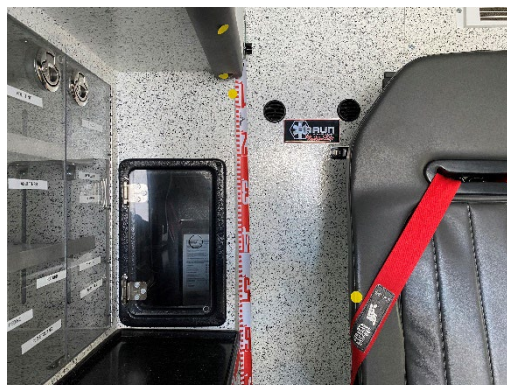
Figure 8. Contact point on the left sidewall corner just behind the rear-facing captain's seat in the patient compartment

The paramedic was seated on the rear-facing captain’s seat leaning to the right with his elbow on the desk area with his head in his right hand. He was not wearing the integrated four-point lap and shoulder seat belt system. At impact he initiated a rearward trajectory (relative to his seated position) in response to the frontal crash forces and loaded the seatback. The posterior aspect of his scalp struck the corner area of an overhead cabinet that resulted in a 4 cm (1.6 in) laceration and an unspecified loss of consciousness. The abrasion to the right shoulder was likely also caused by the overhead cabinet. His back abrasion was probably caused by the seatback and the bruise to his left shin was caused from contact to the patient cot in front of him. He was transported by helicopter to a local hospital and he was admitted overnight for observation.

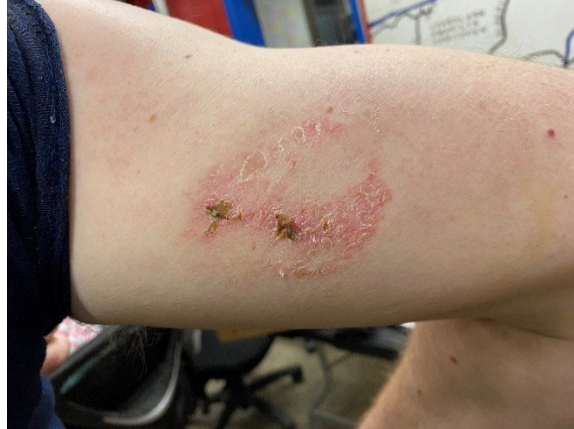
The driver and front right passenger sustained thermal burns on the underside of their upper arms that resulted from the exhaust gases vented from the seat-mounted air bags. The driver sustained burns on his left upper arm whereas the front right passenger sustained burns on his right upper arm. Figure 9 shows the burn damage to the underside of the right front passenger's right upper arm.

Figure 9. View of the right-front passenger's burn marks on the underside of the front right occupant's upper arm

The thermal burns came from the right front passenger's side impact air bags. The air bag vent ports were located on the inboard aspects of the seat-mounted air bags and exhausted toward the respective occupants. The hot exhaust gases vented from the air bag ports, (Figure 10) and burned through the right front passenger's shirt (Figure 11) causing thermal burn to his upper arm. The burn pattern on the shirts aligned with the exhaust vent port on the front side impact air bags. The driver sustained the same type of thermal burns on his left arm from the left front driver's side impact air bag as it deployed.

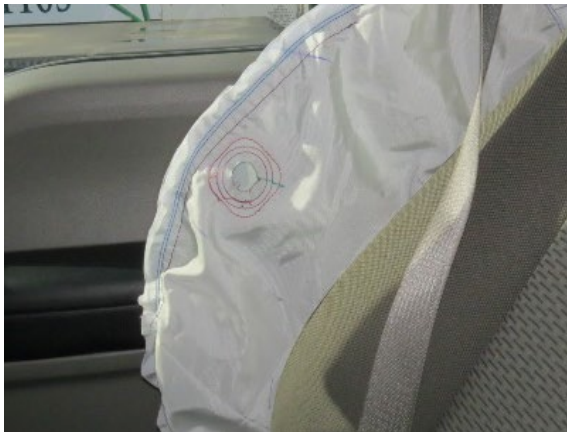
Figure 10. View of the front right occupant side seat-mounted air bag exhaust port

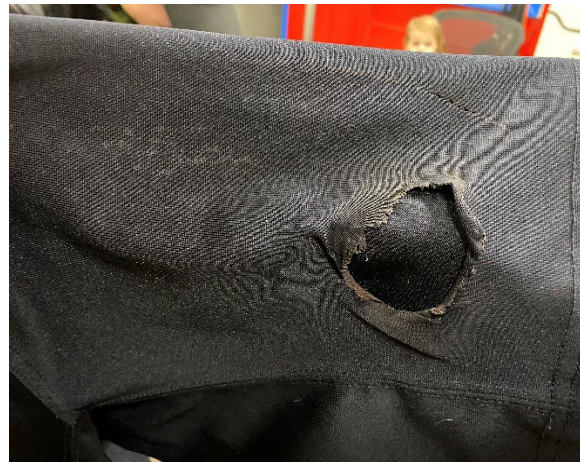
Figure 11. View of the right sleeve from the front right occupant's shirt

The front right passenger of the ambulance was seated in an upright position, the seat track was adjusted between the mid and full-rear track position and was restrained by the seat belt. As a result of the impact with the Dodge, the passenger was displaced forward and to the left. He loaded his seat belt and the deployed frontal air bag. The right seat-mounted side impact air bag also deployed and exhaust gases from the air bag burned through his shirt and caused a thermal burn to his right upper arm.

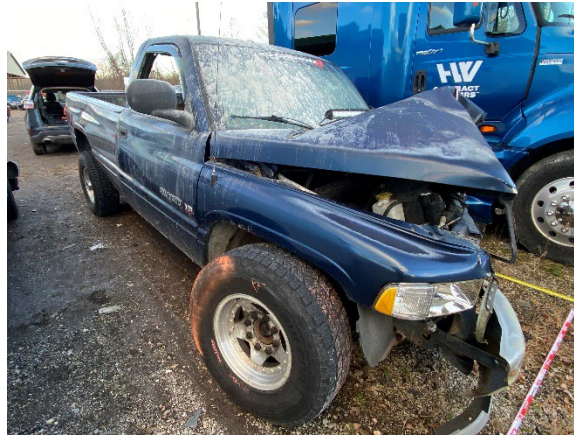
The Dodge (Figure 12) was a rear-wheel drive, 3-passenger pickup truck identified by VIN 3B7KC26Z61Mxxxxxx, manufactured in February 2001. It had a 5.9 liter, 8-cylinder gasoline engine linked to a 4-speed automatic transmission. Its service brakes were power-assisted four-wheel disc with ABS. The gross vehicle weight rating was 3,992 kg (8,800 lb).

Figure 12. Right front oblique view of the Dodge

The crash involved the front plane of the Dodge. The offset frontal impact with the ambulance resulted in a CDC of 12FYEW4. The maximum crush to the front plane was 95 cm (37 in) and was located 53 cm (21 in) right of the left front bumper corner.

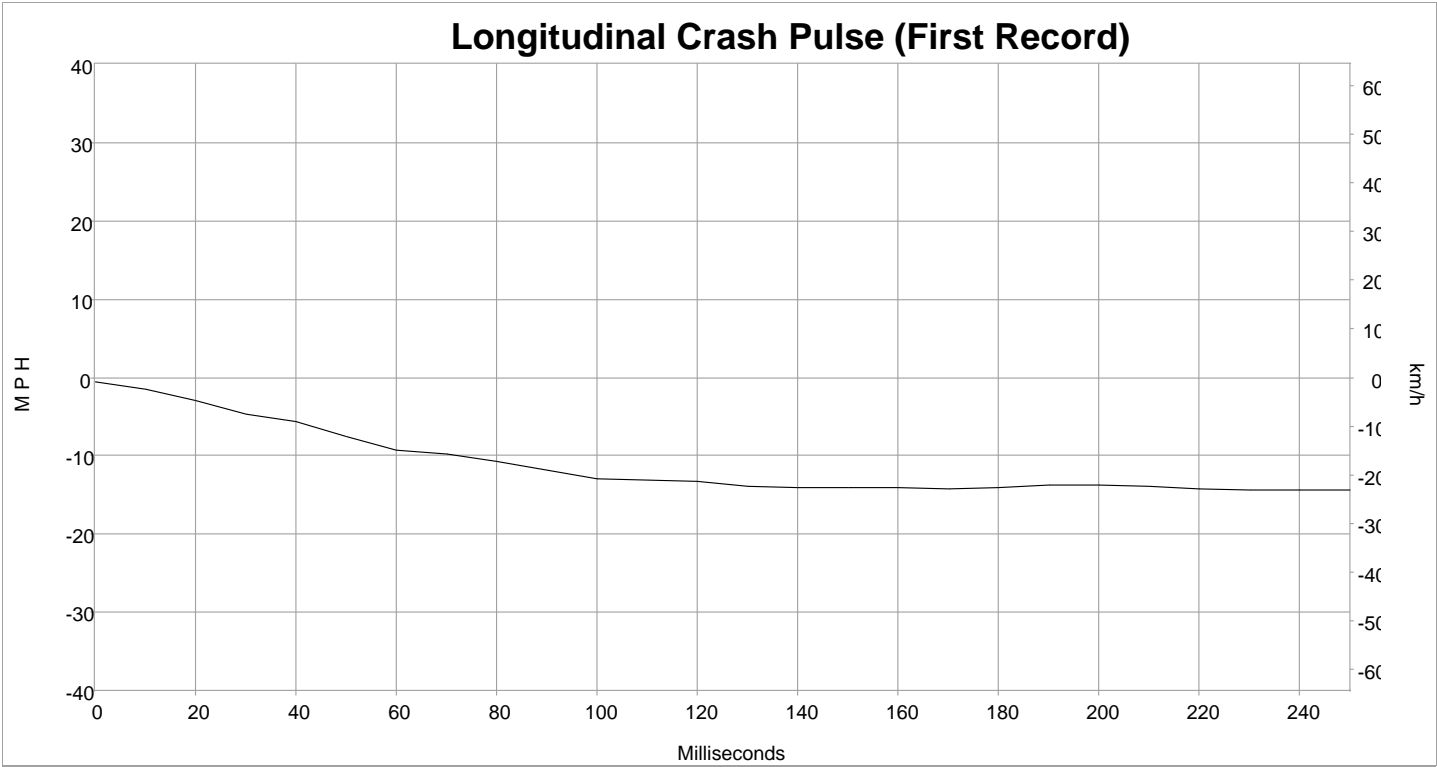
Longitudinal Crash Pulse (First Record)

Time (msec)	Delta-V, longitudinal (MPH)	Delta-V, longitudinal (km/h)
0	-0.60	-0.97
10	-1.49	-2.40
20	-2.98	-4.80
30	-4.65	-7.48
40	-5.66	-9.11
50	-7.49	-12.06
60	-9.24	-14.87
70	-9.82	-15.81
80	-10.74	-17.29
90	-11.90	-19.15
100	-12.91	-20.78
110	-13.04	-20.99
120	-13.32	-21.44
130	-13.86	-22.31
140	-14.02	-22.56
150	-14.05	-22.61
160	-14.15	-22.78
170	-14.26	-22.95
180	-14.02	-22.56
190	-13.76	-22.14
200	-13.79	-22.20
210	-13.96	-22.46
220	-14.21	-22.87
230	-14.35	-23.10
240	-14.42	-23.21
250	-14.47	-23.29

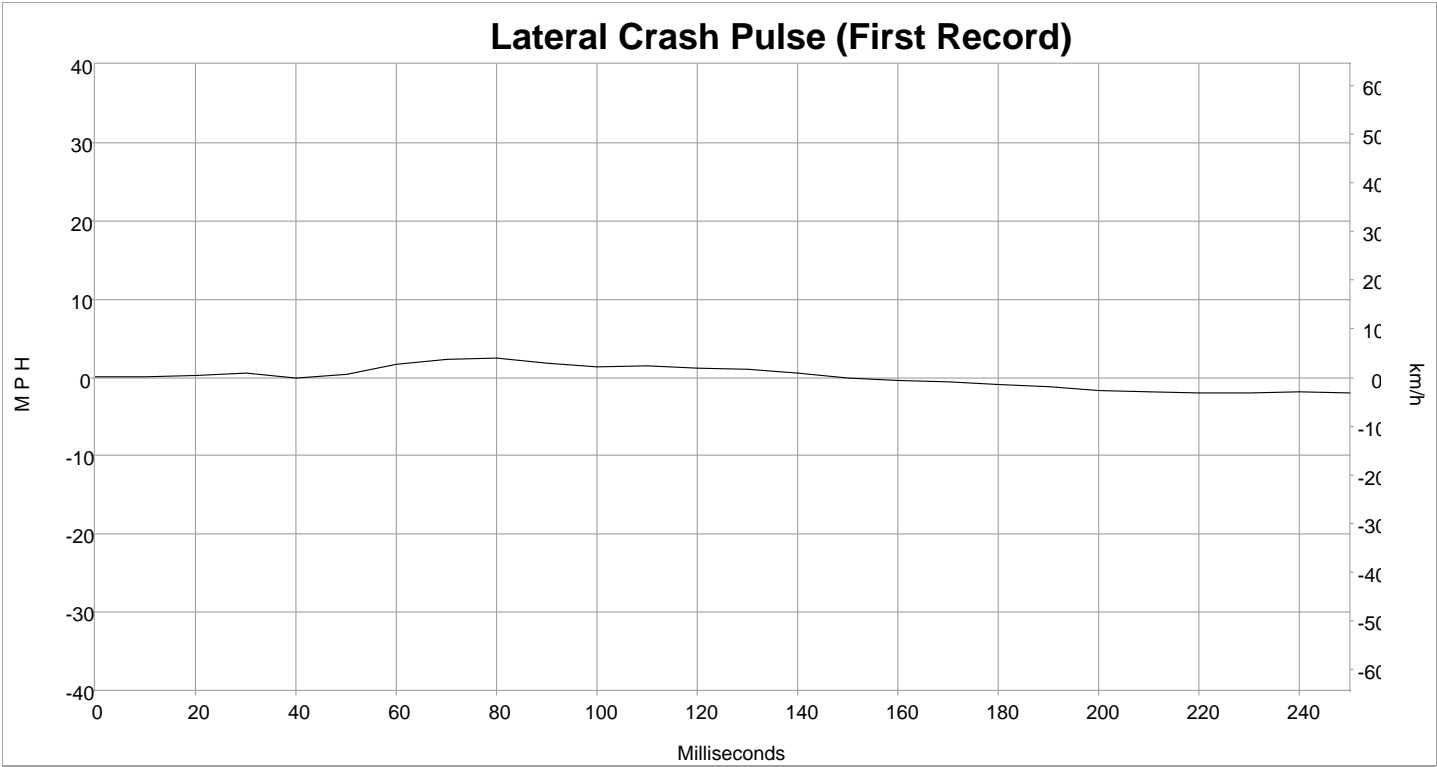
Lateral Crash Pulse (First Record)

Time (msec)	Delta-V, Lateral (MPH)	Delta-V, Lateral (km/h)
0	0.02	0.04
10	0.07	0.12
20	0.29	0.47
30	0.48	0.78
40	-0.15	-0.24
50	0.39	0.63
60	1.60	2.58
70	2.27	3.66
80	2.47	3.97
90	1.86	3.00
100	1.43	2.30
110	1.52	2.44
120	1.26	2.02
130	1.09	1.75
140	0.56	0.90
150	-0.07	-0.12
160	-0.40	-0.64
170	-0.61	-0.98
180	-0.81	-1.31
190	-1.17	-1.88
200	-1.59	-2.56
210	-1.85	-2.98
220	-2.03	-3.26
230	-2.01	-3.24
240	-1.90	-3.05
250	-1.95	-3.14

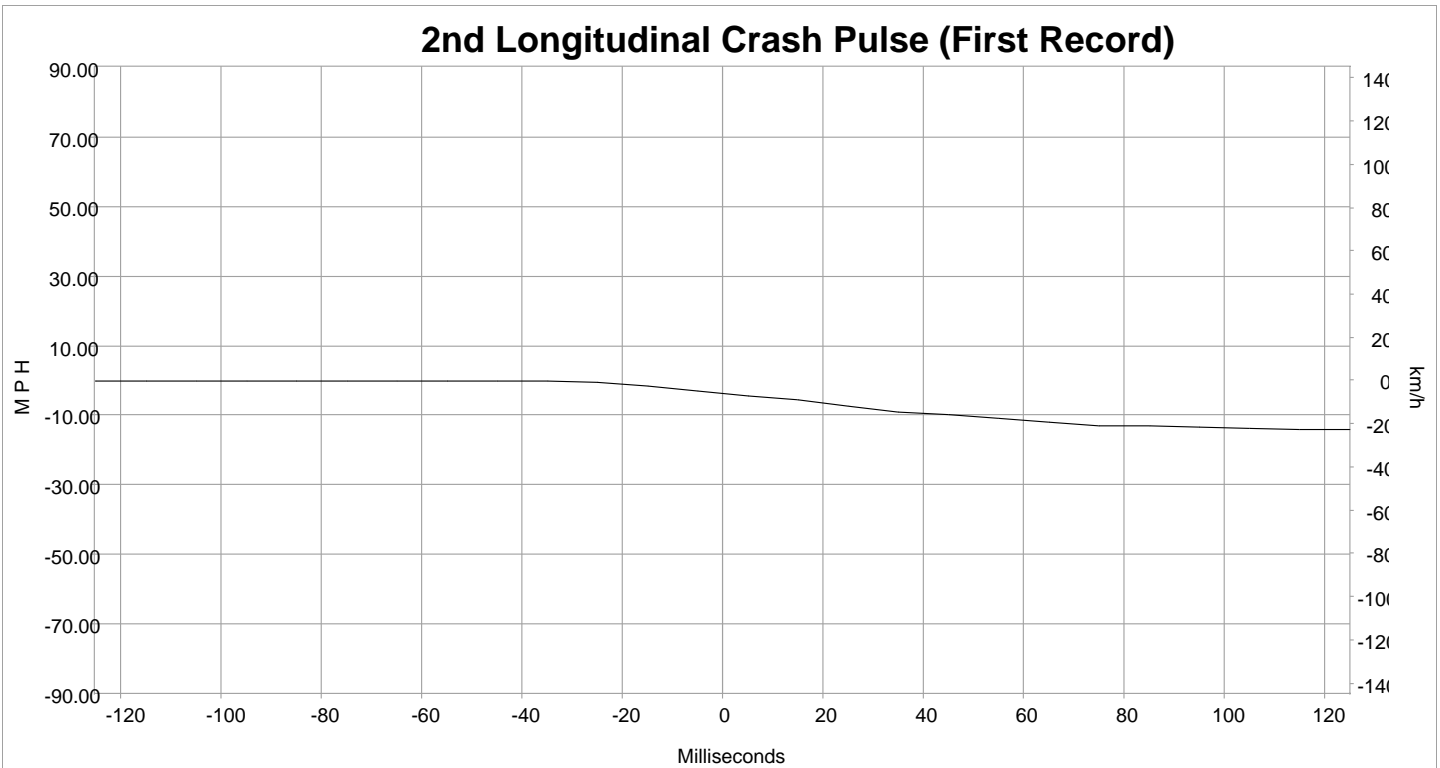
2nd Longitudinal Crash Pulse (First Record)

Time (msec)	2nd Delta-V, longitudinal (MPH)	2nd Delta-V, longitudinal (km/h)
-125	0.00	0.00
-115	0.00	0.00
-105	0.00	0.00
-95	0.00	0.00
-85	0.00	0.00
-75	0.00	0.00
-65	0.00	0.00
-55	0.00	0.00
-45	0.00	0.00
-35	0.00	0.00
-25	-0.60	-0.97
-15	-1.49	-2.40
-5	-2.98	-4.80
5	-4.65	-7.48
15	-5.66	-9.11
25	-7.49	-12.06
35	-9.24	-14.87
45	-9.82	-15.81
55	-10.74	-17.29
65	-11.90	-19.15
75	-12.91	-20.78
85	-13.04	-20.99
95	-13.32	-21.44
105	-13.86	-22.31
115	-14.02	-22.56
125	-14.05	-22.61

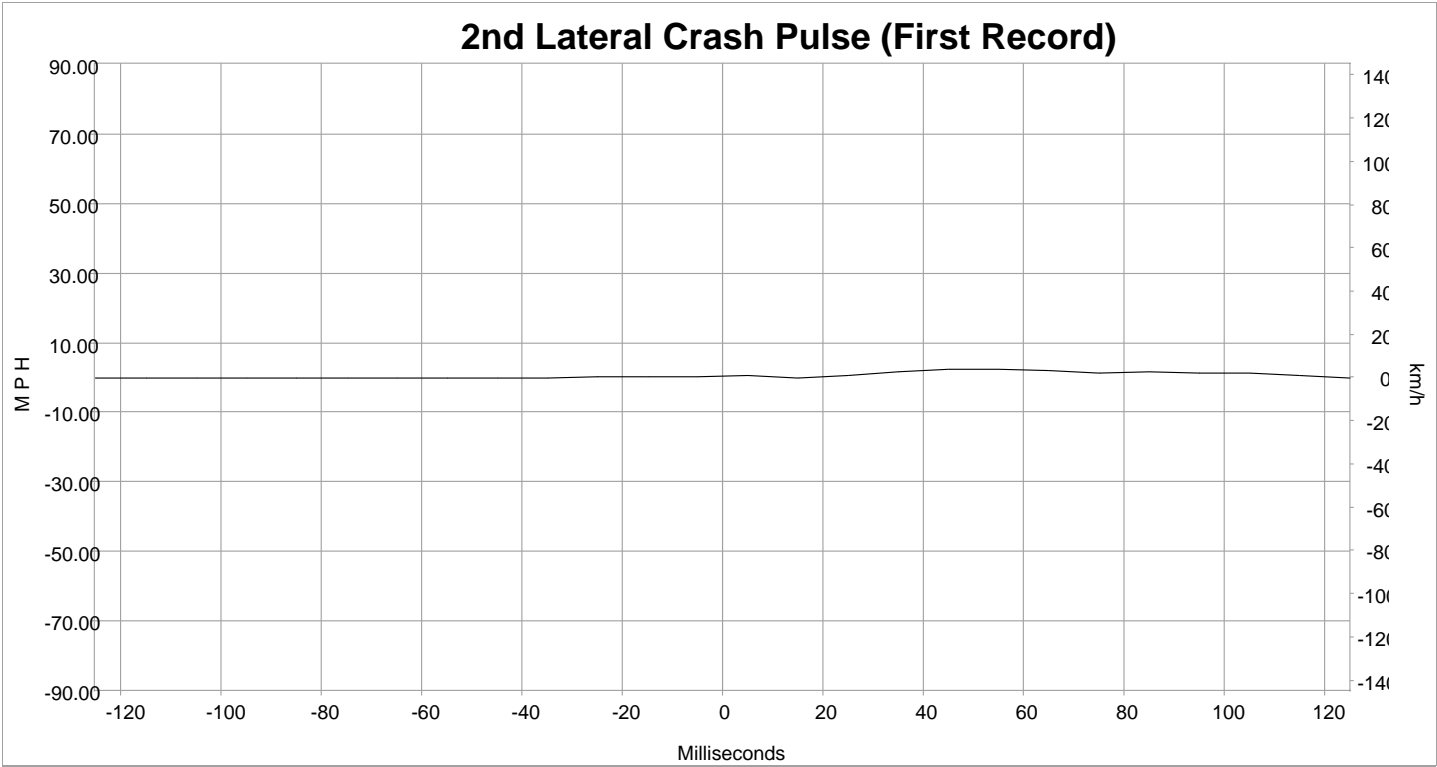
2nd Lateral Crash Pulse (First Record)

Time (msec)	2nd Delta-V, Lateral (MPH)	2nd Delta-V, Lateral (km/h)
-125	0.00	0.00
-115	0.00	0.00
-105	0.00	0.00
-95	0.00	0.00
-85	0.00	0.00
-75	0.00	0.00
-65	0.00	0.00
-55	0.00	0.00
-45	0.00	0.00
-35	0.00	0.00
-25	0.02	0.04
-15	0.07	0.12
-5	0.29	0.47
5	0.48	0.78
15	-0.15	-0.24
25	0.39	0.63
35	1.60	2.58
45	2.27	3.66
55	2.47	3.97
65	1.86	3.00
75	1.43	2.30
85	1.52	2.44
95	1.26	2.02
105	1.09	1.75
115	0.56	0.90
125	-0.07	-0.12

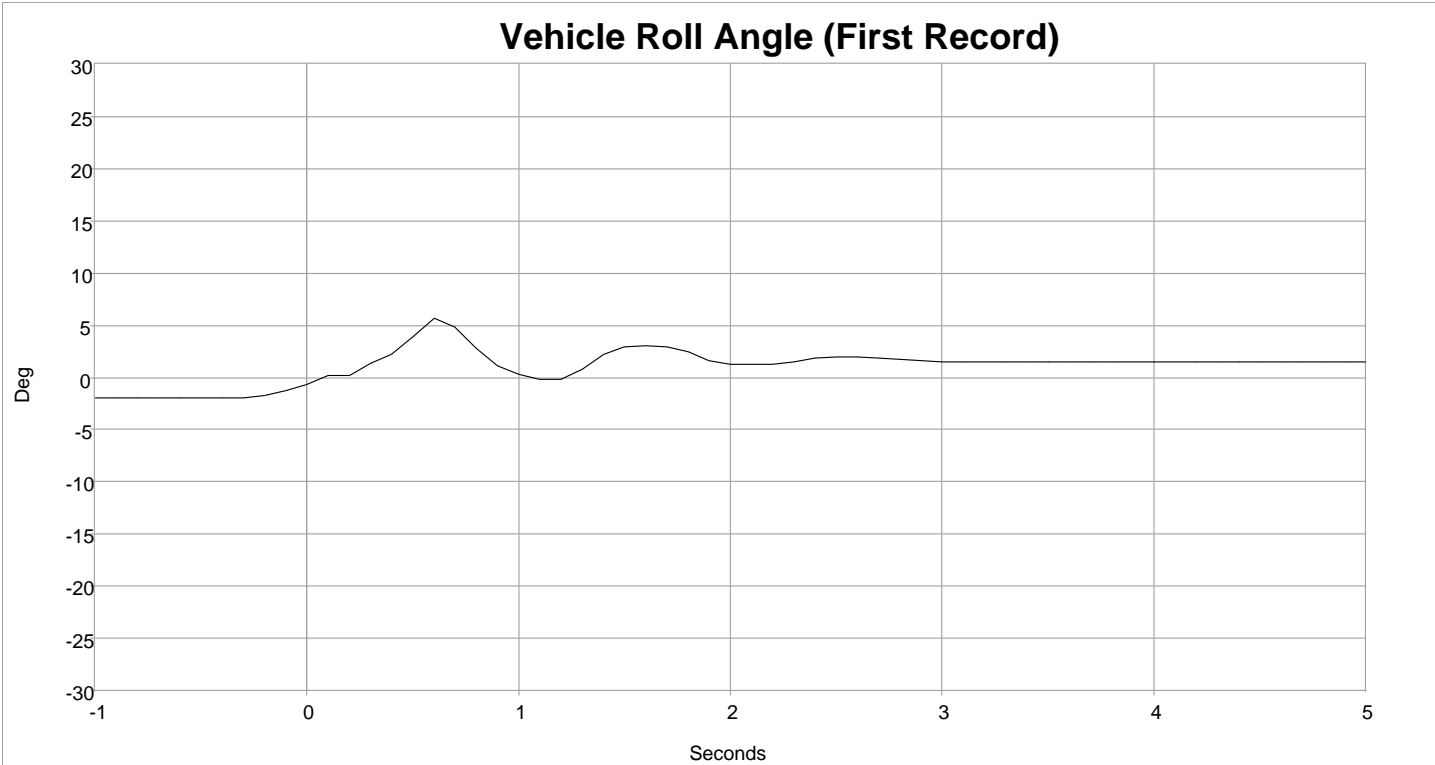
Vehicle Roll Angle (First Record)

Time (sec)	Vehicle Roll Angle (deg)
-1.0	-1.97
-0.9	-1.97
-0.8	-1.99
-0.7	-1.99
-0.6	-1.99
-0.5	-1.99
-0.4	-2.00
-0.3	-1.96
-0.2	-1.71
-0.1	-1.25
0.0	-0.65
0.1	0.22
0.2	0.13
0.3	1.39
0.4	2.18
0.5	3.90
0.6	5.66
0.7	4.86
0.8	2.82
0.9	1.12
1.0	0.25
