DOT HS 813 624

**Special Crash Investigations:
On-Site Child Restraint System
Crash Investigation;
Vehicle: 2018 Honda Civic;
Location: California;
Crash Date: November 2021**

Special Crash Investigations
On-Site Child Restraint System Crash Investigation
Case No. DS22002
Vehicle: 2018 Honda Civic
Location: California
Crash Date: November 2021

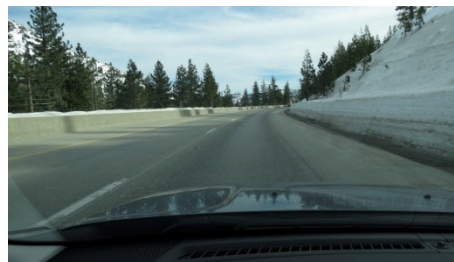
Figure 1. Approach to crash site, looking east

The crash occurred in the eastbound lanes of a divided interstate highway in California. Satellite images and police data sources were used to obtain roadway measurements discussed in this report. In the area of the crash the section of roadway was straight, followed by a right curve and slight uphill slope. The roadway had two eastbound lanes each measuring 3.8 m (12.0 ft) wide. They were separated by a dashed white painted stripe and bordered by a solid yellow painted fog line on the left and a solid white painted fog line on the right. The concrete roadway had grooved concrete shoulders each measuring 3.0 m (10.0 ft) wide with milled-in rumble strips. Bordering the left shoulder was a concrete jersey type barrier. Bordering the right shoulder was a raised asphalt curb, and dirt and rock ascending embankment. The pavement and lane lines were in good condition. The right curve had a radius measuring 774.0 m (304.7 ft) at the right fog line and the slope was approximately 2.0 percent (Figure 1). Super-elevation was -5.2 percent in the left lane and -4.5 in the right lane. The posted speed limit was 105 km/h (65 mph). Conditions at the time of the crash were dark without artificial lighting, clear, and dry. A crash diagram is included at the end of this report.

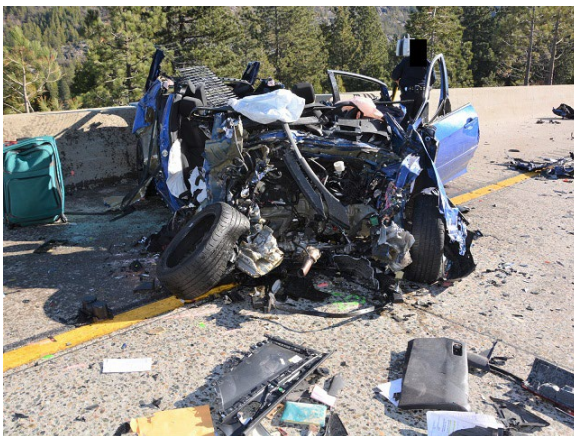
Figure 2. Honda at final rest looking north (police photo)

The crash had five events. The Honda struck the Jeep head-on in the right eastbound lane (Event 1). The impact caused the Honda to rotate clockwise, and briefly came to rest before its right plane (forward of the right A-pillar) was struck by the GMC's front plane (Event 2). The Honda's engine became detached and came to rest on the shoulder approximately 30 m (100 ft) east of the area of impact. Impact forces in Event 2 caused the Honda to rotate counterclockwise and travel northbound until its back plane struck the concrete barrier (Event 3), where it came to rest facing south on the left shoulder (Figure 2). The GMC traveled forward, and its front plane struck the Jeep's right plane (Event 4), and then its right plane struck the Jeep's right plane (Event 5). The Jeep came to rest facing east on the right eastbound shoulder (Figure 3) and the GMC came to rest facing south on the right eastbound shoulder.

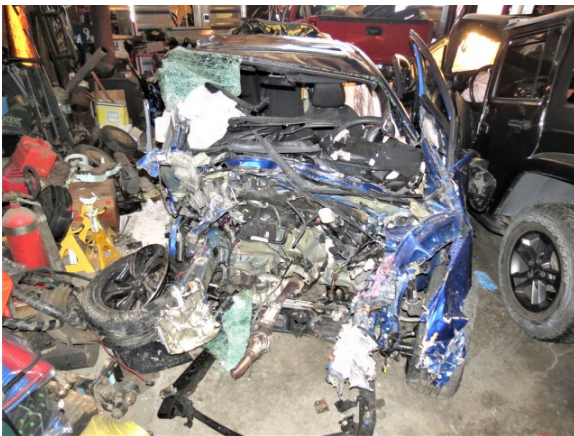
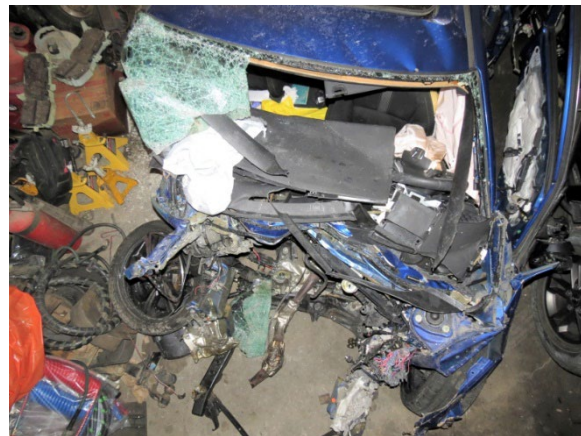
Figure 4. 2018 Honda Civic front plane damage

The Honda had direct damage to the front, right, and back planes, and induced damage to the front, left, right, back, and top planes. Post-crash damage included removal of the roof and right side doors, and forcible opening of the left side doors. The roof and hood were buckled. The front tires were flat, the left front tire was restricted, and the right front wheel was fractured. The left wheelbase was lengthened by 5 cm (2.0 in) and the right wheelbase was reduced by 40 cm (15.7 in). The engine, radiator, grille, bumper fascia, and bumper reinforcement bar were detached from the vehicle.

The bumper reinforcement bar was not available for inspection. Two crush measurements were taken at the left and right frame rails using a Nikon total station and the AutoCrush program calculated six crush measurements as follows: C1 = 48 cm (18.9 in), C2 = 60 cm (23.6 in), C3 = 72 cm (28.3 in), C4 = 80 cm (31.5 in), C5 = 82 cm (32.3 in), and C6 = 84 cm (33.1 in). Maximum crush was located at the front right bumper corner and the collision deformation classification (CDC) for the Honda in Event 1 was 12FDEW04 (Figures 4 and 5).

Figure 5. 2018 Honda Civic front plane damage overhead view

For the Honda in Event 2, the damage was overlapping, and the estimated CDC was 04RFEW99. For Event 3 the CDC was 06BREE01.

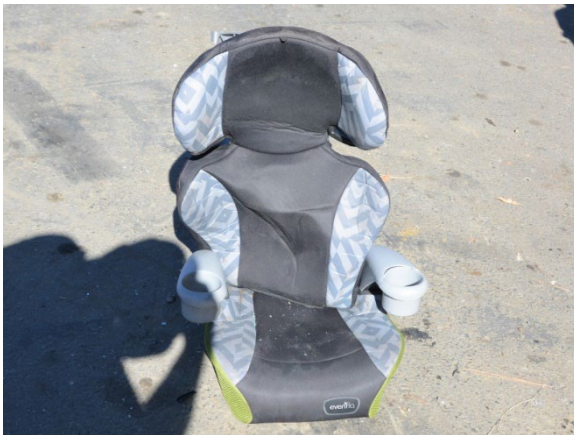
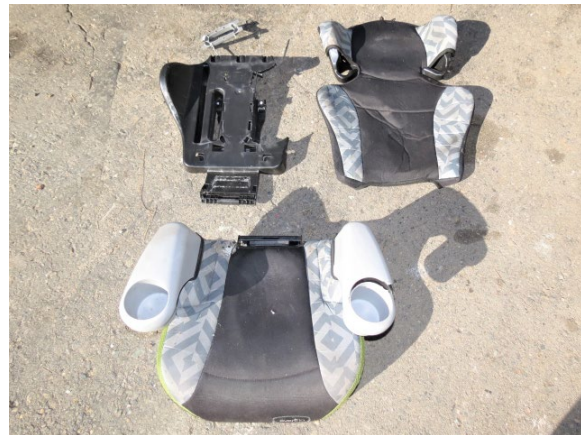
Figure 6. Evenflo Big Kid Sport booster seat

The Evenflo was damaged in the crash. It had damage to the shell on the seating area, high-back and left armrest. The back right corner of the seating area had a vertical fracture measuring 8 cm (3.1 in) long and the padding was torn. The right armrest had a lateral fracture measuring 8 cm (3.1 in) long at the cup holder. The left aspect of the high-back was fractured in a pattern measuring 10 x 27 cm (3.9 x 10.6 in) and a piece from the left aspect was missing. The head restraint was not damaged.

Figure 7. Evenflo Big Kid Sport booster seat

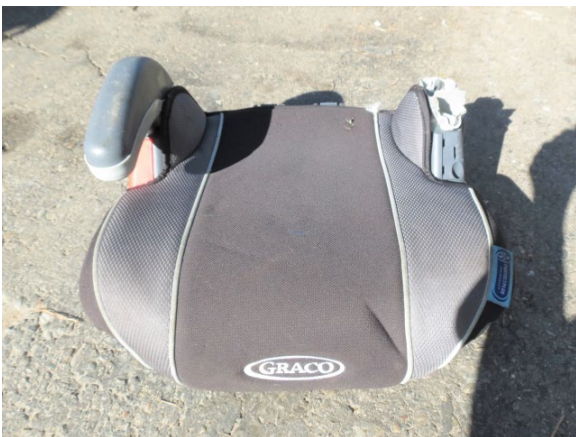
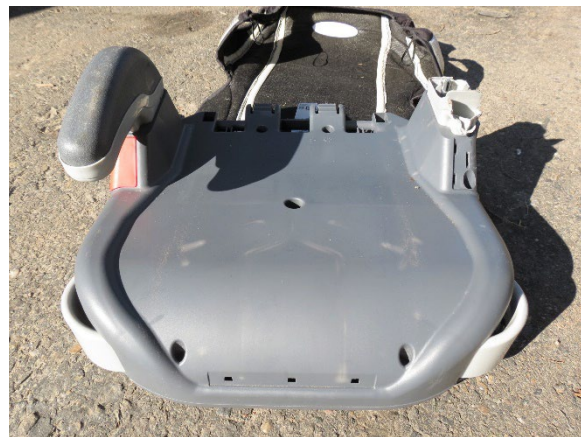
Figure 8. Graco TurboBooster booster seat

The occupant using this booster seat met the age, weight, and height requirements. The Graco had damage to the left and right armrests. The armrests were adjusted to the lowest position and the left armrest was broken off above the shell insertion point. The right armrest revealed a scuff mark at its upper aspect measuring 17 cm (6.7 in) long. The seating area was undamaged.

Figure 9. Graco TurboBooster booster seat

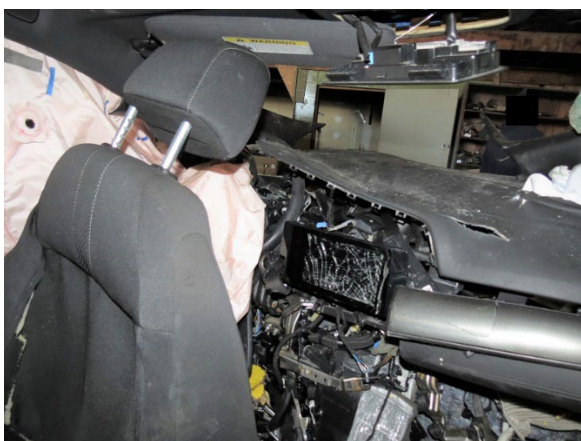
Figure 10. Front-row damage, 2018 Honda Civic

The Honda sustained interior damage caused by impact forces, occupant contacts, deployed air bags, and post-crash activities. The windshield was fractured and missing, and the side glass and backlight were disintegrated. The moon roof was the only glazing that remained intact. The roof and right side doors were removed, and the left side doors were forced open by responders. The left instrument panel was fractured (Figure 10). The steering wheel column was collapsed, and the right half of the steering wheel rim was bent forward. All the vehicle's air bags deployed. The front-row left floor was buckled. The front passenger seat cushion was shifted rearward, and the seat back was shifted to the right. Front-row longitudinal intrusion was documented at the left, center, and right instrument panels, and the left and right toe pans. Second-row longitudinal intrusion was documented at the second-row-right position where the front-right seat and back cushions moved rearward (Figure 11).

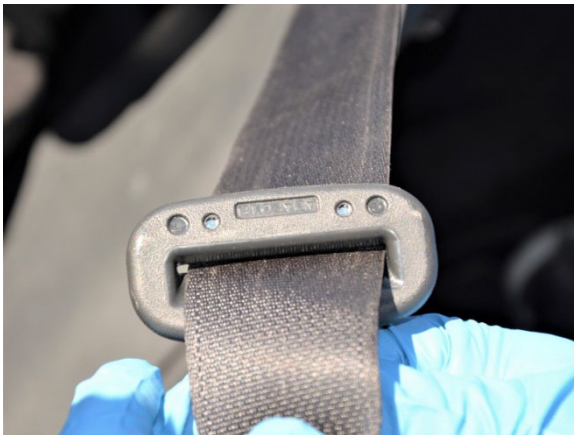
Figure 12. Second-row left latch plate and webbing

The three second-row seat belts had switchable emergency locking retractors and automatic locking retractors and sliding latch plates. The seat belts were used to restrain the three child occupants. The left position belt was used by the 4-year-old male in combination with a high-back booster seat. The latch plate had evidence of historical usage and occupant loading (Figure 12). The center position belt was used by the 9-year-old female. It was cut by emergency responders and the latch plate had evidence of historical usage and occupant loading (Figure 13). Due to her age, this occupant met the minimum requirements for child restraint in California.² The right position belt was used by the 5-year-old male in combination with a backless booster seat. The seat belt was cut by emergency responders and the latch plate had evidence of occupant loading and historical usage (Figure 13). All three second-row occupants sustained seat-belt-related injuries discussed in the Occupant Kinematics sections of this report.

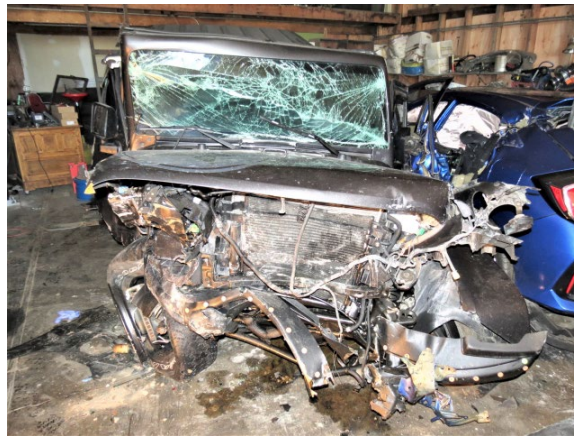
Figure 14. Front plane damage, 2018 Jeep Wrangler

The Jeep was involved in Event 1 with the Honda and Events 4 and 5 with the GMC. The Jeep sustained severe damage to the front plane in the impact with the Honda (Figure 14). The front bumper backing bar was broken into two separate pieces, the fascia and grille were missing. The hood, roof, left fender, right fender, and front right door were buckled. The front tires were flat and restricted, the right front wheel was fractured. The left and right wheelbases were reduced by 13 cm (5.1 in) and 47 cm (18.5 in), respectively. Sixteen crush measurements were taken at bumper level using a Nikon total station and the AutoCrush program calculated 6 crush measurements as follows: C1 = 0 cm, C2 = 10 cm (3.9 in), C3 = 28 cm (11.0 in), C4 = 18 cm (7.1 in), C5 = 42 cm (16.5 in), and C6 = 47 cm (18.5 in). Maximum crush was located at the front right bumper corner and the CDC for the Jeep in Event 1 was 12FDEW02.

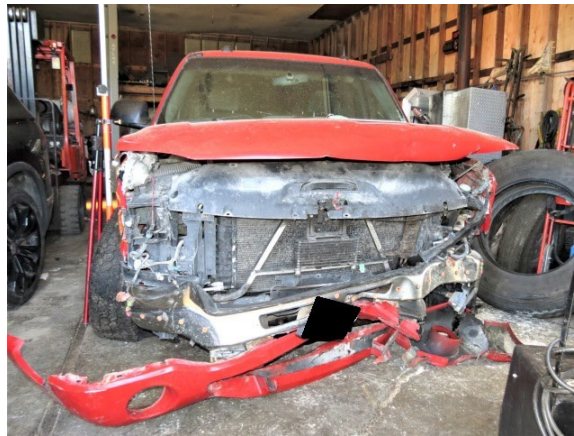
Figure 15. Front plane damage 2004 GMC Sierra

The GMC was involved in Event 2 with the Honda and Events 4 and 5 with the Jeep. The GMC sustained moderate damage to the front plane in the impact with the Honda (Figure 15). The front bumper was bent, the fascia was fractured and displaced, and the grille and headlamps were missing. The hood, and left and right fender were buckled. The front tires were flat and restricted, and the front wheels were fractured. The left and right wheelbases were reduced by 6 cm (2.4 in) and 10 cm (3.9 in), respectively. Twenty crush measurements were taken at bumper level using a Nikon total station and the AutoCrush program calculated 6 crush measurements as follows: C1 = 32 cm (12.6 in), C2 = 28 cm (11.0 in), C3 = 23 cm (11.8 in), C4 = 9 cm (3.5 in), C5 = 3 cm (1.2 in), and C6 = 9 cm (3.5 in). Maximum crush measured 32 cm (12.6 in) and was located at the front left bumper corner. The CDC for the GMC in Event 2 was 12FDEW02.

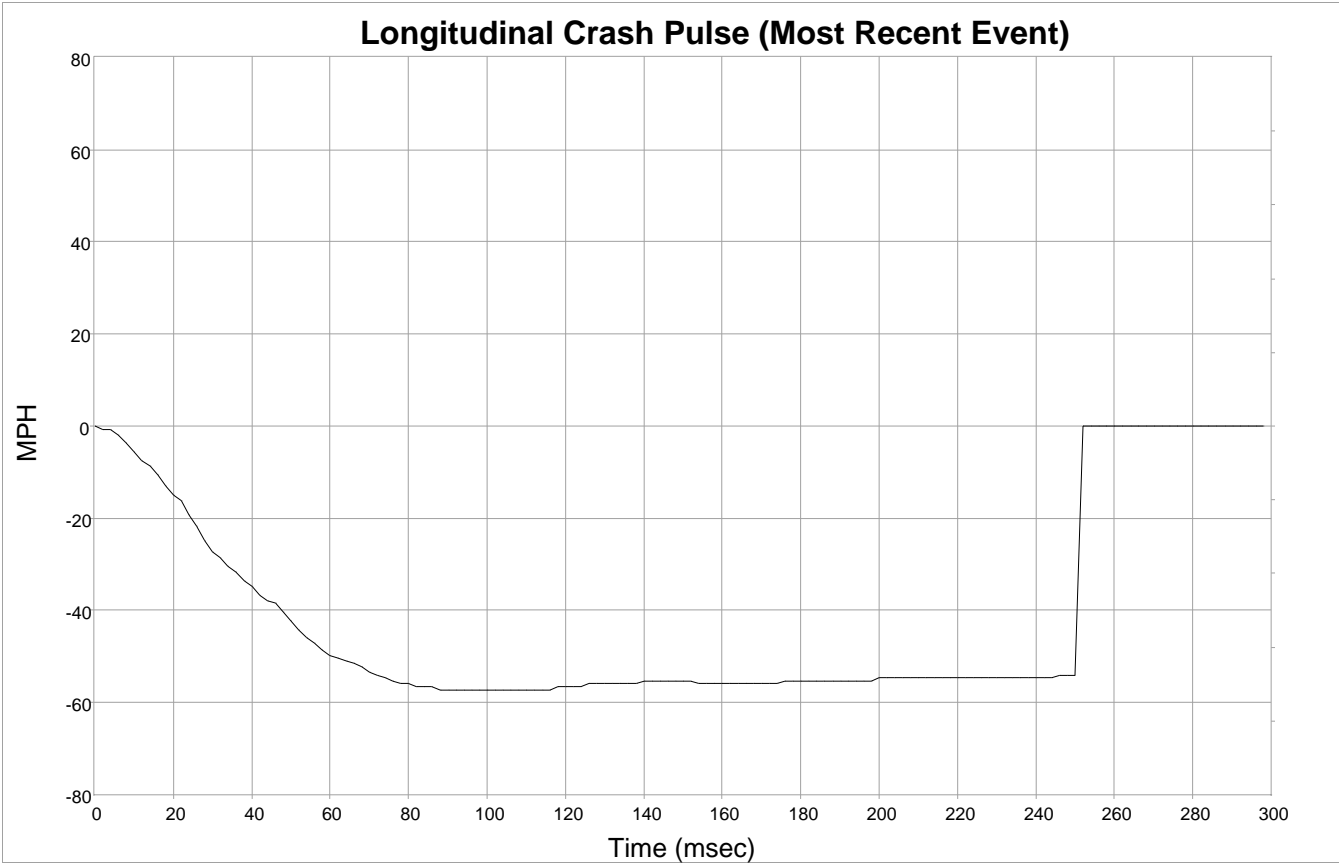
Longitudinal Crash Pulse (Most Recent Event)

Time (msec)	Delta-V, Longitudinal (MPH [km/h])
0	0.0 [0]
2	-0.6 [-1]
4	-0.6 [-1]
6	-1.9 [-3]
8	-3.7 [-6]
10	-5.6 [-9]
12	-7.5 [-12]
14	-8.7 [-14]
16	-10.6 [-17]
18	-13.0 [-21]
20	-14.9 [-24]
22	-16.2 [-26]
24	-19.3 [-31]
26	-21.7 [-35]
28	-24.9 [-40]
30	-27.3 [-44]
32	-28.6 [-46]
34	-30.4 [-49]
36	-31.7 [-51]
38	-33.6 [-54]
40	-34.8 [-56]
42	-36.7 [-59]
44	-37.9 [-61]
46	-38.5 [-62]
48	-40.4 [-65]
50	-42.3 [-68]
52	-44.1 [-71]
54	-46.0 [-74]
56	-47.2 [-76]
58	-48.5 [-78]
60	-49.7 [-80]
62	-50.3 [-81]
64	-51.0 [-82]
66	-51.6 [-83]
68	-52.2 [-84]
70	-53.4 [-86]
72	-54.1 [-87]
74	-54.7 [-88]
76	-55.3 [-89]
78	-55.9 [-90]
80	-55.9 [-90]
82	-56.5 [-91]
84	-56.5 [-91]
86	-56.5 [-91]
88	-57.2 [-92]
90	-57.2 [-92]
92	-57.2 [-92]
94	-57.2 [-92]
96	-57.2 [-92]
98	-57.2 [-92]

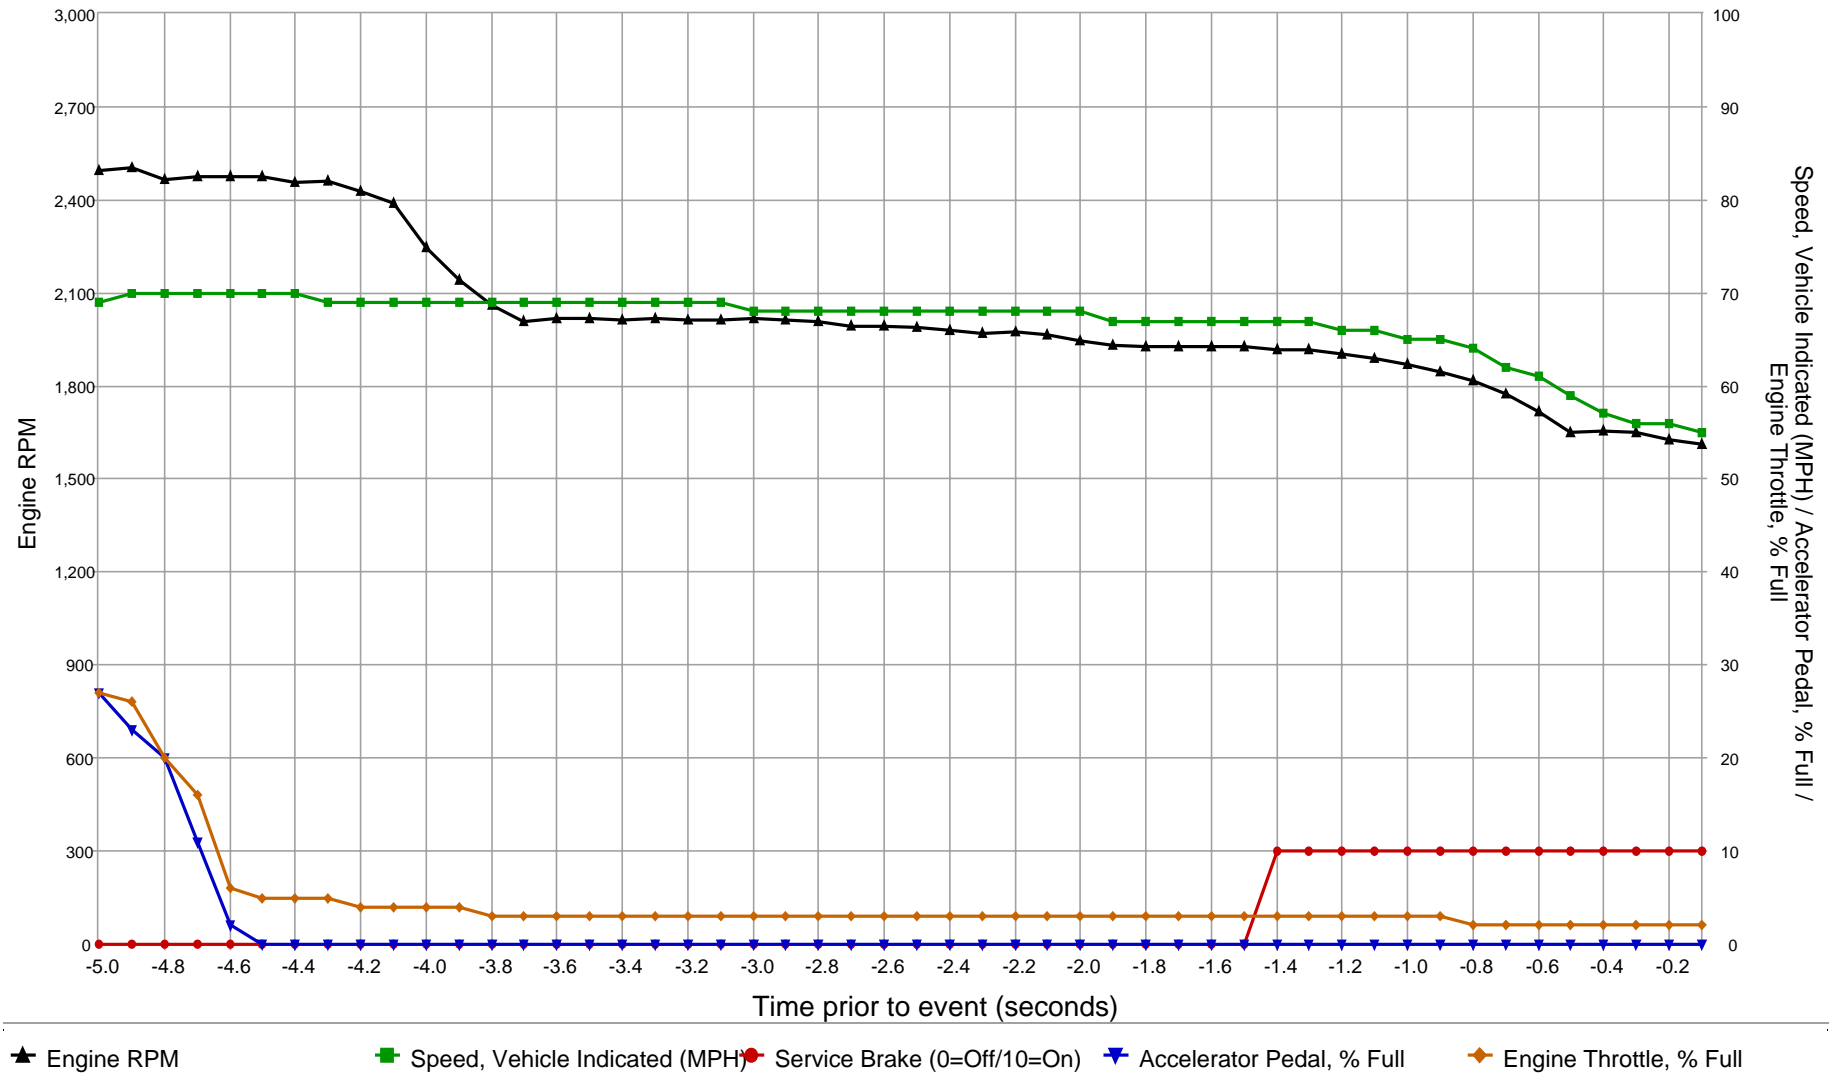
Pre-Crash Data (Most Recent Event)

SNA values will not be plotted on the graph

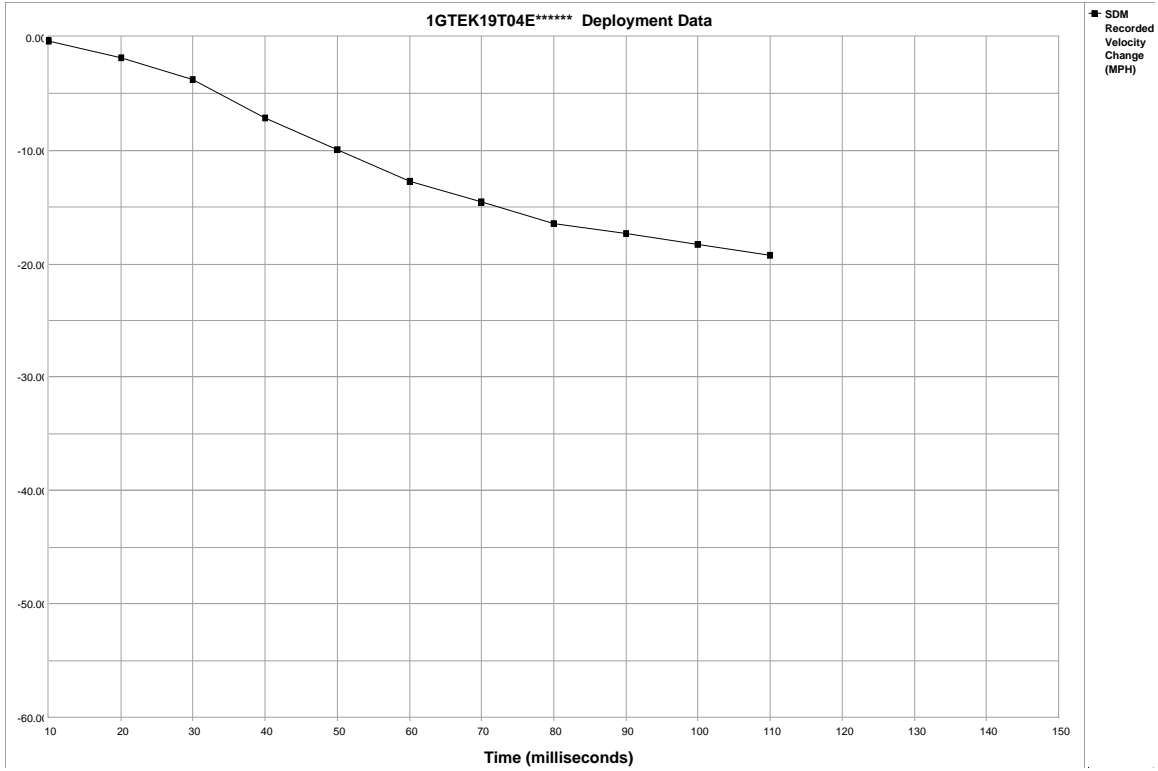
Time (milliseconds)	10	20	30	40	50	60	70	80	90	100	110	120	130	140	150
Recorded Velocity Change (MPH)	-0.31	-1.86	-3.72	-7.13	-9.92	-12.71	-14.57	-16.43	-17.36	-18.29	-19.22	N/A	N/A	N/A	N/A

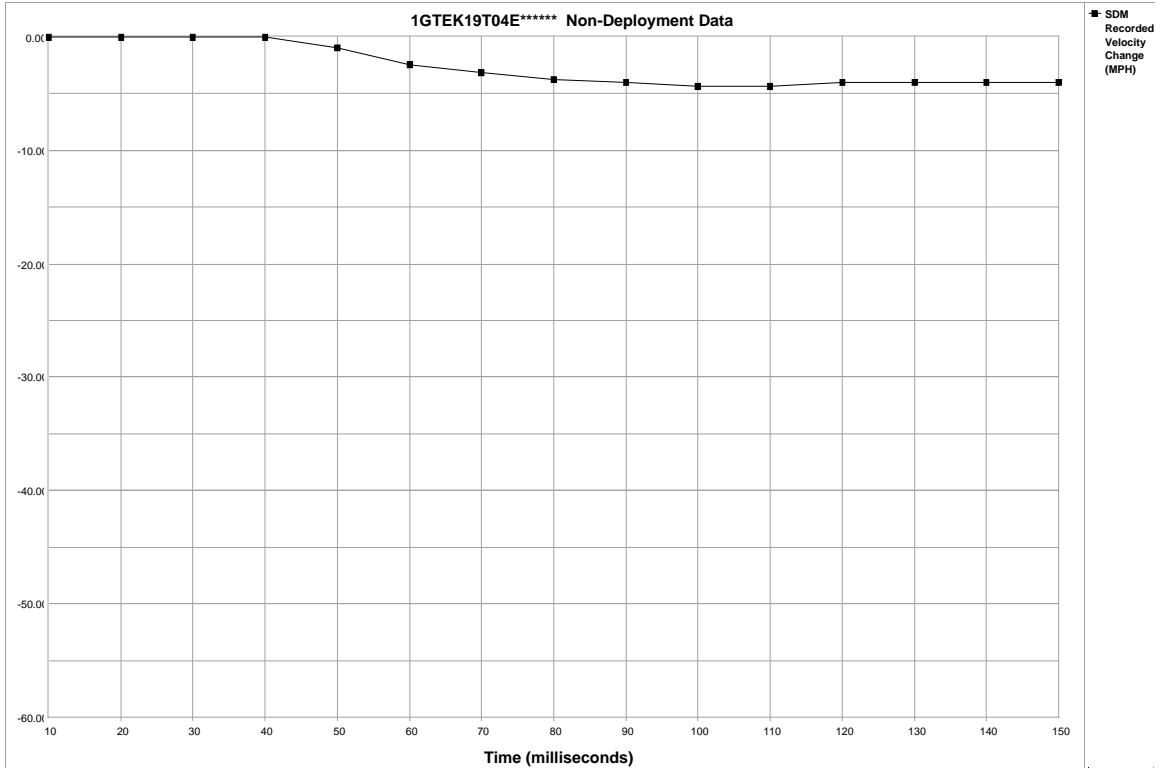
Time (milliseconds)	10	20	30	40	50	60	70	80	90	100	110	120	130	140	150
Recorded Velocity Change (MPH)	0.00	0.00	0.00	0.00	-0.93	-2.48	-3.10	-3.72	-4.03	-4.34	-4.34	-4.03	-4.03	-4.03	-4.03
