DOT HS 813 628

**Special Crash Investigations:
On-Site Rollover and Child
Restraint System Crash
Investigation;
Vehicle: 2018 Hyundai Tucson;
Location: Georgia;
Date: February 2022**

Special Crash Investigations
On-Site Rollover and Child Restraint System Crash Investigation
SCI Case No: CR22006
Vehicle: 2018 Hyundai Tucson
Location: Georgia
Crash Date: February 2022

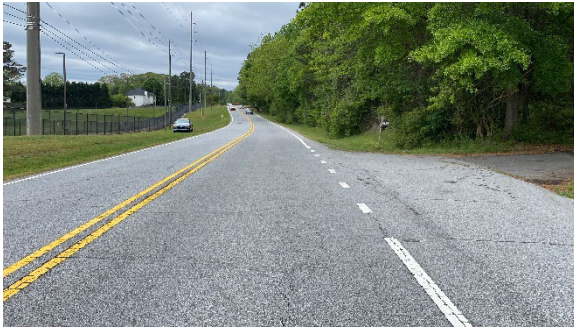
Figure 3. Westward view of the Hyundai's pre-crash approach to the crash site

This crash occurred on a two-lane rural roadway during the day. The reported weather conditions in the locale included fair conditions, a temperature of 19 °C (66 °F), winds from the west-southwest at 15 km/h (9 mph), and the roadway surface condition as being dry. Speed was regulated by a posted limit of 64 km/h (40 mph). Figure 3 shows the Hyundai's west travel lane, while Figure 4 shows the Mercedes-Benz's east travel lane in the pre-crash approaches to the crash site. At the scene there was a tree line with fencing north of the roadway and an embankment with chain link fencing south of the roadway. A crash diagram is attached at the end of this report.

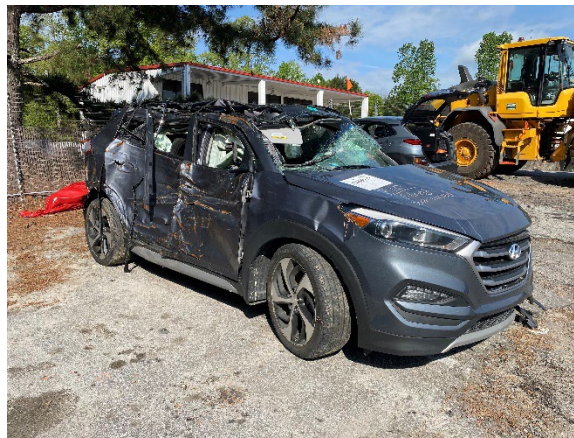
Figure 5. Right front oblique view of the 2018 Hyundai Tucson

The crash involved the front and left planes for Event 1. This damage was indicative of a corner impact. No crush was observed along the front bumper reinforcement bar. Direct damage was located 76 cm (29.9 in) left of the front center point extending 2 cm (0.8 in) left. However, the direct damage extended rearward down the left plane of the vehicle 220 cm (86.6 in). The collision deformation classification¹ (CDC) for this damage profile was 12FLEE7.

The crash also involved a right plane impact for Event 2. A crush profile was documented on the right side of the vehicle. The corresponding direct damage was 306 cm (120.4 in) wide, beginning 2 cm (0.8 in) rear of the right front axle extending rearward. The field-L was 340 cm (133.8 in) starting 10 cm (3.9 in) forward of the right front axle extending rearward. The residual crush at the mid-door level was: C1 = 15 cm (5.9 in), C2 = 0 cm, C3 = 17 cm (6.6 in), C4 = 13 cm (5.1 in), C5 = 0 cm, C6 = 6 cm (2.3 in). Maximum crush was observed to be 17 cm (6.6 in) and located 173 cm (68.1 in) rear of the right front axle. The CDC for this damage profile was 01RDAW2.

Damage from the rollover was noted on the left and top planes of the Hyundai, consistent with two-quarter turns. The rollover resulted in a maximum vertical crush of 5 cm (1.9 in) and a maximum lateral crush of 2 cm (0.8 in) located at the right B-pillar. The CDC was 00TDDO2.

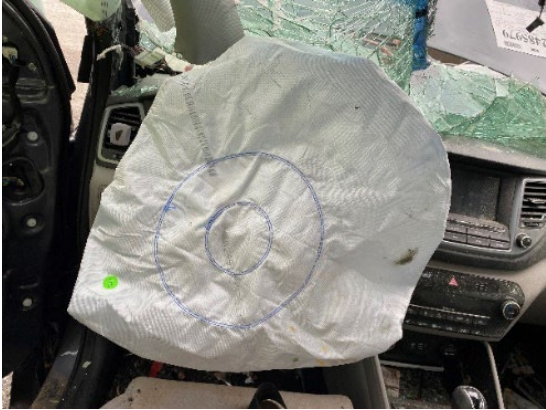
Figure 6. View of the driver's frontal air bag in the Hyundai

The Hyundai had multiple supplemental restraints for its occupants. These included dual-stage driver's and passenger's frontal air bags, front seat-mounted side impact air bags, and IC air bags. The IC air bags could deploy for rollover and/or side impact collisions. The driver's frontal (Figure 6), left side-impact (Figure 7), right-side impact, and both IC air bags deployed during the crash sequence.

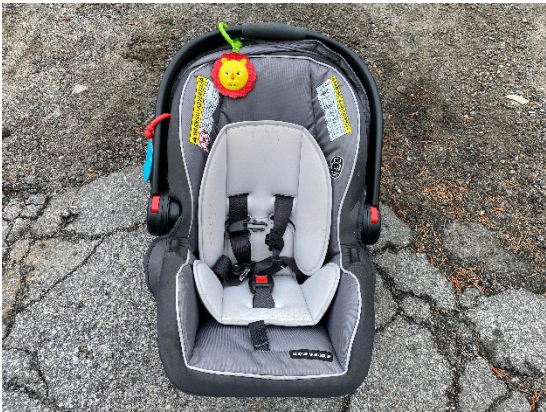
Figure 8. CRS that was secured in the second-row center seating position of the Hyundai.

The CRS was a Graco Snug Ride (Figure 8). The 10-month-old male was secured in the CRS located in the second-row center seating position (Figure 9). The CRS was secured to the base. The base was secured to the seat with the available lap and shoulder belt that was routed through the base in the rear-facing position. The CRS did not use the available Lower Anchors and Tethers for Children (LATCH) system in this incident. Per the owner's manual, the second-row center seating position is not a LATCH-approved position. The manufacturer label on the CRS showed that it was produced on October 23, 2020. The CRS would not have been expired at the time of the incident.

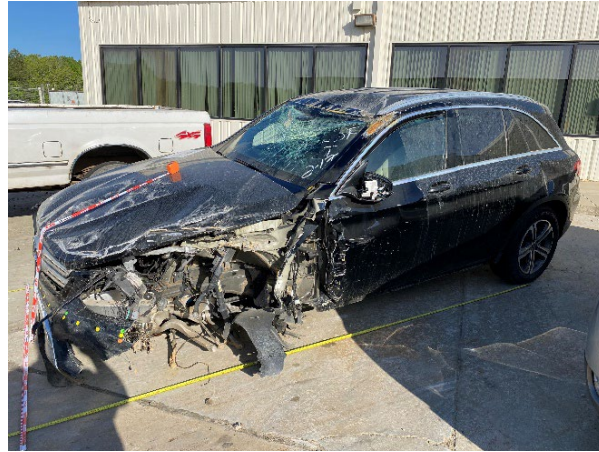
Figure 10. View of the damage to the front

The crash involved the front and left plane for Event 1. A crush profile documented the front bumper fascia of the vehicle. The corresponding direct damage was 32 cm (12.5 in) wide beginning 52 cm (20.4 in) left of the front center point extending left. The field-L was 168 cm (66.1 in) extending across the entire front bumper. The residual crush was documented across the front bumper fascia and the crush values are: C1 = 48 cm (18.8 in), C2 = 18 cm (7.1 in), C3 = 7 cm (2.7 in), C4 = 6 cm (2.3 in), C5 = 7 cm (2.7 in), C6 = 14 cm (5.5 in). Maximum crush was observed to be 48 cm (18.8 in) and located 84 cm (33.1 in) left of the front center point. The CDC for this damage profile was 12FLEE6.
