DOT HS 813 649

# **Special Crash Investigations: Remote Move-Over-Law Crash Investigation; Vehicle: 2017 Ford Explorer; Location: South Dakota; Crash Date: January 2021**

**Special Crash Investigations**  
**Remote Move-Over-Law Crash Investigation**  
**Case No. DS22003**  
**Vehicle: 2017 Ford Explorer**  
**Location: South Dakota**  
**Crash Date: January 2021**

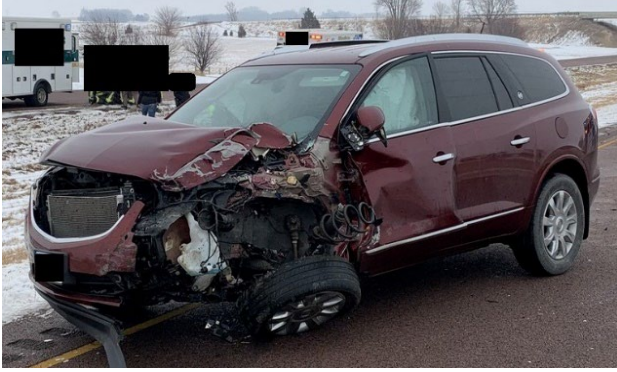
The crash occurred in the morning in January 2021 in South Dakota. The crash site was in the eastbound left lane of a two-lane divided interstate highway. The asphalt roadway was straight and level, and the posted speed limit was 129 kmh (80 mph). The struck vehicle was a fully marked 2017 Ford Explorer State Highway Patrol vehicle. The driver was a belted 34-year-old male trooper. The front-right seat was occupied by a belted 23-year-old female civilian and the second-row-right seat was occupied by an unbelted 25-year-old male trooper recruit. The State Highway Patrol vehicle had responded to an earlier crash that had occurred in the westbound lanes and was parked partially in the left eastbound lane with its left tires on the left shoulder and its blue and amber overhead emergency lights activated. The 23-year-old female had been involved in the previous crash. The striking vehicle was a 2017 Buick Enclave driven by a belted 31-year-old female. The Buick was traveling eastbound in the left lane. The Buick driver said she was initially looking at the crash in the westbound lanes. When she looked forward, she saw the parked State Highway Patrol vehicle but was unable to stop in time. The Buick's front plane (Figure 1) struck the Ford’s back-right plane (Figure 2).

*Figure 1. 2017 Buick Enclave, looking east  
(police photo)*

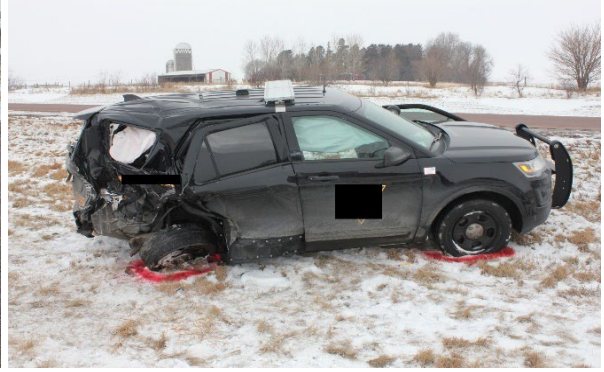
*Figure 2. 2017 Ford Explorer, looking  
northwest (police photo)*

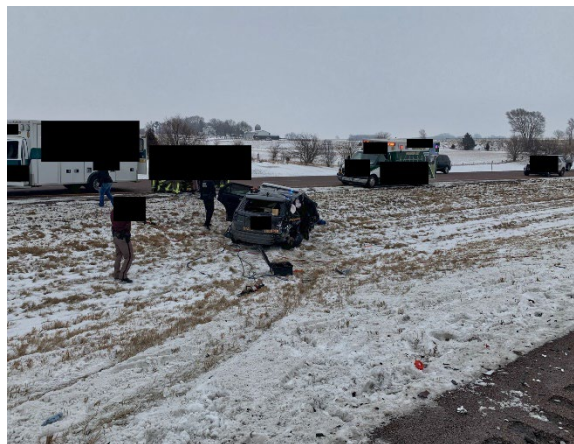
The Buick was displaced to the right as it began a counterclockwise rotation. The vehicle traveled diagonally and came to rest in the right travel lane. The Buick was moved out of the travel lane prior to police arrival by a tow truck. The Ford was displaced to the left as it began a counterclockwise rotation. The vehicle traveled into the median and came to rest in the snow-covered median facing northeast (Figure 4).

*Figure 4. Final rest for the 2017 Ford Explorer, looking northeast (police photo)*

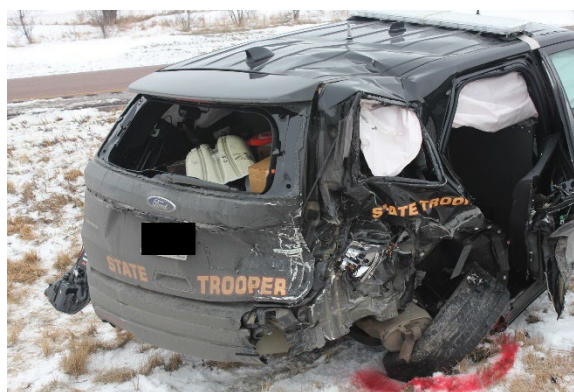
The State Police Ford had moderate back-plane damage from the impact with the Buick's front plane (Figure 5). The Field L extended from the left-bumper corner to the right-bumper corner. There was direct damage that began at the right bumper and extended along the right plane to the C-pillar and right-rear door. There was induced damage and buckling to the roof and the right-rear tire was displaced forward. The rear hatch glazing and right-rear window glazing was disintegrated. The collision deformation classification was 06BREE6.

*Figure 5. Back right, looking northeast, 2017 Ford Explorer (law enforcement image)*

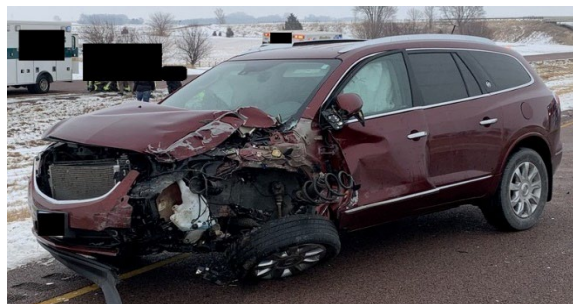
The Buick sustained moderate front-plane damage from the impact to the Ford's back plane (Figure 6). The Field L extended from the left-bumper corner to the right-bumper corner. There was direct damage that began at the left-bumper corner and extended along the left plane to the B-pillar and left-front door. There was direct damage to the grille, hood, and left door. The left-front tire was partially detached. The collision deformation classification was 12FLEE6.

Figure 6. 2017 Buick Enclave, oblique view (police photo)
