DOT HS 813 666

# **Special Crash Investigations: Remote Frontover Incident Investigation; Vehicle: 2022 Toyota Highlander; Location: Nevada; Incident Date: August 2022**

**Special Crash Investigations  
Remote Frontover Incident Investigation  
Case No. DS22023  
Vehicle: 2022 Toyota Highlander  
Location: Nevada  
Incident Date: August 2022**

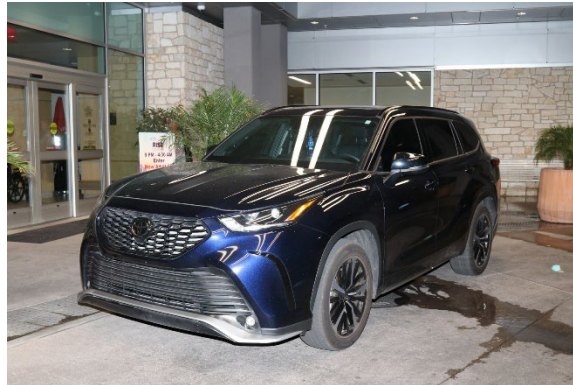
The incident occurred in the afternoon hours in August 2022 in Nevada. The incident site was on a north/south travel lane within a gated apartment complex. Conditions at the time of the incident were clear, daylight, and dry. The vehicle was a 2022 Toyota Highlander SUV (Figure 1) that was being driven by a 36-year-old male.

*Figure 1. 2022 Toyota Highlander (Police photo)*

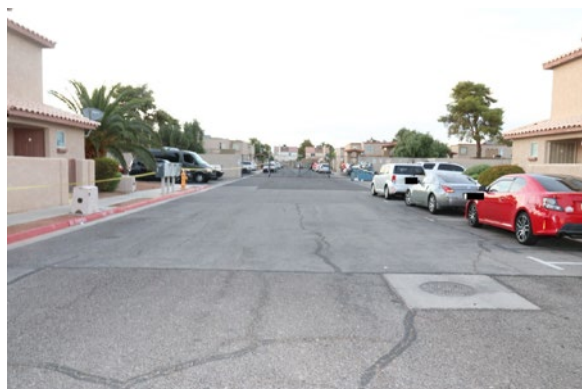
The crash site was on a two-way roadway in a gated apartment community (Figure 2). The north/south roadway was straight and level. When facing north it was bordered on the right by on-street parking, a sidewalk, and apartment entrances. It was bordered on the left by a red no-parking fire lane curb, a dirt separator, a concrete sidewalk, and apartment entrances. There was no posted speed limit. Conditions at the time of the incident were clear, daylight, and dry. The weather at the nearest reporting site was 37°C (100°F), 27 percent humidity, and the winds were calm. An incident diagram is included at the end of this report.

*Figure 2. Northbound view (police photo)*

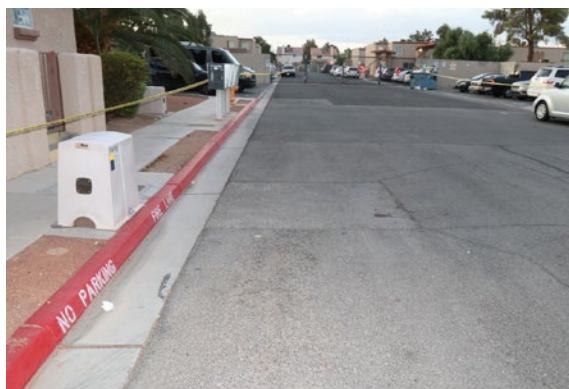
*Figure 3. Parked area, impact area, looking north (police photo)*

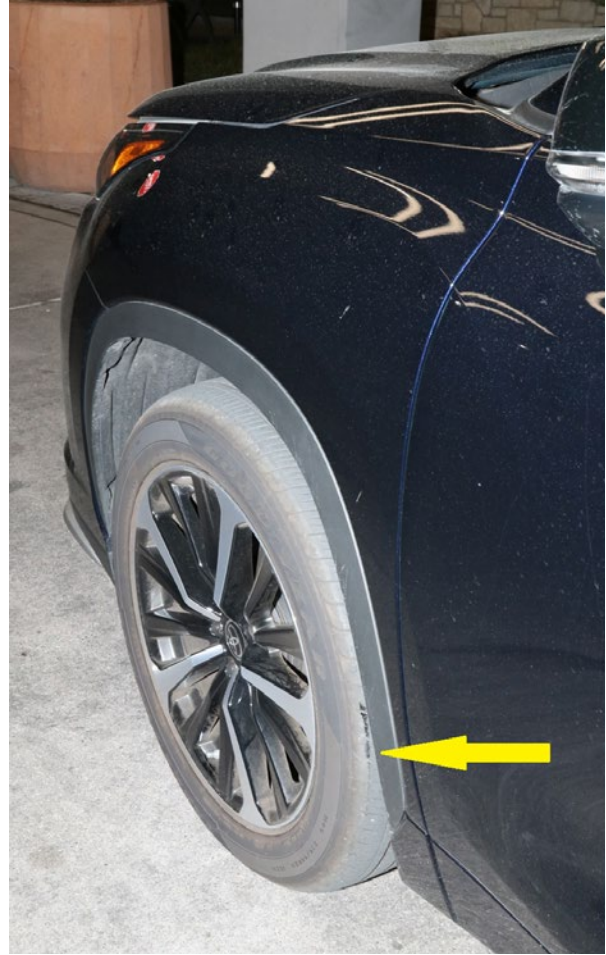
The Toyota did not sustain any crush damage during this incident. Police photos identified an area on the left front fender where dust had been disturbed (Figure 4) and a dark mark on the tread of the left tire (Figure 5). The police report stated that the child was initially struck by the front bumper. The estimated collision deformation classification (CDC) was 12FLWN3.

*Figure 5. Mark on left front tire, 2022 Toyota Highlander (police photo)*

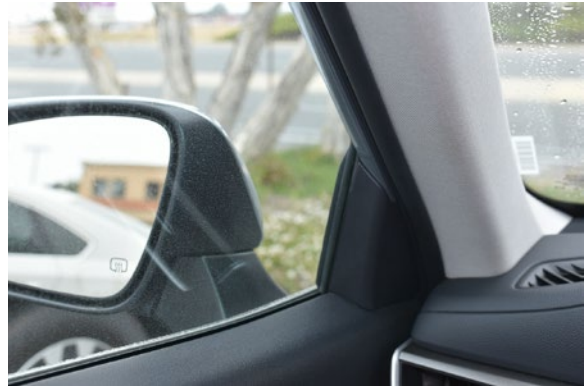
There was also a blind spot created by the left side mirror (Figure 8). The mirror was 27 cm (10.6 in) wide with a 9 cm (3.5 in) gap between the mirror and the lower A-pillar. Additional factors to consider are what the driver may have been looking at in the vehicle before the incident and the normal limits of human vision. Human visual acuity drops approximately 18° from the center of focus, so it is possible that the driver did not notice the nonmotorist even though the nonmotorist partially entered the lateral portion of the driver's field of view.

*Figure 8. Left A-pillar, 2022 Toyota Highlander (exemplar)*
