**Special Crash Investigations:
On-Site Rollover Crash
Investigation;
Vehicle: 2018 Honda Pilot EXL;
Location: Florida;
Date: June 2022**

16. Abstract This on-site investigation documents the roadway departure/rollover crash of a 2018 Honda Pilot EXL in Florida in June 2022 when a belted 47-year-old female drove through a T-intersection and departed the roadway. The Honda traveled through a drainage ditch, striking the edge of a concrete sidewalk at the top of an embankment. This non-horizontal impact deployed the driver's frontal air bag, the driver's outboard seat-mounted side-impact air bag, and the driver's inflatable curtain air bag and started a slight clockwise rotation leading to a left-side-leading rollover event that deployed the passenger's outboard seat-mounted side-impact air bag and the passenger's inflatable curtain air bag. The Honda rolled a total of five-quarter turns and came to final rest on its left side. The driver was transported by ambulance to a nearby medical facility with police-reported incapacitating (A-level) injuries.

Special Crash Investigations
On-Site Rollover Crash Investigation
Case Number: CR22012
Vehicle: 2018 Honda Pilot EXL
Location: Florid

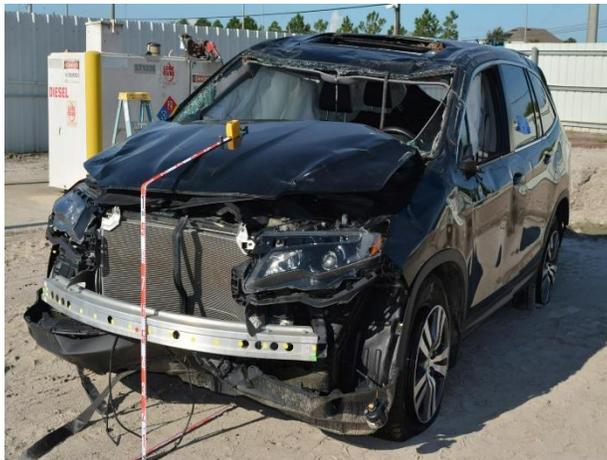
*Figure 1. Front-left oblique view of the
Honda*

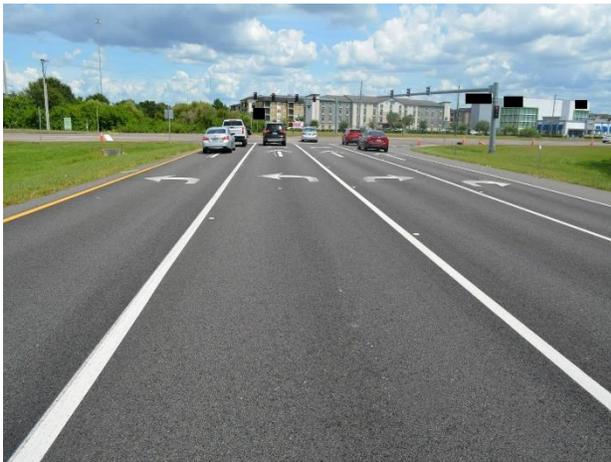
The intersection consisted of a straight and level four-lane south-easterly exit ramp that terminated into a controlled three-lane divided north/south roadway divided by a raised 7.2 m (23.6 ft) wide grass median. The exit ramp was 14.5 meters (47.5 ft) wide with two right turn lanes and two left turn lanes each measuring 3.7 meters (12.1 ft) wide. The lanes were separated by a solid white lane line, and each had a designated painted turn arrow indicator and traffic-controlled, tri-colored turn signal. The adjacent roadway was 29 meters (95.1 ft) wide with lanes measuring 3.7 meters (12.1 ft) wide. The lanes were separated by solid and dashed painted white lane lines. The posted speed limit was 72 km/h (45 mph). Each section of the roadway was traffic-controlled with corresponding tri-colored traffic signal. The far side of the intersection transitioned into a drainage ditch that was 12 meters (39.3 ft) wide and 69 cm (27.1 in) deep. The drainage ditch transitioned to a 3 meter (9.8 ft) wide concrete sidewalk. Beyond the sidewalk was a large flat grass field. Figures 2 and 3 show the intersection and roadside along the Honda's trajectory.

Figure 2. View of the Honda's east trajectory into the intersection

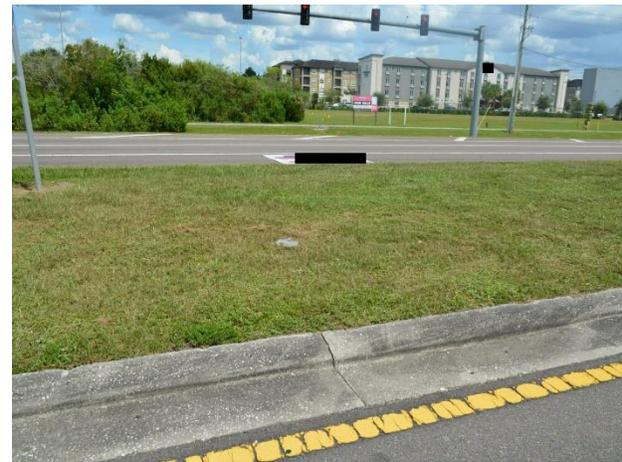
Figure 3. East-view across the median dividing the south and north lanes of travel

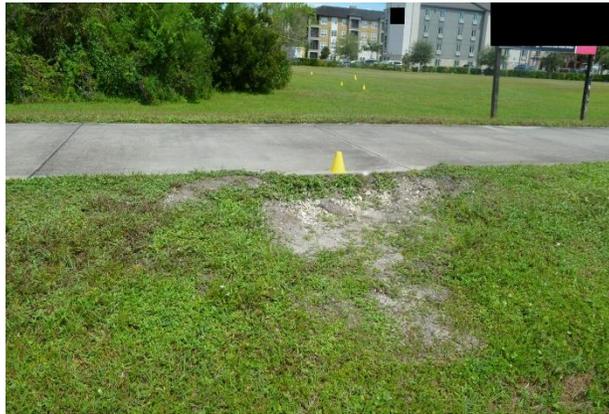
The Honda's front bumper lower valance stuck the upslope of the embankment and edge of the sidewalk (Event 1; Figure 4). This nonhorizontal impact deployed the driver's frontal air bag, the driver's outboard seat-mounted side-impact air bag, and the driver's IC air bag. The vehicle traveled 15 meters (49 ft) over the sidewalk into the soft grass area beyond and began to rotate clockwise. As the Honda contacted the ground, the left front and rear wheels furrowed into the soft earth and tripped the vehicle into a left-side-leading rollover event (Event 2). The rollover initiation deployed the front row passenger's outboard seat-mounted side-impact air bag and right-side IC air bag. The Honda rolled five quarter-turns over approximately 18 meters (59 ft) and came to rest on its left side facing south.

Figure 4. Facing east, viewing the point of impact. Cones represent curb strike and gouge marks.

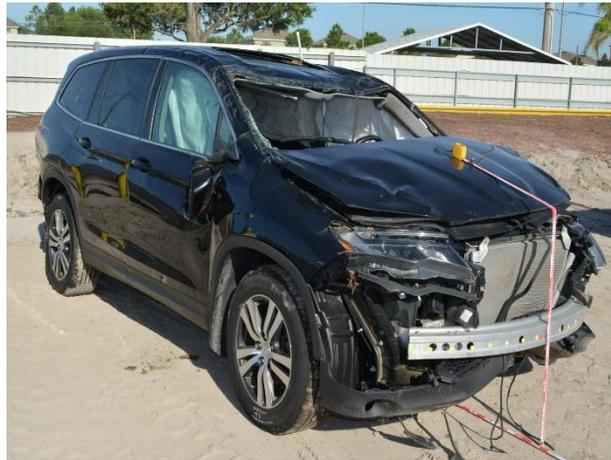
The 2018 Honda Pilot EXL was a 4-door SUV (Figure 5) manufactured in February 2018 and identified by the VIN 5FN9YF6H53JBxxxxxx. It was constructed on a 282 cm (111.0 in) wheelbase and powered by a 3.5-liter; V6-cylinder gasoline engine linked to a 6-speed automatic transmission with all-wheel drive. The service brakes were a power-assisted 4-wheel disc system with ABS. Steering was operated by a speed-sensitive electric rack and pinion system. The Honda had an antilock braking system, electronic stability control, traction control, and daytime running lights.

Figure 5. Front-right oblique view of the Honda

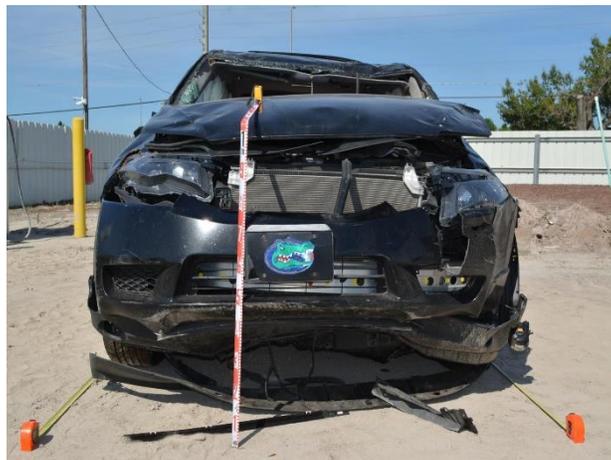
The Honda sustained damage across the front bumpers lower valance from the initial contact with the ground/sidewalk (Event 1 - Figure 6). The direct contact damage was primarily non-horizontal and was located below the structural bumper bar with direct contact at the centerline and left aspect of the front undercarriage/engine compartment and left front wheel assembly. The left and right wheelbases each measured 277 cm (109.0 in) with a track width of 168 cm (66.1 in). The exposed front bumper was measured with a total station that resulted in a maximum induced deformation of 4 cm (1.6 in) at the left corner of the bumper bar. Due to the non-horizontal forces associated with this impact, this profile was outside the scope of the barrier algorithm of the WinSMASH program, and an analysis was not generated. The collision deformation classification (CDC) assigned to the damage pattern for Event 1 is 00FDLW1.

Figure 6. Damage to the front undercarriage of the Honda in association to Event 1

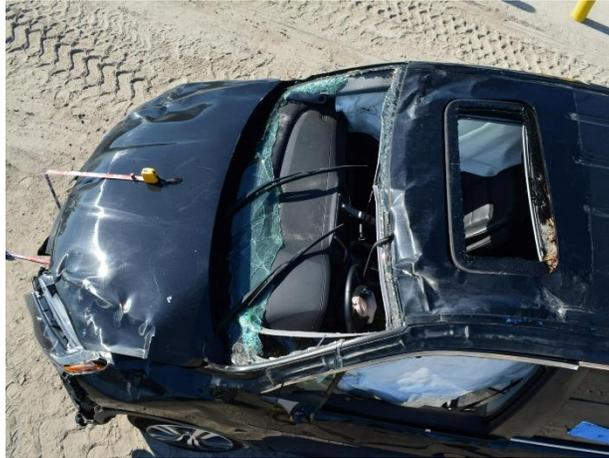
The Honda sustained moderate damage during the five-quarter turn rollover (Event 2). The event was initiated when the non-horizontal impact to the front frame/engine lifted the vehicle and caused an unloading of suspension, resulting in a clockwise rotation. The Honda began to sideslip through the soft earth and tripped over its left tires approximately 15 m (49 ft) from the sidewalk/ground impact. The left tires were debanded with grass and mud embedded in the spokes. Heavy scraping and gouging were present across the driver's A-pillar and roof rail (Figure 7). There was some minor crush to the front side panel that was aligned with the hood. During the rollover, the Honda landed on its roof causing 8 cm (3.1 in) of vertical intrusion to the

Figure 7. Rollover damage to the left side

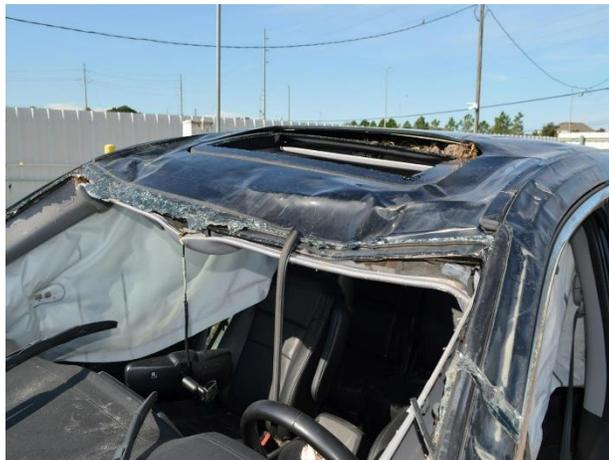
windshield header (Figure 8). The hood of the engine compartment and headlight components were also crushed in and rearwards approximately 10 cm (4 in) as the Honda rolled and traveled across the ground to final rest. The right side of the Honda sustained some minor abrasions and slight crush to the right roof rail and A-pillar (Figure 9). The Honda rolled approximately 18 meters (59 ft) coming to rest on its left side facing south (Figure 10). The CDC assigned to the damage pattern for Event 2 is 00TYDO2.

Figure 8. Vertical intrusion to the windshield header during the rollover event

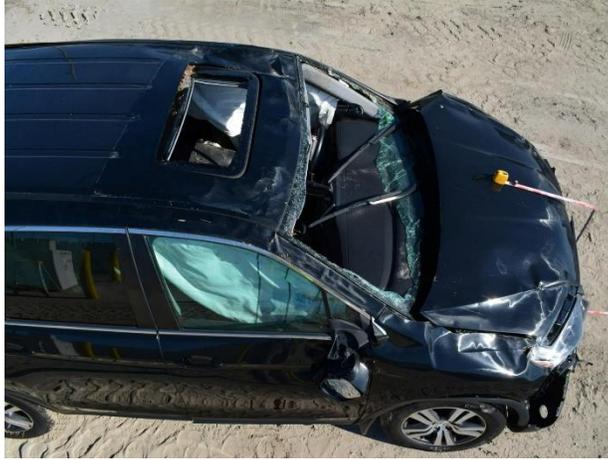
Figure 9. Rollover damage to the right side

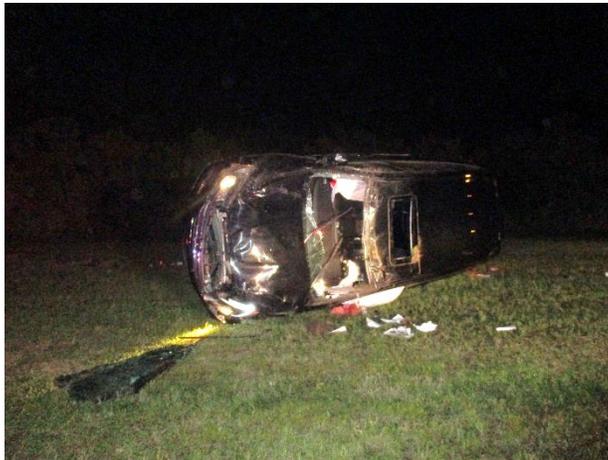
Figure 10. On-scene image of the Honda at final rest. Photo obtained from investigating law enforcement.

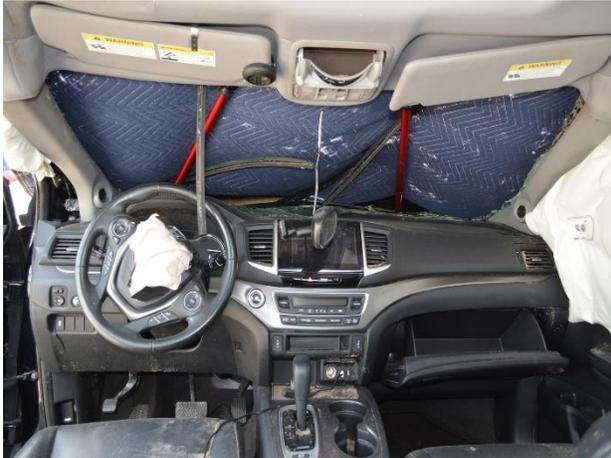
There was minor interior damage which was associated to the intrusion, air bag deployment, and occupant contacts. There was an 8 cm (3.1 in) intrusion of the roof into the front passenger compartment (Figure 11). The driver contacts consisted of scuffs to the knee bolster, upper door panel, driver's IC and outboard seat-mounted side-impact air bags, driver's frontal air bag, and sunroof header (Figure 12).

Figure 11. Overview of the front row

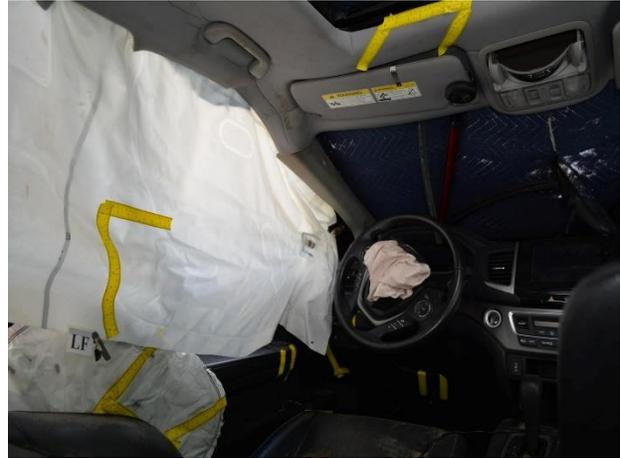
Figure 12. Driver's contacts

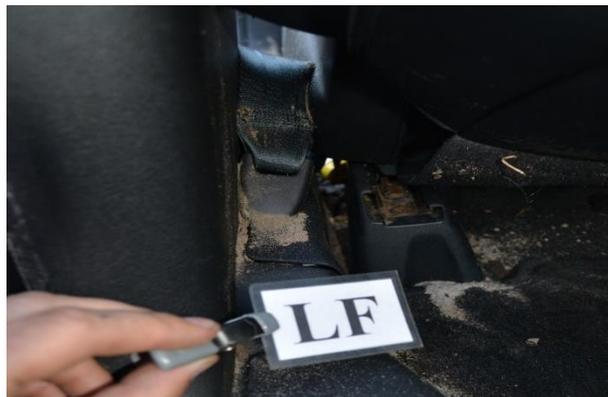
The Honda had 3-point continuous loop lap and shoulder seat belts for each of the five seating positions. The front row used sliding latch plates and adjustable D-rings. The second row used sliding latch plates. The Honda was also equipped with retractor and lower anchor pretensioners (Figure 13) that had actuated due to the crash forces associated with Event 1.

Figure 13. Viewing the driver's actuated lower anchor pretensioner

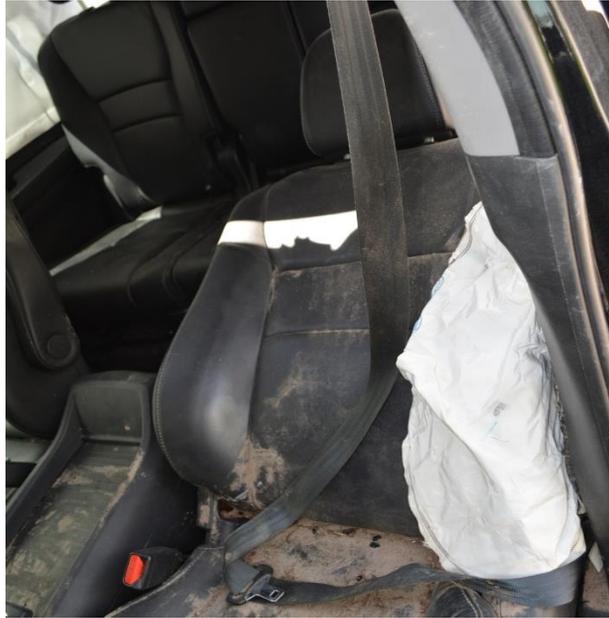
At the time of the SCI inspection, it was observed that the driver's seat belt was locked out from the retractor and hanging loosely from the full-up positioned D-ring (Figure 14). Sand particles were embedded in the webbing of the lap portion of the seat belt. Friction burns from the webbing by the pretensioner actuation and occupant loading were found on the latch plate (Figure 15). Based on the belt evidence and the EDR report, the driver was belted at the time of the crash.

Figure 14. Driver's seat belt

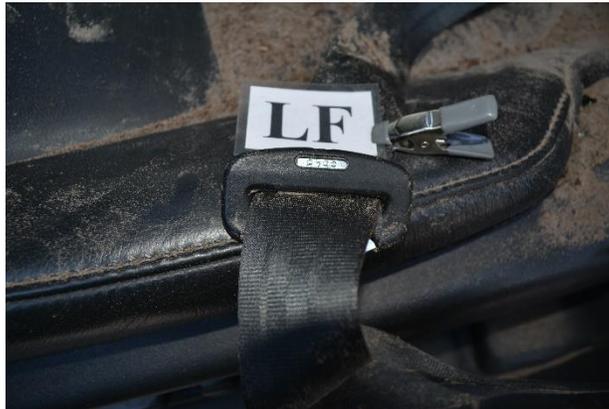
Figure 15. Driver's latch plate with friction burns

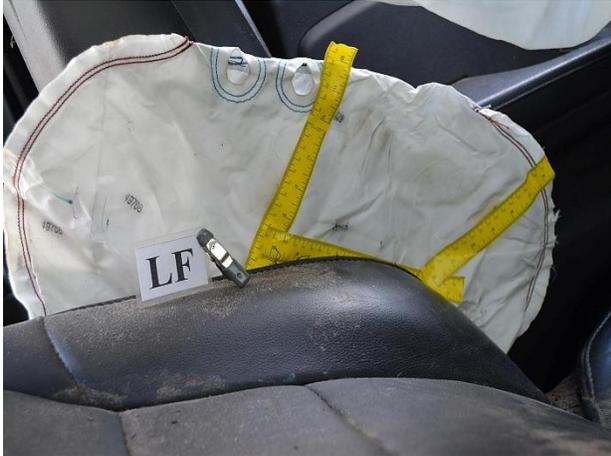
The Honda had dual-stage driver's and passenger's frontal air bags, outboard seat-mounted side-impact air bags and IC air bags. Both drivers and passenger's seat-mounted side-impact air bags (Figures 16 and 17), IC air bags (Figures 18 and 19) and the driver's frontal air bag (Figure 20) deployed due to the crash forces. There were occupant contacts to the driver's frontal, seat-mounted side-impact and IC air bags.

Figure 16. Driver's outboard seat-mounted air bag

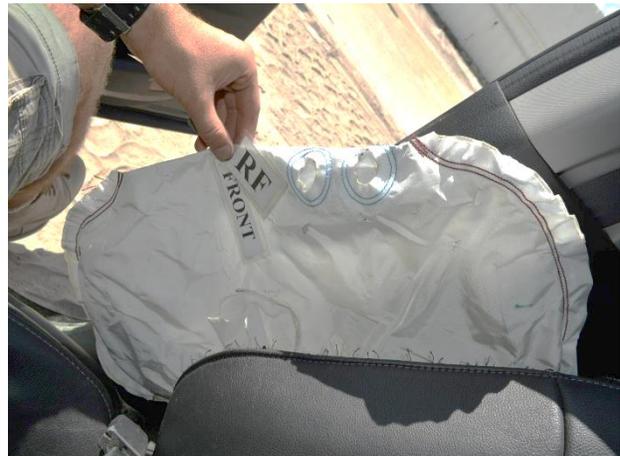
Figure 17. Front passenger's outboard seat-mounted air bag

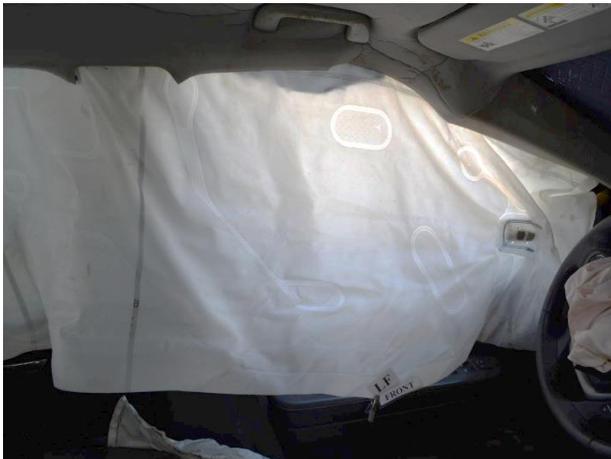
Figure 18. Driver's IC air bag

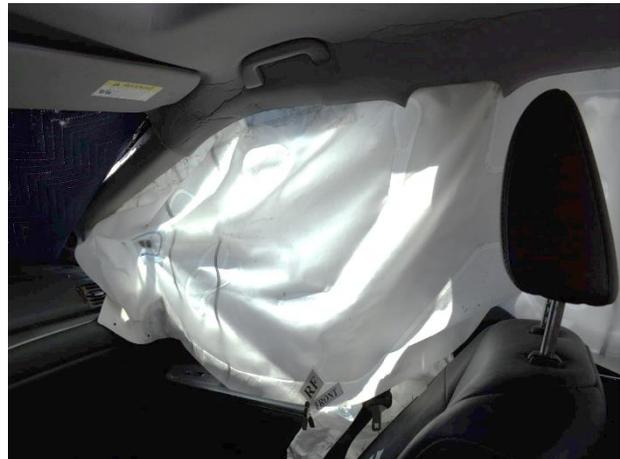
Figure 19. Front passenger's IC air bag

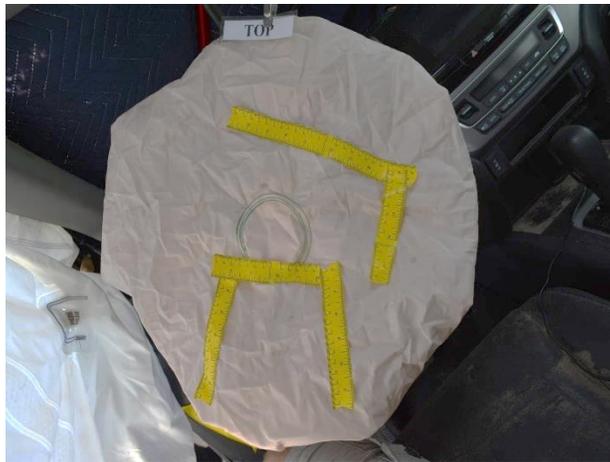
Figure 20. Driver's frontal air bag

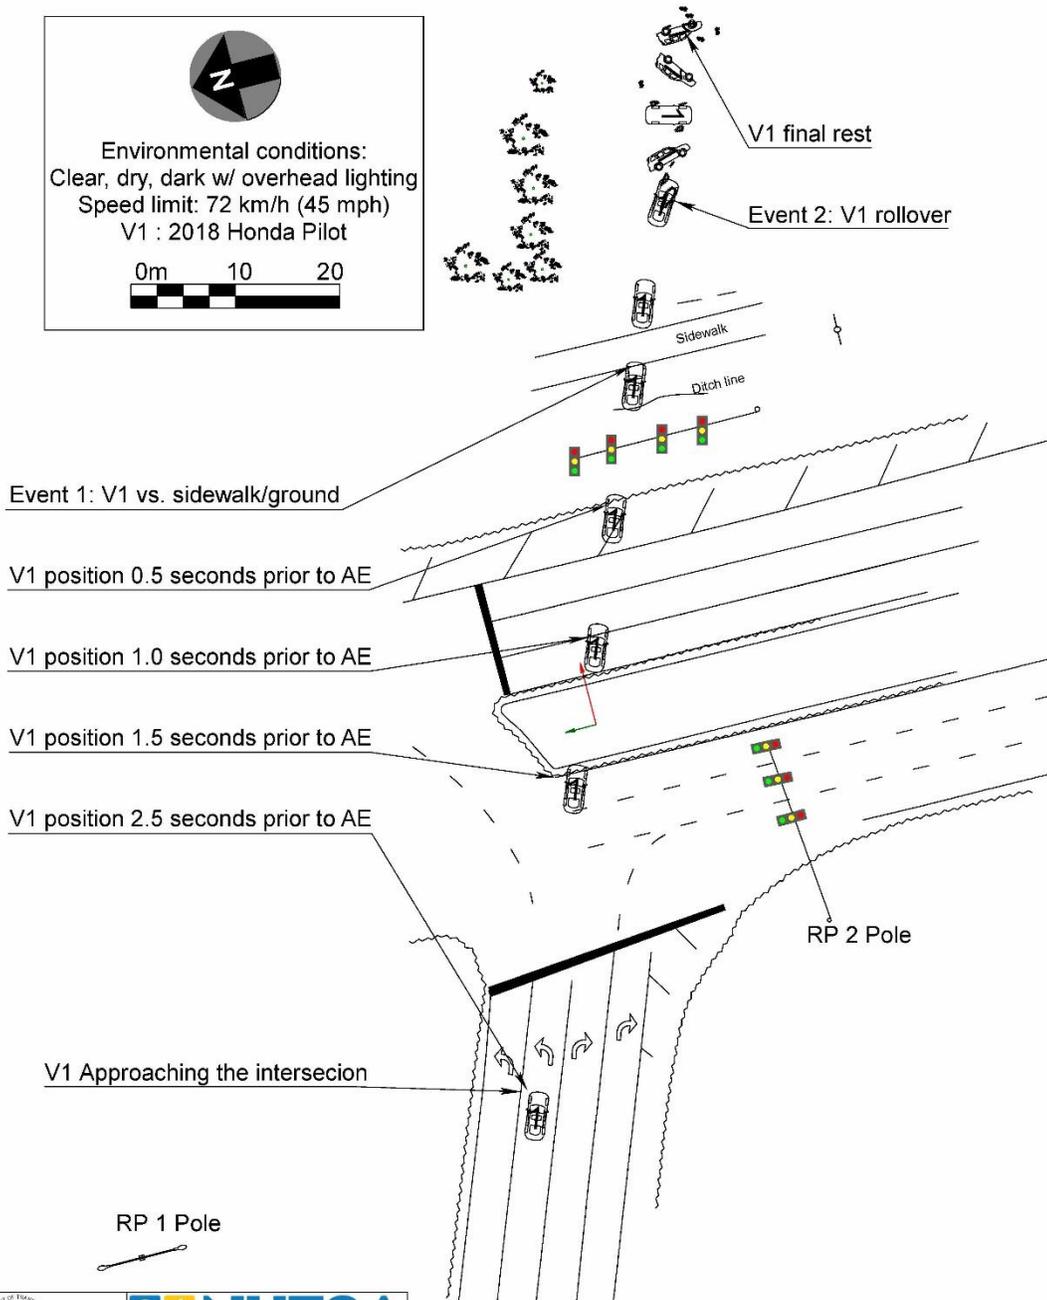
Crash Diagram

Environmental conditions:
 Clear, dry, dark w/ overhead lighting
 Speed limit: 72 km/h (45 mph)
 V1 : 2018 Honda Pilot

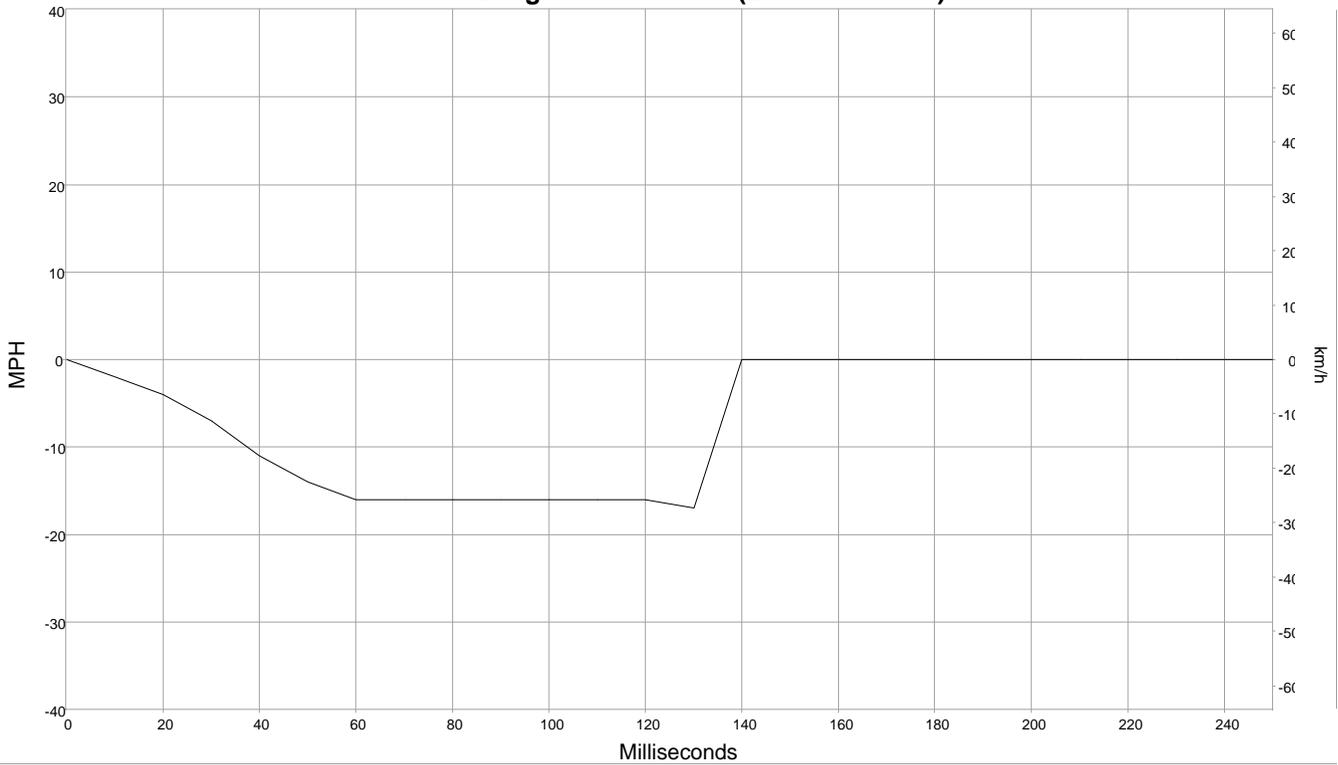
Longitudinal Delta V (Event Record 1)

Time (msec)	MPH [km/h]
0	0 [0]
10	-2 [-3]
20	-4 [-7]
30	-7 [-11]
40	-11 [-17]
50	-14 [-23]
60	-16 [-25]
70	-16 [-26]
80	-16 [-26]
90	-16 [-26]
100	-16 [-26]
110	-16 [-26]
120	-16 [-26]
130	-17 [-27]
140	0 [0]
150	0 [0]
160	0 [0]
170	0 [0]
180	0 [0]
190	0 [0]
200	0 [0]
210	0 [0]
220	0 [0]
230	0 [0]
240	0 [0]
250	0 [0]

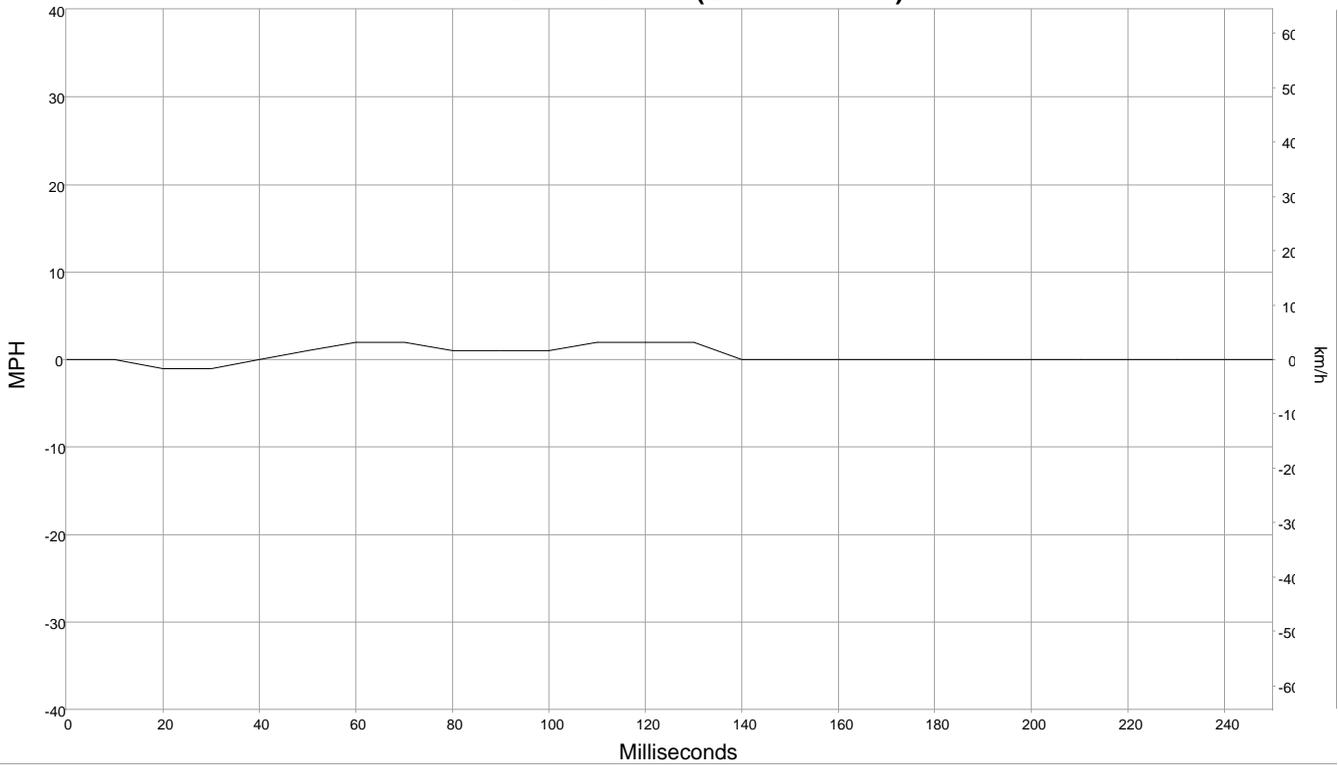
Lateral Delta V (Event Record 1)

Time (msec)	MPH [km/h]
0	0 [0]
10	0 [0]
20	-1 [-1]
30	-1 [-1]
40	0 [0]
50	1 [2]
60	2 [3]
70	2 [3]
80	1 [2]
90	1 [1]
100	1 [1]
110	2 [3]
120	2 [3]
130	2 [3]
140	0 [0]
150	0 [0]
160	0 [0]
170	0 [0]
180	0 [0]
190	0 [0]
200	0 [0]
210	0 [0]
220	0 [0]
230	0 [0]
240	0 [0]
250	0 [0]

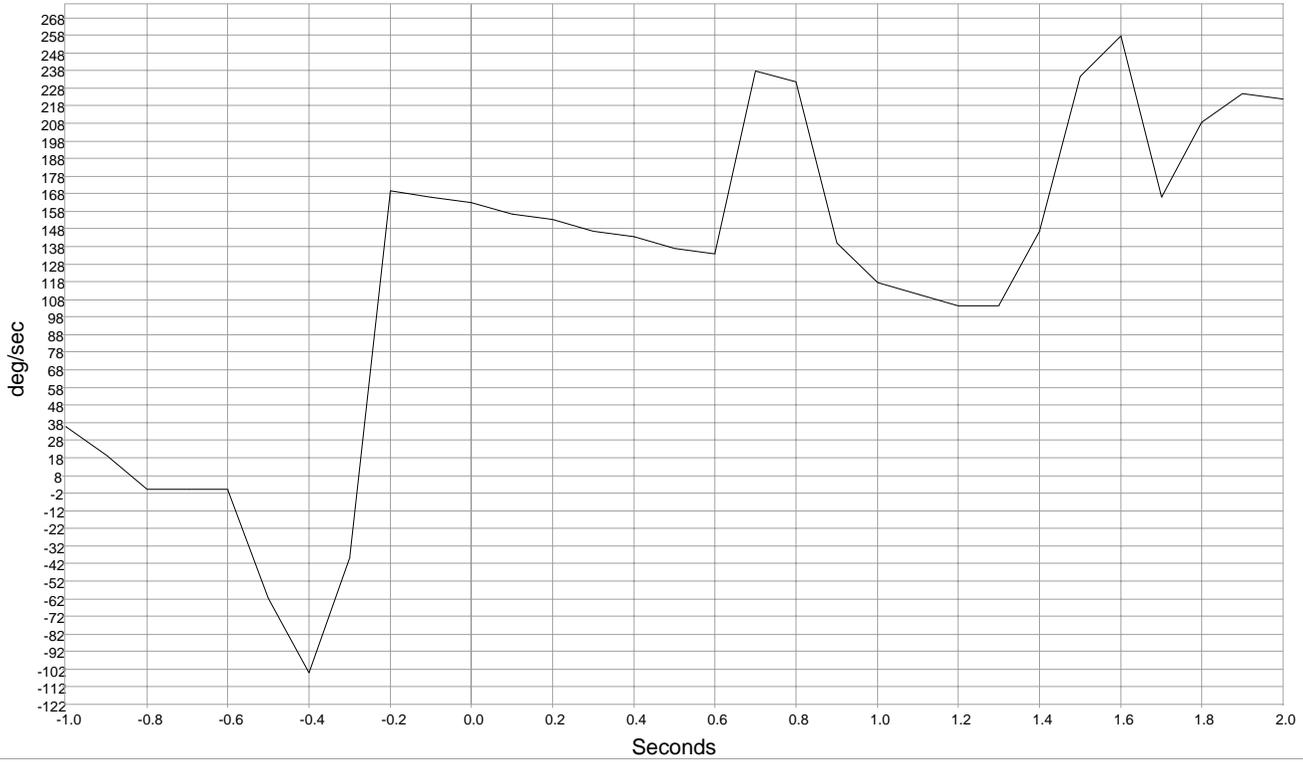
Vehicle Roll Rate (Rollover Event Record)

Positive roll rate indicates right-to-left (counterclockwise) rotation

Columns 1 and 2 in Table 2 below represent the recorded time history of the vehicle's roll rate in 0.2 second intervals. The SCI-calculated roll angle of the Honda is presented in column 3. The calculated angle was consistent with the rollover event.
