DOT HS 812 569

# **Special Crash Investigations On-Site Inflatable Curtain Air Bag Non-Deployment Investigation**

**Vehicle: 2013 Ford Edge**

**Crash Date: November 2015**

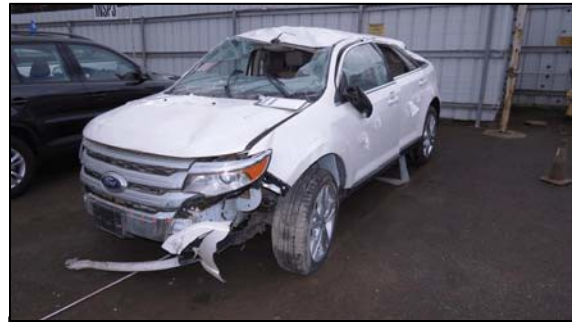
**Figure 1.** 2013 Ford Edge

This report documents the on-site investigation of the non-deployment of the Inflatable Curtain (IC) air bags in a 2013 Ford Edge involved in a rollover crash (**Figure 1**). This investigation was initiated by the Office of Defects Investigation (ODI) in response to a driver notification. The Special Crash Investigations (SCI) group of the National Highway Traffic Safety Administration assigned the case to Dynamic Science, Inc., in March, 2016. The inspection was completed in March, 2016. The Ford was supported by the Bosch Crash Data Retrieval (CDR) system and the vehicle's event data recorder (EDR) was imaged during the inspection.

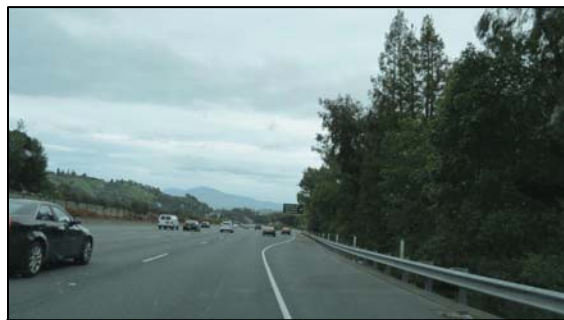
**Figure 2.** Eastbound approach

The crash site was in the eastbound lanes of a divided State highway (**Figure 2**). The four straight eastbound travel lanes were separated from the westbound lanes by a concrete median with an asphalt shoulder. The lanes were separated by dashed white lines and raised pavement markers. The asphalt roadway was bordered on the right by an asphalt shoulder, a 20.3 cm (8.0 in) concrete curb, and a 9.7 m (32.0 ft) wide dirt/grass shoulder with bushes. The shoulder was adjacent to a 3.9 m (13.0 ft) wide asphalt off ramp lane. It was dark at the time of the crash and there were no streetlights present.
