DOT HS 812 584

**Special Crash Investigations
On-Site Air Bag
Non-Deployment
Crash Investigation
Vehicle: 2004 Lexus GX470
Location: Massachusetts
Crash Date: August 2017**

SPECIAL CRASH INVESTIGATIONS
CASE NO: CR17027
OFFICE OF DEFECTS INVESTIGATION
ON-SITE AIR BAG NON-DEPLOYMENT CRASH INVESTIGATION
VEHICLE: 2004 LEXUS GX470
LOCATION: MASSACHUSETTS
CRASH DATE: AUGUST 2017

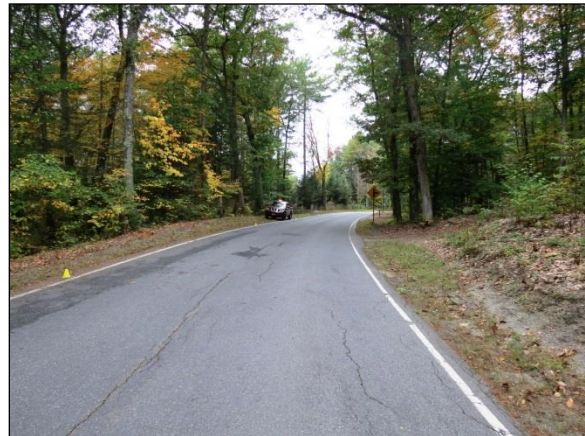
Figure 2: West-facing trajectory view of the roadway in the vicinity of the crash.

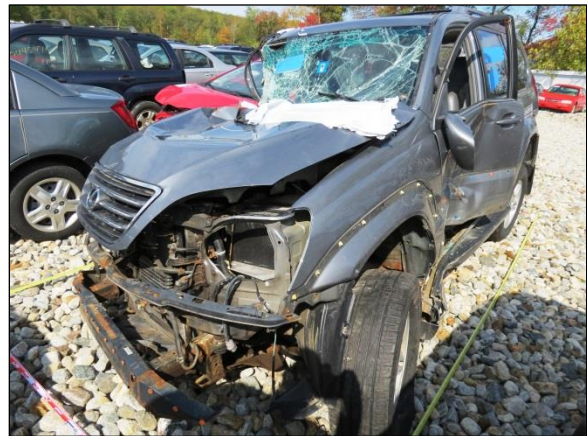
Figure 5: Front left oblique view of the 2004 Lexus GX470 at the time of the SCI vehicle inspection.

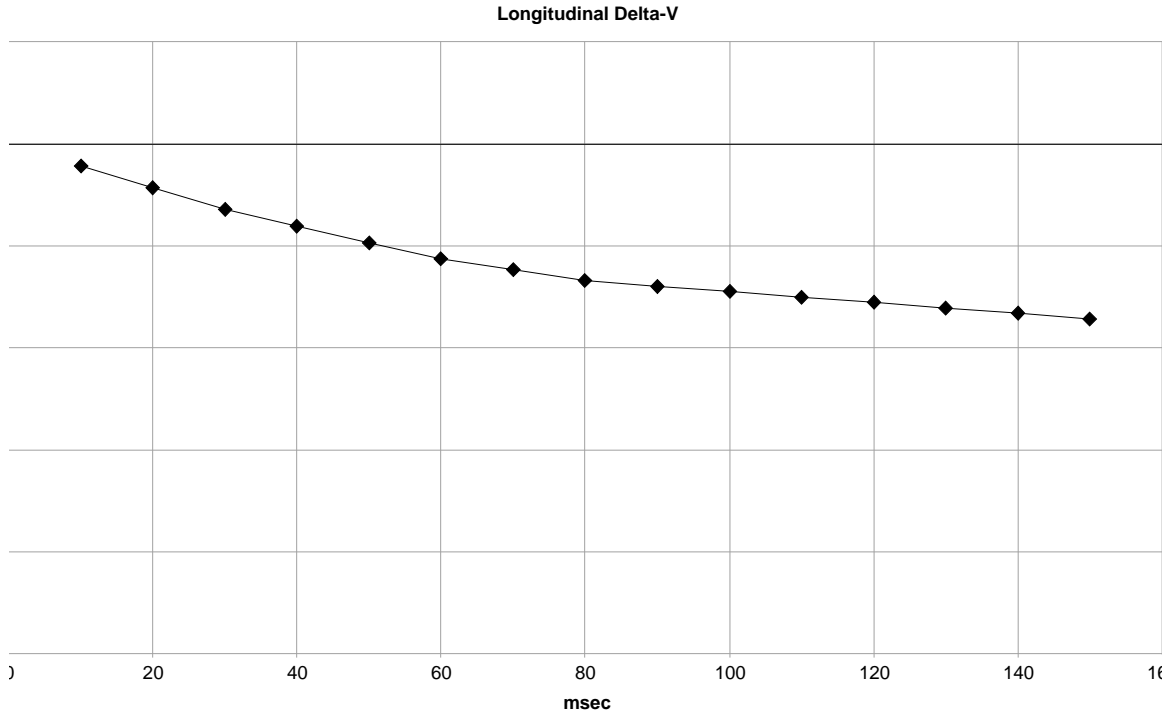
Longitudinal Crash Pulse (Most Recent Frontal/Rear Event, TRG 2 - table 1 of 2)

Max Longitudinal Delta-V (MPH [km/h])	-3.4 [-5.5]
---------------------------------------	-------------

Time (msec)	
10	-0.4 [-0.7]
20	-0.9 [-1.4]
30	-1.3 [-2.1]
40	-1.6 [-2.6]
50	-1.9 [-3.1]
60	-2.2 [-3.6]
70	-2.5 [-4.0]
80	-2.7 [-4.3]
90	-2.8 [-4.5]
100	-2.9 [-4.7]
110	-3.0 [-4.8]
120	-3.1 [-5.0]
130	-3.2 [-5.2]
140	-3.3 [-5.3]
150	-3.4 [-5.5]

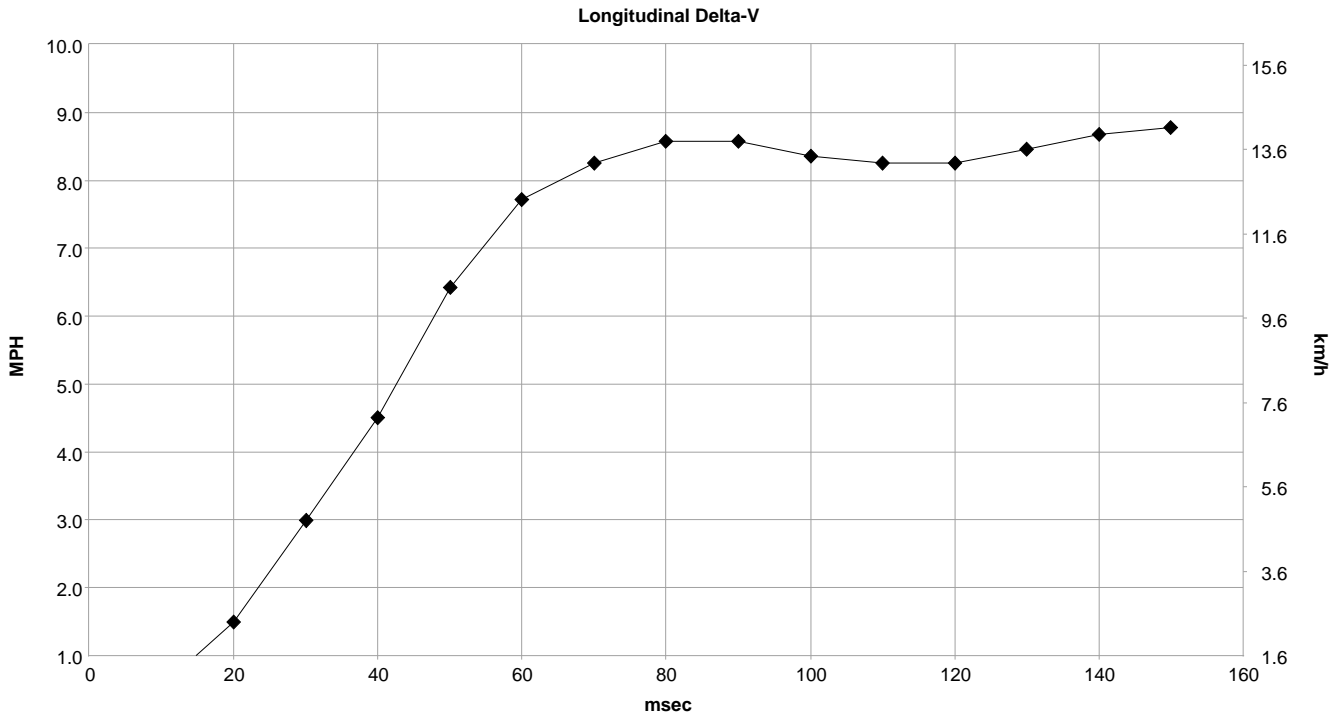
Longitudinal Crash Pulse (1st Prior Frontal/Rear Event, TRG 1 - table 1 of 2)

Max Longitudinal Delta-V (MPH [km/h])	8.8 [14.1]
---------------------------------------	------------

Time (msec)	Longitudinal Delta-V (MPH [km/h])
10	0.5 [0.9]
20	1.5 [2.4]
30	3.0 [4.8]
40	4.5 [7.2]
50	6.4 [10.3]
60	7.7 [12.4]
70	8.2 [13.3]
80	8.6 [13.8]
90	8.6 [13.8]
100	8.4 [13.4]
110	8.2 [13.3]
120	8.2 [13.3]
130	8.5 [13.6]
140	8.7 [14.0]
150	8.8 [14.1]

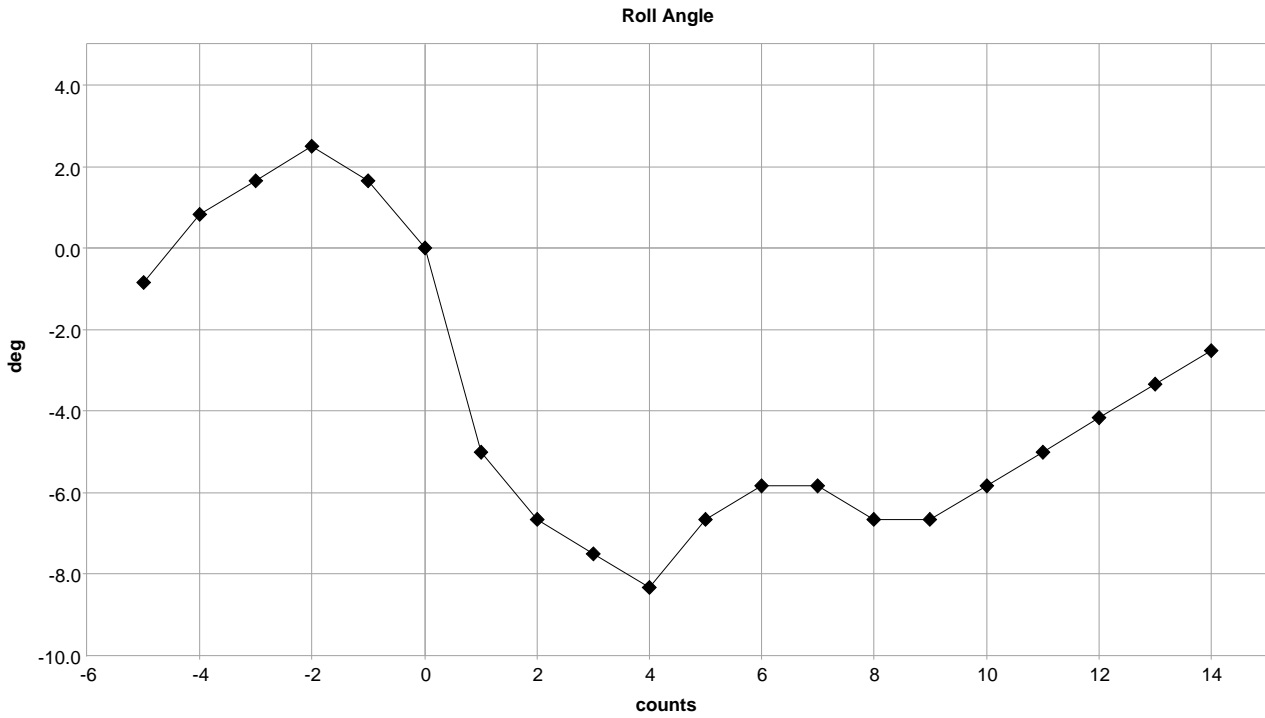
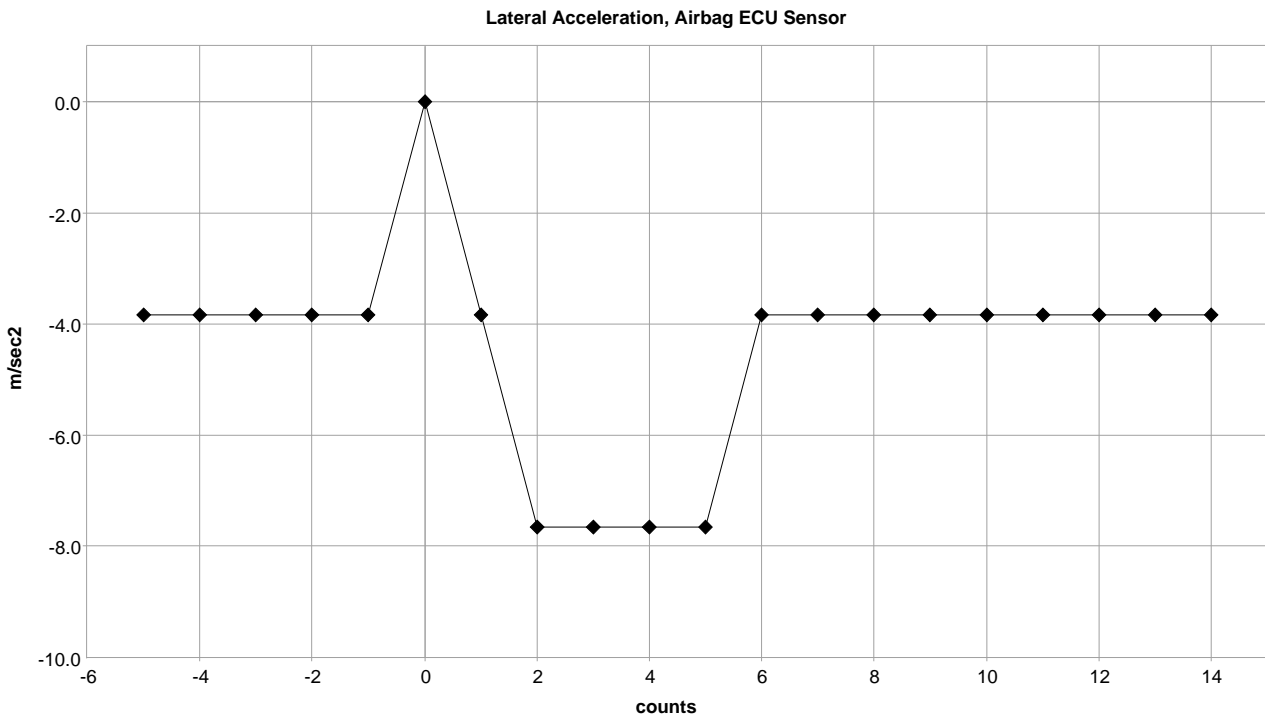
Rollover Crash Pulse for Rollover Event (table 1 of 2)

Roll Angle Peak (degrees)	-8
---------------------------	----

Counts	Roll Angle (degrees)	Lateral Acceleration, Airbag ECU Sensor (m/sec²)
-5	-0.8	-3.8
-4	0.8	-3.8
-3	1.7	-3.8
-2	2.5	-3.8
-1	1.7	-3.8
0	0.0	0.0
1	-5.0	-3.8
2	-6.7	-7.7
3	-7.5	-7.7
4	-8.3	-7.7
5	-6.7	-7.7
6	-5.8	-3.8
7	-5.8	-3.8
8	-6.7	-3.8
9	-6.7	-3.8
10	-5.8	-3.8
11	-5.0	-3.8
12	-4.2	-3.8
13	-3.3	-3.8
14	-2.5	-3.8
