DOT HS 812 624

October 2018

# **Special Crash Investigations On-Site Small Overlap/Oblique Impact Investigation Vehicle: 2014 Nissan Versa Location: Missouri Crash Date: August 2016**

Indiana University  
Transportation Research Center  
On-Site Small Overlap/Oblique Impact Investigation  
Case Number - IN16024  
Location - Missouri  
Vehicle - 2014 Nissan Versa  
Crash Date - August 2016

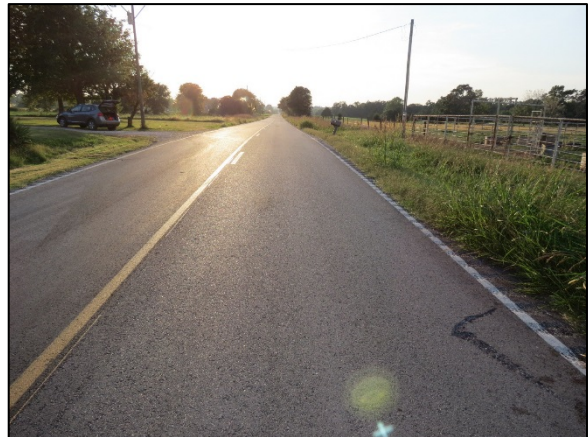
**Figure 2:** Westbound approach of the Nissan

The Nissan was traveling west in a westbound lane (**Figure 2**) at an EDR- reported speed of 115 km/h (71 mph) at -5.0 sec prior to algorithm enable (AE). The Ford was traveling east in the eastbound lane and crossed the centerline into the westbound lane. The Nissan's EDR reported a 24-degree right steer at -0.5 sec indicating that the Nissan's driver initiated a right steering maneuver in an attempt to avoid the crash. The vehicle's speed at -0.5 sec was reported as 117 km/h (73 mph). The service brake was reported as "On" at 0.0 sec at which point the vehicle's speed was 112 km/h (70 mph).

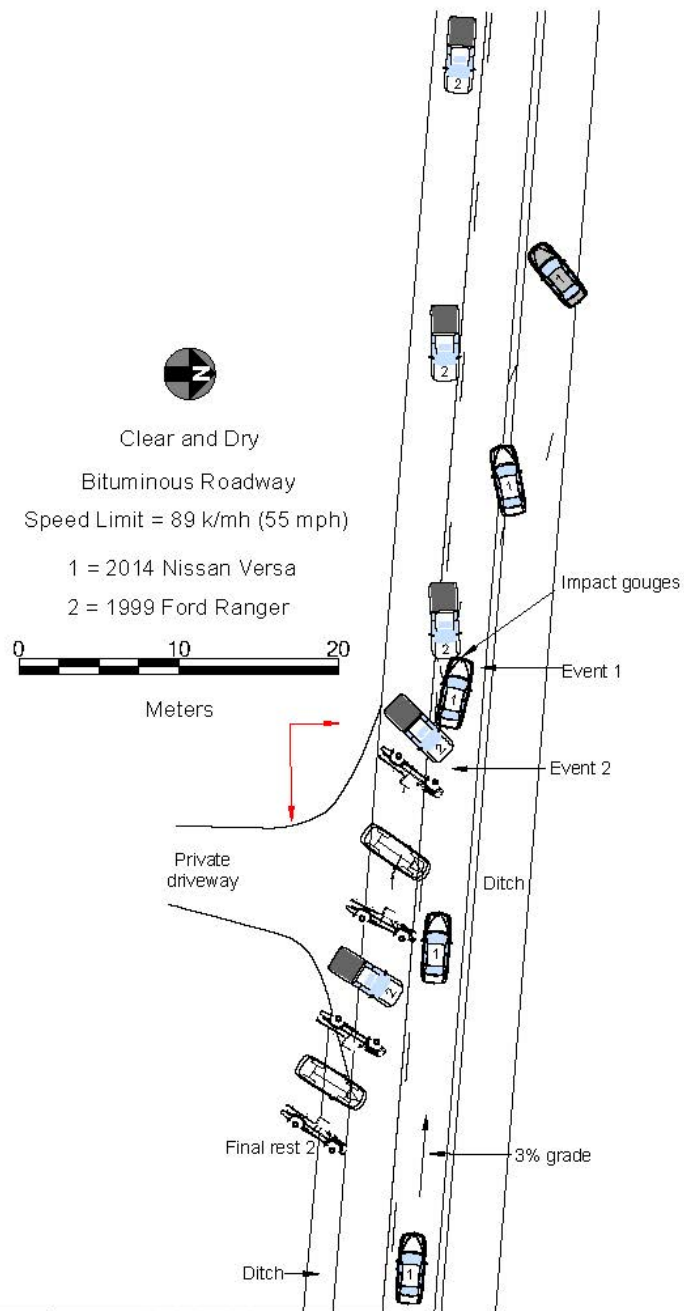
# CRASH DIAGRAM

The roadway surface was dry bituminous. The speed limit for each vehicle was 89 km/h (55 mph). The crash diagram is included at the end of this report on page 9.

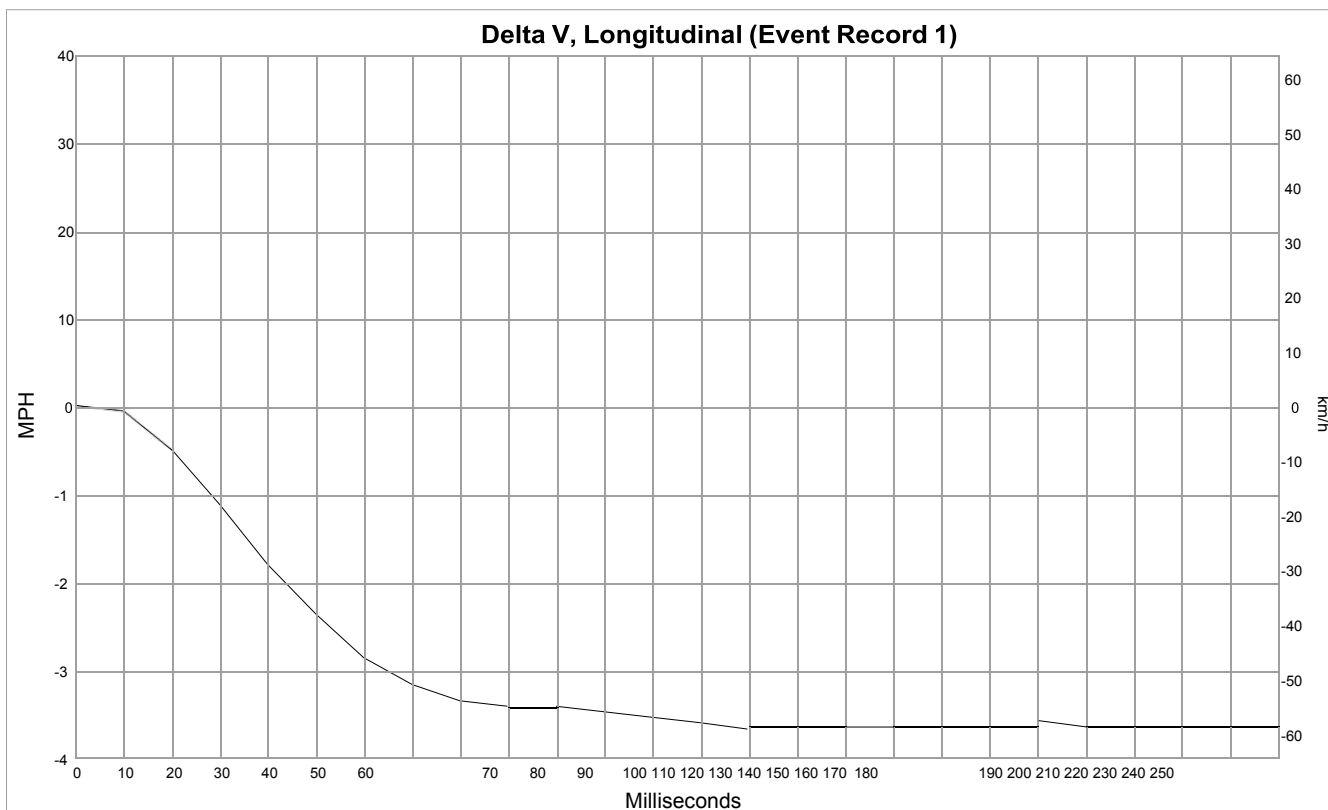
### Longitudinal Delta V (Event Record 1)

The Damage algorithm of the WinSMASH program calculated the Nissan's total delta-V as 91 km/h (57 mph). The longitudinal and lateral velocity changes were -90 km/h (-56 mph) and 16 km/h (10 mph), respectively. WinSMASH calculated the total delta-V for
