DOT HS 812 643

# **Special Crash Investigations On-Site Child Restraint System Crash Investigation Vehicle: 2006 Nissan Pathfinder Location: Oregon Crash Date: January 2016**

**SCI Case Number: DS16002**

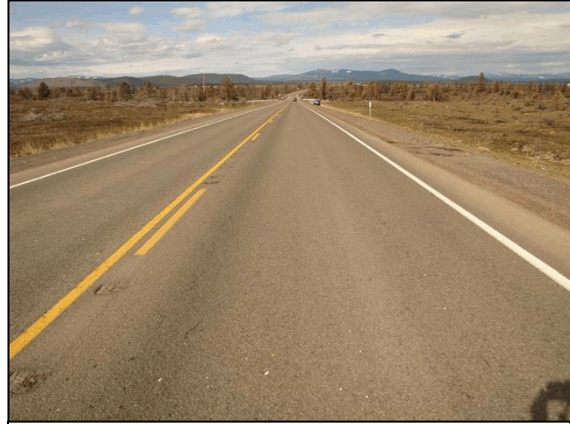
**Figure 2.** Crash site, looking west

The crash occurred on a two-lane, undivided, east/west U.S. highway in a rural area in Oregon (**Figure 2**). The roadway was asphalt surfaced and configured with one lane for each direction of travel. The travel lanes each measured 3.7 m (12.0 ft) wide and were separated by a double solid/dashed painted stripe configured with a centerline rumble strip. The roadway was bordered by solid white painted fog lines, paved shoulders and gravel shoulders. The paved shoulders each measured 1.0 m (3.3 ft) wide and the gravel shoulders each measured 2.7 m (9.0 ft) wide. This roadway was straight with a descending negative slope of 3.5 percent in the westbound direction. The posted speed limit was 89 km/h (55 mph).

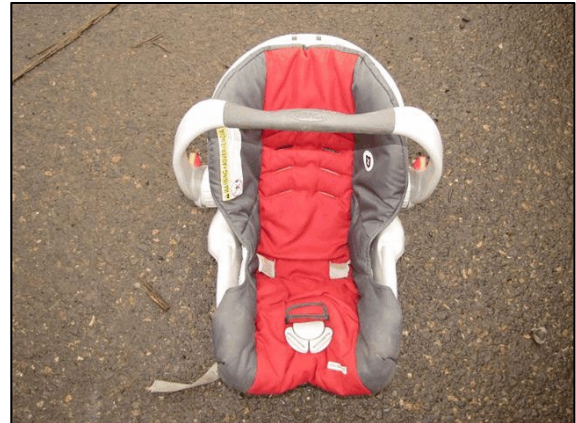
**Figure 8.** Graco Snugride 35 CRS

The Graco Snugride 35 CRS was a rear-facing infant safety seat (**Figure 8**) Model Number 1759689 and date of manufacture 09/03/2009. It was used by the 12-month-old female occupant of the Nissan and installed in the second row right seat position. The mother of the child was the front right occupant in the Nissan at the time of the crash. She was interviewed and provided data on the installation, adjustment, usage, and history of the CRS. The occupant obtained the CRS from a friend who had purchased it new and used it for a short time (approximately two months) for a newborn infant. The CRS had not been in prior crashes and was not previously damaged. All components were present including the instruction manual and no recalls were in effect. The Graco was configured with a 5-point harness system with buckle and retainer clip, three-level harness slots, adjustable handle, level indicator, padded cushion and removable canopy.
