DOT HS 812 732

Special Crash Investigations On-Site Rollover Crash Investigation

**Vehicle: 2017 Mercedes-
Benz GLA 250**

Case Number: DS17016

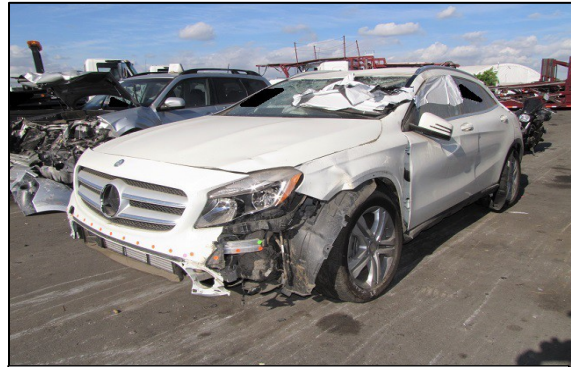
Figure 1. 2017 Mercedes-Benz GLA 250

This report documents the investigation of a 2017 Mercedes-Benz GLA 250 4MATIC (**Figure 1**) involved in a rollover crash and the vehicle's safety systems that complied with Federal Motor Vehicle Safety Standard (FMVSS) No. 226, Ejection Mitigation, a rule established to reduce the partial and complete ejection of vehicle occupants through side windows in crashes, particularly rollover crashes. Neither occupant was ejected during the rollover.

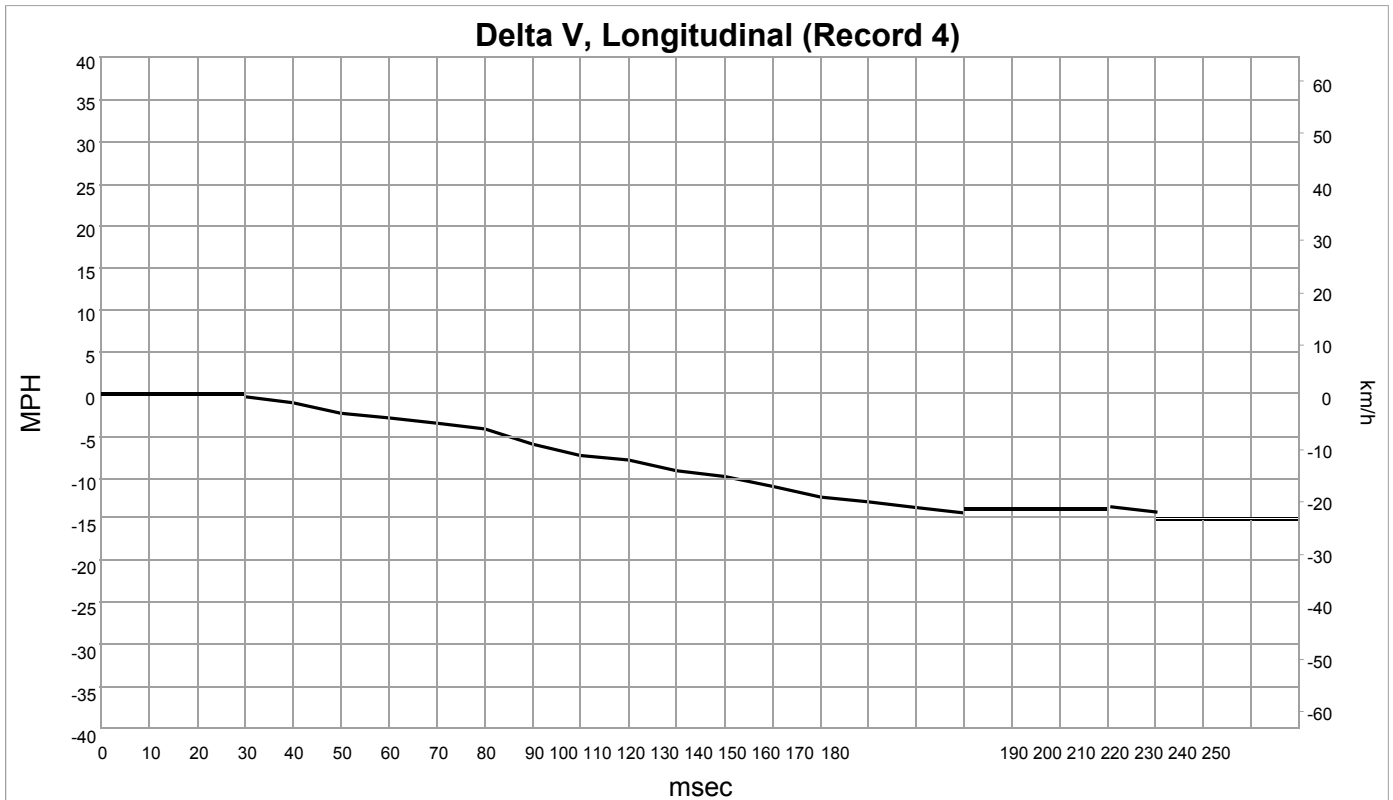
Longitudinal Crash Pulse (Record 4)

For the Mercedes in Event 1, overlapping damage to the front plane and swiping damage to the undercarriage precluded a reconstruction using the WinSMASH program. The EDR Record 4 reported a maximum longitudinal delta V of -23 km/h (-14.3 mph) at 213 ms and a maximum lateral delta V of -7 km/h (-4.3 mph) at 278 ms. The calculated principal direction of force (PDOF) was positive 17 degrees.
