**National Highway  
Traffic Safety  
Administration**

DOT HS 812 752

June 2019

# **Analysis of Real-World Crashes Where Involved Vehicles Were Equipped With Adaptive Equipment**

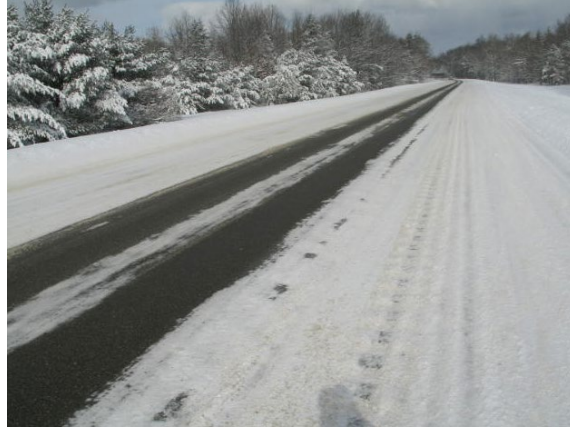
**Figure 3: Case No 2008-13-021 Scene Photo**

A 2006 Dodge Ram pickup truck (Case No. 2008-13-021) was coded as equipped with a steering knob, hand controls, and a low effort steering system (Figure 2). The vehicle was traveling on a divided icy highway and lost control (Figure 3). It subsequently went off the right side of the road and rolled over. The posted speed limit at the location of the crash was 70 mph. The restrained 60-year-old male driver sustained minor rib contusions during the four-quarter turn rollover. The pre-crash movement was going straight with the critical event traveling too fast for conditions. The driver of the Dodge was coded as attentive or not distracted.

There were 5 cases where the critical pre-crash category was coded loss of control for the subject vehicles. In 2 of the cases, vehicles were equipped with low-effort steering (Case Nos. 2008-13-021 and 2007-05-002). In Case No. 2008-13-021 (Figure 3) the driver was coded as traveling too fast for conditions, and in Case No. 2007-05-002 poor road conditions (puddle, pot hole, ice, etc.) were coded as the critical pre-crash event. There were 2 cases where the vehicles were equipped with steering knobs and hand controls (Case Nos. 2008-13-021 and 2006-12-119). In Case No 2008-13-021, the driver was coded as traveling too fast for conditions, and the vehicle in Case No. 2006-12-119 was coded as having a disabling failure, which appears unrelated to the adaptive equipment. That case involved a 2004 Chevrolet Impala equipped with a steering knob and hand controls. The case summary stated, “The steering became disabled and the vehicle left the roadway to the right and struck a utility pole with the front plane and came to rest.” Upon review of the case data, the steering knob was mechanically fastened to the steering wheel, and it is unlikely to have “disabled” the steering system as a steering knob only provides leverage to the driver and does not provide mechanical assistance. Finally, Case No. 2014-75-041 was equipped with a steering knob only; however, the control loss appears to be related to a medical condition that may have incapacitated the driver. In these cases, there appear to be other factors that may have resulted in the drivers losing control of the vehicles that are unrelated to the adaptive equipment.

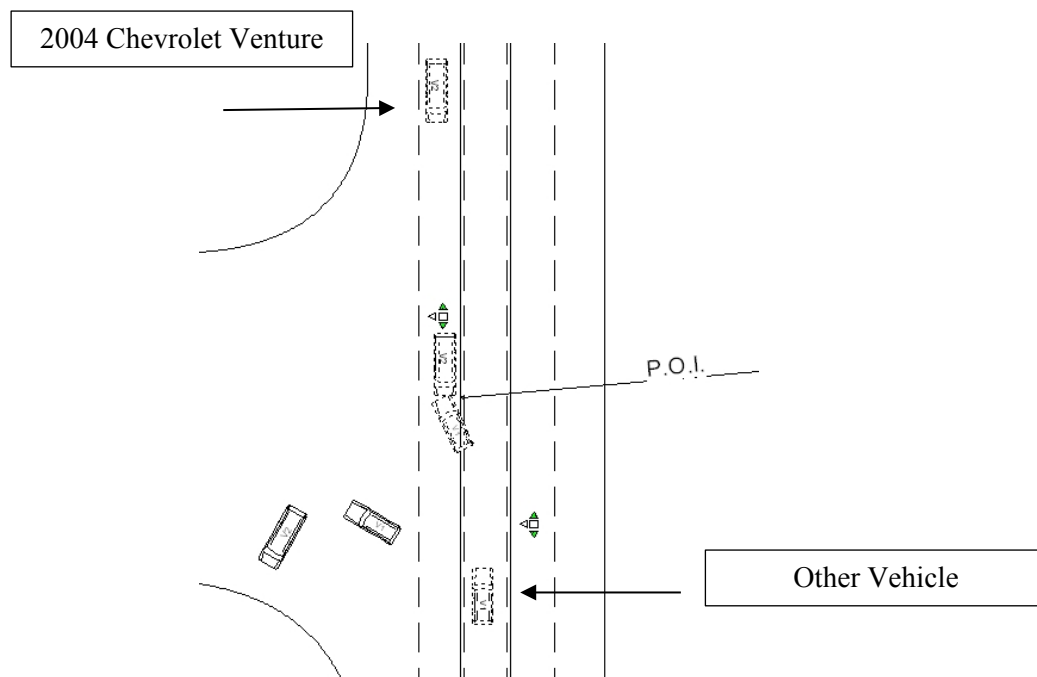
**Figure 4: Case No. 2008-12-099 Scene Diagram (P.O.I. = Point of Impact)**

In this example of an intersection crash (Case No. 2008-12-099), a 2004 Chevrolet Venture was equipped with a steering knob and hand controls. Another vehicle was traveling east intending on turning left onto an expressway entrance ramp under dark but lighted conditions with a posted speed limit of 45 mph. The Chevrolet was traveling west as the other vehicle turned into it (Figure 4). The Chevrolet was coded as going straight and did not take an avoidance maneuver. The frontal crash severity was 28 km/h. The unrestrained 50-year-old male driver of the Chevrolet sustained minor spine injuries, and the unrestrained front passenger sustained serious lower leg injuries. The frontal air bags deployed in the crash. The driver of the Chevrolet was coded as attentive or not distracted.

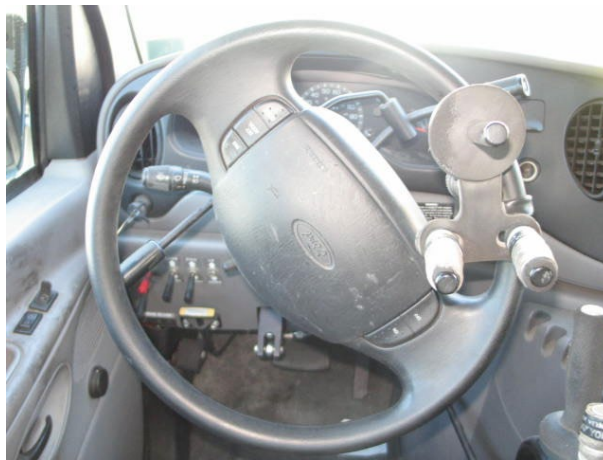
**Figure 5: Case No. 2008-79-016 Steering Knob (Tri Pin) and Hand Controls**

Case No. 2008-79-016 occurred on a not physically divided (two-way traffic) roadway with a posted speed limit of 35 mph. Another vehicle was exiting a driveway traveling northbound. A 2000 Ford E-Series van modified to accommodate a wheelchair seated driver, and equipped with a steering knob and hand controls (Figure 5), was traveling eastbound as it approached the driveway (Figure 6). The other vehicle was attempting a right turn onto the roadway when its left plane was contacted by the subject vehicle's front plane. The Ford's pre-crash movement was going straight, and the driver did not take an avoidance maneuver. The 40-year-old male driver was properly restrained while sitting in a wheelchair. In the 12 km/h delta-v frontal crash the driver sustained minor lower extremity contusions from contact with the knee bolster. The frontal air bags did not deploy in the crash. The driver of the Ford was coded as attentive or not distracted.

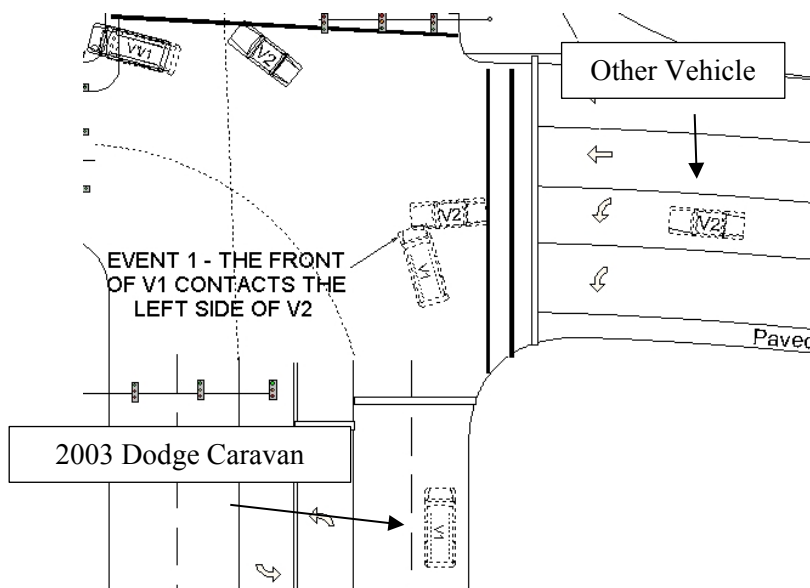
Figure 7: Case No. 2010-75-103 Scene Diagram

The last example occurred on a not physically divided roadway (two-way traffic) at an interchange (Case No. 2010-75-103). A 2003 Dodge Caravan equipped with a steering knob and hand controls was traveling northbound approaching an intersection (Figure 7) with a posted speed limit of 40 mph. Another vehicle was westbound approaching the same intersection. The Dodge entered the intersection going straight. The other vehicle turned left at the intersection. The front of the Dodge struck the left side of the other vehicle. The pre-crash movement for the subject vehicle was going straight, and the driver tried to avoid the crash by steering left. The 38-year-old, properly restrained male driver sustained a moderate severity ulna fracture in the 12 km/h delta-v frontal impact. The frontal air bags deployed in the crash. The driver of the Dodge was coded as inattentive or distracted.

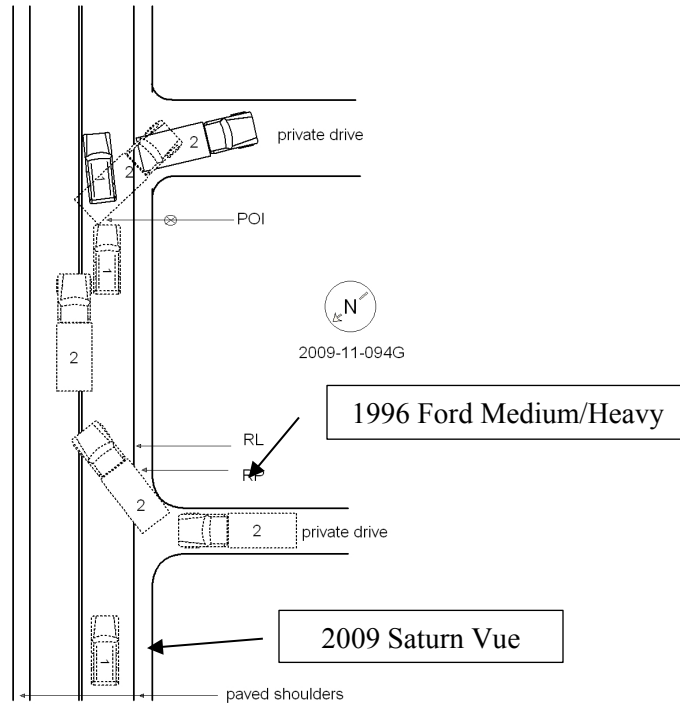
**Figure 8: Case No. 2009-11-094 Scene Diagram**

With respect to Case No. 2009-11-094, the Saturn and a 1996 Ford medium/heavy vehicle were traveling in the same direction on a road that was not physically divided (two-way traffic) with a posted speed limit of 45 mph. The Ford was in front of the Saturn and was turning right into a private drive (Figure 8). The front of the Saturn struck the rear of the Ford. The properly restrained

Saturn driver was in a minor impact, and the air bags did not deploy because they were suppressed by an air bag switch (this case will be discussed again in this document). The driver, who was the sole occupant, did not sustain any reported injuries. The driver of the Saturn was coded as attentive or not distracted.

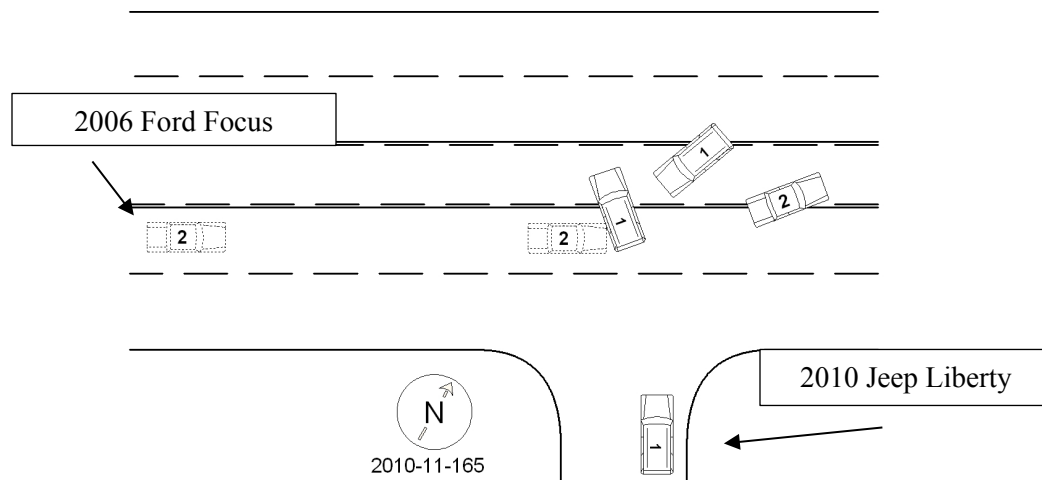
**Figure 11: Case No. 2010-11-165 Scene Diagram**

There were two cases identified where the vehicles' accelerator pedals were relocated to the left side of the brake pedals (Case Nos. 2010-02-066 and 2010-11-165). In Case No. 2010-11-165, a 2010 Jeep Liberty was traveling south out of a commercial driveway to turn left onto a roadway with a posted speed limit of 45 mph. The subject vehicle, a 2006 Ford Focus, was equipped with the relocated accelerator pedal and was traveling eastbound (Figure 10) and coded going straight on a not physically divided roadway with two-way left turn lane (Figure 11). The front of the Ford contacted the left side of the Jeep in the roadway. The attempted avoidance maneuver by the 63-year-old male driver of the Ford was braking. The driver of the Ford was coded as attentive or not distracted. However, the driver of the Jeep was coded as looked but did not see.

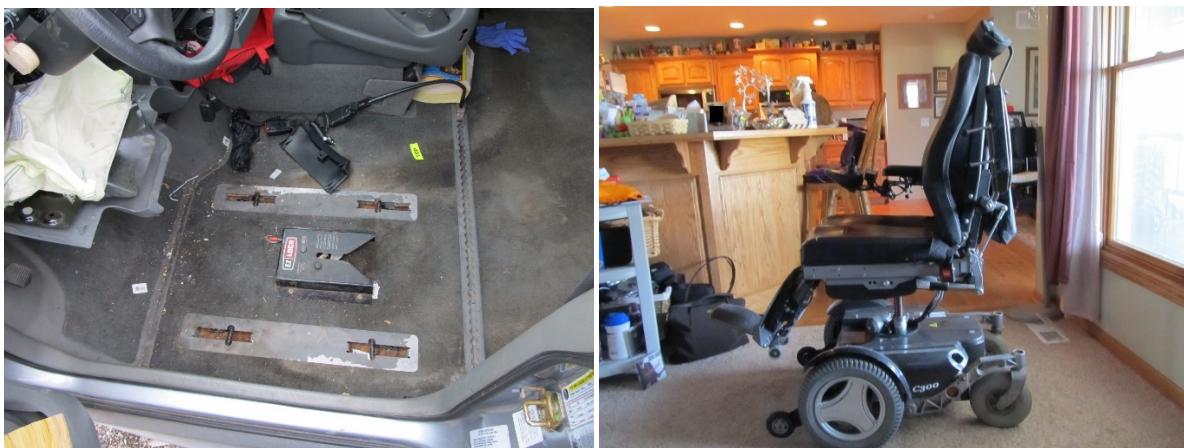
**Figure 13: Case No. 2011-74-166 Wheelchair Docking-Securement Device and Wheelchair**

There were 6 cases identified where wheelchair-seated drivers were involved in crashes. Case No. 2011-74-166 is an example of an altered vehicle that was also extensively modified. This case documented and photographed all the necessary labels per the 49 CFR Part 595 regulation. In this case, an involved vehicle was turning left at an intersection. The subject vehicle, a 2006 Dodge Caravan, was traveling straight through the same intersection. The front of the Dodge struck the left of the other vehicle within the intersection. The driver of the Dodge was seated in a motorized wheelchair, and the vehicle was altered to provide accessibility and securement for the wheelchair (Figure 13).

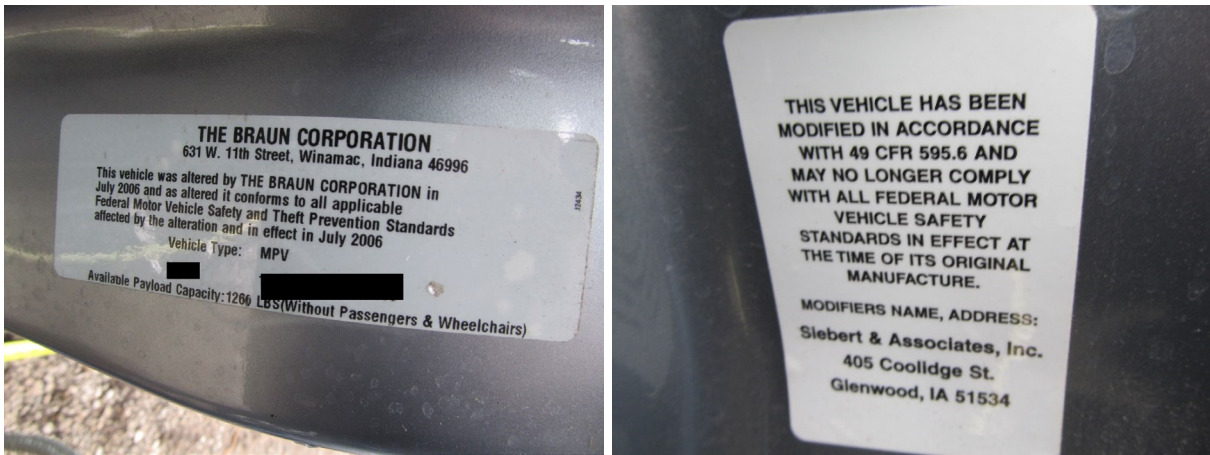
**Figure 14: Case No. 2011-74-166 Certification Label of Alterer and 49 CFR 595 Modifier Label**

The Dodge was altered by Braun Corporation (Figure 14) to be driven by a wheelchair-seated driver. Subsequently, the vehicle was further modified and used the 49 CFR 595 exemption regulation because changes to the vehicle took the vehicle out of compliance with the FMVSSs. Both required labels were documented with this crash (Figure 14).

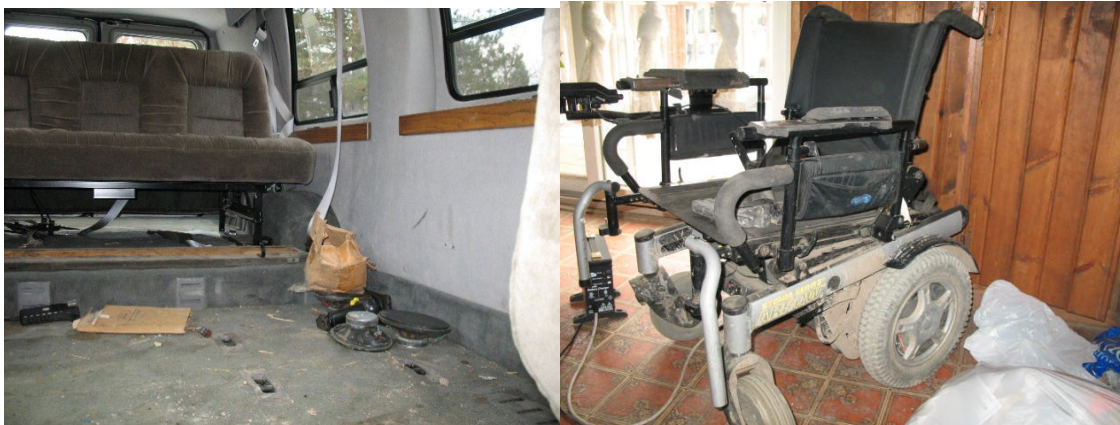
**Figure 16: Case No. 2007-11-197 Seated Position and Wheelchair**

Case No. 2007-11-197 was a multi-vehicle crash where a properly restrained 41-year-old male was seated in a wheelchair in the second row (Figure 16) of a 2003 Ford E Series altered van. The occupant was seated in a motorized wheelchair. From the photo, the seat belt strap is visible in addition to the four wheelchair tie-downs on the floor.

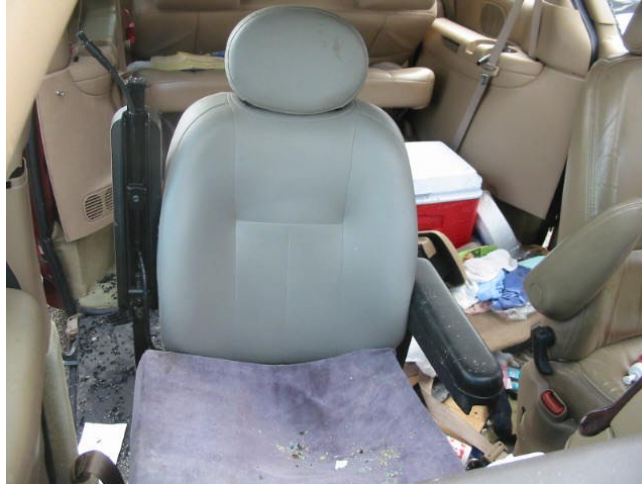
**Figure 22: Case No. 2009-45-021 Front Row Passenger**

There was only one case where the front row passenger side seat position was modified to accommodate a wheelchair and was occupied at the time of the crash. Case No. 2009-45-021 involved a 2000 Chrysler Town & Country van altered and modified to accommodate a wheelchair-seated front row passenger (Figure 22). In this case, the Chrysler was traveling south, and a 2003 Ford Ranger was traveling north on a two-lane rural roadway. While negotiating a curve, the two vehicles struck head-on. This case resulted in the death of occupants in both vehicles. A more detailed discussion of the case, including the crash severity and injuries, will be presented in the section reviewing all the fatal cases.

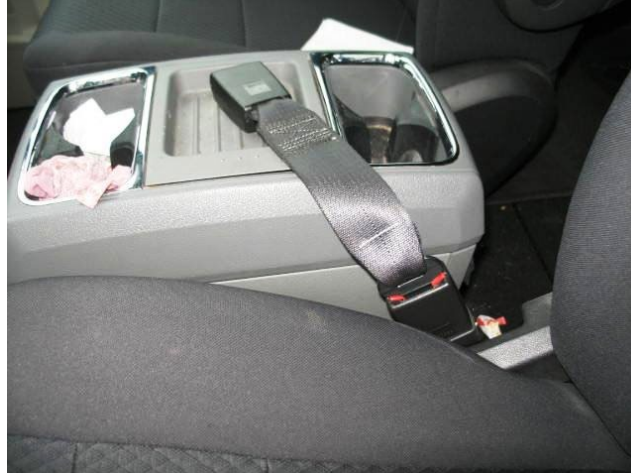
**Figure 23: Case No. 2011-11-221 Seat Belt Extender**

There were two cases (Case Nos. 2011-11- 221 and 2010-02-066) where the subject vehicles were equipped with a driver's side seat belt extender. In Case No. 2011-11- 221 (Figure 23), the 48-year-old male driver weighed 145 kg and did not sustain an injury after striking a deer with his vehicle. For this crash, the delta-v was not calculated, but a review of the photos indicates the severity was minor as there was no visual damage to the vehicle. Last, the 63-year-old male driver in Case No. 2010-02-066 weighed 150 kg and sustained an AIS-1 lower extremity skin abrasion in a 15 km/h delta-v frontal crash with an embankment after striking a deer with his vehicle.

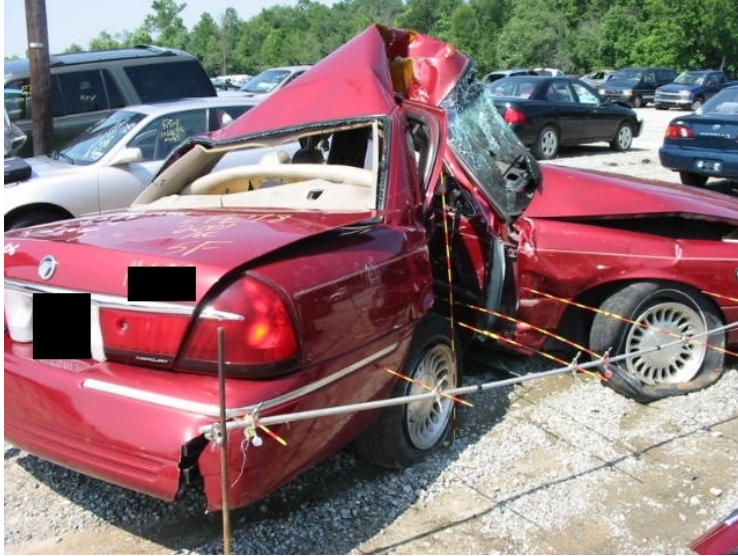
**Figure 35: Case No. 2006-43-094 Subject Vehicle Damage**

In the 4 cases where the drivers were the fatalities, 2 involved alcohol. In Case No. 2006-43-094, a 2001 Mercury Grand Marquis was equipped with hand controls, where the 39-year-old male driver was unrestrained and had a BAC of .32 g/dL. The front and left side of the Mercury contacted the right side of another vehicle, departed the roadway where the right side contacted a utility pole. The reported travel speed at the time of the crash was 105 mph where the posted speed limit for the roadway was 45 mph. The driver sustained fatal injuries from the intrusion (Figure 35).

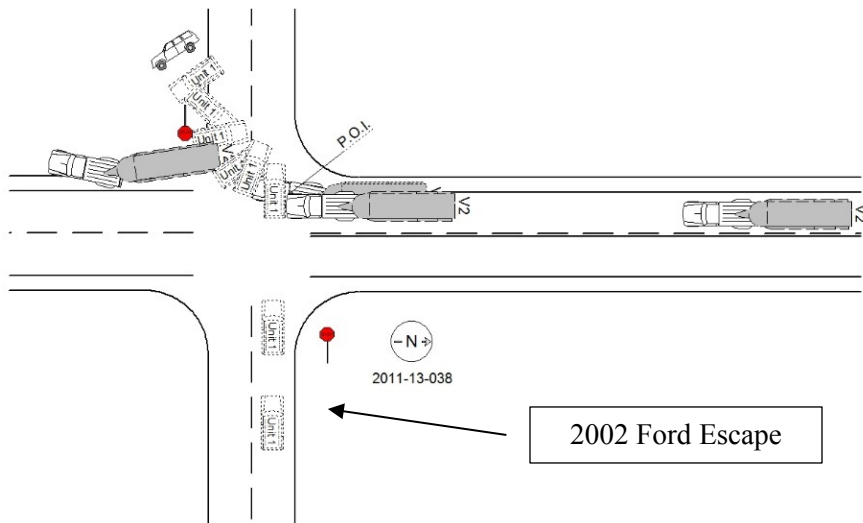
**Figure 36: Case No. 2011-13-038 Scene Diagram**

The other case involving alcohol use by the driver was Case No. 2011-13-038. An unrestrained 67-year-old female driver of a 2002 Ford Escape was coded as having alcohol present without specifying the BAC. The Ford was going west, and another vehicle was going south on an intersecting roadway (Figure 36). The front of the other vehicle struck the right side of the Ford, resulting in the vehicle rolling over. The driver of the Ford was ejected, sustaining fatal injuries from contact with the ground.

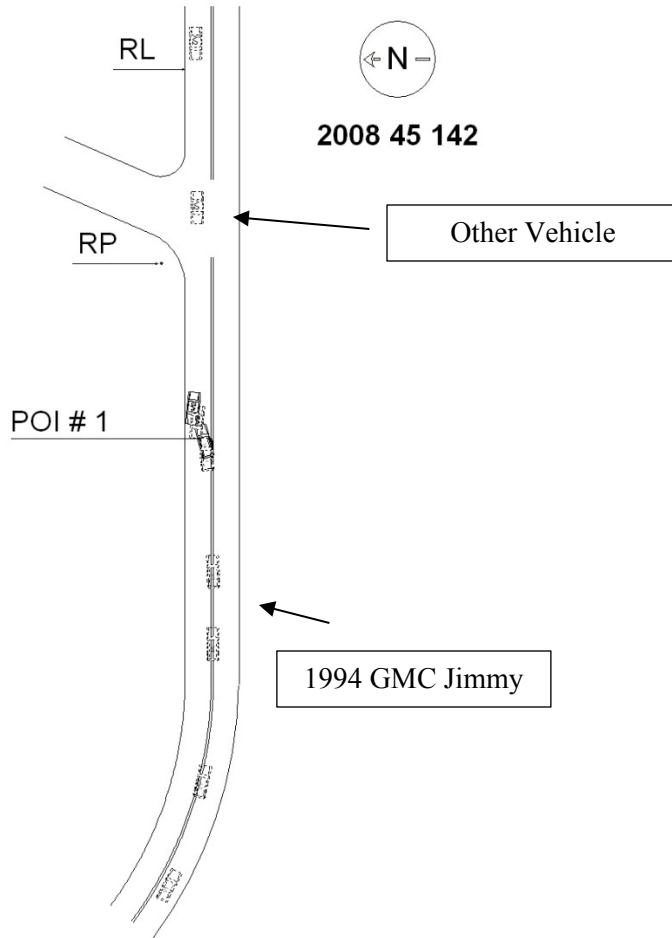
**Figure 41: Case No. 2008-45-142 Scene Diagram**

Case No. 2008-45-142 involved a 1994 GMC Jimmy driven by an unrestrained 77-year-old male. The GMC was equipped with a steering knob (Figure 40). The GMC was eastbound on a two-lane road under dry/daylight conditions. Another vehicle was westbound on the same roadway directly in front of the GMC moving in the opposite direction. As the GMC exited a left curve (Figure 41), it crossed over the center line and struck the front of the other vehicle.

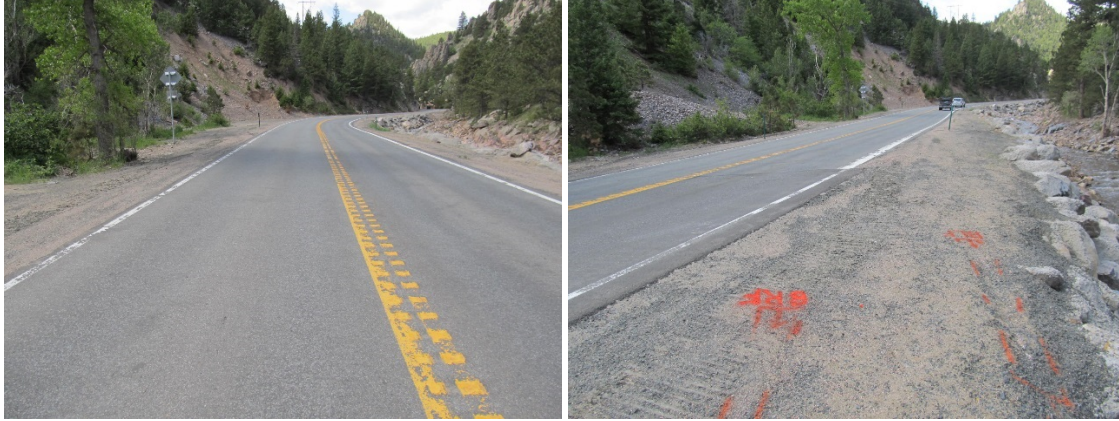
**Figure 42: Case No. 2014-75-041 Scene Photos**

Case No. 2014-75-041 involved a 2013 Subaru Forester equipped with a steering knob. The Subaru was eastbound on a mountain road, traveled into the westbound lane and then departed the road to the left. The undercarriage of the vehicle struck a boulder, then traveled over the edge of an embankment, became airborne, went over a creek, and struck an embankment on the far side of the creek. The Subaru then rolled over onto the top plane and came to rest in the creek (Figure 42). The injuries coded to the 74-year-old restrained male driver were drowning, with cardiac arrest documented by medical personnel. The pre-crash movement was coded as negotiating a curve. It was unknown if the driver was distracted.

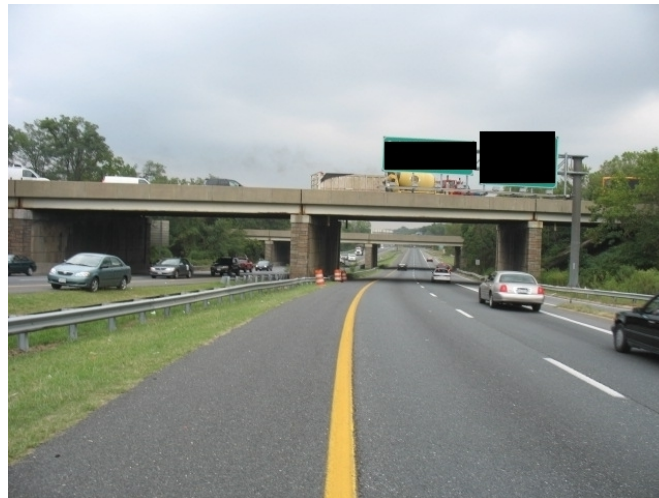
**Figure 43: Case No. 2008-09-108 Scene Photos of Approach**

There were two cases where occupants sustained fatal injuries in adaptive vehicles. In Case No. 2008-09-108, a 2000 Lincoln Town Car was equipped with hand controls. The Lincoln was traveling east when it departed the roadway to the left and contacted a metal guardrail with its front (Figure 43). The vehicle then climbed the guardrail, rotated counterclockwise, and struck a concrete/stone overpass support with its right side. The Lincoln then came down on the guardrail with its undercarriage before coming to rest in the roadway, where it was subsequently struck by a second vehicle (Figure 44).

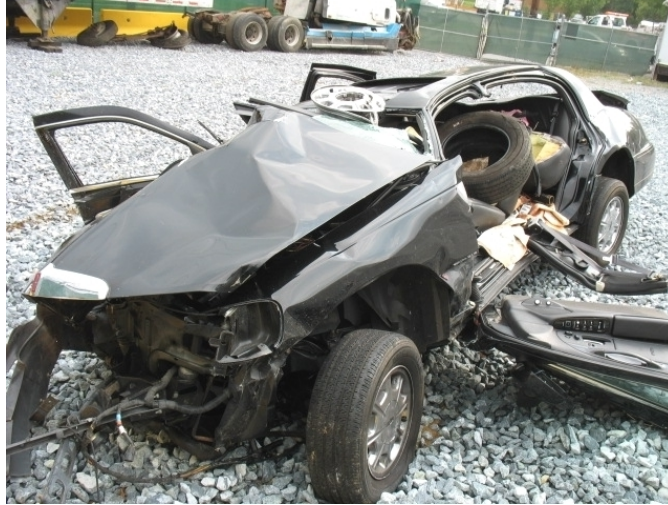
**Figure 44: Case No. 2008-09-108 Subject Vehicle Damage**

The posted speed limit at the location of the crash was 55 mph. It was dark and raining when the crash occurred. The pre-crash movement was coded as negotiating a curve. It was unknown if the driver attempted an avoidance maneuver or was distracted prior to the crash. There were no injuries coded to the 32-year-old male driver. However, the 15-year-old female front seat passenger sustained unspecified fatal injuries.

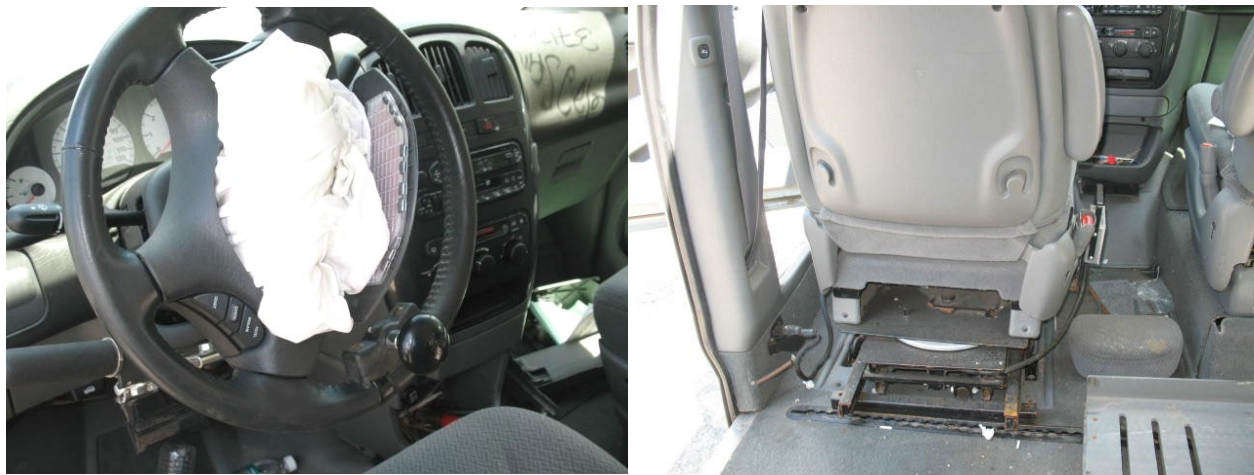
**Figure 45: Case No. 2009-11-131 Hand Controls, Steering Knob, and Modified Seat Base**

Case No. 2009-11-131 involved a 2006 Dodge Caravan altered to accommodate a wheelchair-seated occupant and modified for a steering knob, hand controls, and driver's seat that appears to rotate allowing the driver to transfer from a wheelchair (Figure 45).

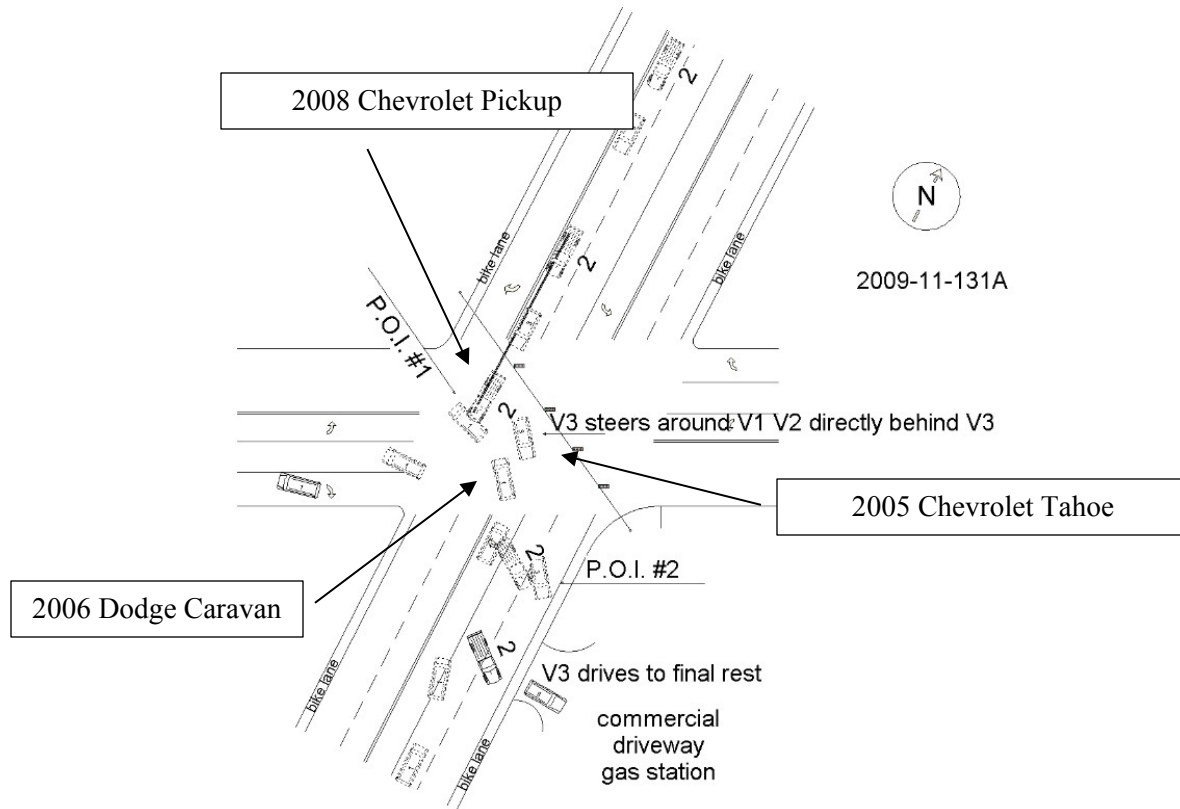
**Figure 46: Case No. 2009-11-131 Scene Diagram**

The Dodge was traveling northbound in lane three turning left at the intersection to travel westbound. A 2005 Chevrolet Tahoe was traveling southbound in lane two, approaching the intersection. A 2008 Chevrolet pickup truck was traveling southbound in lane two behind the Tahoe. The Tahoe steered around the Dodge turning left, and the front of the pickup truck contacted the right side of the Dodge in the intersection (Figure 46).

Finally, there were 2 fatal crashes that occurred at intersections. The vehicles in Case Nos. 2009-11-131 (Figure 46) and 2015-49-053, a 2006 Dodge Caravan and a 2009 Chevrolet HHR, respectively, were modified and equipped with steering knobs and hand controls. In the case involving the Dodge, the vehicle was turning left and was struck by another vehicle on the right side, resulting in fatal injuries of the right rear-most occupant. As discussed previously, it could not be determined if the occupant was in a wheelchair or seated in the third row. In the case of the Chevrolet, the vehicle struck another vehicle in the side, killing the driver. In both crashes, there was no conclusive indication that the use of the operational adaptive equipment caused the crashes. It appears the driver of the Dodge did not survey the roadway adequately or misjudged the distance and speed of the encroaching vehicle that led to the crash. Furthermore, it is not known if the driver of the vehicle was using the adaptive controls. As for Case No 2015-49-053, one of the involved vehicles drove through a controlled intersection. Either one of the drivers involved could be at fault. From the case, there was no information whether either driver attempted an avoidance maneuver. Again, there was no indication from the data that the use of the adaptive controls was the cause of or contributed to the crash.

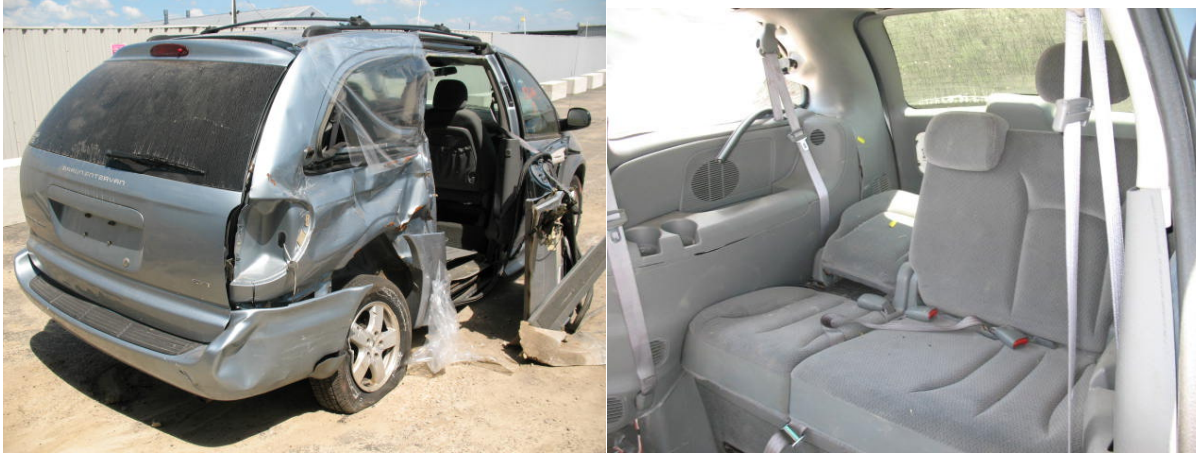
**Figure 47: Case No. 2009-11-131 Subject Vehicle Damage and Third Row Seat**

The 62-year-old female driver of the Dodge sustained an AIS-3 humerus fracture. An unrestrained 62-year-old male seated in the rear (Figure 47) sustained numerous injuries with MAIS-5 rib cage flail chest injuries that were fatal. From the case, it is unclear if the occupant was seated in the third row as the second row was removed for wheelchair accessibility, or it was possible the passenger may have been in a wheelchair that was not tied down and the occupant unrestrained. Based upon contact marks and the seat back damage to the right side third row seat, the occupant may have been seated in that position. Furthermore, given the non-operational adaptive equipment added to the vehicle and the modifications made to the driver's seat, it was also possible, that a wheelchair-seated person transferred to the driver's position, and the rear wheelchair seating location was unoccupied. The evidence and data in the case file were inconclusive.

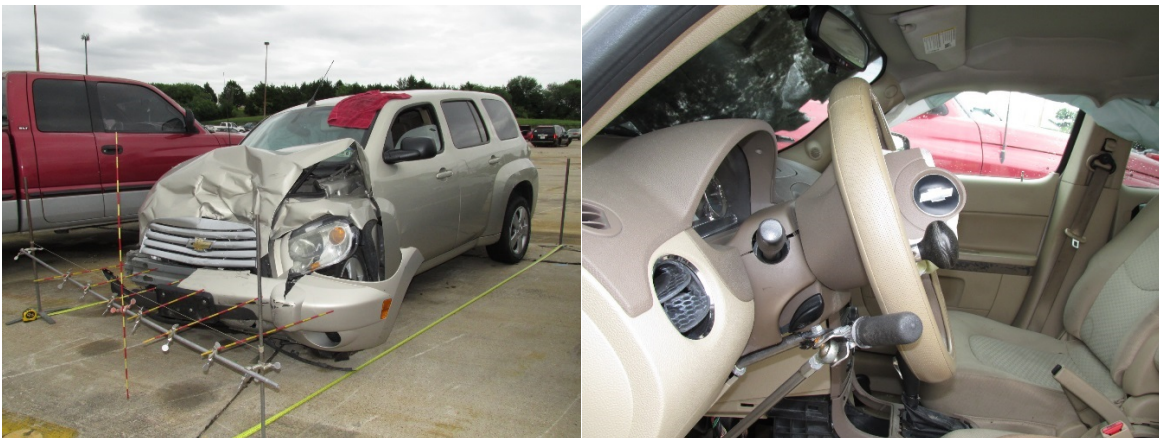
**Figure 48: Case No. 2015-49-053 Chevrolet HHR Damage and Adaptive Equipment**

Case No. 2015-49-053 involved a 2009 Chevrolet HHR adapted with both a steering knob and hand controls (Figure 48). The vehicle was being driven by a restrained 41-year-old female. The Chevrolet was southbound, approaching an intersection. A 2013 Hyundai Elantra was eastbound, approaching the same intersection. In the intersection, the front of the Chevrolet struck the left side of Hyundai. The Hyundai struck another vehicle, departed the roadway, and its front struck a wooden pole.

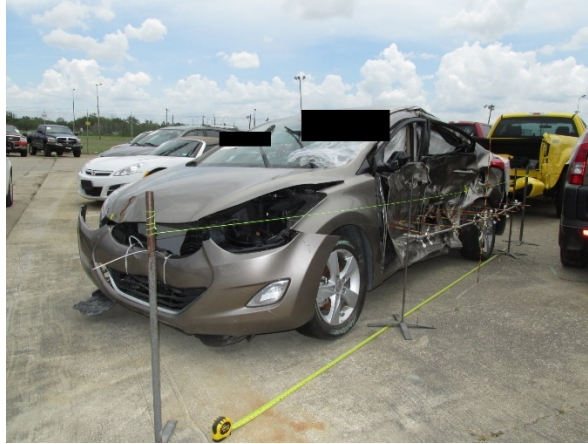
**Figure 49: Case No. 2015-49-053 Hyundai Elantra Damage**

The pre-crash movement for both the Chevrolet and Hyundai were coded as going straight. The avoidance maneuver and distraction were both coded as unknown. The driver of the Chevrolet did not have any coded injuries. However, the 76-year-old female driver of the Hyundai sustained fatal injuries from the intrusion (Figure 49). The total delta-v for the Hyundai was 36 km/h.

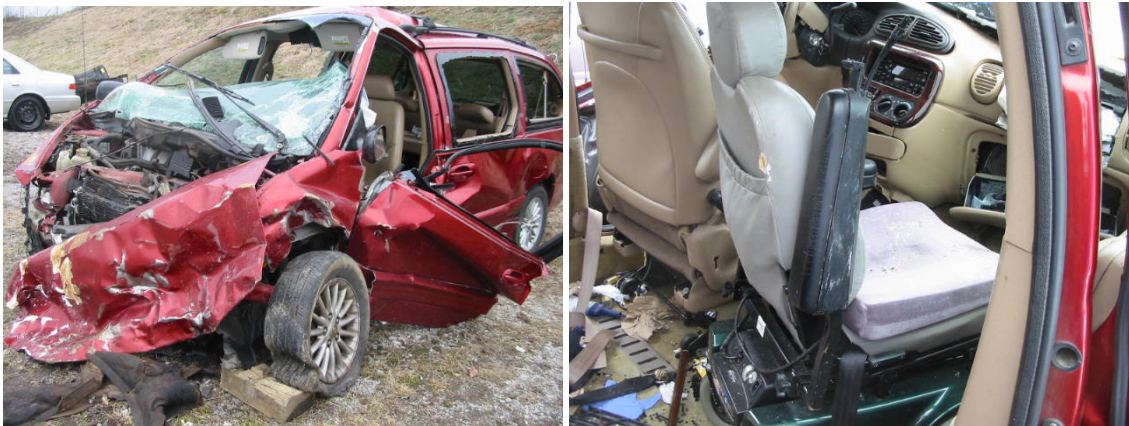
**Figure 50: Case No. 2009-45-021 Chrysler Town & Country Damage**

Case No. 2009-45-021 was a two-vehicle crash where a passenger in each vehicle sustained fatal injuries. A 2000 Chrysler Town & Country was altered to accommodate a wheelchair-seated front passenger (Figure 50). The Chrysler was traveling south and a 2003 Ford Ranger north on a two-lane rural roadway. While negotiating a curve, the two vehicles struck head-on (Figure 51). The total delta-v for the Chrysler was 62 km/h and 84 km/h for the Ford.

It should be noted: it appears the Chrysler was not equipped with hand controls or any other operational adaptive equipment. From the scene diagram, it appears the 63-year-old male driver of the Chrysler drifted out of his lane into oncoming traffic. The restrained 61-year-old female front passenger seated in a wheelchair sustained fatal injuries in the crash. It should be noted the front passenger sustained numerous AIS-1 and AIS-2 injuries, which were fatal. The unrestrained driver sustained multiple nonfatal serious injuries including MAIS-5 chest injuries.

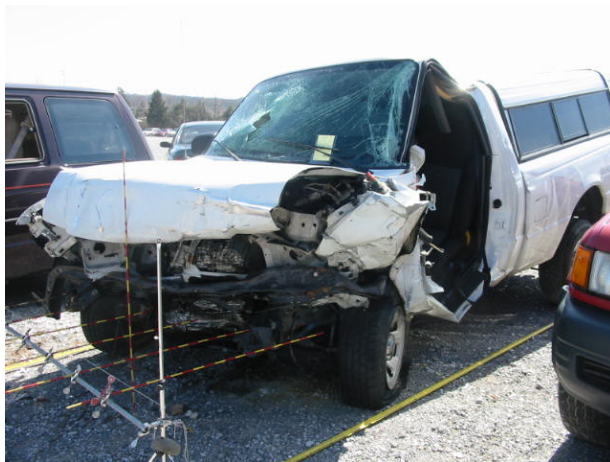
**Figure 52: Case No. 2009-45-021 Ford Ranger Damage**

The 59-year-old male driver of the Ford sustained multiple minor to moderate nonfatal injuries with an MAIS-3 tibia fracture. The 58-year-old female front seat passenger sustained fatal injuries (Figure 52).

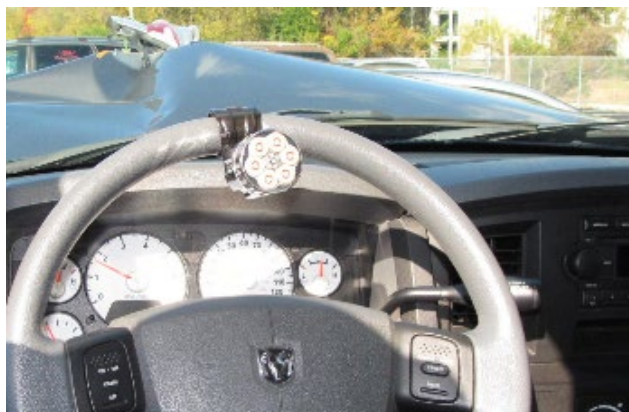
**Figure 53: Case No. 2012-48-162 “Novelty” Steering Knob**

One of the limitations with this study is not knowing the extent of the driver's disabilities or if the adaptive equipment was in use at the time of the crash or if the driver was disabled. This is especially true for those cases of vehicles equipped only with steering knobs. For example, in Case No. 2012-48-162 a 2008 Dodge Ram driven by a 19-year-old male was equipped with a steering knob. The subject vehicle struck the rear of another vehicle. The pre-crash movement of the vehicle was coded as going straight. Figure 53, is a photo of the steering knob installed on the vehicle at the time of the inspection. Again, because of limitations with the data, whether the steering knob was being used at the time of the crash is unknown. Moreover, it is unknown if there was a legitimate need for the knob to accommodate a disability.

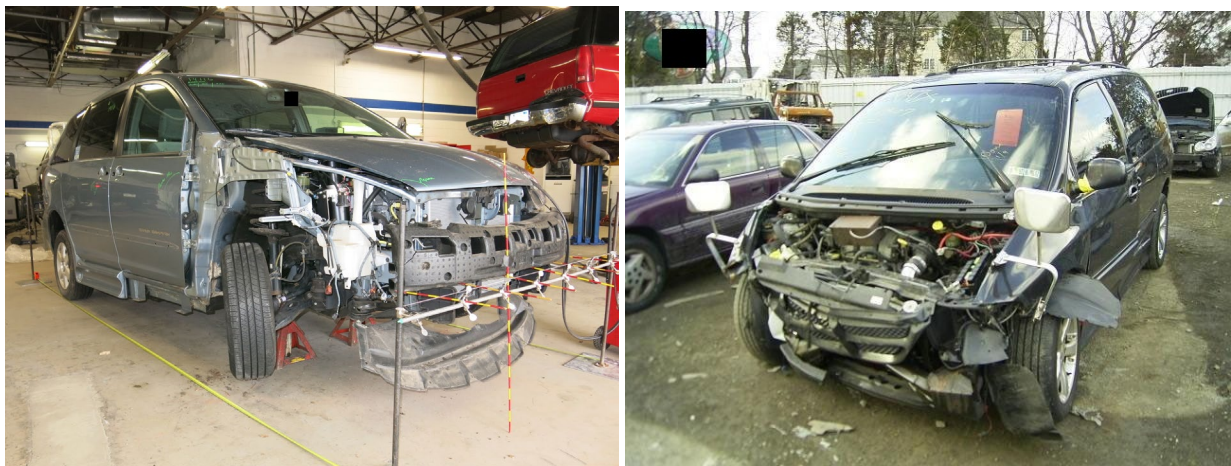
**Figure 54: Damage Case Nos. 2014-05-035 and 2007-05-002**

From a review of the case files, in all the frontal crashes the vehicles performed as expected given the severity. There were 2 cases where the driver side air bags were removed to accommodate modified steering wheels (Case Nos. 2014-05-035 and 2007-05-002). In a low-severity 12 km/h delta-v crash, the passenger side air bag did not deploy (Case No. 2014-05-035), and, in a moderate severity impact with a total delta-v of 19 km/h, the passenger's side air bag deployed (Case No. 2007-05-002, Figure 54). The non-deployment or deployment of air bags were consistent with the level of severity of the crashes. As discussed earlier, only in Case No 2007-05-002 were the injuries sourced to the replacement steering wheel, and the occupant likely would have benefited from the air bag. However, based upon the type of disability the driver likely had, maintaining the air bag was probably not an option when decisions were made to modify the vehicle and remove the air bag.

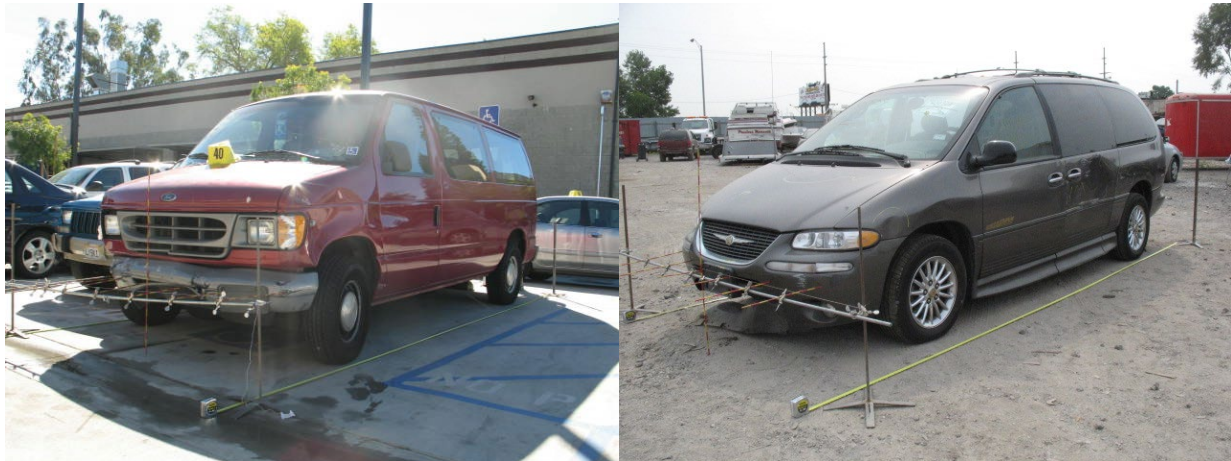
**Figure 55: Frontal Damage Case Nos. 2008-79-016 and 2008-72-083**

In the remaining crashes,<sup>44</sup> there were only 3 where frontal air bags did not deploy.<sup>45</sup> However, upon inspection of the frontal damage and the severity of the crash, it can reasonably be assumed crash severity did not warrant the deployment of air bags. Figure 55 shows the damage to subject vehicles in which both were involved in 12 km/h delta-v crashes (Case Nos 2008-79-016 and 2008-72-083). The air bags did not deploy and both cases were consistent with Case No 2014-05-035 where the frontal air bags did not deploy. Overall, there was no indication occupants were not provided the proper protection from the original equipment air bags unless systems were deactivated or removed for aspecific occupant positions to accommodate disability.

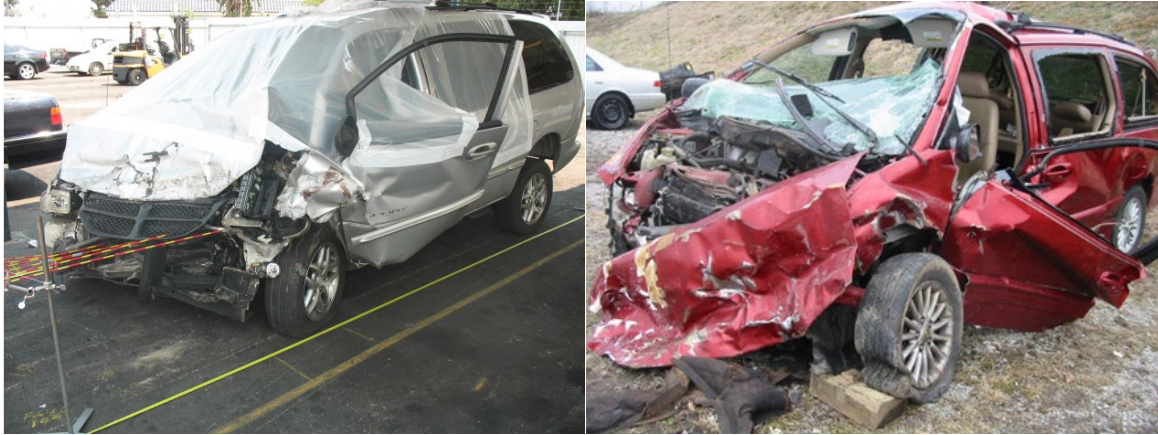
**Figure 56: Case Nos. 2007-79-127 and 2009-45-021 and 51 and 62 km/h Delta-V Frontal Impact Respectively**

There were no frontal crash cases identified where it was assessed that extensive modifications made to vehicle structure, such as lowering the floor, were an issue. Upon inspection of crash photos, it appeared in all cases, the vehicles' crush characteristics were consistent with that of the original equipment vehicles. This was concluded by comparing post-crash photos of the altered vehicle with the original equipment vehicle in a similar crash type and severity. As shown in Figure 56, even though the crash severity in the altered vehicle was more than 10 km/h greater than the reference vehicle (Case Nos. 2007-79-127), the damage was consistent. In the reference vehicle, the driver sustained severe injuries. The vehicle was also compared to crash test data to identify anomalies (Figure 47).

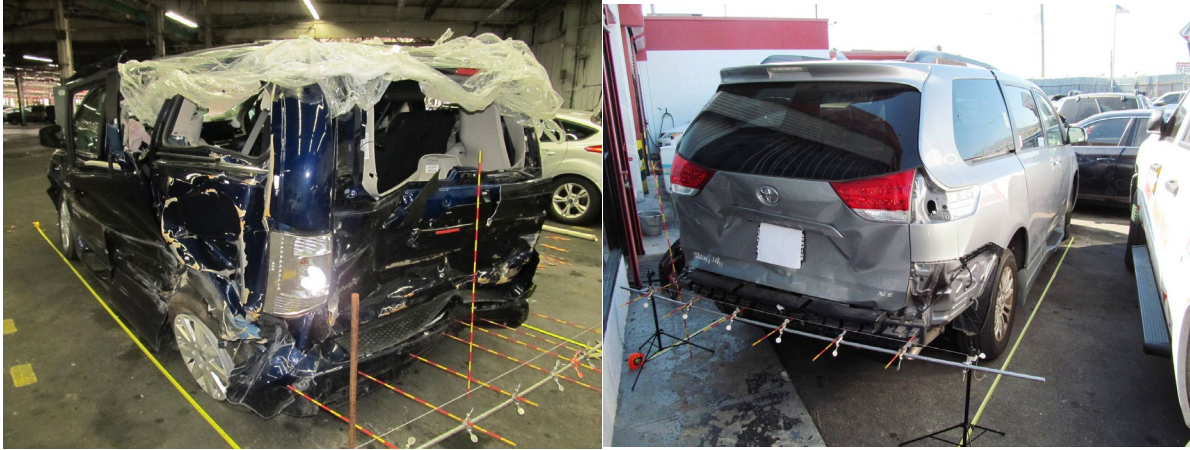
**Figure 58: Rear Damage Case Nos. 2014-81-33 and 2013-03-089**

There were 2 crashes where the altered and modified vehicles were in rear impacts (Case Nos. 2014-81-33 and 2013-03-089). The 2014 Chrysler Town & Country in Case No. 2014-81-33 was involved in a 34 km/h delta-v rear impact and the 2012 Toyota Sienna in Case No. 2013-03-089 was involved in a less severe 10 km/h impact (Figure 58). Both crashes were not severe and did not result in post-crash fires or any other observed concern with the structures.

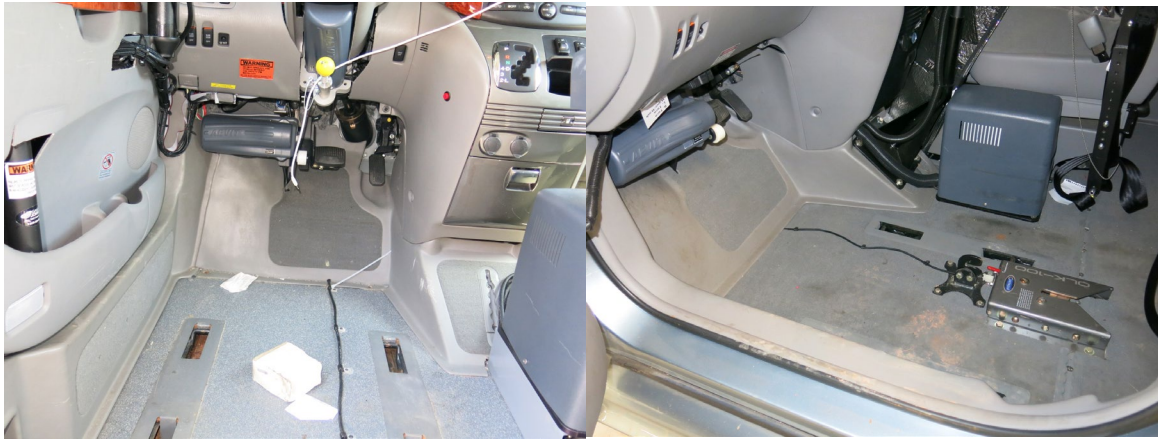
**Figure 59: Docking-Securement Device Case Nos. 2014-05-040 and 2014-05-035**

After review of the case data, it appears the driver's seating position was modified and equipped with a docking-securement device that would secure the wheelchair to the vehicle in 6 cases. In two cases (Case Nos. 2014-05-040 and 2007-05-002), the docking-securement device was not shown as it may have been removed from the vehicle prior to the inspection by the investigator. Figures 59 - 61 show the driver's seating position and, when available, the docking-securement device. In all these cases, there was no evidence of any buckling of the floor where the device was attached, and, when photos of the docking-securement device were available to review, there did not appear to be any deformation or damage to the securement device resulting from the crash. One limitation of this analysis is there was no information or photos available for the wheelchair and the attachment mechanism to the docking-securement device. Even though the securement devices in this analysis appear undamaged, the wheelchair may have experienced deformation, which cannot be accounted for, during the event.

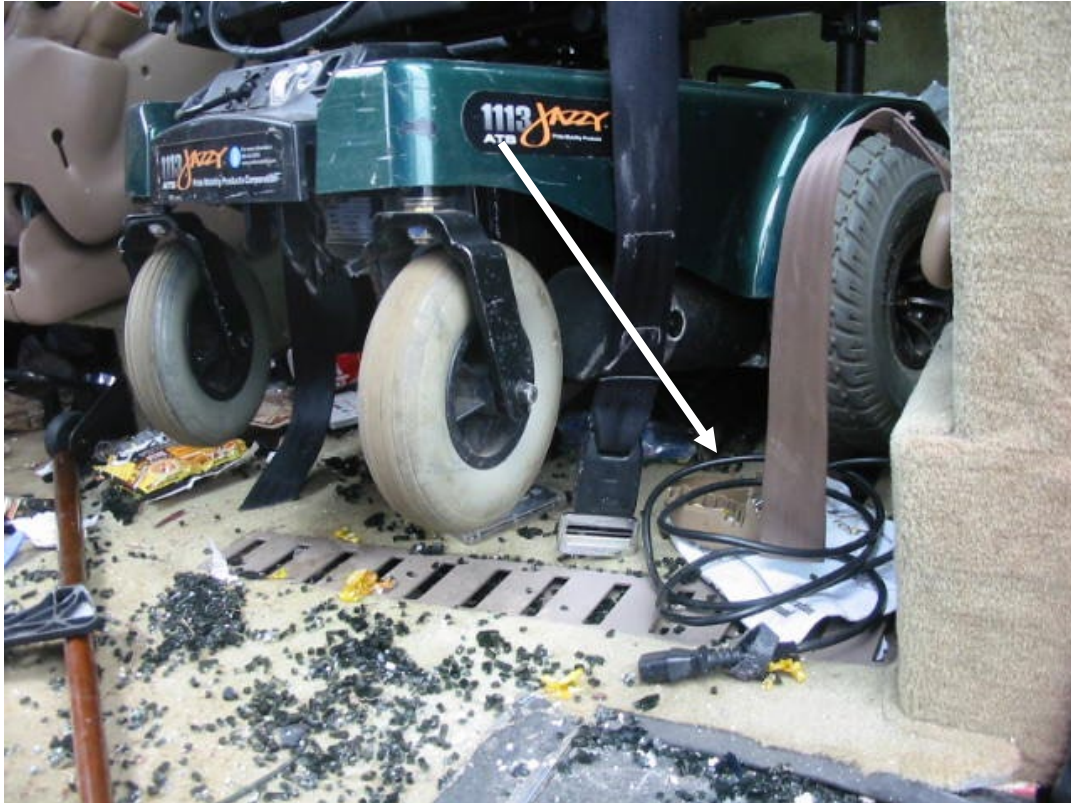
**Figure 62: Docking-Securement Device Case No. 2009-45-021**

In Case No. 2009-45-021, the front passenger seat was modified to accommodate a wheelchair-seated driver. It appears from Figure 62 the wheelchair was secured with a docking-securement device similar to the examples presented for the driver's position. The subject vehicle in this case was involved in a severe 62 km/h delta-v frontal impact. This crash exceeded the crash test severity specified in FMVSS No. 208, which was conducted at 48 km/h, at the time the vehicle was manufactured.<sup>47</sup> In addition, the crash severity exceeded the industry standard test condition specified in ANSI/RESNA WC-4: Section 19 (WC19), for wheelchairs used as seats in vehicles. This standard requires wheelchairs to be successfully tested in a 48-km/h frontal sled test using a 4-point strap-type tie-down system to secure the occupied wheelchair. For docking-securement devices the industry standard ANSI/RESNA WC-4: Section 18 (WC18), *Wheelchair Tiedown and Occupant Restraint Systems for Use in Motor Vehicles* specifies a similar test condition.<sup>48</sup>

From Figure 62, the post-crash photo appears to show, the wheelchair and docking-securement device remain attached to the floor of the vehicle. There appears to be some deformation of the wheelchair base or securement device as the rear wheels of the chair are not sitting on the floor of the vehicle. However, severity of the crash is estimated to have exceeded the vehicle and wheelchair standards; there does not appear to be any obvious concerns with the performance of the wheelchair and docking-securement device in the crash. It should be noted whether the wheelchair was designed for use in a motor vehicle or if it was certified to industry requirements is unknown. However, there is a statement in the owner's manual<sup>49</sup> for a similar model (Pride Mobility 1113 Jazzy) indicating the wheelchair should not be used to transport an occupant in a motor vehicle. The following statement is from the owner's manual: "Pride recommends that you do not remain seated in your power chair while traveling in a motor

As discussed earlier, the occupant sustained fatal injuries in this severe crash. It is possible that, the wheelchair if not designed to industry standards or not intended by the manufacturer to be used while the vehicle is in motion, may have contributed to some excess excursion creating higher risk for injuries. However, the crash severity did exceed Federal requirements, and overall, the docking-securement device did appear to be secured to the wheelchair and vehicle from the available information.
