**National Highway  
Traffic Safety  
Administration**

DOT HS 812 752

June 2019

# **Analysis of Real-World Crashes Where Involved Vehicles Were Equipped With Adaptive Equipment**

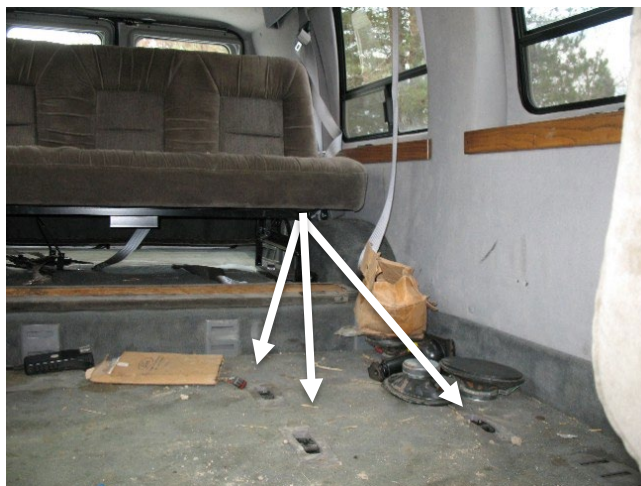
**Figure 63: Four-Point, Strap-Type Tie-Down Case No. 2007-11-197**

Last, the sole case where there was a wheelchair-seated occupant seated in the second row (Case No. 2007-11-197) was secured with a four-point, strap-type tie-down system as shown in Figure 63. From the available information, it appeared the wheelchair and securement system held in the crash. Also, it should be noted whether the wheelchair was tested and certified to industry standards is unknown.
