# **Special Crash Investigations On-Site Ambulance Crash Investigation**

**Vehicle: 2004 Ford**

**E-350 Type III Ambulance**

**Crash Date: April 2016**

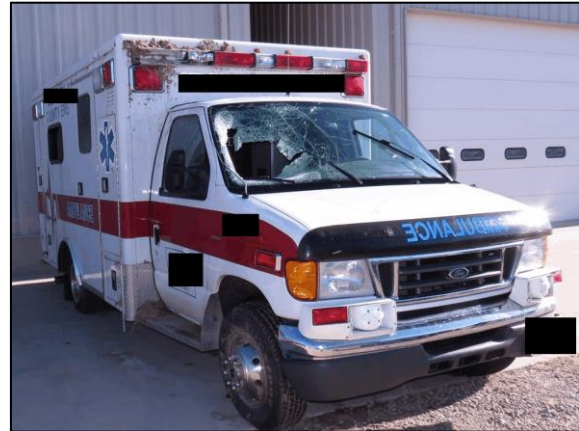
**Figure 1.** 2004 Ford E-350 Type III Ambulance.

This report documents the on-site investigation of the rollover crash of a 2004 Ford E-350 Type III van-based ambulance and the injury sources to the patient and two crew members occupying the vehicle (**Figure 1**). The National Highway Traffic Safety Administration's Office of Emergency Medical Services (EMS) and Dynamic Science, Inc., concurrently notified NHTSA's Special Crash Investigations (SCI) group of the crash in April 2016. Permission to inspect the vehicle was obtained in April 2016 and the case was assigned on the same day. The Ford was inspected in May 2016. The vehicle was under a police evidentiary hold and two State patrol officers were present during the inspection.

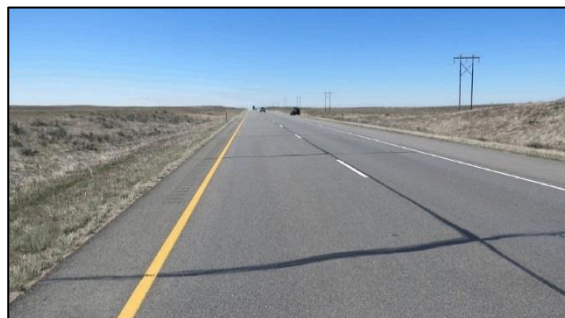
**Figure 2.** Crash site looking west.

The crash site was in the westbound lanes of a two-lane, divided, east/west interstate highway (**Figure 2**). The asphalt roadway was straight with a positive slope of 1 percent. The roadway was bordered on the right by a solid white painted fog line, a rumble strip, and an asphalt shoulder. It was bordered on the left by a solid yellow painted stripe, a rumble strip, an asphalt shoulder, and a 28.8 m (93.5 ft) wide grass-covered, depressed median. The median had a descending slope of 10 percent from north to south that leveled out at approximately 10.7 m (35.1 ft) south of the roadway. The posted speed limit was 121 km/h (75 mph). It was dark with no streetlights present and the police reported that it was snowing at the time of the crash with near white-out conditions. The roadway was slush-covered. The weather at the nearest reporting station was -6 °C (21 °F), 98 percent humidity, 2.4 km (1.5 miles) visibility, and the winds were out of the north northwest at 18.5 km/h (11.5 mph). A crash diagram is included at the end of this report.

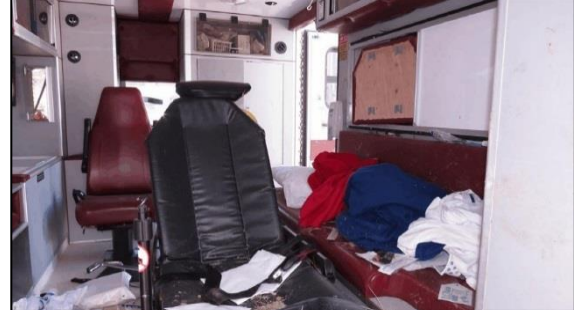
**Figure 6.** Patient compartment, 2004 Ford E-350 ambulance.

In the patient compartment module was seating for up to three crew members as well as the patient (**Figure 6**). This included a rearward-facing high-back attendant seat at the forward plane, a two-passenger squad bench seat on the right plane, and a centrally located single-occupant cot. The attendant seat was equipped with adjustable arm rests and a lap belt. It was configured with a lap belt. The squad bench was configured with lap belts.

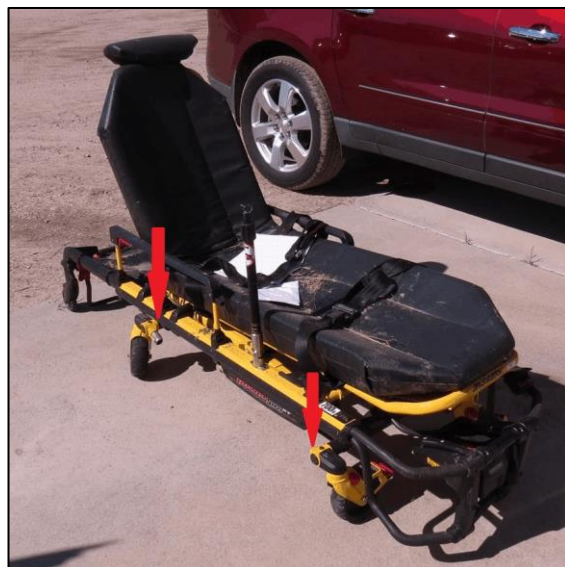
**Figure 10.** Rugged POWER-PRO XT Ambulance Cot.

During the crash, the lower left attachment arm of the patient cot fractured at both ends and the cot separated from the floor fastener. The cot and patient were displaced from their anchored position and, during the rollover, moved freely in the patient compartment. This topic is discussed further in the Patient Cot and Occupant Kinematics sections of this report.

The patient cot was a Rugged POWER-PRO XT ambulance cot that was manufactured by Stryker (**Figure 10**). The X-frame supporting the mattress platform featured power height adjustment capabilities and the mattress platform featured 0-73 degrees of backrest articulation. Its length was 203 cm (80 in) and the width was 58 cm (23 in). The cot (minus mattress and restraints with one battery on board) weighed 57 kg (125 lbs) and had a maximum weight capacity of 318 kg (700 lbs). The cot was equipped with three lateral cot restraints manufactured by Ferno. The cot was secured in place in the passenger compartment using a Stryker antler design floor-mount cot fastener system. The system consisted of a forward antler bracket and rearward locking-clamp mechanism. The antler bracket cradled the forward portion (location of the patient's head area) of the cot's frame, while the vertically-oriented locking

mechanism clamped around a pin protruding from the cot's lower frame rail. During this crash, the lower frame rail fractured at both ends (**Figures 11–13**) and the cot and patient were displaced to the right and toward the roof (probably during the first one- quarter roll). The lower frame rail/pin remained clamped to the cot fastener system (**Figure 14**).

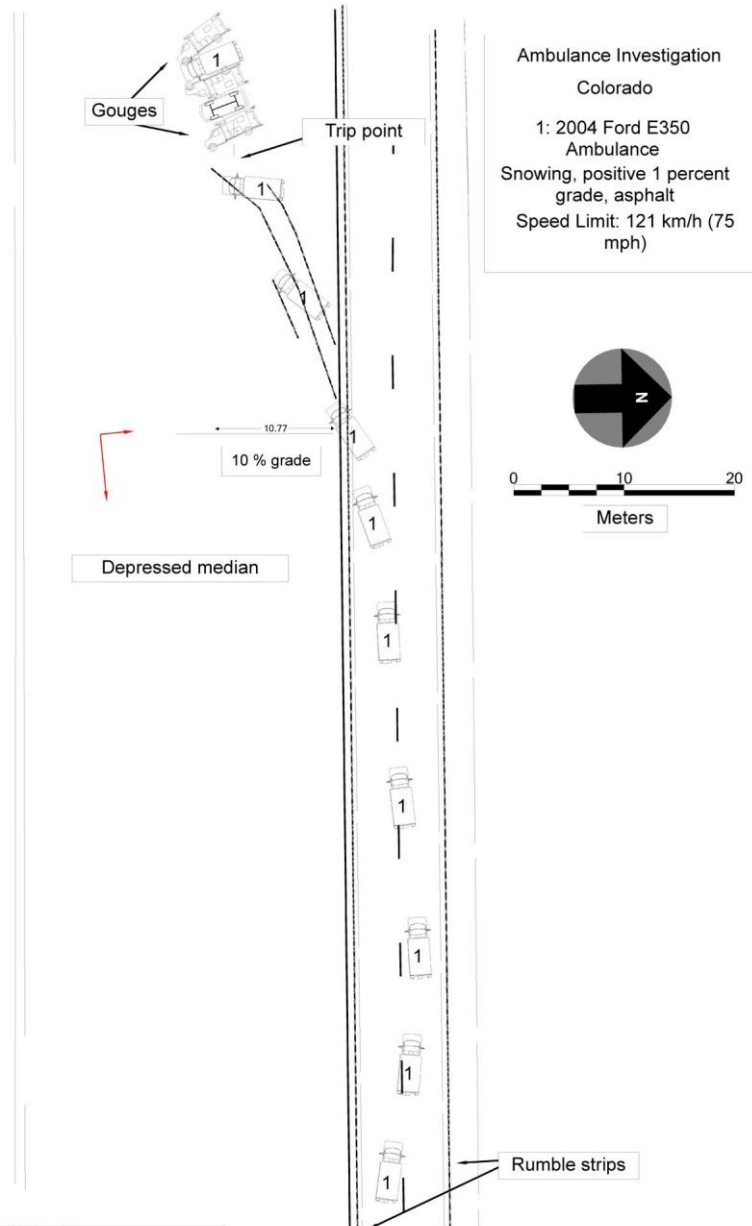
# CRASH DIAGRAM

The Ford began a counterclockwise rotation while traveling down the descending median. The right side tires engaged the ground with sufficient opposing lateral force to cause a right side leading trip rollover. The trip point was documented in the median at approximately 25.0 m (82.0 ft) southwest of the area of departure. Initially, the Ford rolled one quarter turn and the right side roof rail of the ambulance body struck the ground (**Figure 4**). The distance from trip point to the roof rail impact was 3.0 m (9.8 ft). The vehicle continued to roll four more quarter-turns along its longitudinal axis while traveling approximately 9.1 m (30.0 ft). The total rollover distance measured 12.1 m (39.8 ft). It came to rest on its right side in the center of the median facing generally south (**Figure 5**).
