DOT HS 812 856

Special Crash Investigations Child Restraint System Crash Investigation Vehicle: 2010 Dodge Avenger Location: Missouri Crash Date: August 2018

Special Crash Investigations
Child Restraint System Crash Investigation
Case Number: DS18022
Vehicle: 2010 Dodge Avenger
Location: Missouri
Crash Date: August 2018

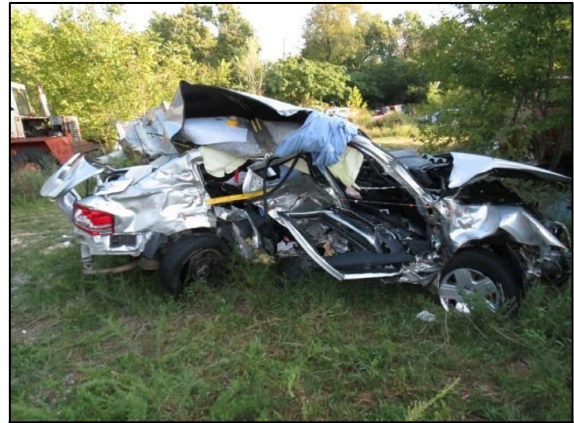
Figure 1. 2010 Dodge Avenger.

This report documents the on-site investigation of a child restraint system (CRS) used by the juvenile occupant of a 2010 Dodge Avenger involved in a crash with a 2017 Ford Flex and the disparate injuries sustained by the occupants of the Dodge (**Figure 1**). A 3-year-old male occupant was restrained in a CRS and was transported to a local hospital with minor injuries. The front row adult occupants were both fatally injured. The investigation will look at what role manual restraint usage played in the occupants' kinematics and injury mitigation, with a focus on the CRS-restrained occupant. This investigation was identified by the Special Crash Investigations

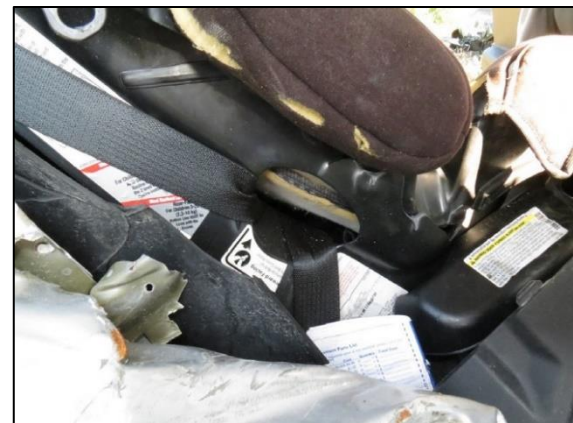
Figure 6. Alpha Omega Elite CRS, installation.

The 3-year-old male was seated in a Safety 1st Alpha Omega Elite CRS (**Figure 5**) identified by the model number CC159-CRML with a manufacture date of 5/22/2015. The convertible CRS was designed to be used in one of three modes: rear-facing, forward-facing, or a belt positioning booster. This CRS was being used in the forward-facing orientation. The CRS was intended to be used for children weighing between 10.1-18 kg (22-40 lbs) and whose age is greater than 1 year. The child met the age and size requirements. The seat was configured with an adjustable 5-point internal harness, 3-position recline, and LATCH. The CRS was intended to be installed using either LATCH or the vehicle's seat belt. In this case, the seat was installed using the vehicle lap and shoulder seat belt (**Figure 6**). The tether was not used. It is unknown if the seat belt locking mode was engaged. The CRS was held tightly in place at the time of the inspection by intruding vehicle components. The seat belt buckle could not be accessed during the inspection. The CRS was removed from the vehicle by the SCI investigator by cutting the seat belt. The internal harness was adjusted to the top slot. The seat sustained damage due to the impact/intrusion. There were 21 cm (8.2 in) long longitudinal and 10 cm (3.9 in) lateral fractures along the right side (**Figure 7**). There was a series of cuts along the right seat pad measuring 16 cm (6.2 in).
