DOT HS 812 866

Special Crash Investigations Alleged Air Bag Fatality Crash Investigation Vehicle: 2009 Lexus ES350 Location: Texas Crash Date: August 2018

Special Crash Investigations
Alleged Air Bag Fatality Crash Investigation
Case Number: DS18029
Vehicle: 2009 Lexus ES350
Location: Texas
Crash Date: August 2018

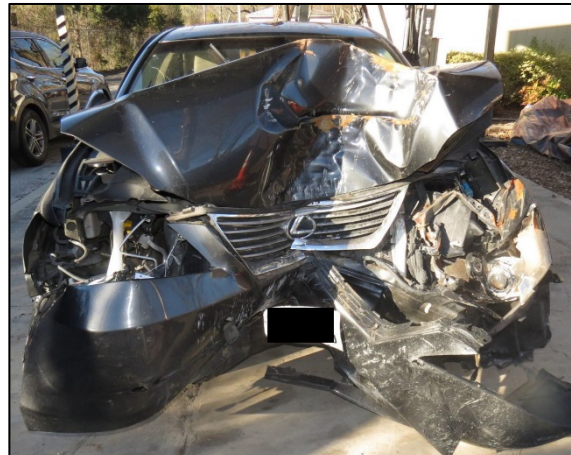
Figure 1. 2009 Lexus ES350.

This report documents the on-site investigation of an alleged air-bag-related fatality of a 9-year-old female in the front right seat of a 2009 Lexus ES350 involved in a single-vehicle crash (**Figure 1**). This case was initiated in response to a notification from National Highway Traffic Safety Administration’s Fatal Analysis Reporting System (FARS). Dynamic Science, Inc. was notified of the crash by the Special Crash Investigations (SCI) group in November 2018 with instructions to attempt to locate the vehicle. The vehicle was located and permission to inspect the vehicle was obtained in December 2018 and the case was assigned on the same day. The investigation was intended to determine occupant restraint usage, kinematics, injury sources, and air bag deployment parameters for the Lexus. The vehicle is equipped with a Certified Advanced 208-Compliant (CAC) frontal air bag system for the front row occupants, seat-mounted side air bags for the front and second row, front row knee bags, and inflatable curtain (IC) air bags for both rows. The Lexus was supported by the Bosch Crash Data Retrieval (CDR) system and the vehicle’s event data recorder (EDR) was imaged during the vehicle inspection. A representative from the driver’s attorney was present during the inspection.

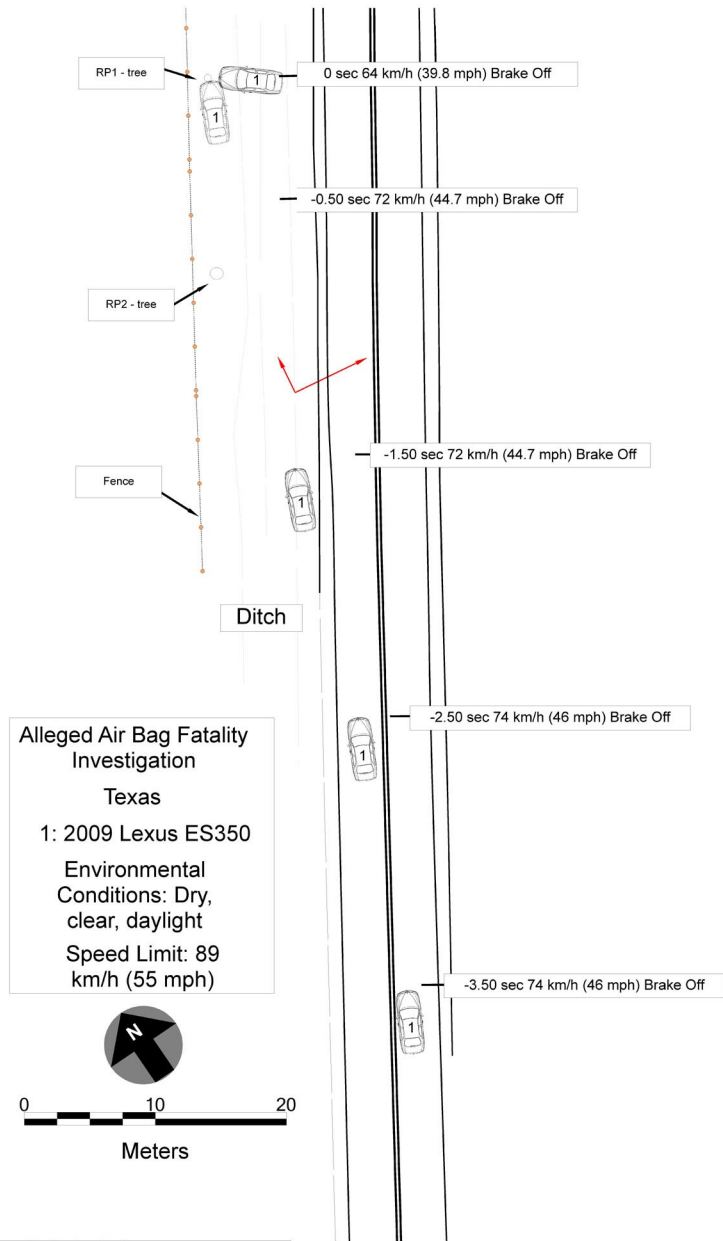
CRASH DIAGRAM

The crash site was a two-lane undivided east/west roadway in rural Texas (**Figure 2**). There were no reported defects to the roadway and visibility was unobstructed. The posted speed limit was 89 km/h (55 mph). The asphalt roadway was straight with a negative grade of 2 percent. Pavement markings on the road include solid white fog lines on both roadway edges, and a continuous double yellow centerline. The roadway was bordered on the left by an asphalt shoulder, a grass/dirt ditch, and a barbed wire fence. A 70 cm (27.5 in) diameter tree was located 8.7 m (28.5 ft) to the north of the roadway edge. The weather at the nearest reporting station was 26 degrees C (79 degrees F), 40 percent humidity, fair skies, and the winds were out of the southeast at 19 km/h (12 mph). A crash diagram is attached at the end of this technical report.

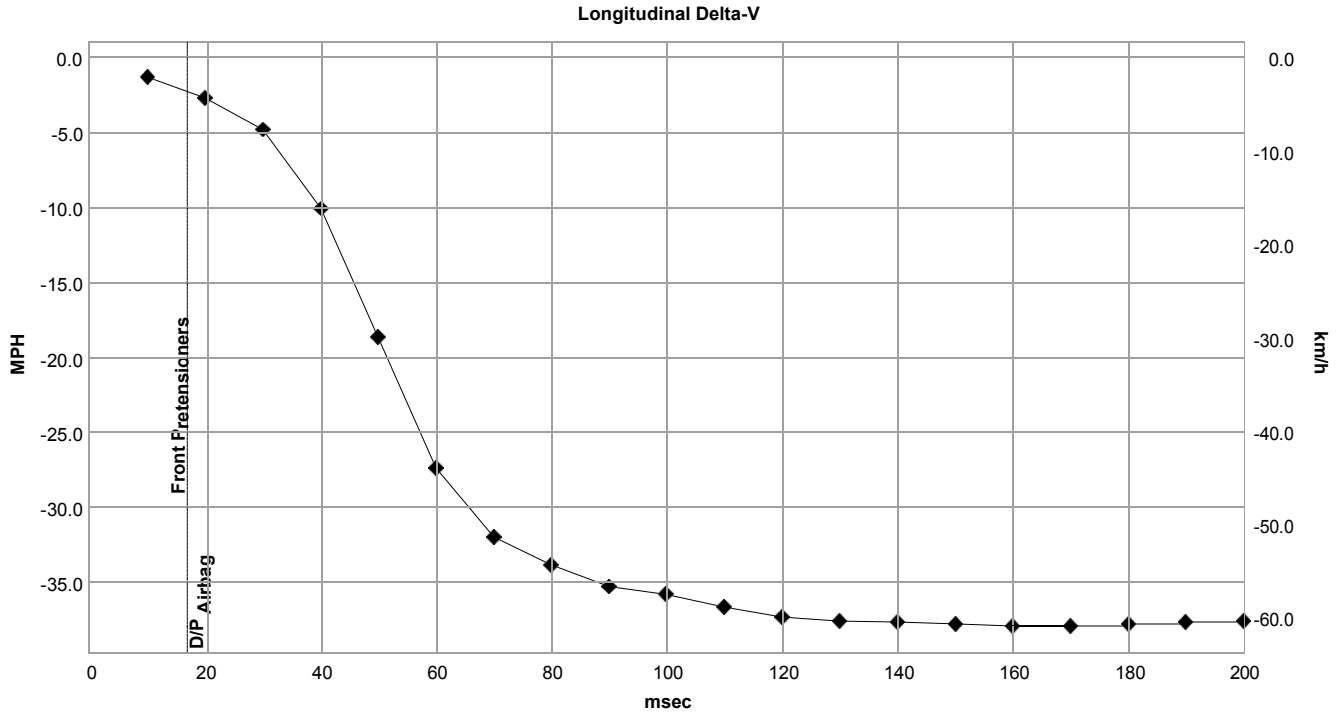
Longitudinal Crash Pulse (1st Prior Event, TRG 18 - table 1 of 2)

Recording Status, Time Series Data	Complete
Max Longitudinal Delta-V (MPH [km/h])	-37.9 [-61.0]

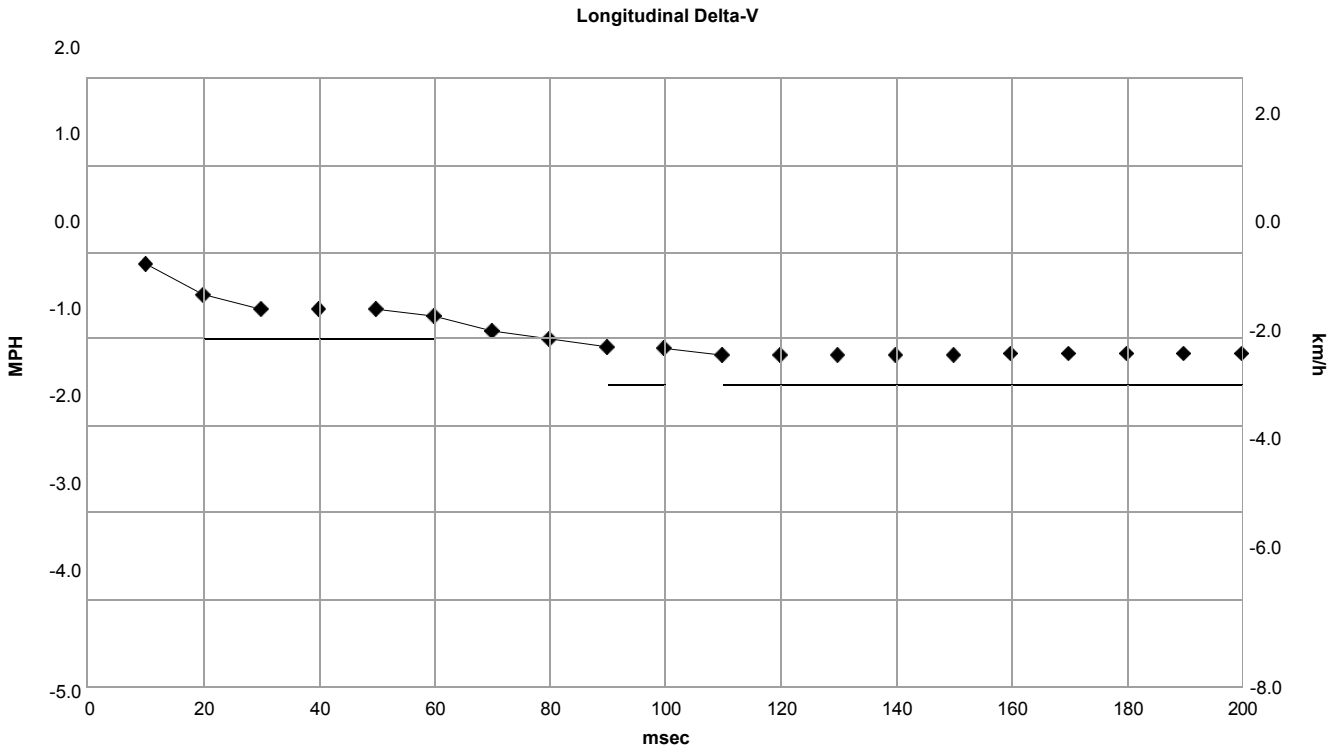
Longitudinal Crash Pulse (2nd Prior Event, TRG 17 - table 1 of 2)

Recording Status, Time Series Data	Complete
Max Longitudinal Delta-V (MPH [km/h])	-1.5 [-2.5]
