DOT HS 812 941

**Special Crash Investigations:  
On-Site Guardrail End Terminal  
Investigation;  
Vehicle: 2005 Nissan Maxima;  
Location: Missouri;  
Crash Date: August 2017**

**Special Crash Investigation  
On-Site Guardrail End Terminal Investigation  
Case Number: IN17026  
Vehicle: 2005 Nissan Maxima  
Location: Missouri  
Crash Date: August 2017**

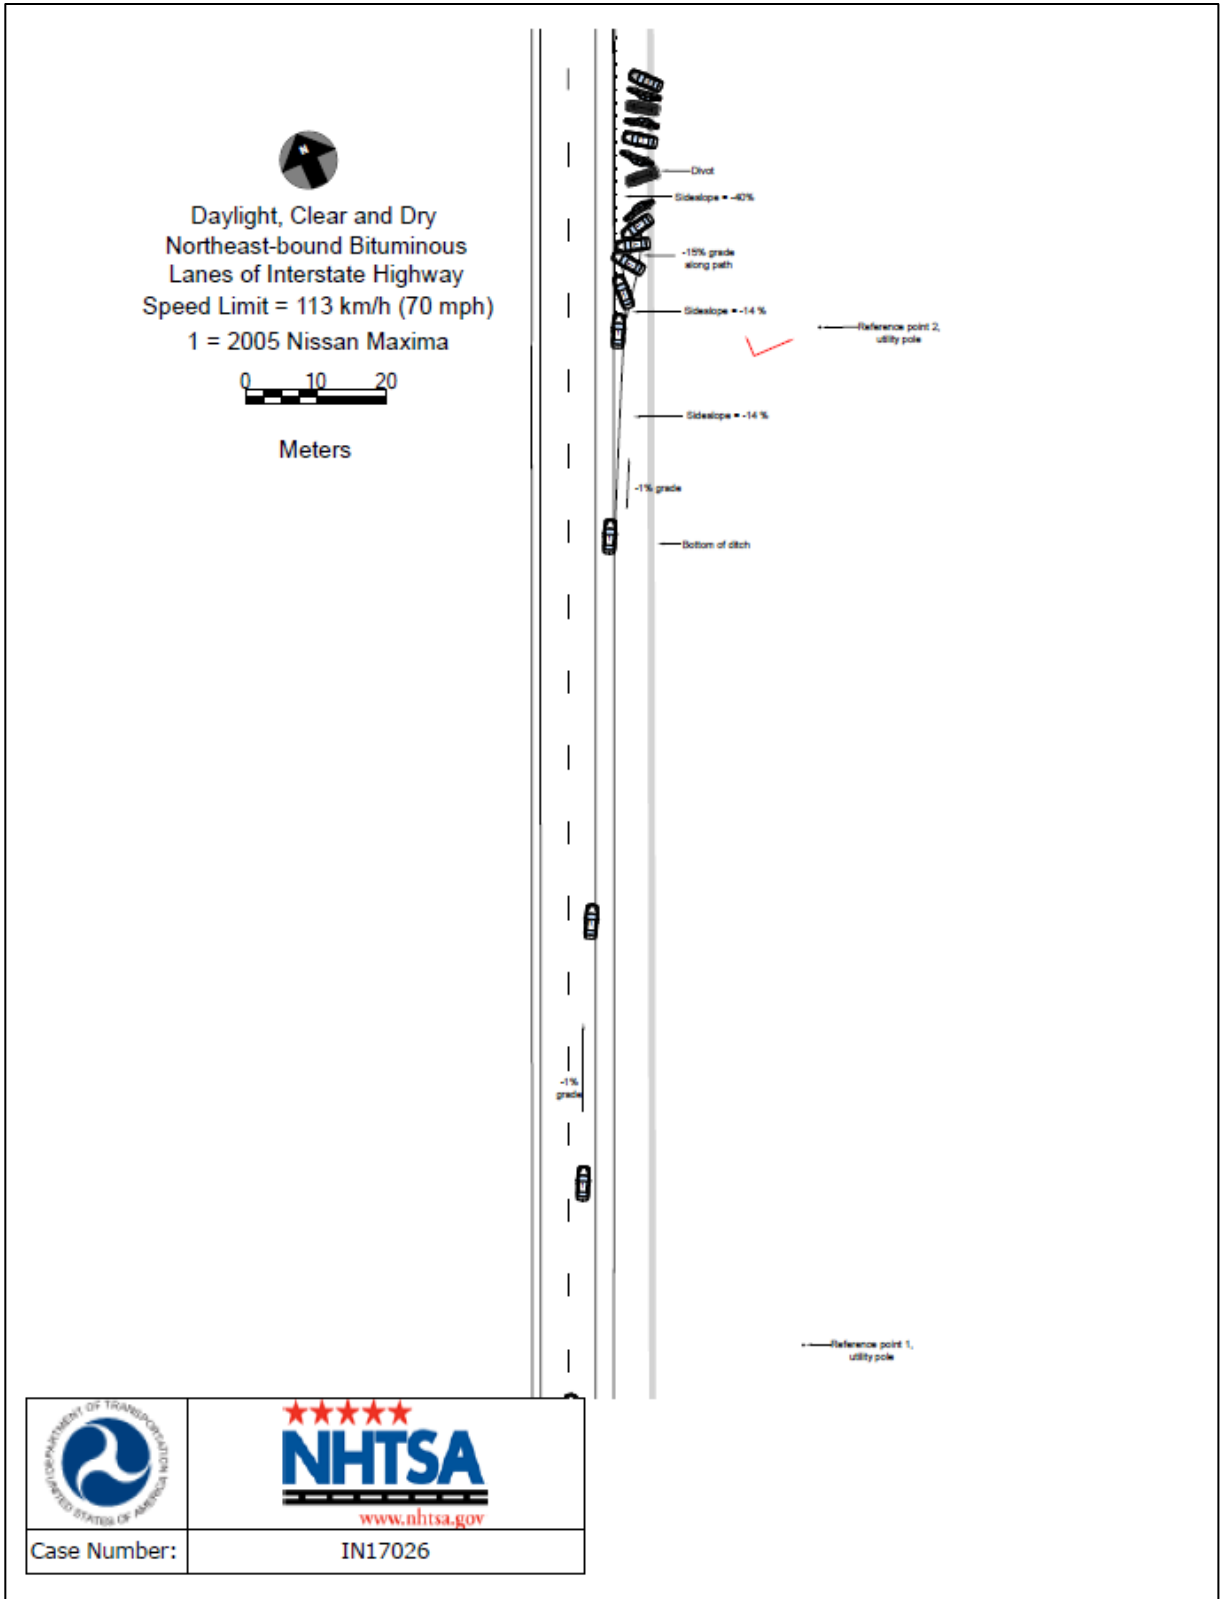
# CRASH DIAGRAM

direction. He sustained a right chest contusion and a posterior scalp abrasion from unknown sources. The Nissan came to final rest on its wheels. The driver opened the left-front door and exited the vehicle without assistance. He was subsequently transported by ambulance to a local hospital where he was treated in the emergency room and then hospitalized for three days for treatment of his injuries.
