DOT HS 813 036

# **Special Crash Investigations: Alleged Air Bag Injury Investigation; Vehicle: 2018 Volkswagen Passat; Location: Tennessee; Crash Date: January 2019**

**Special Crash Investigations  
Alleged Air Bag Injury Investigation  
Office of Defects Investigation  
Case Number: DS19005  
Vehicle: 2018 Volkswagen Passat  
Location: Tennessee  
Crash Date: January 2019**

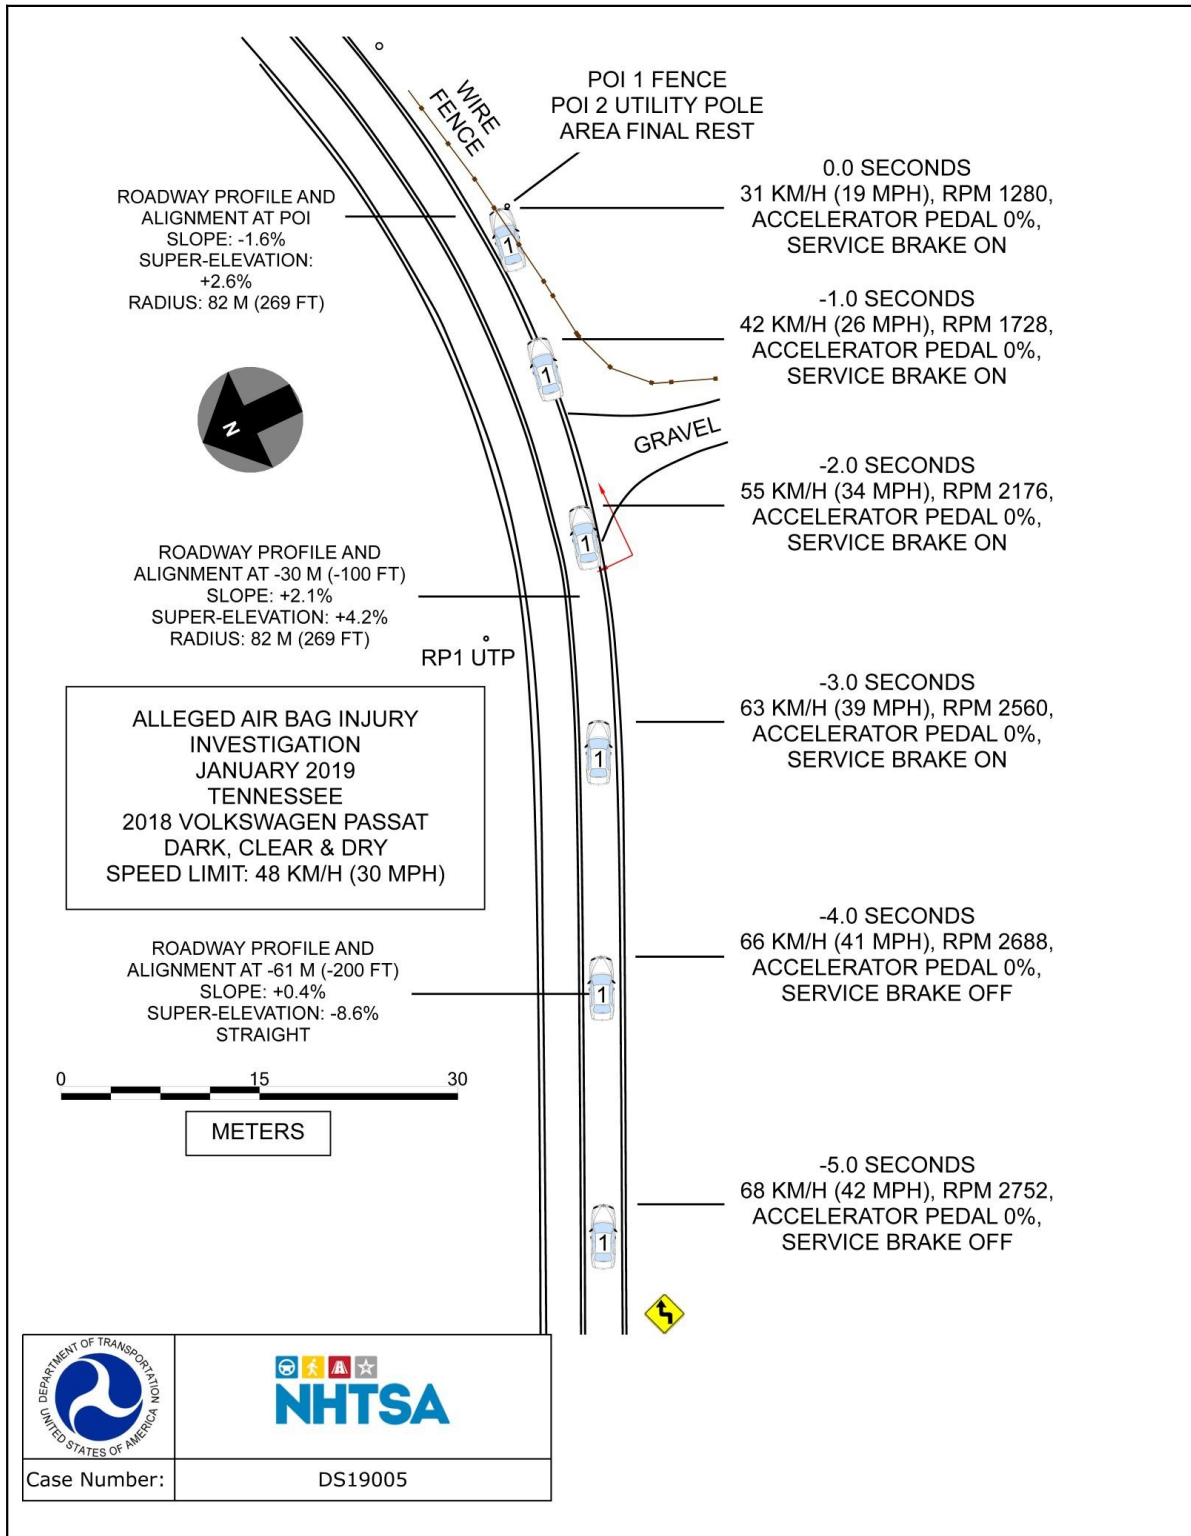
# CRASH DIAGRAM

The unbelted 63-year-old male driver was seated in an upright posture and, for undetermined reasons, departed the roadway on the right edge while actively braking and steering. At impact with the utility pole, the driver was displaced forward and slightly right in response to the 12 o'clock direction of force. The driver's pelvis and lower extremities likely loaded his seat cushion, and his chest and abdomen likely loaded the deployed frontal air bag causing a compression fracture to the lumbar spine at L1. Neither the seat cushion nor frontal air bag revealed evidence of occupant contact. His right forearm probably loaded the right aspect of the air bag causing an abrasion, and his neck and head possibly hyper-extended forward over the air bag and steering wheel rim causing a transverse process fracture of the cervical spine at C2. Given the driver's unbelted status and the crash severity, it seems likely that he was displaced from his seated position. It was not known if his head contacted interior components but he allegedly sustained a concussion. His medical records did not identify any evidence of head injury. Following the crash, the driver exited the vehicle without assistance and awaited the arrival of responders. He was transported by ambulance to a local hospital, where he was treated for approximately 3 hours. The driver was then transferred by ambulance to a trauma hospital in another city, where he was admitted overnight.
