DOT HS 813 125

# **Special Crash Investigations: On-Site Guardrail End Terminal Crash Investigation; Vehicle: 1998 Ford Ranger; Location: Missouri; Crash Date: August 2018**

**Special Crash Investigations**  
**On-Site Guardrail End Terminal Crash Investigation**  
**Case Number: DS18023**  
**Vehicle: 1998 Ford Ranger**  
**Location: Missouri**  
**Crash Date: August 2018**

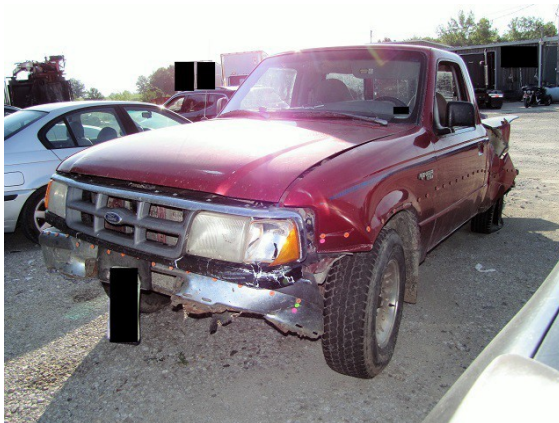
*Figure 1. The 1998 Ford Ranger*

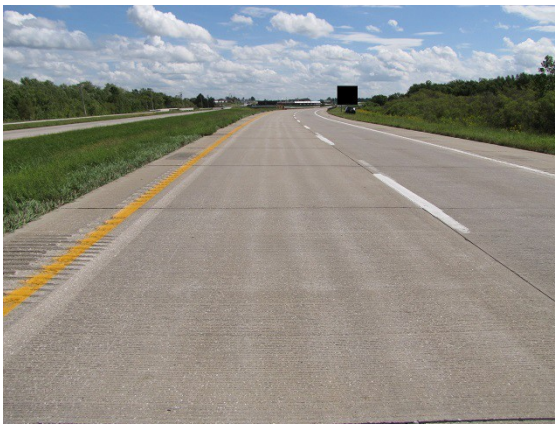
The crash site was a divided eastbound State highway. The roadway included two concrete eastbound lanes, each measuring 3.6 m (12.7 ft), separated by a dashed white painted stripe and bordered by a solid yellow painted fog line on the left and a solid white painted fog line on the right (Figure 3). The roadway was configured with a paved concrete shoulder on the left measuring 1.0 m (3.0 ft) in width and a paved concrete shoulder on the right measuring 3.1 m (9.2 ft) in width. The left shoulder was configured with two types of rumble strips. Milled-in 13 cm (5.0 in) grooves, cut 1 cm (7/16 in) deep and spaced 30 cm (12.0 in) apart, were present on the yellow-painted fog line. Intermittent traverse rumble strips measuring 40 cm (16.0 in) in width and spaced 8.6 m (28.2 ft) apart were offset 15 cm (6.0 in) left of the fog line. A metal post and steel guardrail configured with an SKT end terminal was located 1.3 m (4.3 ft) left of the left fog line (Figure 4, see Guardrail End Terminal Discussion of this report.). The roadway curved right at a radius measuring 630.0 m (2,067.0 ft) at the left fog line with a level slope measured at 15.0 m (50.0 ft) in advance of the end terminal. The super-elevation at that point was positive 6.6 percent. The roadway straightened at the SKT and continued straight for 25.0 m (82.0 ft) before curving back to the right. At Post 1, the roadway slope was level and the super-elevation was positive 5.7 percent.

*Figure 3. Crash site looking east*
