DOT HS 813 220

# **Special Crash Investigations: On-Site Alleged Driver Air Bag Fatality Crash Investigation; Vehicle: 2009 Saturn Aura; Location: Indiana; Crash Date: January 2020**

**Special Crash Investigations**  
**On-Site Alleged Driver Air Bag Fatality Crash Investigation**  
**SCI Case No: CR20014**  
**Vehicle: 2009 Saturn Aura**  
**Location: Indiana**  
**Crash Date: January 2020**

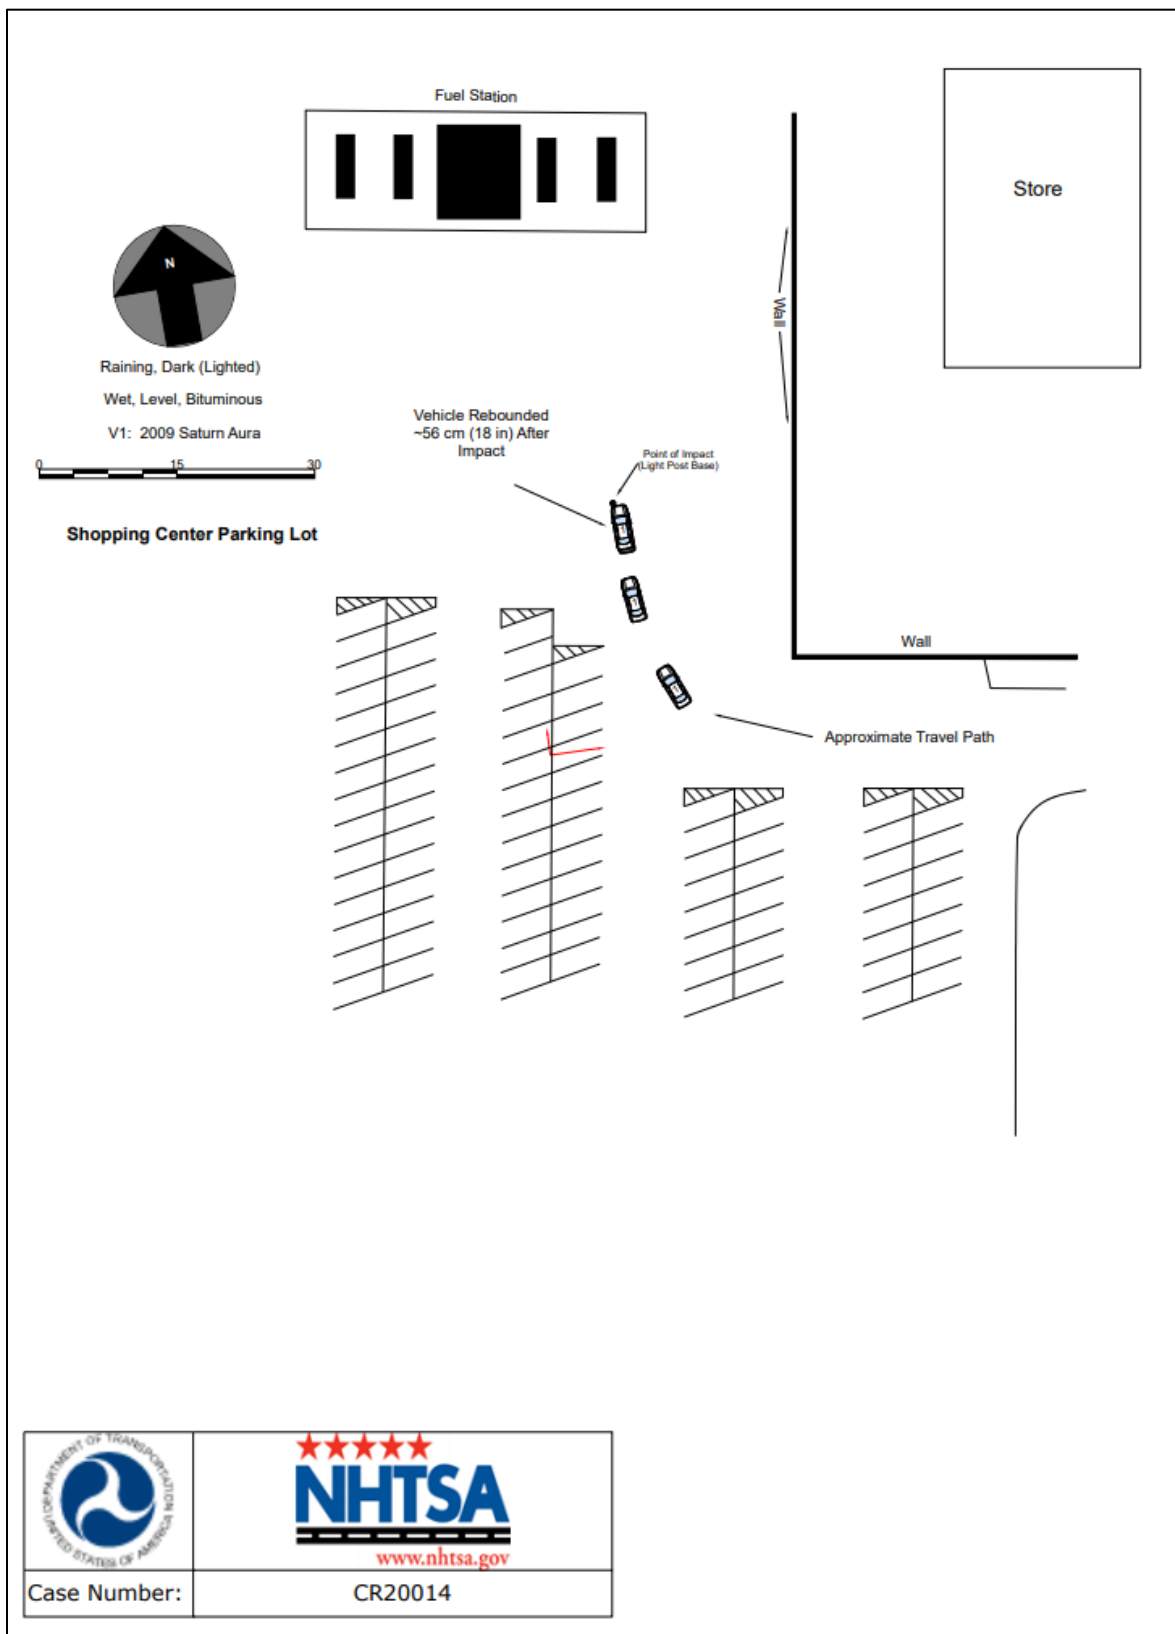
## Crash Diagram

The front plane/left and center aspect of the Saturn struck the concrete base of the light pole. The resultant direction of force was 12 o'clock. The out-of-position driver initiated a forward trajectory in response to the impact force. Her anterior neck likely engaged the edge of the horizontally held cell phone and captured the phone against the steering wheel rim/spoke, causing a fracture of the thyroid cartilage with vocal cord involvement, a pharynx laceration, and an abrasion and contusion over the midline of the neck. The dimensions of the focal contusion and cartilage

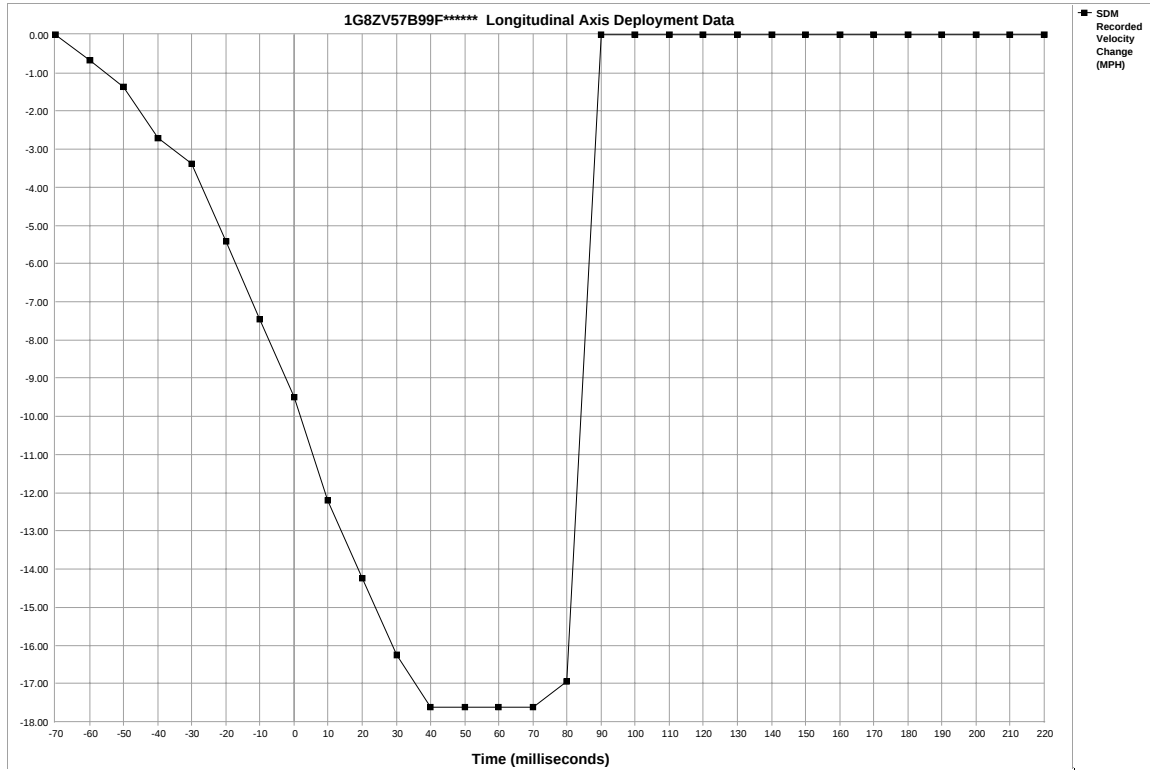
| SDM Longitudinal Axis Recorded Velocity Change (MPH) | 0.00 | -0.68 | -1.36 | -2.71 | -3.39 | -5.42 | -7.45 | -9.49 | -12.20 | -14.23 | -16.26 | -17.62 | -17.62 | -17.62 | -17.62 |
| SDM Longitudinal Axis Recorded Velocity Change (MPH) | -16.94 | 0.00 | 0.00 | 0.00 | 0.00 | 0.00 | 0.00 | 0.00 | 0.00 | 0.00 | 0.00 | 0.00 | 0.00 | 0.00 | 0.00 |

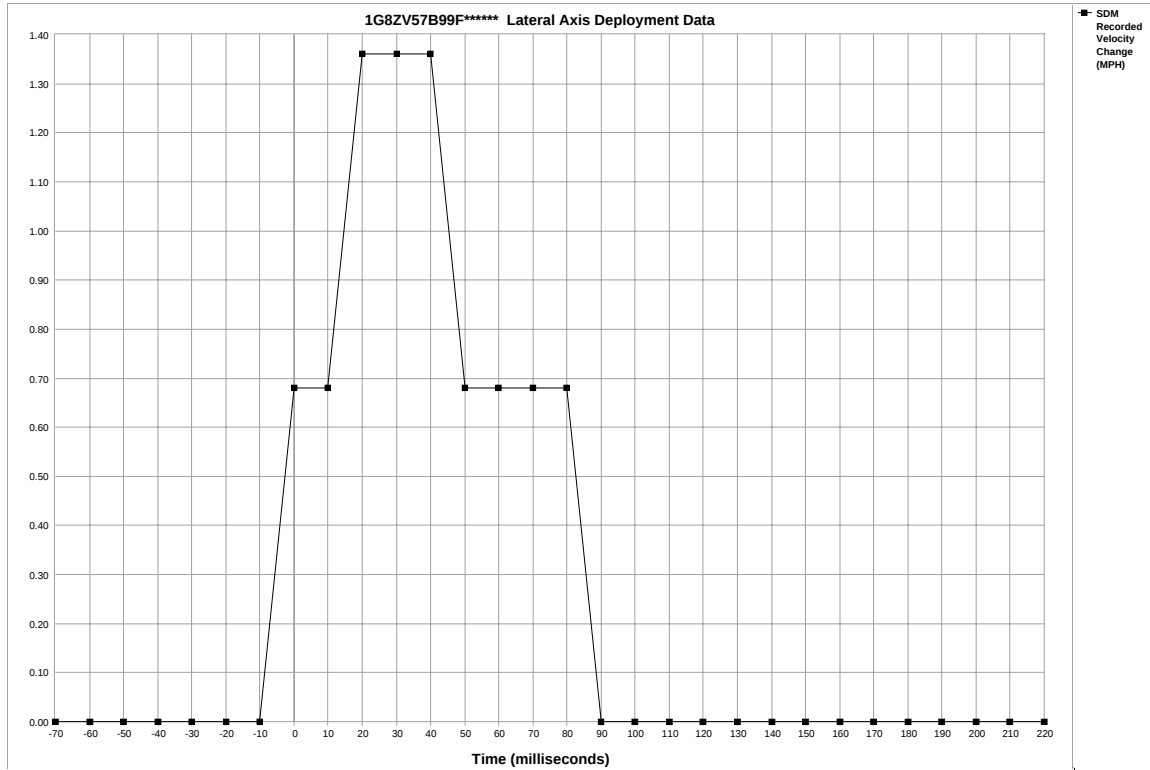
| SDM Lateral Axis Recorded Velocity Change (MPH) | 0.00 | 0.00 | 0.00 | 0.00 | 0.00 | 0.00 | 0.00 | 0.68 | 0.68 | 1.36 | 1.36 | 1.36 | 0.68 | 0.68 | 0.68 |
